Visual Site Inspection Report

Project Name H-600 Pipeline Spread G		AFE 124300137	Spread H-600 Pipeline Spread G
Contractor Precision		Report # 19584	
Inspector Chris Burns		Date/Time 2/1/2021 11:46 AM	
Permit # TBD	Inspection Type VA SWPP	Station Begin 11254+99	
State VA	Inspection Area Partial	Station End 11353+67	
County Giles	Ground Frozen	Temperature (°F) 36.00	
Municipality N/A	Weather Cloudy	Rain Gauge (in) 0.00	
			Rain Accumulation Time (days) 1.00

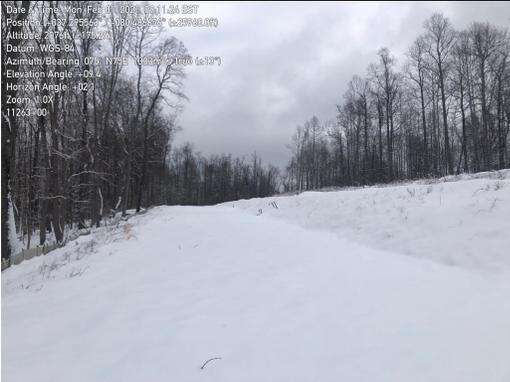
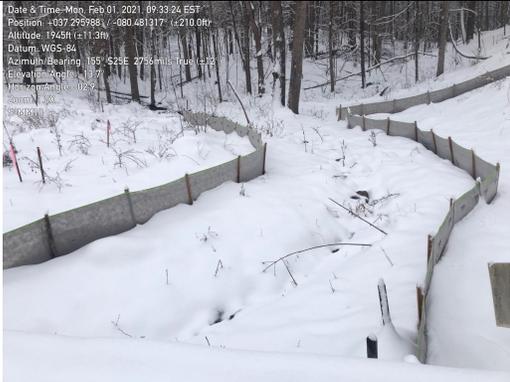
GPS Location 1		GPS Location 2			
Field Station# 11263+00		Field Station# 11292+80			
Pic 1 Desc. Section of RoW showing conditions and controls.		Pic 2 Desc. S-MM18 and controls.

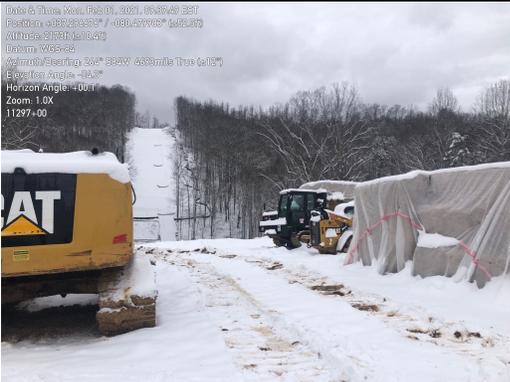
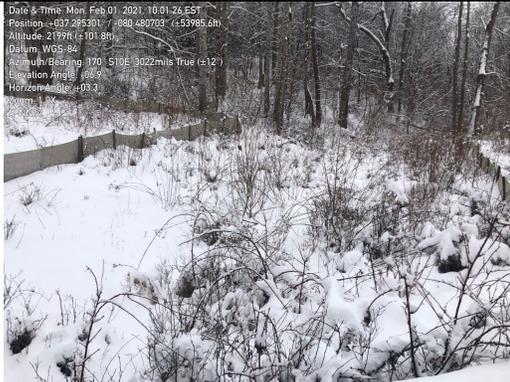
GPS Location 3		GPS Location 4			
Field Station# 11297+00		Field Station# 11327+85			
Pic 3 Desc. Equipment and materials staged.		Pic 4 Desc. S-NN12 and controls.

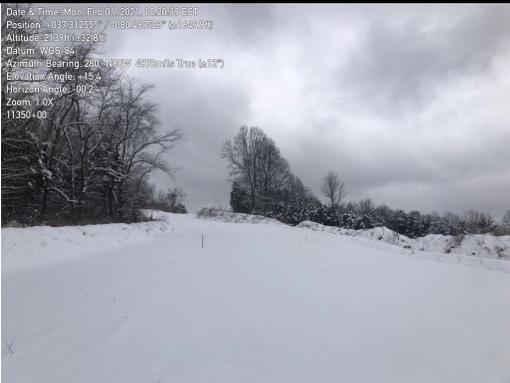
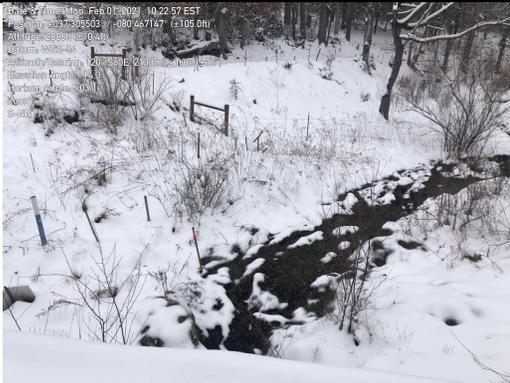
GPS Location 5		GPS Location 6			
Field Station# 11350+00		Field Station# 11352+97			
Pic 5 Desc. Section of RoW showing conditions and controls.		Pic 6 Desc. S-NN11.

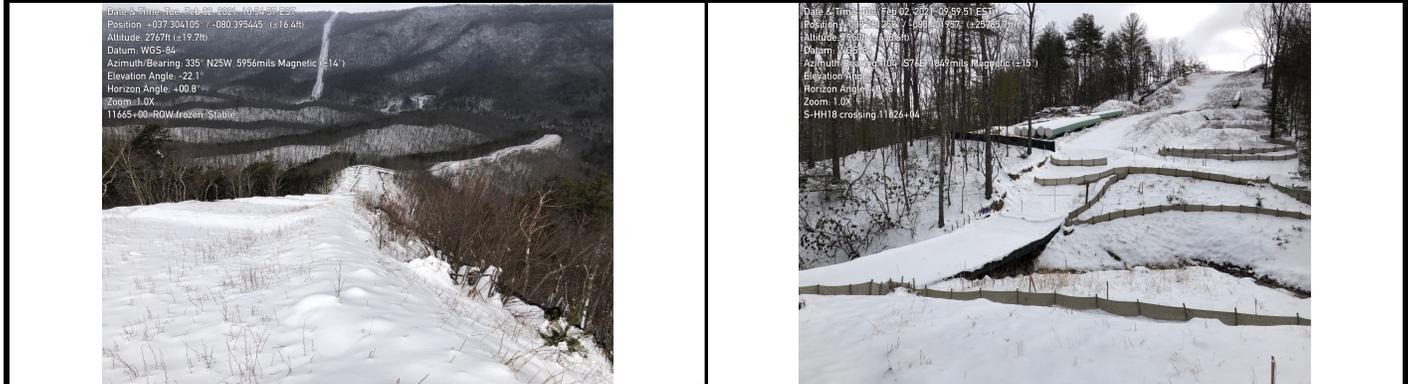
GPS Location	On photo	GPS Location	On photo
Field Station#	11665+00	Field Station#	11626+04
Pic 1 Desc.	ROW stable with perimeter controls in place. Ground frozen with no runoff occurring.	Pic 2 Desc.	The S-HH18 crossing is stable, ECDs in place and no visible impact.

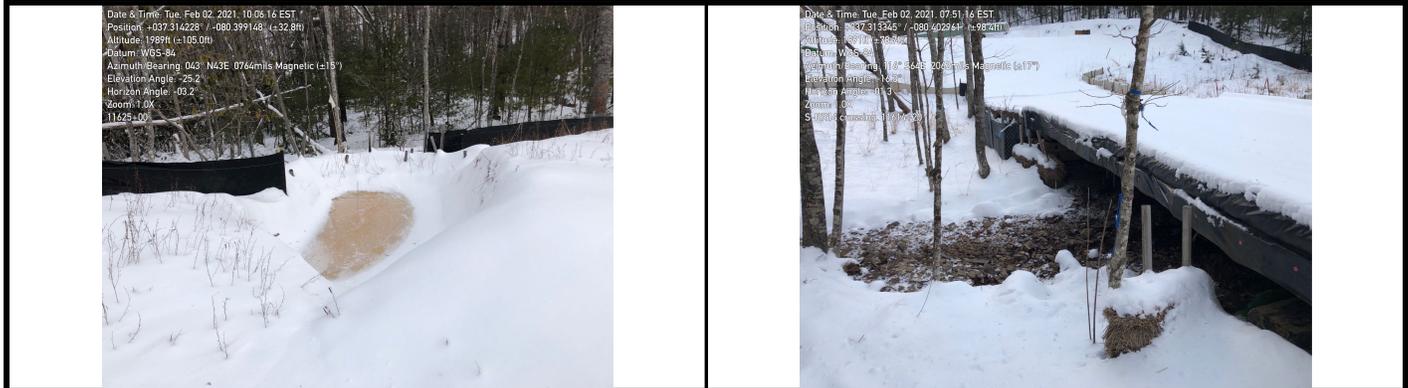
GPS Location	On photo	GPS Location	On photo
Field Station#	11625+00	Field Station#	11614+20
Pic 3 Desc.	Frozen conditions. ROW stable with no runoff. ECDs are in place.	Pic 4 Desc.	S-RR14 crossing and buffer currently stable with ECDs in place.

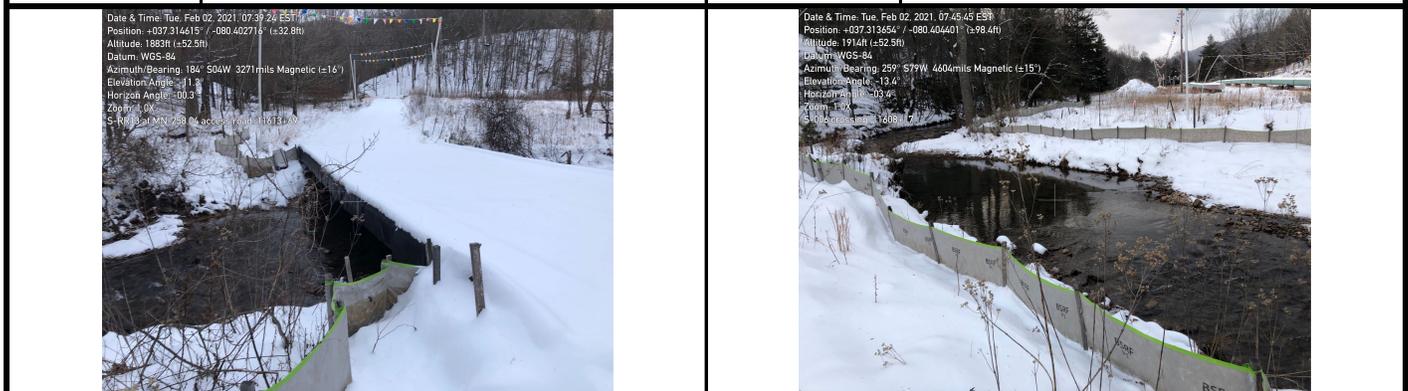
GPS Location	On photo	GPS Location	On photo
Field Station#	11613+69	Field Station#	11608+17
Pic 5 Desc.	S-RR13 crossing at access road MN-258.04 stable with ECDs in place.	Pic 6 Desc.	The S-006 crossing and buffer zone is stable with ECDs in place.

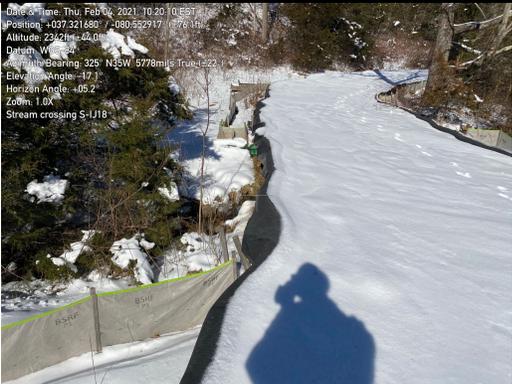
<p><small>Date & Time: Thu, Feb 04, 2021, 10:20:10 EST Position: +037.321680 / -080.522917 (-62.110) Altitude: 2329ft (-70.0m) Datum: WGS-84 Azimuth/Bearing: 325° N5W, 5778mils True (-22) Elevation Angle: -17.1 Horizon Angle: -05.2 Zoom: 1.0x Stn: 10922+00 - Row, snow covered water bars, controls</small></p>

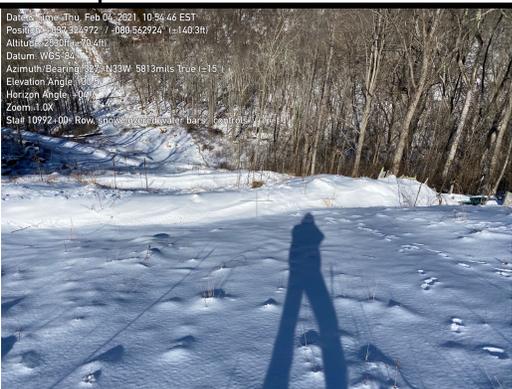
<p><small>Date & Time: Thu, Feb 04, 2021, 10:54:46 EST Position: +037.324972 / -080.522924 (-62.1403hr) Altitude: 2350ft (-71.6m) Datum: WGS-84 Azimuth/Bearing: 313° N3W, 5813mils True (-15) Elevation Angle: -10.1 Horizon Angle: -01.1 Zoom: 1.0x Stn: 10992+00 - Row, snow covered water bars, controls</small></p>

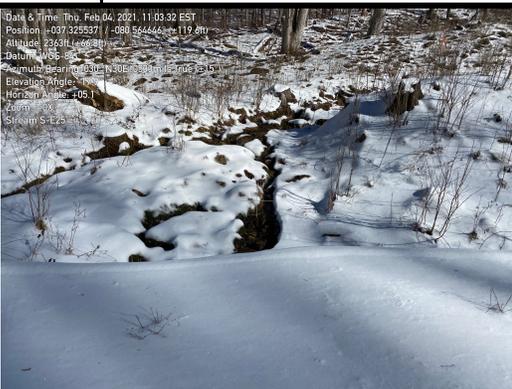
<p><small>Date & Time: Thu, Feb 04, 2021, 11:03:32 EST Position: +037.325371 / -080.564444 (-62.1198hr) Altitude: 2363ft (-72.0m) Datum: WGS-84 Azimuth/Bearing: 305° N3W, 5613mils True (-15) Elevation Angle: -09.5 Horizon Angle: -00.1 Zoom: 1.0x Stn: 10986+00 - Stream S- E25</small></p>

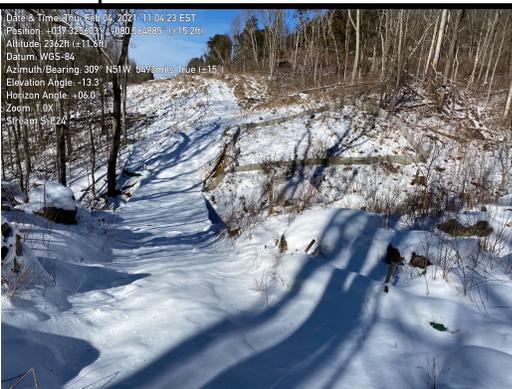
<p><small>Date & Time: Thu, Feb 04, 2021, 11:04:23 EST Position: +037.325381 / -080.564895 (-62.152hr) Altitude: 2352ft (-71.7m) Datum: WGS-84 Azimuth/Bearing: 309° N5W, 5693mils True (-15) Elevation Angle: -13.3 Horizon Angle: -06.0 Zoom: 1.0x Stn: 10985+00 - Stream S- E24, bridge and ECD's</small></p>

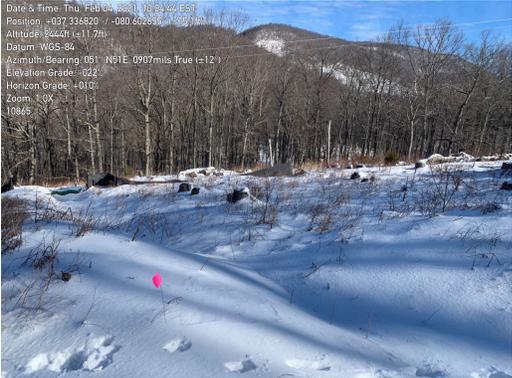
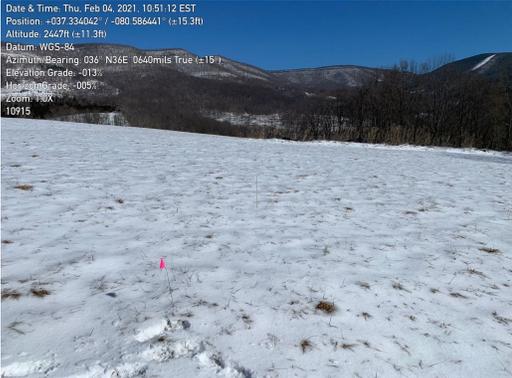
GPS Location		See picture above for GPS coordinates		GPS Location	
See picture above for GPS coordinates				See picture above for GPS coordinates	
Field Station#		10865+00		Field Station#	
10865+00				10915+00	
Pic 3 Desc.		Damaged ECD's		Pic 4 Desc.	
				Damaged ECD's
