Visual Site Inspection Report

Project Name	H-600 Pipeline Spread G	AFE	124300137	Spread	H-600 Pipeline Spread G
Contractor	Precision			Report #	22157
Inspector	Len Kruizenga			Date/Time	4/12/2021 7:57 AM
Permit #	TBD	Inspection Type	VA SWPP	Station Begin	12005+00
State	VA	Inspection Area	Full	Station End	12005+00
County	Giles	Ground	Wet	Temperature (°F)	61.00
Municipality	N/A	Weather	Sunny	Rain Gauge (in)	0.00
				Rain Accumulation Time (days)	1.00

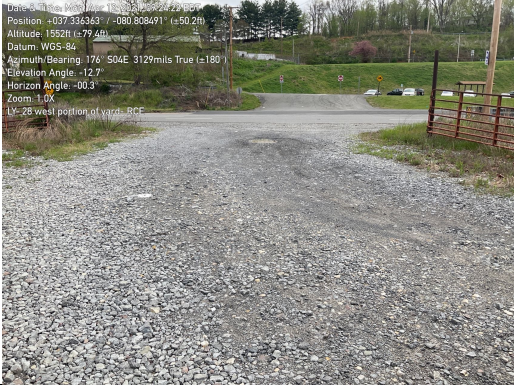
GPS Location	See photo GPS		GPS Location	See photo GPS	
Field Station#	12005+00		Field Station#	12005+00	
Pic 1 Desc.	LY28- RCE		Pic 2 Desc.	LY28- Transport buses, five have containment units under them.

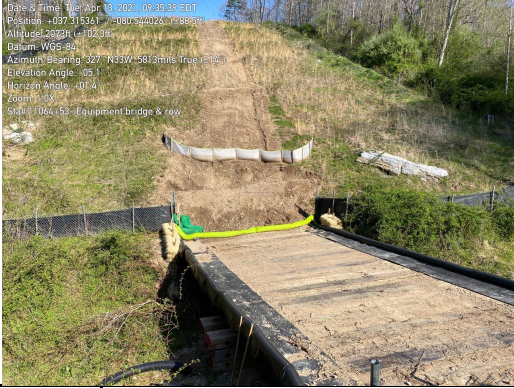
GPS Location	See photo GPS		GPS Location	See photo GPS	
Field Station#	11064+53		Field Station#	11058+00	
Pic 1 Desc.	Bridge over drainage feature and steep slope.		Pic 2 Desc.	Karst ECD's.

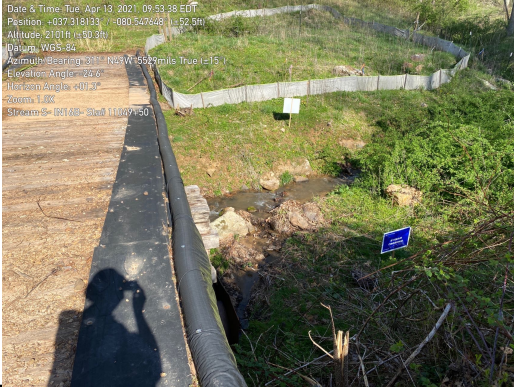
GPS Location	See photo GPS		GPS Location	See photo GPS	
Field Station#	11049+50		Field Station#	11045+00	
Pic 3 Desc.	Stream S- IJ16B		Pic 4 Desc.	Vegetation and water bars on steep slope.

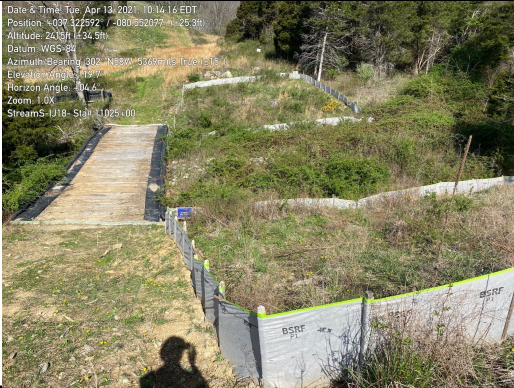
GPS Location	See photo GPS		GPS Location	See photo GPS	
Field Station#	11025+00		Field Station#	11023+88	
Pic 5 Desc.	Stream S- IJ18		Pic 6 Desc.	AR-244.00- Stream -S-IJ19

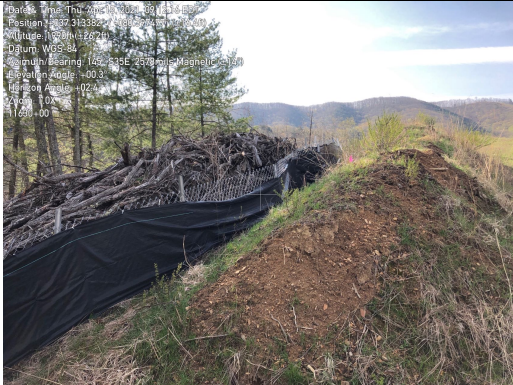
<p>Date & Time: Thu, Apr 15, 2021, 09:13:48 EDT Position: +321.31333° / +88.397688° (+16.4ft) Altitude: 1990ft (+19.2ft) Datum: WGS 84 Azimuth Bearing: 102.5° 0907mils Magnetic (+14) Elevation Angle: -34.2 Horizon Angle: +00.3 Zoom: 1.0X 11630+00</p>					
GPS Location		On photo		GPS Location		On photo	
Field Station#		11629+25		Field Station#		11630+00	
Pic 1 Desc.		Communication. ECD maintenance need identified. Contractor notified.		Pic 2 Desc.		Communication. ECD maintenance need identified. Contractor notified.

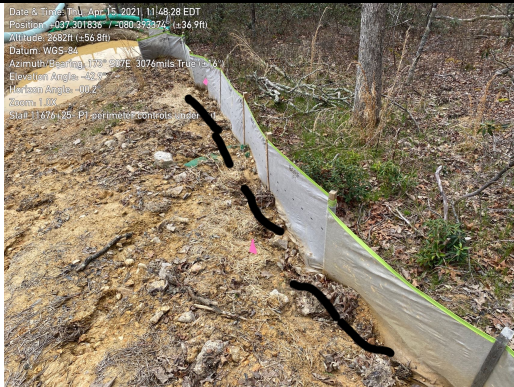
<p>Date & Time: Thu Apr 15, 2021, 11:48:28 EDT Position: +037 299845 / -080 391556 (+44.9ft) Altitude: 2456ft (+44.9ft) Datum: WGS-84 Azimuth-Bearing: 130° S/E 3074mils True (+14°) Elevation-Angle: -02.3 Horizon-Angle: -00.2 Zoom: 1.0X Stn: 11676+25: P1 perimeter controls under cut</p>			
GPS Location	See photo GPS	GPS Location	See photo GPS		
Field Station#	11672+00	Field Station#	11676+25		
Pic 1 Desc.	Water bars, P1 perimeter controls, CFS end treatments.	Pic 2 Desc.	P1 perimeter controls are under cut, issue punch listed.

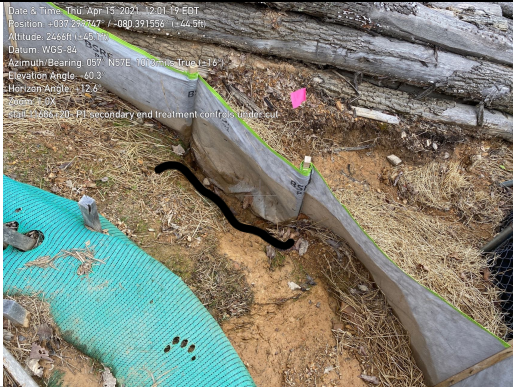
<p>Date & Time: Thu Apr 15, 2021, 12:11:19 EDT Position: +037 299845 / -080 391556 (+44.9ft) Altitude: 2456ft (+44.9ft) Datum: WGS-84 Azimuth-Bearing: 051° NS/E 428mils True (+14°) Elevation-Angle: +21.7 Horizon-Angle: +01.1 Zoom: 1.0X Stn: 11686+20: P1 secondary end treatment controls under cut</p>

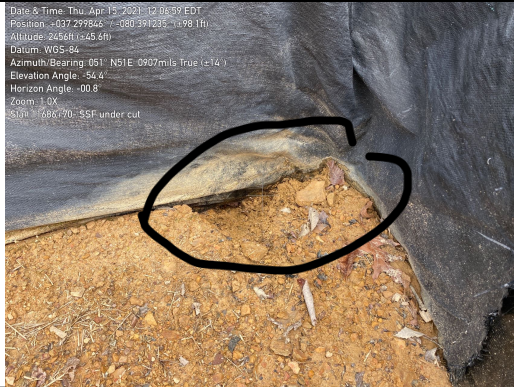
<p>Date & Time: Thu Apr 15, 2021, 12:06:59 EDT Position: +037 299845 / -080 391235 (+44.9ft) Altitude: 2456ft (+44.9ft) Datum: WGS-84 Azimuth-Bearing: 051° NS/E 428mils True (+14°) Elevation-Angle: +21.7 Horizon-Angle: +01.1 Zoom: 1.0X Stn: 11686+70: SSF under cut</p>			
GPS Location	See photo GPS	GPS Location	See photo GPS		
Field Station#	11686+20	Field Station#	11686+70		
Pic 3 Desc.	P1 secondary end treatment controls are under cut, issue added to the punch list.	Pic 4 Desc.	SSF perimeter controls are under cut, issue added to the punch list.

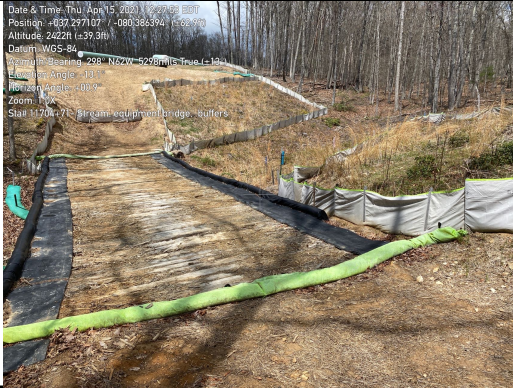
<p>Date & Time: Thu Apr 15, 2021, 12:27:04 EDT Position: +037 297109 / -080 385941 (+38.9ft) Altitude: 2422ft (+38.9ft) Datum: WGS-84 Azimuth-Bearing: 208° NW/E 5298mils True (+14°) Elevation-Angle: +13.1 Horizon-Angle: +06.4 Zoom: 1.0X Stn: 11704+71: Stream, equipment bridge, buffers</p>

GPS Location	See photo GPS	GPS Location	See photo GPS		
Field Station#	11704+71	Field Station#	11734+00		
Pic 5 Desc.	Stream, equipment bridge, buffers.	Pic 6 Desc.	Stabilized row, mulched with new growth showing through mulch.

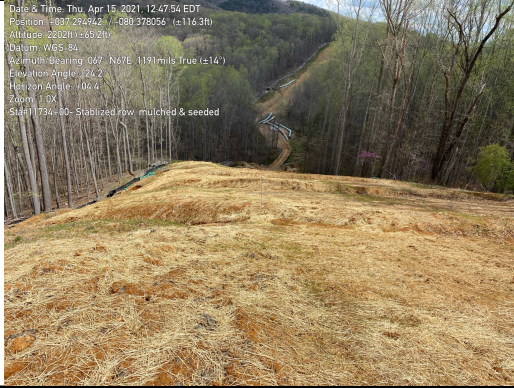
<p>Date & Time: Thu Apr 15, 2021, 12:47:34 EDT Position: +037 297109 / -080 378656 (+116.3ft) Altitude: 2402ft (+116.3ft) Datum: WGS-84 Azimuth-Bearing: 067° N/E 1191mils True (+14°) Elevation-Angle: +12.2 Horizon-Angle: +06.4 Zoom: 1.0X Stn: 11734+00: Stabilized row, mulched & seeded</p>

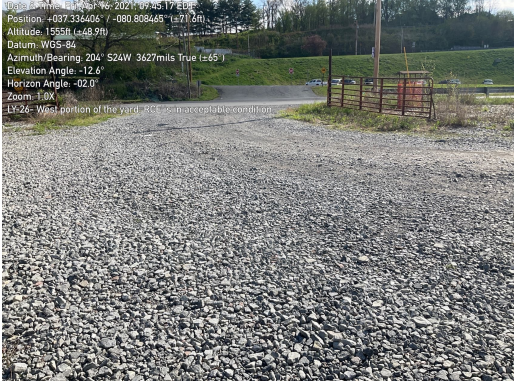
GPS Location	See photo GPS	GPS Location	See photo GPS		
Field Station#	12005+00	Field Station#	12005+00		
Pic 1 Desc.	LY-28- West most portion of the yard. RCE.	Pic 2 Desc.	LY-28- Transport buses with containment units under them.

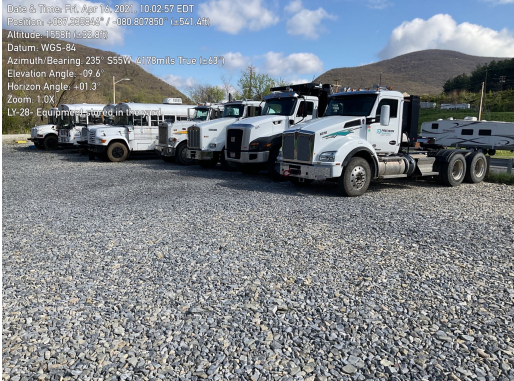
GPS Location	See photo GPS	GPS Location	See photo GPS		
Field Station#	12005+00	Field Station#	12005+00		
Pic 3 Desc.	LY 28- Dump truck and semi tractors stored in the yard.	Pic 4 Desc.	LY-28- East portion- Employees parking, did not observe any fluid leaks from vehicles.

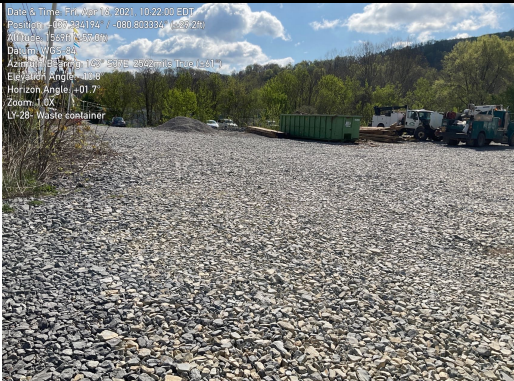
GPS Location	See photo GPS	GPS Location	See photo GPS		
Field Station#	12005+00	Field Station#	12005+00		
Pic 5 Desc.	LY-28- Waste container.	Pic 6 Desc.	LY-28- CFS perimeter controls.
