Visual Site Inspection Report

Project Name	H-600 Pipeline Spread G	AFE	124300137	Spread	H-600 Pipeline Spread G
Contractor	Precision			Report #	22407
Inspector	Patrick Shields			Date/Time	4/19/2021 7:05 AM
Permit #	TBD	Inspection Type	VA SWPP	Station Begin	10674+81
State	VA	Inspection Area	Partial	Station End	10929+62
County	Giles	Ground	Dry	Temperature (°F)	61.00
Municipality	N/A	Weather	Cloudy	Rain Gauge (in)	0.00
				Rain Accumulation Time (days)	1.00

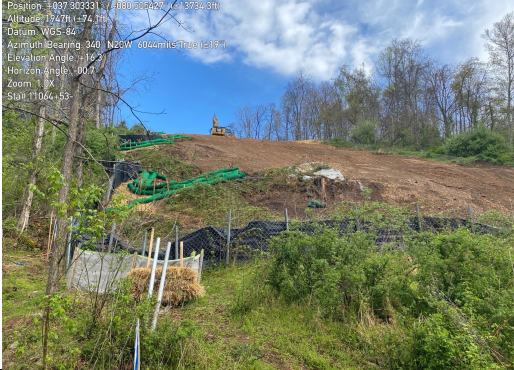
<p>Date & Time: Mon, Apr 19, 2021, 09:09:43 EDT Position: +037.303100, -080.528600, (+129.9ft) Altitude: 2211ft (+331.1ft) Datum: WGS 84 Azimuth/Bearing: 337° N23W 599mils True (±19°) Elevation Angle: +13.1° Horizon Angle: +02.5° Zoom: 1.0x Star: 11058+00 - Karst ECD's</p>

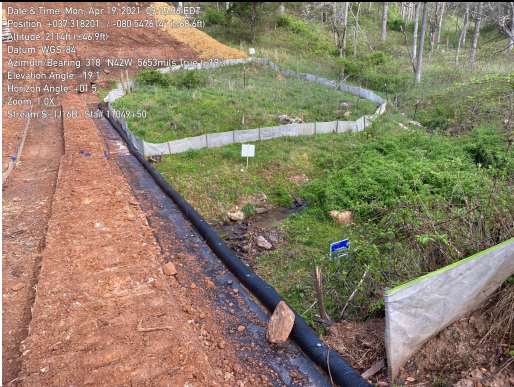
<p>Date & Time: Mon, Apr 19, 2021, 09:15:56 EDT Position: +037.339100, -080.547720, (+15.0ft) Altitude: 2103ft (+315.9ft) Datum: WGS 84 Azimuth/Bearing: 288° N74W 508mils True (±19°) Elevation Angle: +08.5° Horizon Angle: +02.5° Zoom: 1.0x Star: 11045+00 - Row grading</p>

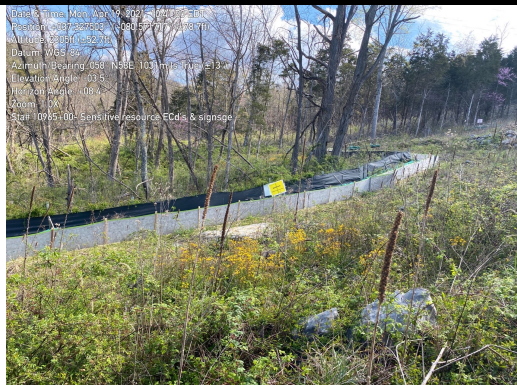
<p>Date & Time: Mon Apr 19 2021 10:24:51 EDT Position: +037.326332 / -080.553337 / 139.3ft Altitude: 2270ft (±10.3m) Datum: WGS-84 Azimuth Bearing: 239° N62W 5594mils True (±15m) Elevation Angle: -11.5 Horizontal Angle: -02.4 Zoom: 1.0X Staff: 10953+00- Drainage feature, bridge, ECD's</p>

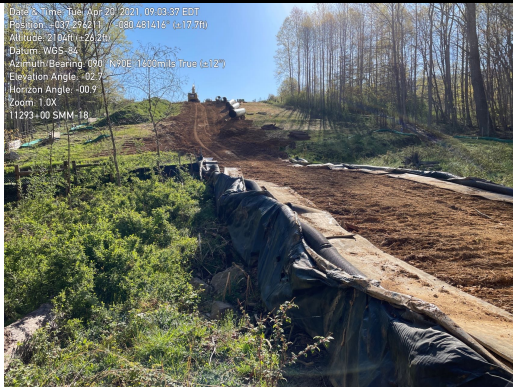
<p>Date & Time: Tue, Apr 20, 2021, 09:03:39 EDT Position: +037.316213, -080.443013, +221.7m Altitude: 2194ft (+221.7m) Datum: WGS 84 Azimuth Bearing: 050. NSSE 0889mils True (+2.4°) Elevation Angle: -32.4° Horizon Angle: -00.6° Zoom: 1.0x 11293+00</p>			
GPS Location				See photo				GPS Location				See photo			
Field Station#				11444+50				Field Station#				111293+00			
Pic 1 Desc.				Flow path slope drain needs cleared				Pic 2 Desc.				Bridge needs repaired

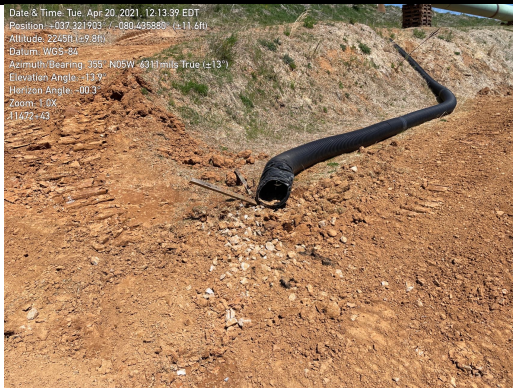
<p>Date & Time: Tue, Apr 20, 2021, 12:13:39 EDT Position: +037.321093, -080.438009, +215.1m Altitude: 2225ft (+225.1m) Datum: WGS 84 Azimuth Bearing: 050. NSW 6364mils True (+1.1°) Elevation Angle: -45.1° Horizon Angle: -00.3° Zoom: 1.0x 11472+43</p>			
GPS Location				See photo				GPS Location				See photo			
Field Station#				11487+00				Field Station#				11472+43			
Pic 5 Desc.				CWD pipe not connected properly				Pic 6 Desc.				RFO on slope drain not functional

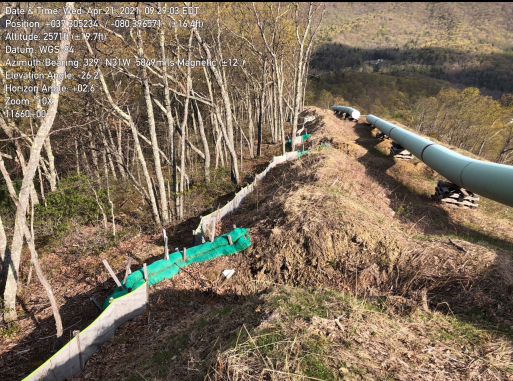
GPS Location		On photo		GPS Location	
Field Station#		11661+00		Field Station#	
Pic 5 Desc.		Communication; worn P1 to be repaired and/or replaced.		Pic 6 Desc.

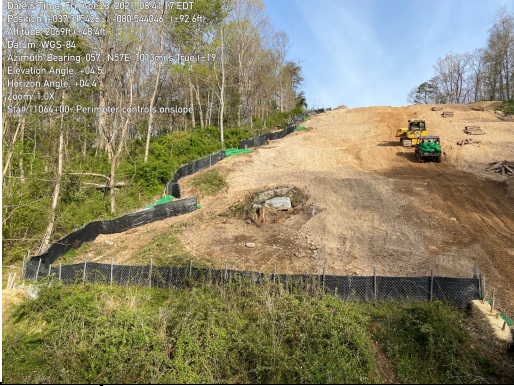
<p>Date & Time: Fri, Apr 23, 2021, 08:47:17 EDT Position: +037°31'53.187" / -080°54'28.0" (+42.7m) Altitude: 21850 (+42.2m) Datum: WGS-84 Azimuth/Bearing: 057° N57E 1031mils True (+1.9) Elevation Angle: +04.5° Horizon Angle: -04.2° Horizon Angle: -02.2° Zoom: 1.0X Sta# 11064+00- Perimeter controls on slope</p>

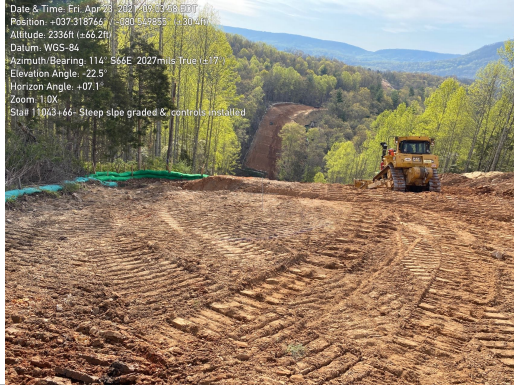
<p>Date & Time: Fri, Apr 23, 2021, 09:16:49 EDT Position: +037°31'57.666" / -080°54'28.0" (+42.7m) Altitude: 23368 (+66.2m) Datum: WGS-84 Azimuth/Bearing: 116° S44E 2027mils True (+17) Elevation Angle: -22.5° Horizon Angle: +07.1° Zoom: 1.0X Sta# 11043+66- Steep slope graded & controls installed</p>

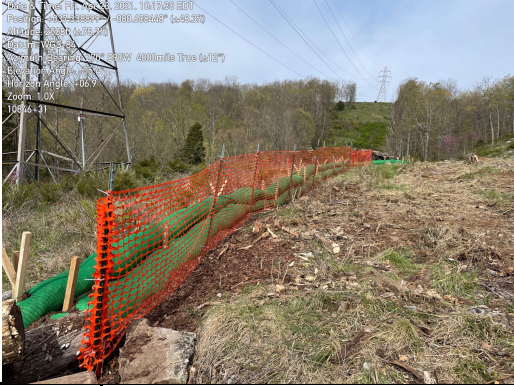
GPS Location	See photo	GPS Location	See photo		
Field Station#	10846+31	Field Station#	10862+80		
Pic 1 Desc.	Safety fence in around tower	Pic 2 Desc.	Waterbar needs installed
