Visual Site Inspection Report

Project Name	H-600 Pipeline Spread G	AFE	124300137	Spread	H-600 Pipeline Spread G
Contractor	Precision			Report #	22674
Inspector	Patrick Shields			Date/Time	4/26/2021 6:55 AM
Permit #	TBD	Inspection Type	VA SWPP	Station Begin	11254+99
State	VA	Inspection Area	Partial	Station End	11524+16
County	Giles	Ground	Muddy	Temperature (°F)	72.00
Municipality	N/A	Weather	Sunny	Rain Gauge (in)	0.00
				Rain Accumulation Time (days)	1.00

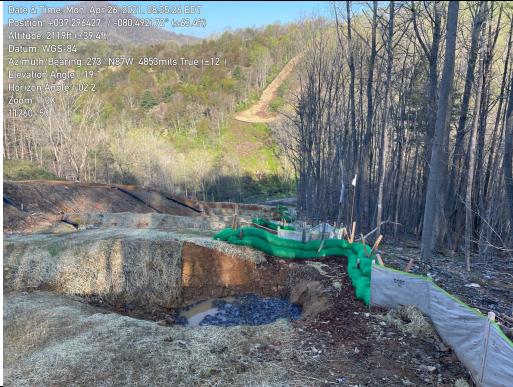
GPS Location				See photo				GPS Location				See photo			
Field Station#				11260+50				Field Station#				11293+00			
Pic 1 Desc.				New 12" CFS triple stack end treatments in place on hill				Pic 2 Desc.				Equipment bridge in place over SWM-18

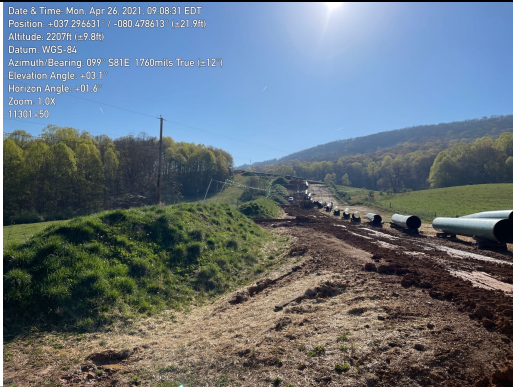
GPS Location				See photo				GPS Location				See photo			
Field Station#				11301+50				Field Station#				11522+17			
Pic 3 Desc.				Good vegetation on topsoil piles				Pic 4 Desc.				Perimeter controls in place. Top soil piles mulched

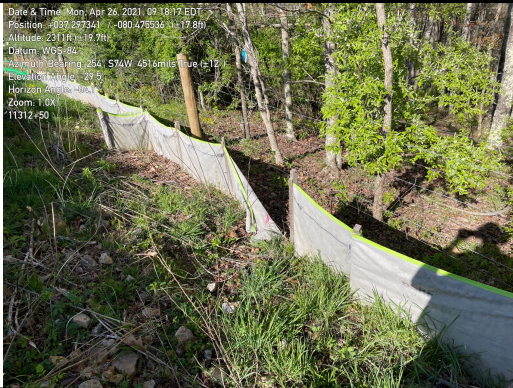
GPS Location				See photo				GPS Location				See photo			
Field Station#				11312+50				Field Station#				11371+00			
Pic 5 Desc.				P1 damaged by wildlife				Pic 6 Desc.				End of culvert buried from last storm water event

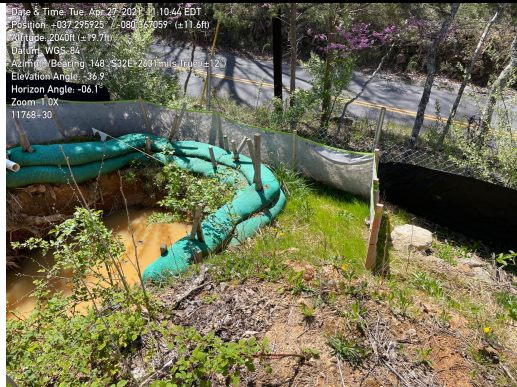
GPS Location	See photo	GPS Location	See photo		
Field Station#	11768+30	Field Station#	11773+00		
Pic 11 Desc.	Good stabilization behind CFS end treatment	Pic 12 Desc.	P1 undermined

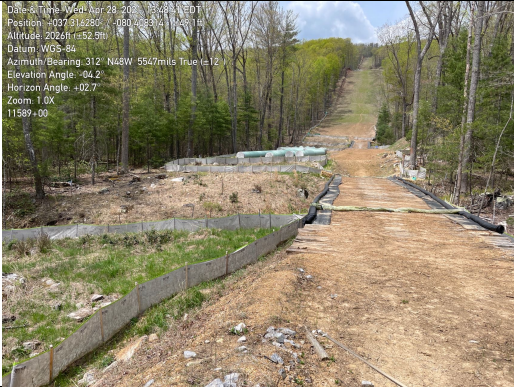
GPS Location	See photo	GPS Location	See photo		
Field Station#	11589+00	Field Station#	11545+00		
Pic 1 Desc.	Buffer in place	Pic 2 Desc.	Composite crew digging ditch/ new ECDs

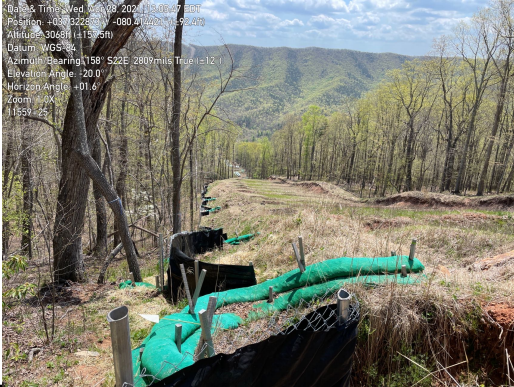
GPS Location	See photo	GPS Location	See photo		
Field Station#	11559+25	Field Station#	11565+00		
Pic 3 Desc.	End treatments in place on hill	Pic 4 Desc.	Clean water diversion berm in place

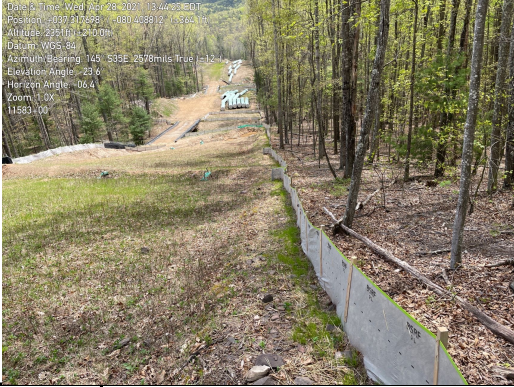
GPS Location	See photo	GPS Location	See photo		
Field Station#	11583+00	Field Station#	11573+00		
Pic 5 Desc.	P1 silt fence perimeter control in place	Pic 6 Desc.	Good vegetation on ROW

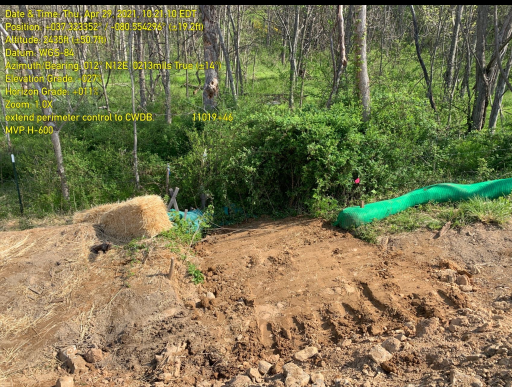
<p>Date & Time: Thu, Apr 29, 2021, 10:02:26 EDT Position: 4071.512329, -88.550459 (e=25.8ft) Altitude: 2309ft (e=72.3m) Datum: WGS-84 Azimuth Bearing: 212.532W 3769mils True (e=14.1) Elevation Grade: -037 Horizontal Grade: -003 Zoom: 1.0X Scale: 1:1000 Install and treatment: MVP H-606</p>			
GPS Location	See photo		GPS Location	See photo	
Field Station#	11003+60		Field Station#	11019+46	
Pic 1 Desc.	Install to spec water bar end treatment.		Pic 2 Desc.	Remove old CFS j-hook and extend CFS 12" perimeter control to CWDB. eliminate the potential for water to run back onto ROW.

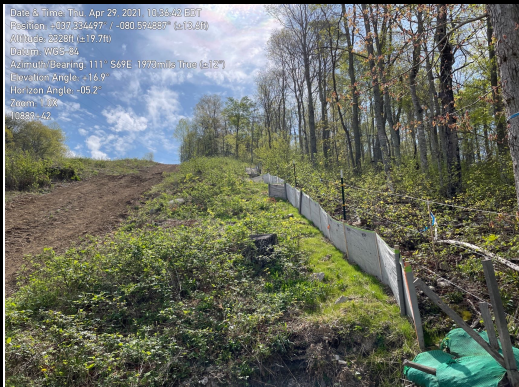
GPS Location	See photo		GPS Location	See photo	
Field Station#	10889+42		Field Station#	1090+00	
Pic 7 Desc.	P1 silt fence perimeter control in place		Pic 8 Desc.	Vegetation on ROW

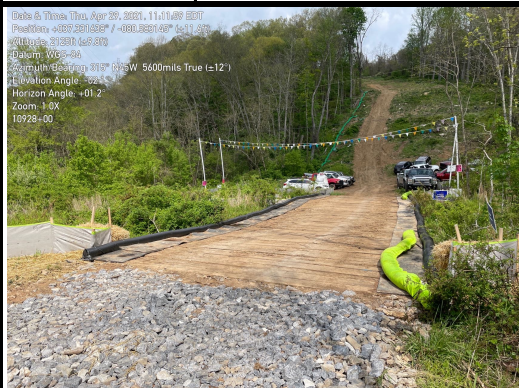
GPS Location	See photo		GPS Location	See photo	
Field Station#	10928+00		Field Station#	10698+83	
Pic 9 Desc.	Equipment bridge in place and clean		Pic 10 Desc.	Buffer in place

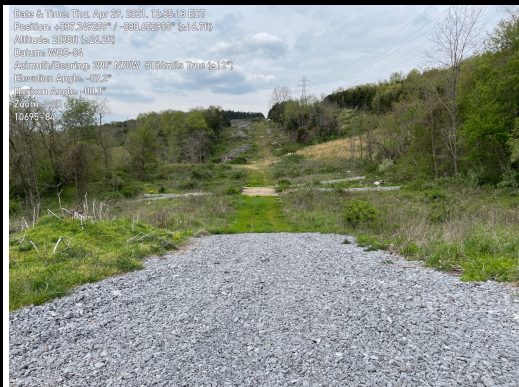
GPS Location	See photo		GPS Location	See photo	
Field Station#	10695+84		Field Station#	10714+00	
Pic 11 Desc.	RCE in place		Pic 12 Desc.	Erosion control blanket in place on travel lane
