Visual Site Inspection Report

Project Name H-600 Pipeline Spread G		AFE 124300137	Spread H-600 Pipeline Spread G
Contractor Precision		Report # 21906	
Inspector Len Kruizenga		Date/Time 4/5/2021 12:46 PM	
Permit # TBD	Inspection Type VA SWPP	Station Begin 11788+53	
State VA	Inspection Area Full	Station End 12005+00	
County Montgomery	Ground Dry	Temperature (°F) 61.00	
Municipality N/A	Weather Sunny	Rain Gauge (in) 0.00	
			Rain Accumulation Time (days) 1.00

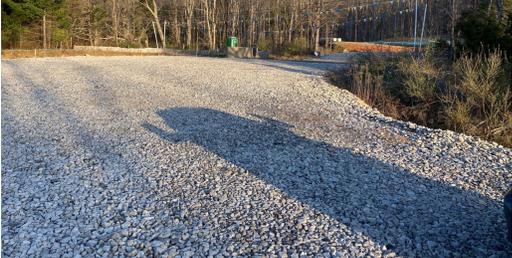
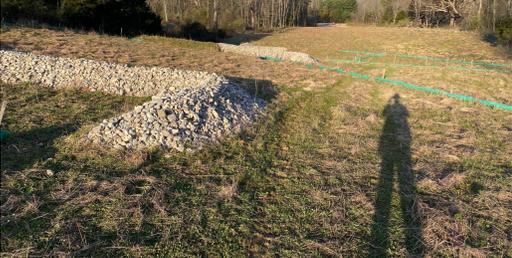
GPS Location	See photo GPS	GPS Location	See photo GPS		
Field Station#	11792+00	Field Station#	11797+00		
Pic 1 Desc.	Tabor RCE	Pic 2 Desc.	Level spreaders and controls.

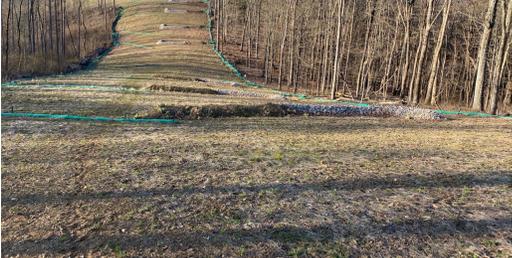
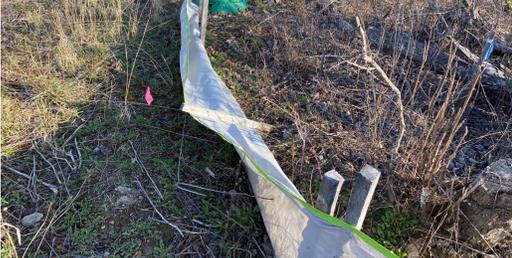
GPS Location	See photo GPS	GPS Location	See photo GPS		
Field Station#	11827+00	Field Station#	11855+96		
Pic 3 Desc.	Level spreaders and Karst ECD's.	Pic 4 Desc.	P1 stakes broken off, contractor notified and items added to the punch list.

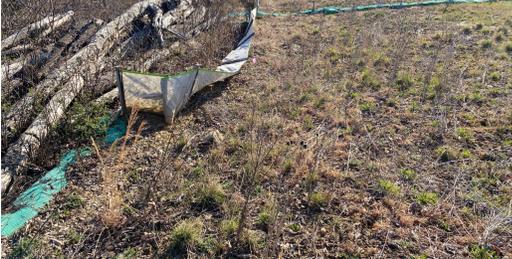
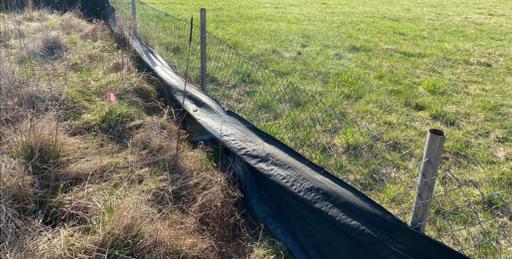
GPS Location	See photo GPS	GPS Location	See photo GPS		
Field Station#	11861+00	Field Station#	11847+00		
Pic 5 Desc.	P1 stakes broken off, contractor notified and items added to the punch list.	Pic 6 Desc.	SSF fabric detached from chain link, item added to the punch list, contractor notified.

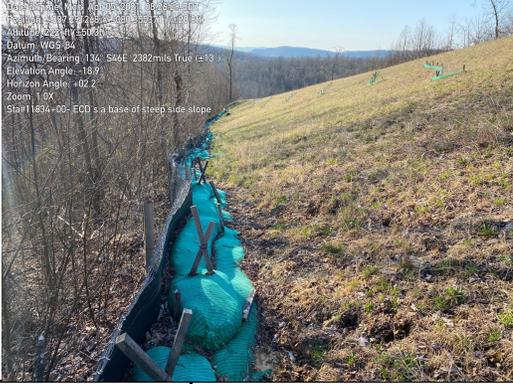
<p><small>Date & Time: Mon, Apr 05, 2021, 09:34:23 EDT Position: +37.231635° / -80.334331° (-29.47ft) Altitude: 2240ft (-68.11ft) Datum: WGS-84 Azimuth Bearing: 136.544E, 2382mils True (+13°) Elevation Angle: -16.9° Horizon Angle: +02.2° Zoom: 1.0X Staff: 11834+00- ECD's at a base of steep side slope</small></p>

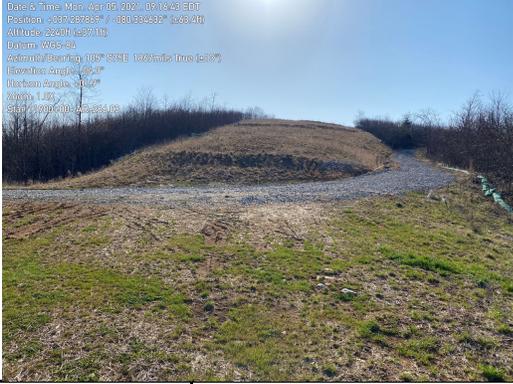
<p><small>Date & Time: Mon, Apr 05, 2021, 09:12:43 EDT Position: +37.231635° / -80.334331° (-29.47ft) Altitude: 2240ft (-68.11ft) Datum: WGS-84 Azimuth Bearing: 105° S34E, 1888mils True (+13°) Elevation Angle: -15.7° Horizon Angle: +13.0° Zoom: 1.0X Staff: 11900+00- Karst ECD's</small></p>	
GPS Location	See photo GPS	GPS Location	See photo GPS
Field Station#	11834+00	Field Station#	11900+00
Pic 7 Desc.	ECD's at the base of steep side slope.	Pic 8 Desc.	AR-266.03

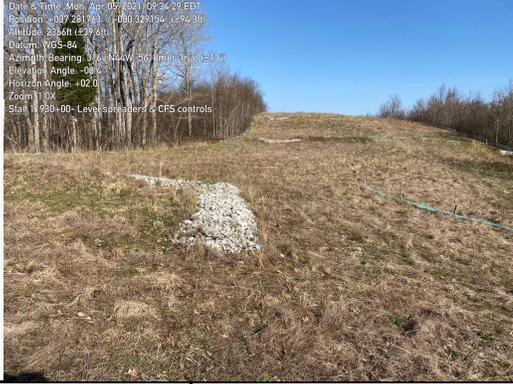
<p><small>Date & Time: Mon, Apr 05, 2021, 09:34:23 EDT Position: +37.231635° / -80.334331° (-29.47ft) Altitude: 2240ft (-68.11ft) Datum: WGS-84 Azimuth Bearing: 316.124W, 303mils True (+13°) Elevation Angle: -08.7° Horizon Angle: +02.0° Zoom: 1.0X Staff: 11930+00- Level spreaders & CFS controls</small></p>

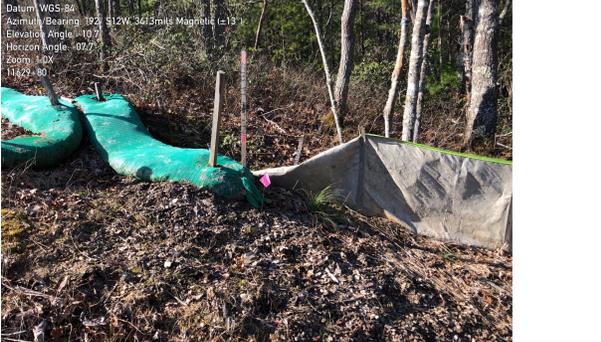
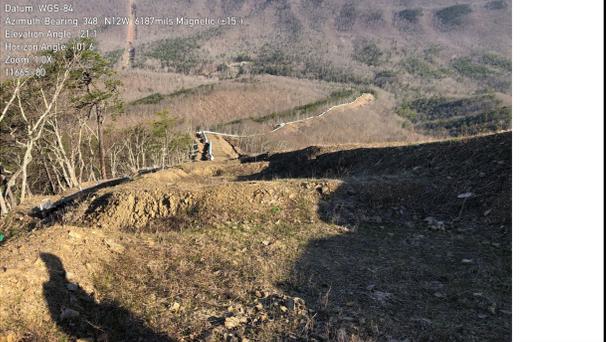
GPS Location	On photo	GPS Location	On photo	
Field Station#	11629+80	Field Station#	11665+00	
Pic 1 Desc.	Communication with contractor via punch list for repair of P1 silt fence seen above.	Pic 2 Desc.	Slope breakers on steep slope effective. Surface currently stable.

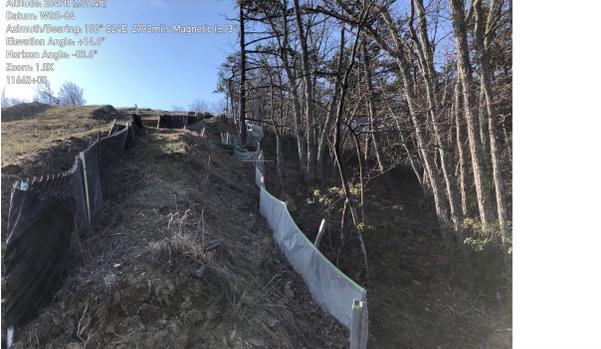
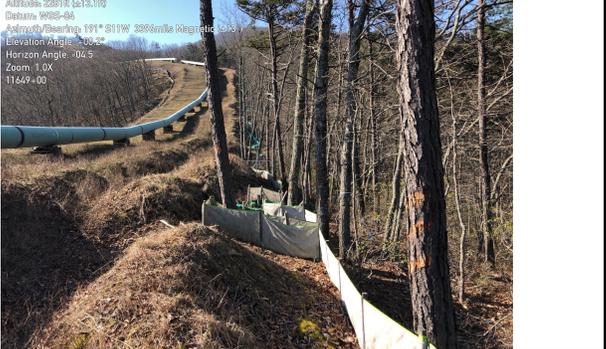
GPS Location	On photo	GPS Location	On photo	
Field Station#	11662+00	Field Station#	11649+00	
Pic 3 Desc.	Perimeter controls are in place. ROW surface stable.	Pic 4 Desc.	Perimeter ECDs are in place. ROW stable.

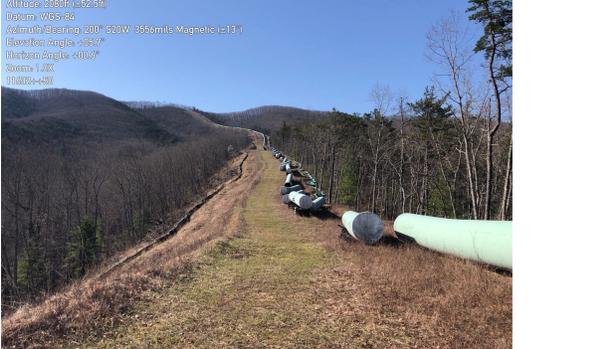
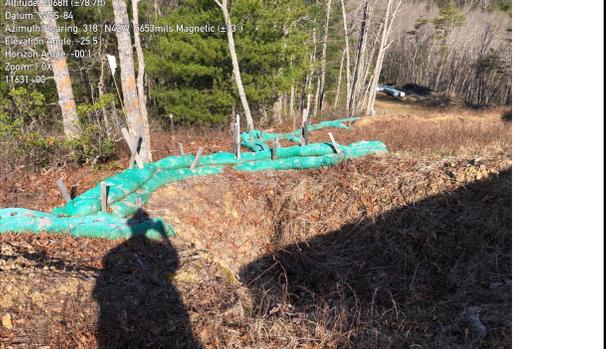
GPS Location	On photo	GPS Location	On photo	
Field Station#	11632+50	Field Station#	11631+00	
Pic 5 Desc.	Slope breakers functional. Perimeter controls are in place. Surface stable.	Pic 6 Desc.	Perimeter controls are in place. ROW stable.

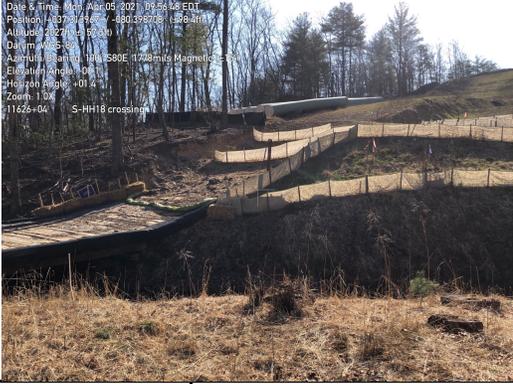
GPS Location	On photo		GPS Location	On photo	
Field Station#	11626+04		Field Station#	11614+20	
Pic 7 Desc.	S-HH18 crossing stable with ECDs in place.		Pic 8 Desc.	S-RR14 crossing stable with ECDs in place.

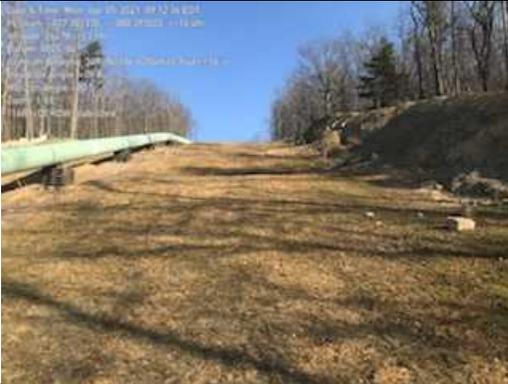
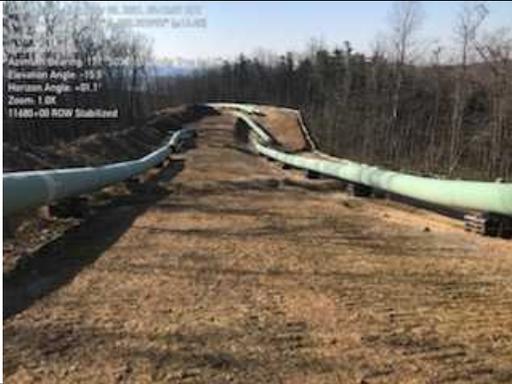
GPS Location see photo		GPS Location see photo			
Field Station# 11680+00		Field Station# 11680+00			
Pic 1 Desc. temporary stabilization of ROW		Pic 2 Desc. temporary stabilization of ROW

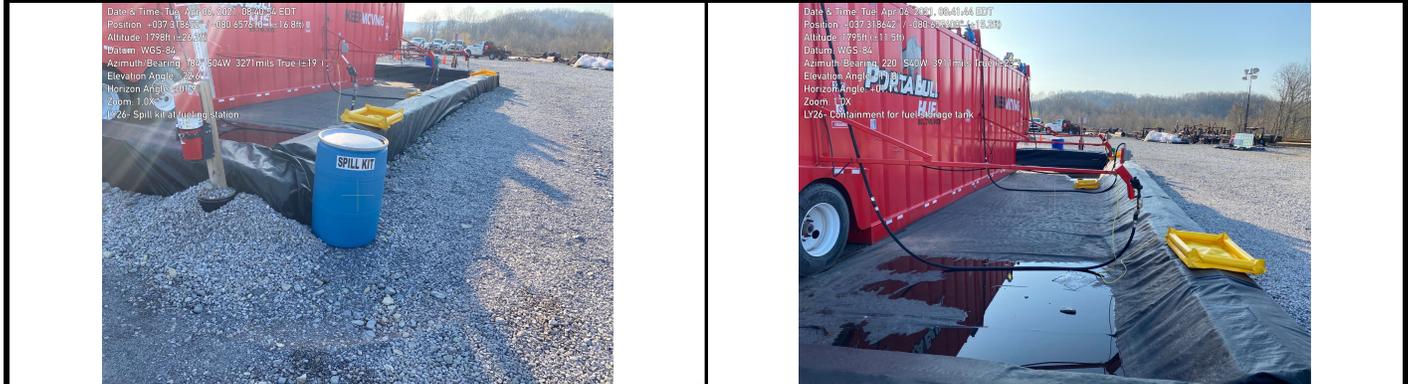
GPS Location	See photo GPS	GPS Location	See photo GPS
Field Station#	12005+00	Field Station#	12005+00
Pic 1 Desc.	LY26- Spill kits available at fueling station.	Pic 2 Desc.	LY26- Containment for fuel tank.

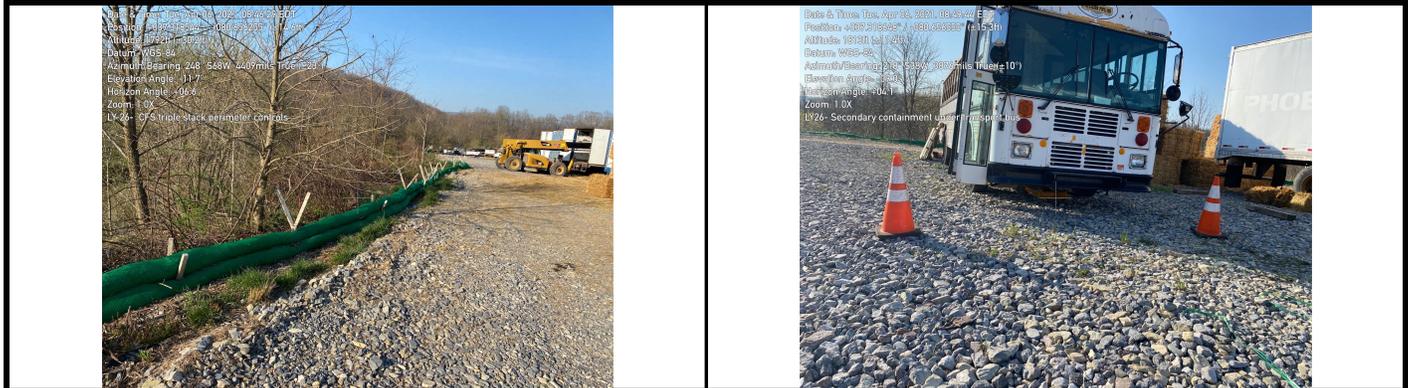
GPS Location	See photo GPS	GPS Location	See photo GPS
Field Station#	12005+00	Field Station#	12005+00
Pic 3 Desc.	CFS triple stack perimeter controls.	Pic 4 Desc.	LY26- Secondary containment under transport bus.

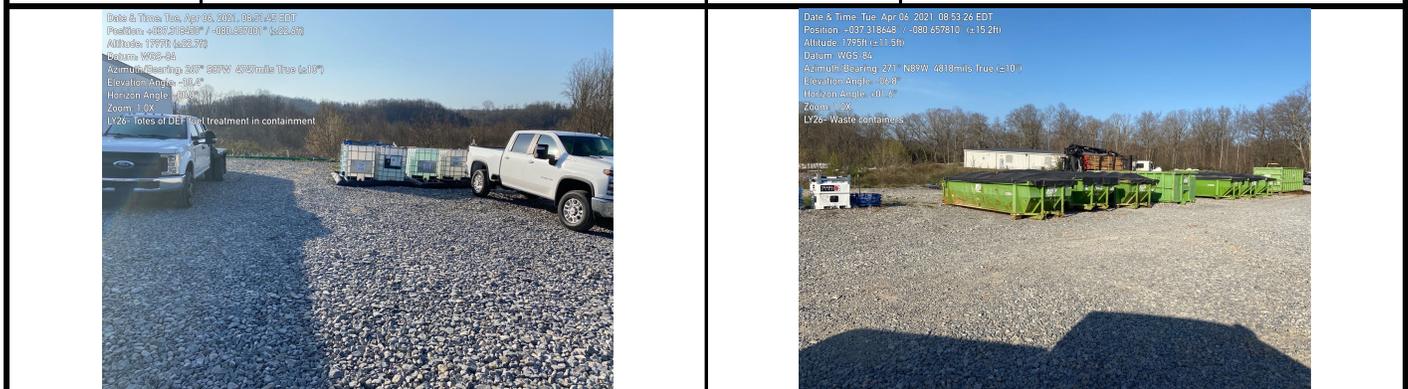
GPS Location	See photo GPS	GPS Location	See photo GPS
Field Station#	12005+00	Field Station#	12005+00
Pic 5 Desc.	LY26- Totes of DEF fuel treatment in containment	Pic 6 Desc.	LY26- Waste containers.

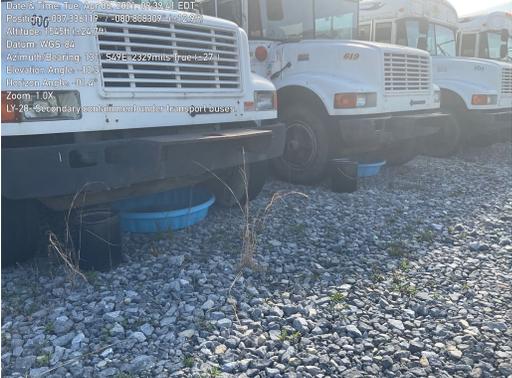
<p><small>Date & Time: Tue, Apr 06, 2021, 09:34:51 EDT Position: +037 334001 / -080 803041 (+8.51ft) Altitude: 15671 (+21.1ft) Datum: WGS 84 Azimuth Bearing: 132.542E 2453mils True (+27) Elevation Angle: +00.8 Horizon Angle: +00.8 Zoom: 1.0X LY28- Secondary containment under transport buses.</small></p>

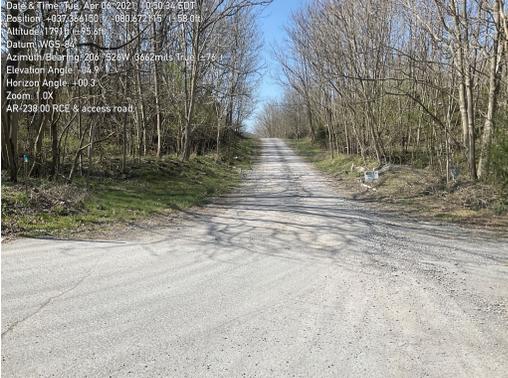
<p><small>Date & Time: Tue Apr 06 2021 10:50:34 EDT Position: +037.363112 / -080.676859 / 1563.7m Altitude: 1795ft (L=42.5ft) Datum: WGS 84 Azimuth Bearing: 204.526W 3462mils True (±10°) Elevation Angle: -04.7° Horizon Angle: -100.3° Zoom: 1.0X LY29- AR-238.00 RCE & access road.</small></p>

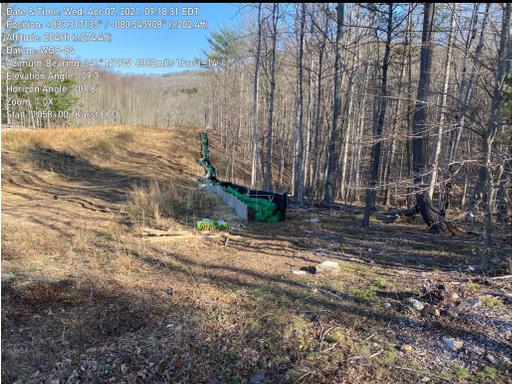
<p>Date & Time: Wed Apr 07 2021 07:18:31 EDT Position: 4880.310137, -880.243087, 4202.401 Altitude: 2150.1 (400 ft) Datum: WGS 84 Azimuth/Bearing: 321.10366, 320.616 miles True (±14.7) Elevation Angle: -17.3 Horizon Angle: -10.1 Zoom: 1.0X Star: 11058+00 - Karst ECD</p>

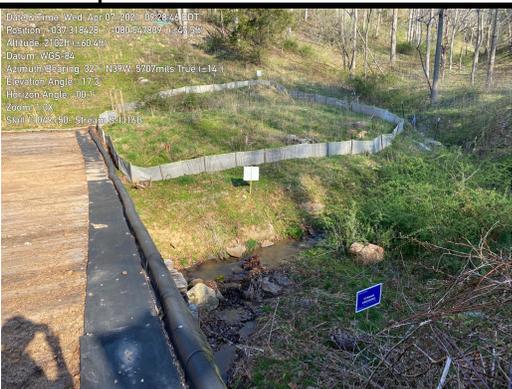
<p>Date & Time: Wed Apr 07 2021 10:28:23 EDT Position: -037.318425, -080.542887, 1201.88 Altitude: 2102.1 (400 ft) Datum: WGS 84 Azimuth/Bearing: 323.10394, 570.7 miles True (±14.7) Elevation Angle: -17.3 Horizon Angle: -10.1 Zoom: 1.0X Star: 11049+50 - Stream S- IJ16B</p>

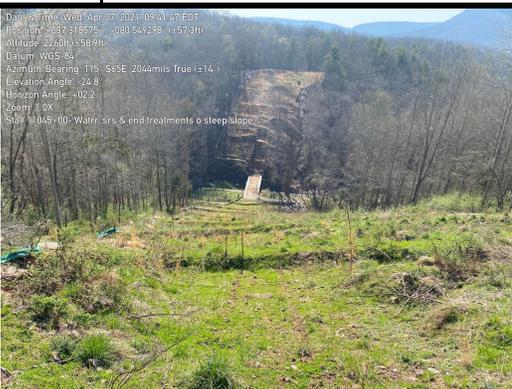
<p>Date & Time: Wed Apr 07 2021 09:41:20 EDT Position: 4837.318575, -880.54238, 1457.311 Altitude: 2226.1 (458 ft) Datum: WGS 84 Azimuth/Bearing: 115.565E, 204.4 miles True (±14.7) Elevation Angle: -24.8 Horizon Angle: -10.2 Zoom: 1.0X Star: 11045+00 - Water bars & end treatments on steep slope</p>

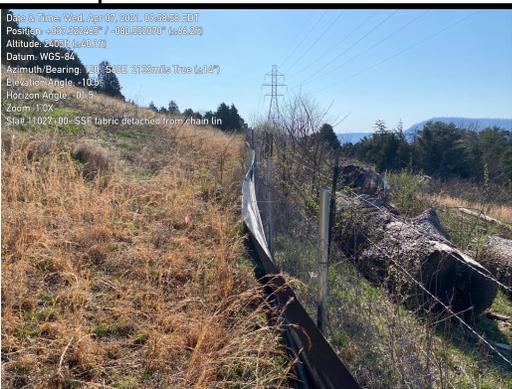
<p>Date & Time: Wed Apr 07 2021 05:48:58 EDT Position: 4880.253427, -880.253007, 1433.211 Altitude: 2111.1 (411 ft) Datum: WGS 84 Azimuth/Bearing: 115.565E, 313.0 miles True (±14.7) Elevation Angle: -10.5 Horizon Angle: -10.3 Zoom: 1.0X Star: 11027+00 - SSF fabric detached from chain link</p>

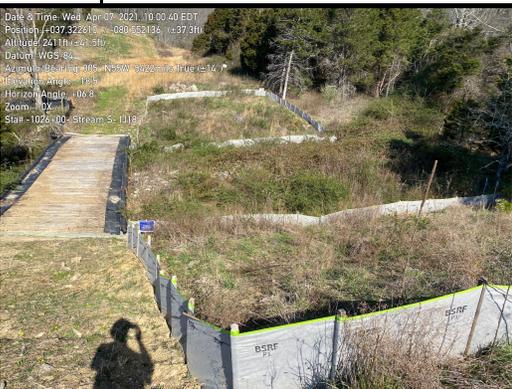
<p>Date & Time: Wed Apr 07 2021 10:00:40 EDT Position: 4837.22618, -880.554134, 1471.311 Altitude: 2411.1 (491 ft) Datum: WGS 84 Azimuth/Bearing: 105.565E, 322.2 miles True (±14.7) Elevation Angle: -18.5 Horizon Angle: -10.8 Zoom: 1.0X Star: 11026+00 - Stream S- IJ18</p>			
GPS Location	See photo GPS	GPS Location	See photo GPS		
Field Station#	11027+00	Field Station#	11026+00		
Pic 5 Desc.	SSF fabric detached from chain link, contractor notified and items added to the punch list.	Pic 6 Desc.	Stream S- IJ18- Equipment Bridge, buffers, signage.

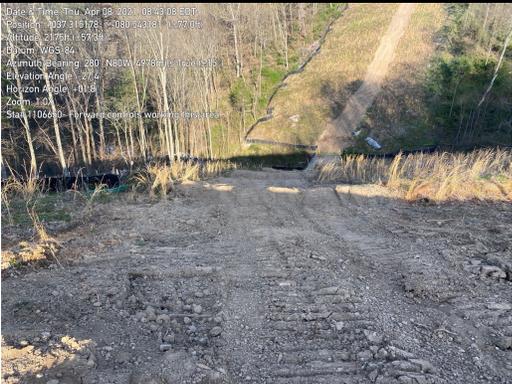
<p><small>Date & Time: Thu, Apr 08, 2021, 08:49:08 EDT Position: +037°31'27.6" / +080°42'31" (+87.71) Altitude: 2173ft (+662m) Datum: WGS-84 Azimuth/Bearing: 200 NSOW 278mils True (+12.1) Elevation Angle: -27.2° Horizon Angle: +01.8° Zoom: 1.0X Sta# 11066+00 - Forward controls work area</small></p>

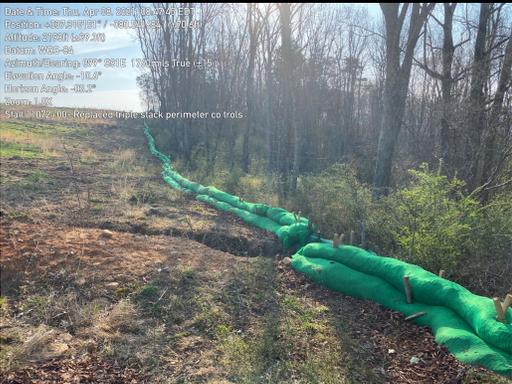
<p><small>Date & Time: Thu, Apr 08, 2021, 08:49:08 EDT Position: +037°31'27.6" / +080°42'31" (+87.71) Altitude: 2173ft (+662m) Datum: WGS-84 Azimuth/Bearing: 09° SESE 130mils True (+15.1) Elevation Angle: -10.2° Horizon Angle: -03.2° Zoom: 1.0X Sta# 11072+00 - Recently triple stack perimeter controls</small></p>			
GPS Location	See photo GPS	GPS Location	See photo GPS		
Field Station#	11066+50	Field Station#	11072+00		
Pic 1 Desc.	Forward controls crew are working in the area.		Pic 2 Desc.	Recently replaced triple stack CFS perimeter controls.

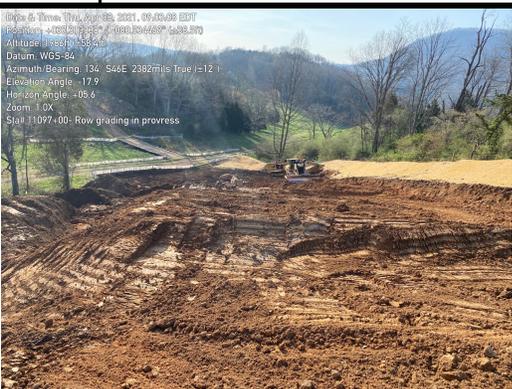
<p><small>Date & Time: Thu, Apr 08, 2021, 09:00:00 EDT Position: +037°31'55.5" / +080°42'46.8" (+88.87) Altitude: 1950ft (+594m) Datum: WGS-84 Azimuth/Bearing: 134 S44E 2382mils True (+12.1) Elevation Angle: -17.9° Horizon Angle: +05.4° Zoom: 1.0X Sta# 11097+00 - Row grading in progress</small></p>

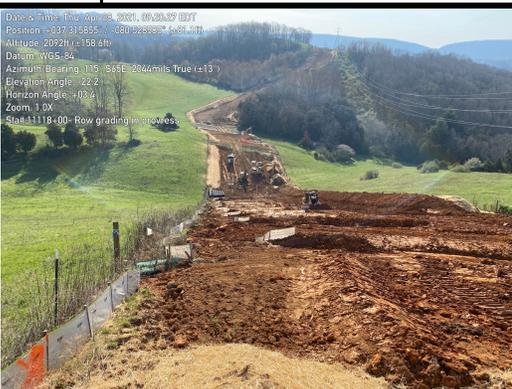
<p><small>Date & Time: Thu, Apr 08, 2021, 09:00:00 EDT Position: +037°31'55.5" / +080°42'46.8" (+88.87) Altitude: 2092ft (+638.6m) Datum: WGS-84 Azimuth/Bearing: 105 S45E 2044mils True (+13.1) Elevation Angle: -22.2° Horizon Angle: +03.4° Zoom: 1.0X Sta# 11118+00 - Row grading in progress</small></p>			
GPS Location	See photo GPS	GPS Location	See photo GPS		
Field Station#	11097+00	Field Station#	11118+00		
Pic 3 Desc.	Row grading in progress.		Pic 4 Desc.	Row grading and ECD installation.

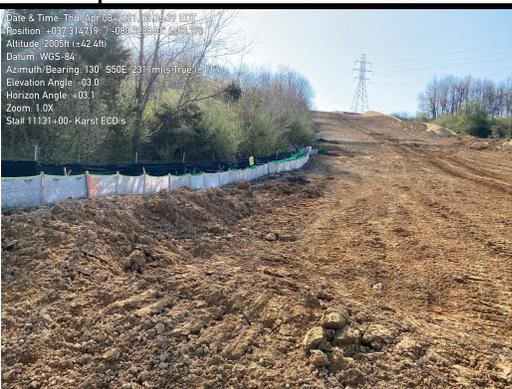
<p><small>Date & Time: Thu, Apr 08, 2021, 09:00:00 EDT Position: +037°31'42.1" / +080°42'58.4" (+88.8m) Altitude: 2005ft (+610.8m) Datum: WGS-84 Azimuth/Bearing: 130 S50E 231mils True (+13.1) Elevation Angle: -03.0° Horizon Angle: +03.1° Zoom: 1.0X Sta# 11131+00 - Karst ECD's</small></p>

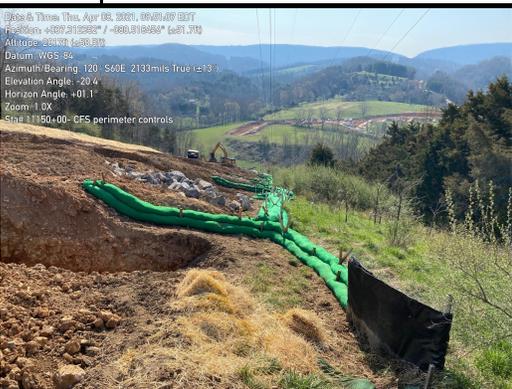
<p><small>Date & Time: Thu, Apr 08, 2021, 09:00:00 EDT Position: +037°31'52.2" / +080°42'58.4" (+88.8m) Altitude: 2117ft (+645.3m) Datum: WGS-84 Azimuth/Bearing: 120 S60E 2133mils True (+13.1) Elevation Angle: -20.4° Horizon Angle: +01.1° Zoom: 1.0X Sta# 11150+00 - CFS perimeter controls</small></p>

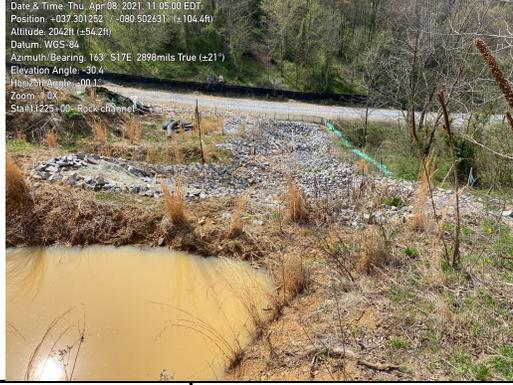
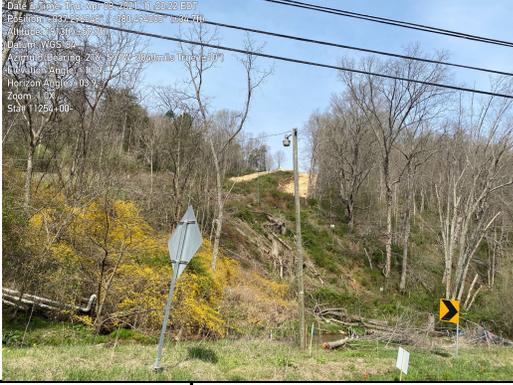
<p><small>Date & Time: Thu, Apr 08, 2021, 11:05:00 EDT Position: +037 301282 / -080 502831 (+104.4ft) Altitude: 2042ft (+54.2ft) Datum: WGS-84 Azimuth Bearing: 163° S17E 2898mils True (+21°) Elevation Angle: +30.4° Horizon Angle: +00.1° Zoom: 1.0X Start: 11254+00-Row slope coming in to HWY 42</small></p>

GPS Location	See photo GPS	GPS Location	See photo GPS
Field Station#	11225+00	Field Station#	11254+00
Pic 11 Desc.	Rock channel	Pic 12 Desc.	Row slope coming in to HWY 42.

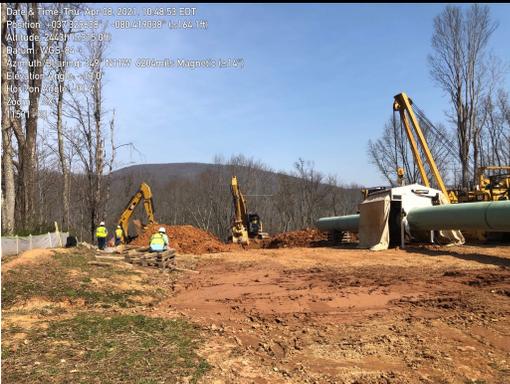
<p><small>Date & Time: Thu, Apr 08, 2021, 10:28:05 EDT Position: +037.327693, -080.417680 (+98.4ft) Altitude: 2557ft (+850ft) Datum: WGS-84 Azimuth (Bearing): 239° 55'W 420mils Magnetic (+14°) Elevation Angle: -21.3° Horizon Angle: -00.0° Zoom: 1.0x 11532+51 trench breaker locations marked by survey.</small></p>

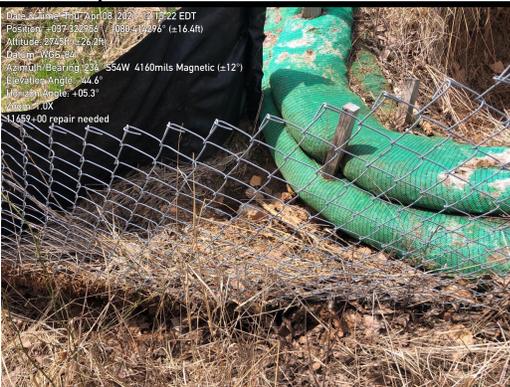
<p><small>Date & Time: Thu, Apr 08, 2021, 12:12:22 EDT Position: +037.326676, -080.416976 (+16.4ft) Altitude: 2723ft (+829ft) Datum: WGS-84 Azimuth (Bearing): 231° 55'W 416mils Magnetic (+12°) Elevation Angle: -44.6° Horizon Angle: -05.3° Zoom: 0.5x 11659+00 repair needed</small></p>

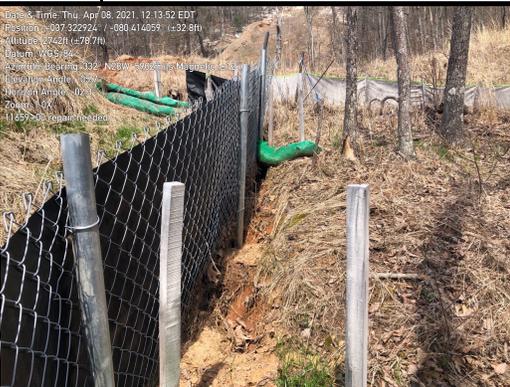
<p><small>Date & Time: Thu, Apr 08, 2021, 12:13:52 EDT Position: +037.322224, -080.414659 (+32.8ft) Altitude: 2342ft (+717ft) Datum: WGS-84 Azimuth (Bearing): 322° N28W 608mils Magnetic (+14°) Elevation Angle: -33.8° Horizon Angle: -00.0° Zoom: 0.5x 11659+00 repair needed</small></p>

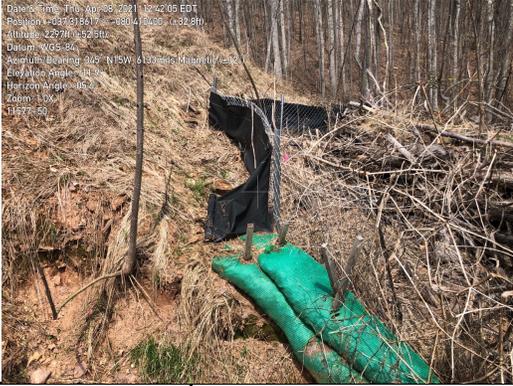
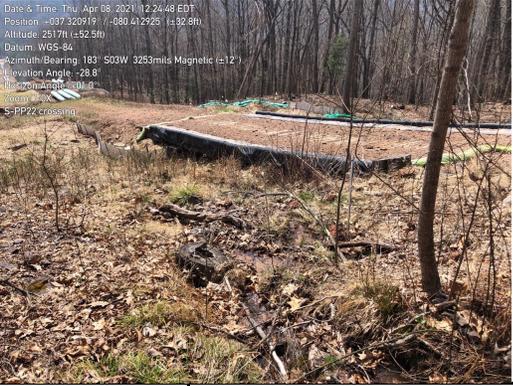
GPS Location	On photo	GPS Location	On photo		
Field Station#	11557+50	Field Station#	11568+22		
Pic 7 Desc.	Communication: Replace broken stake.		Pic 8 Desc.	The S-PP22 crossing is currently stable.

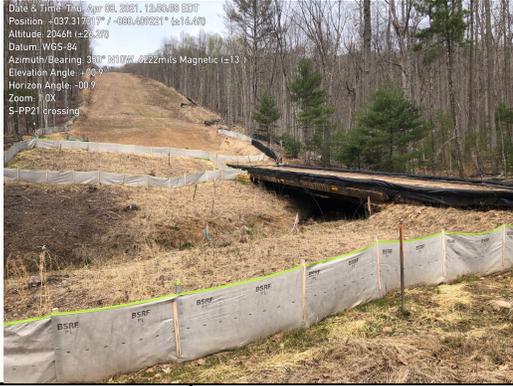
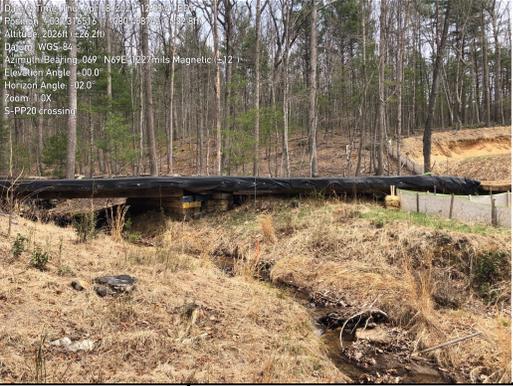
GPS Location	On photo	GPS Location	On photo		
Field Station#	11585+48	Field Station#	11588+41		
Pic 9 Desc.	S-PP21 crossing stable.		Pic 10 Desc.	S-PP20 crossing stable.

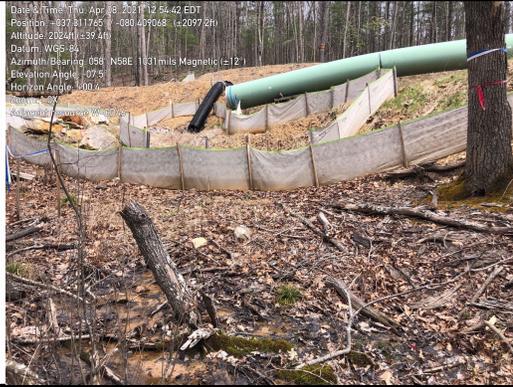
GPS Location	On photo	GPS Location			
Field Station#	11589+25	Field Station#			
Pic 11 Desc.	Adjacent wetland W-CD46 has no impact.		Pic 12 Desc.	Insert image here

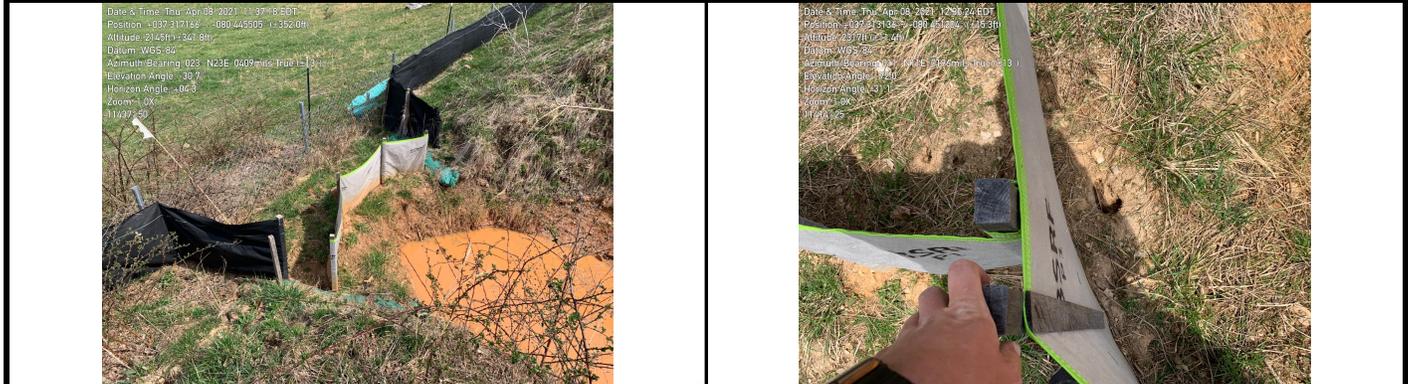
GPS Location	See photo for GPS location.	GPS Location	See photo for GPS location.
Field Station#	11437+50	Field Station#	11414+25
Pic 1 Desc.	Priority one silt fence end treatment needs upgraded to new spec.	Pic 2 Desc.	Priority one silt fence end treatment undermined.

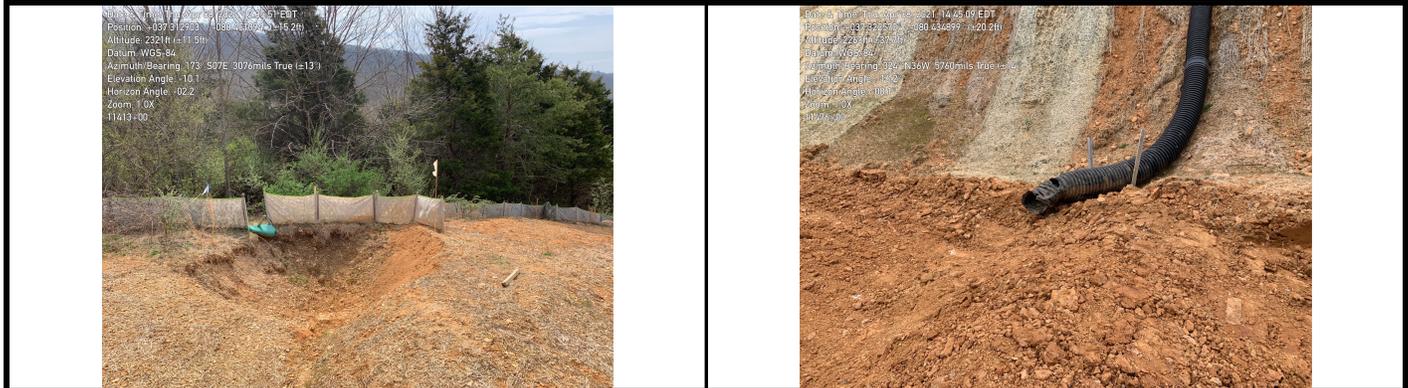
GPS Location	See photo for GPS location.	GPS Location	See photo for GPS location.
Field Station#	11413+00	Field Station#	11476+00
Pic 3 Desc.	Priority one silt fence trap exposed on end treatment	Pic 4 Desc.	No rock outlet at slope drain pipe.

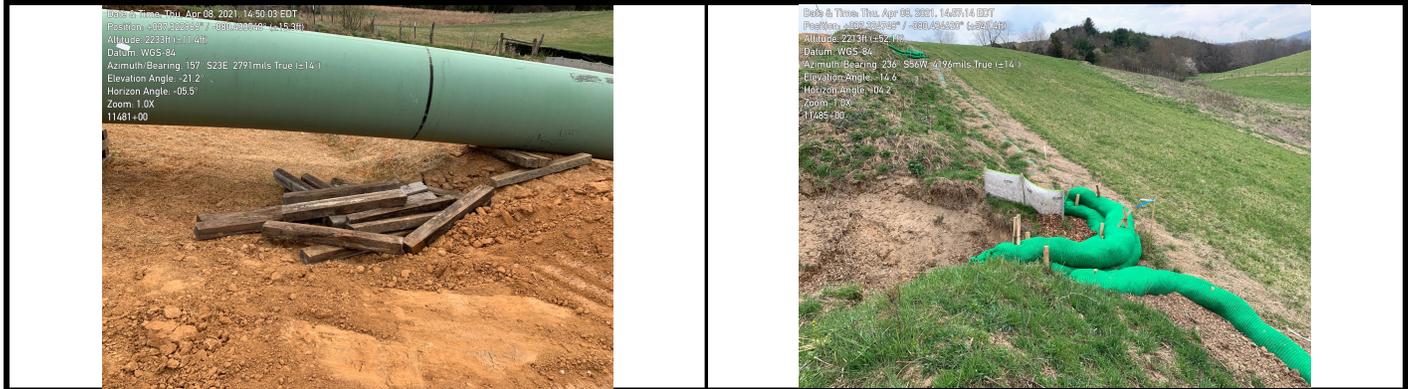
GPS Location	See photo for GPS location.	GPS Location	See photo for GPS location.
Field Station#	11481+00	Field Station#	11485+00
Pic 5 Desc.	Construction debris in waterbar throat.	Pic 6 Desc.	Triple stack compost filter sock improperly installed.

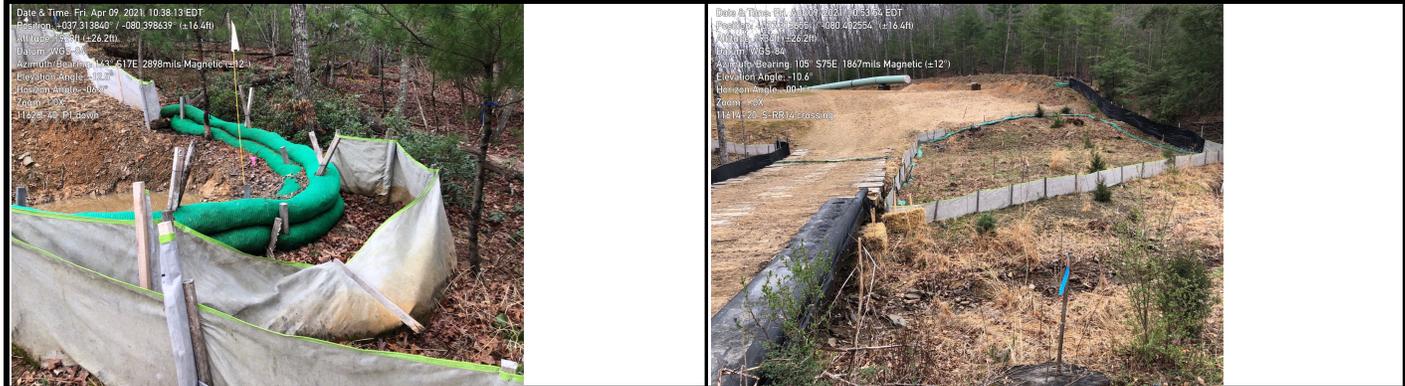
GPS Location	On photo	GPS Location	On photo
Field Station#	11626+40	Field Station#	11614+20
Pic 7 Desc.	Communication: Replace worn P1 silt fence.	Pic 8 Desc.	The S-RR14 crossing is stable with ECDs in place.
