# Visual Site Inspection Report

<b>Project Name</b>	H-600 Pipeline Spread G	<b>AFE</b>	124300137	<b>Spread</b>	H-600 Pipeline Spread G
<b>Contractor</b>	Precision			<b>Report #</b>	23196
<b>Inspector</b>	Patrick Shields			<b>Date/Time</b>	5/10/2021 2:05 PM
<b>Permit #</b>	TBD	<b>Inspection Type</b>	VA SWPP	<b>Station Begin</b>	12005+00
<b>State</b>	VA	<b>Inspection Area</b>	Partial	<b>Station End</b>	12005+00
<b>County</b>	Giles	<b>Ground</b>	Damp	<b>Temperature (°F)</b>	60.00
<b>Municipality</b>	N/A	<b>Weather</b>	Cloudy	<b>Rain Gauge (in)</b>	0.15
				<b>Rain Accumulation Time (days)</b>	1.00

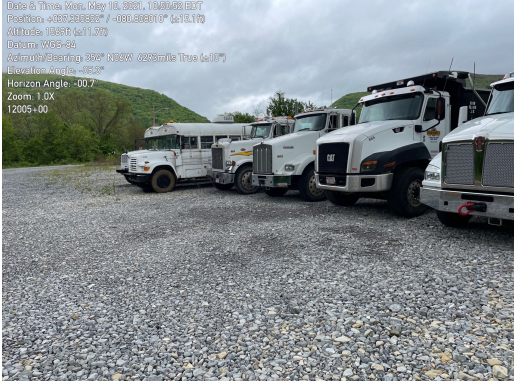
<b>GPS Location</b>	See photo	<b>GPS Location</b>	See photo		
<b>Field Station#</b>	12005+00	<b>Field Station#</b>	12005+00		
<b>Pic 1 Desc.</b>	Road trucks and transport buses parked	<b>Pic 2 Desc.</b>	Secondary containments in place

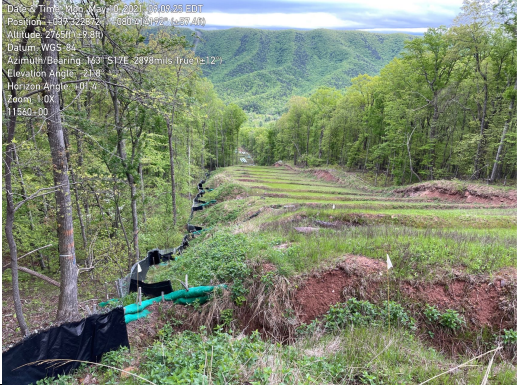
<b>GPS Location</b>	See photo	<b>GPS Location</b>	See photo		
<b>Field Station#</b>	11560+00	<b>Field Station#</b>	11569+18		
<b>Pic 7 Desc.</b>	End treatments in place	<b>Pic 8 Desc.</b>	Good vegetation on ROW

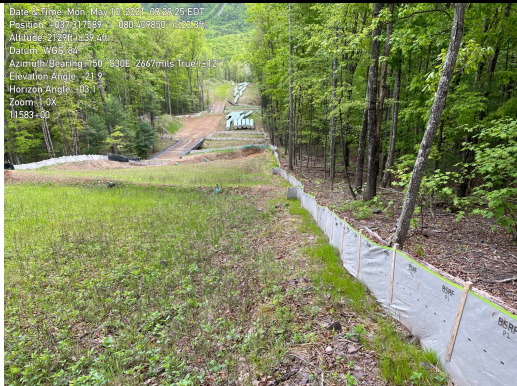
<b>GPS Location</b>	See photo	<b>GPS Location</b>	See photo		
<b>Field Station#</b>	11583+00	<b>Field Station#</b>	11588+00		
<b>Pic 9 Desc.</b>	P1 perimeter control in place	<b>Pic 10 Desc.</b>	Buffer in place

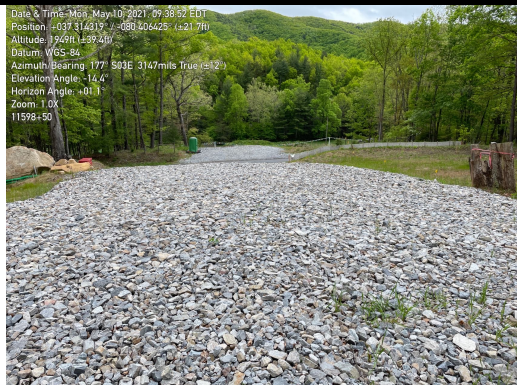
<b>GPS Location</b>	See photo	<b>GPS Location</b>	See photo		
<b>Field Station#</b>	11598+50	<b>Field Station#</b>	11527+00		
<b>Pic 11 Desc.</b>	RCE in place	<b>Pic 12 Desc.</b>	Open ditch through clean water drainage feature

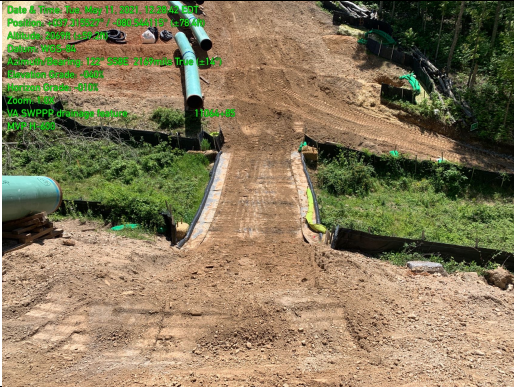
<b>GPS Location</b>	See photo		<b>GPS Location</b>	See photo	
<b>Field Station#</b>	11064+85		<b>Field Station#</b>	11055+00	
<b>Pic 1 Desc.</b>	Pull sediment back from the corner of the bridge across drainage feature.		<b>Pic 2 Desc.</b>	Karst feature with triple protection functioning.

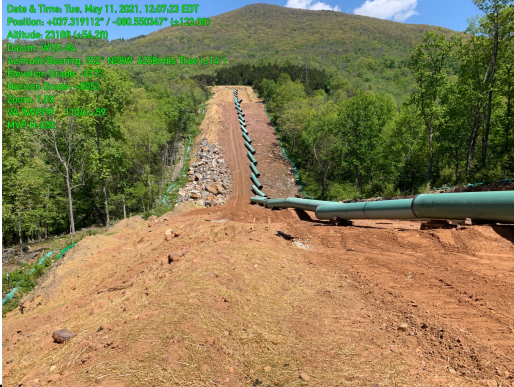
<b>GPS Location</b>	See photo		<b>GPS Location</b>	See photo	
<b>Field Station#</b>	11041+59		<b>Field Station#</b>	10995+50	
<b>Pic 3 Desc.</b>	VA SWPPP INSPECTION OF ROW		<b>Pic 4 Desc.</b>	Replace P1 filter fence along perimeter of LOD.

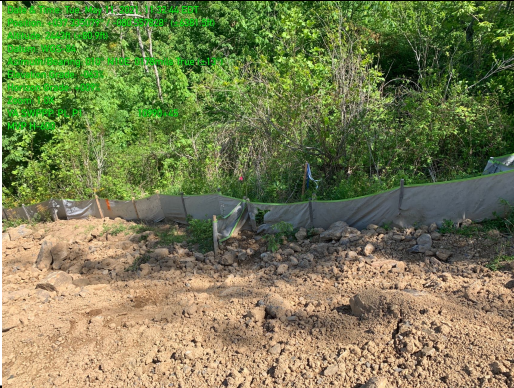
<b>GPS Location</b>	See photo		<b>GPS Location</b>	See photo	
<b>Field Station#</b>	10990+45		<b>Field Station#</b>	10978+00	
<b>Pic 5 Desc.</b>	Repair or replace P1 perimeter ECDs		<b>Pic 6 Desc.</b>	Complete installment of slope drain.

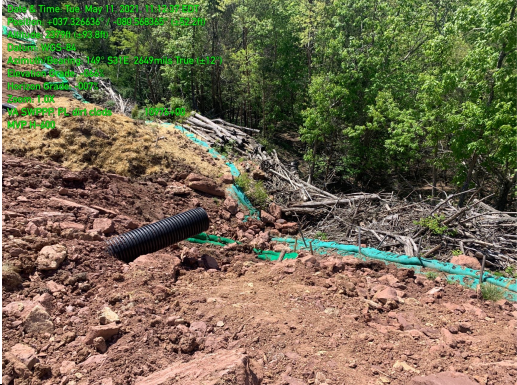
<b>GPS Location</b>	See photo		<b>GPS Location</b>	See photo	
<b>Field Station#</b>	10976+00		<b>Field Station#</b>	10971+00	
<b>Pic 7 Desc.</b>	Remove dirt clods and sediment laden rock past perimeter ECDs.		<b>Pic 8 Desc.</b>	Install CFS checks on clean water diversion berm

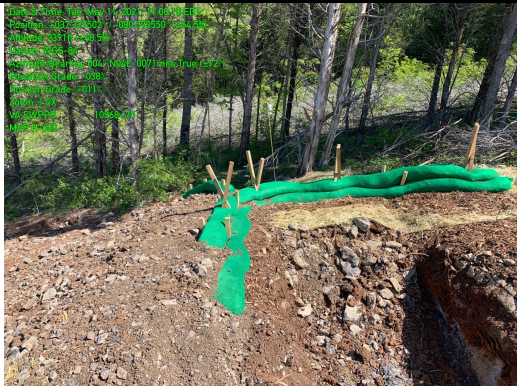
<b>GPS Location</b>	See photo		<b>GPS Location</b>	See photo	
<b>Field Station#</b>	10968+70		<b>Field Station#</b>	10954+50	
<b>Pic 9 Desc.</b>	VA SWPPP. End treatment installed to spec.		<b>Pic 10 Desc.</b>	Install diversion to divert water off LOD below end treatment.

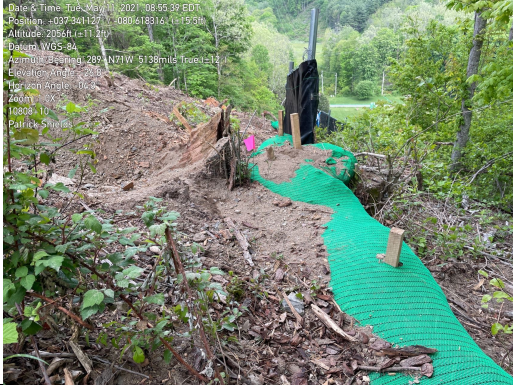
GPS Location		See photo		GPS Location	
Field Station#		10808+10		Field Station#	
Pic 1 Desc.		Soil starting to overtop CFS perimeter control		Pic 2 Desc.	
				Waterbar needs maintenance	
<p>Date &amp; Time: Tue, May 11, 2021, 10:29:28 EDT Position: -037.336327° -080.600454° (+15.140) Altitude: 2426ft (+11.770) Datum: WGS 84 Azimuth Bearing: 071° N71E 1262/mils True (+12) Elevation Angle: -22.3° Horizon Angle: -05.2° Zoom: 1.0x 10871+50 Patrick Shields</p>

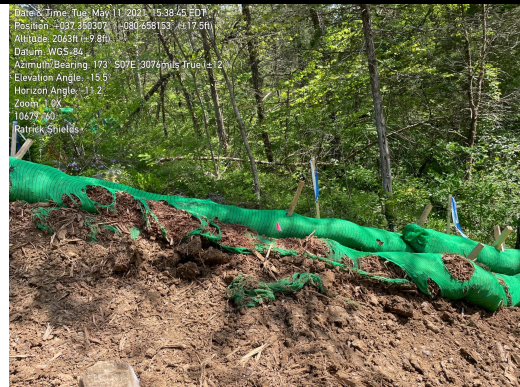
GPS Location		See photo		GPS Location	
Field Station#		10871+50		Field Station#	
Pic 3 Desc.		CFS perimeter control is badly damaged		Pic 4 Desc.	
				CFS triple stack perimeter control is badly damaged	
<p>Date &amp; Time: Tue, May 11, 2021, 09:44:34 EDT Position: -037.355307° -080.658153° (+17.540) Altitude: 2426ft (+11.770) Datum: WGS 84 Azimuth Bearing: 154° S26E 2138/mils True (+12) Elevation Angle: -19.3° Horizon Angle: -00.2° Zoom: 1.0x 10848+00 Patrick Shields</p>

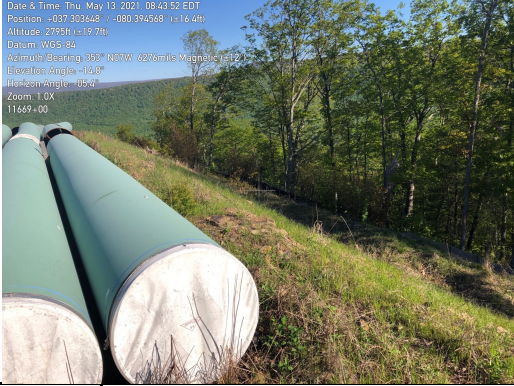
<b>GPS Location</b>	On photo	<b>GPS Location</b>	On photo		
<b>Field Station#</b>	11669+00	<b>Field Station#</b>	11661+00		
<b>Pic 1 Desc.</b>	Perimeter controls are in place at top of Brush Mountain. No vandalism evidence observed.	<b>Pic 2 Desc.</b>	End treatment functional.

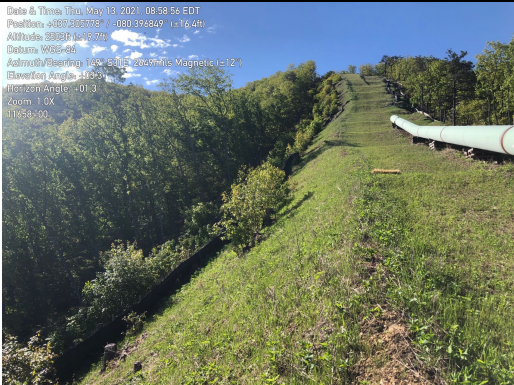
<b>GPS Location</b>	On photo	<b>GPS Location</b>	On photo		
<b>Field Station#</b>	11658+00	<b>Field Station#</b>	11638+00		
<b>Pic 3 Desc.</b>	Perimeter controls in place. Slope breakers effective.	<b>Pic 4 Desc.</b>	ROW stable. Perimeter ECDs in place.

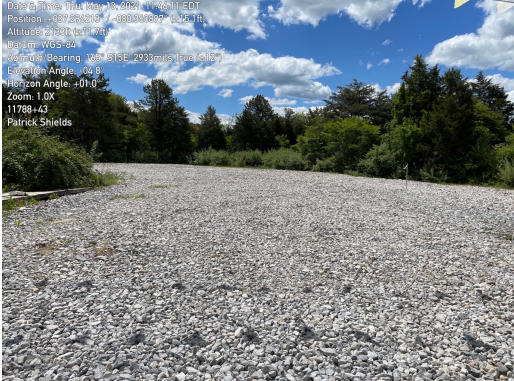
<b>GPS Location</b>	See photo	<b>GPS Location</b>	See photo		
<b>Field Station#</b>	11788+43	<b>Field Station#</b>	11792+07		
<b>Pic 1 Desc.</b>	RCE in place	<b>Pic 2 Desc.</b>	ECDs in place

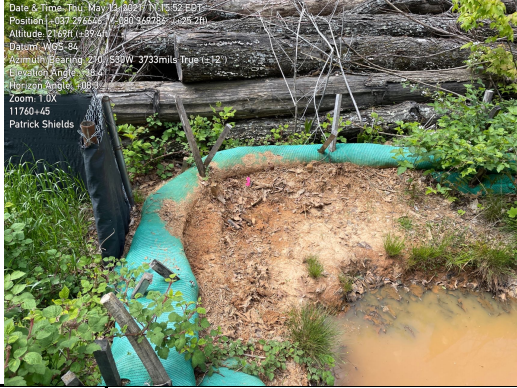
<p>Date &amp; Time: Thu May 13 2021 11:52:55 EDT Position: +837.231221° / +880.368655° (+42.3ft) Altitude: 2529ft (+863.7ft) (+803.66ft) Datum: WGS-84 Azimuth/Bearing: 210.153W 3733mils True (+12°) Elevation Angle: -18.5° Horizon Angle: -00.5° Zoom: 1.0X 11760+45 Patrick Shields</p>			
<b>GPS Location</b>	See photo	<b>GPS Location</b>	See photo		
<b>Field Station#</b>	11719+00	<b>Field Station#</b>	11760+45		
<b>Pic 1 Desc.</b>	Silt fence damaged by wildlife	<b>Pic 2 Desc.</b>	Sediment built up on end treatment
