# Visual Site Inspection Report

<b>Project Name</b>	H-600 Pipeline Spread G	<b>AFE</b>	124300137	<b>Spread</b>	H-600 Pipeline Spread G
<b>Contractor</b>	Precision			<b>Report #</b>	23484
<b>Inspector</b>	Len Kruizenga			<b>Date/Time</b>	5/17/2021 4:44 PM
<b>Permit #</b>	TBD	<b>Inspection Type</b>	VA SWPP	<b>Station Begin</b>	11064+52
<b>State</b>	VA	<b>Inspection Area</b>	Full	<b>Station End</b>	10929+62
<b>County</b>	Giles	<b>Ground</b>	Dry	<b>Temperature (°F)</b>	56.00
<b>Municipality</b>	N/A	<b>Weather</b>	Cloudy	<b>Rain Gauge (in)</b>	0.00
				<b>Rain Accumulation Time (days)</b>	1.00

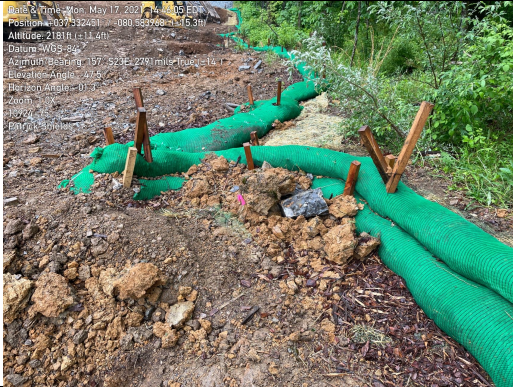
GPS Location				See photo				GPS Location				See photo			
Field Station#				10924+75				Field Station#				10868+50			
Pic 1 Desc.				Soil and rock on end treatment				Pic 2 Desc.				Break in perimeter control

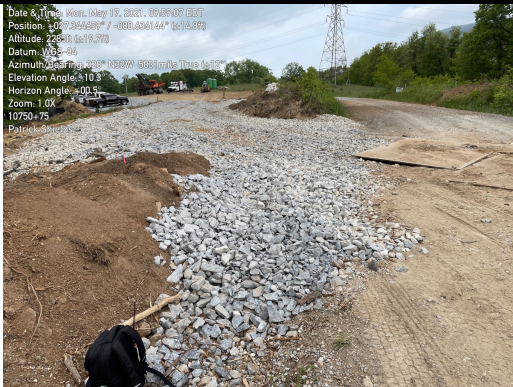
GPS Location				See photo				GPS Location				See photo			
Field Station#				10750+75				Field Station#				10704+80			
Pic 3 Desc.				Culvert buried by rock				Pic 4 Desc.				Waterbar needs maintenance

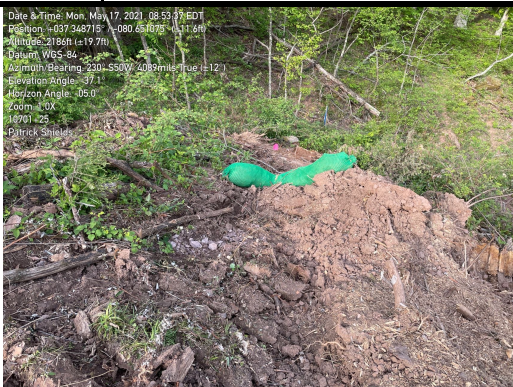
GPS Location				See photo				GPS Location				See photo			
Field Station#				10701+25				Field Station#				10700+80			
Pic 5 Desc.				End treatment not staked in				Pic 6 Desc.				Flow path to end treatment blocked by soil

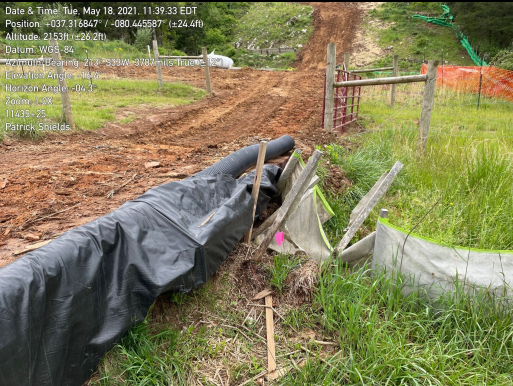
<b>GPS Location</b>	See photo	<b>GPS Location</b>	See photo		
<b>Field Station#</b>	11375+00	<b>Field Station#</b>	11435+25		
<b>Pic 5 Desc.</b>	Clean water drainage pipe in place	<b>Pic 6 Desc.</b>	P1 damaged by equipment

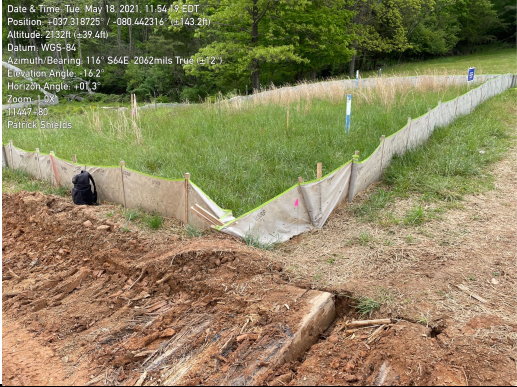
<b>GPS Location</b>	See photo	<b>GPS Location</b>	See photo		
<b>Field Station#</b>	11447+80	<b>Field Station#</b>	11449+50		
<b>Pic 7 Desc.</b>	P1 damaged by equipment	<b>Pic 8 Desc.</b>	CFS full of dirt		
<p>Date &amp; Time: Tue, May 18, 2021, 12:02:14 EDT  Position: -037.318894° / -080.441160° (-143.44)  Altitude: 2128ft (-39.80)  Datum: WGS-84  Azimuth/Bearing: 025° N25E 1044mils True (-12°)  Elevation Angle: -16.7°  Horizon Angle: +05.8°  Zoom: 1.0X  11450+75  Patrick Shields</p>		<p>Date &amp; Time: Tue, May 18, 2021, 12:18:26 EDT  Position: -037.320561° / -080.439814° (-143.61)  Altitude: 2140ft (-39.80)  Datum: WGS-84  Azimuth/Bearing: 004° N04E 6071mils True (-12°)  Elevation Angle: -11.7°  Horizon Angle: +04.9°  Zoom: 1.0X  11468+50  Patrick Shields</p>

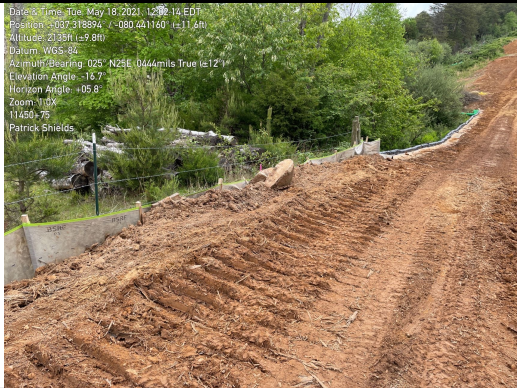
<b>GPS Location</b>	See photo	<b>GPS Location</b>	See photo		
<b>Field Station#</b>	11450+75	<b>Field Station#</b>	11468+50		
<b>Pic 9 Desc.</b>	P1 full of dirt	<b>Pic 10 Desc.</b>	Triple protection in place at karst feature		
<p>Date &amp; Time: Tue, May 18, 2021, 12:54:31 EDT  Position: -037.232355° / -080.435884° (-141.61)  Altitude: 2207ft (-37.50)  Datum: WGS-84  Azimuth/Bearing: 197° S19W 650mils True (-13°)  Elevation Angle: -42.0°  Horizon Angle: +00.1°  Zoom: 1.0X  11479+50  Patrick Shields</p>		<p>Date &amp; Time: Tue, May 18, 2021, 12:54:47 EDT  Position: -037.232755° / -080.437575° (-141.81)  Altitude: 2218ft (-37.60)  Datum: WGS-84  Azimuth/Bearing: 055° N55E 1153mils True (-12°)  Elevation Angle: -14.7°  Horizon Angle: -01.4°  Zoom: 1.0X  11503+25  Patrick Shields</p>

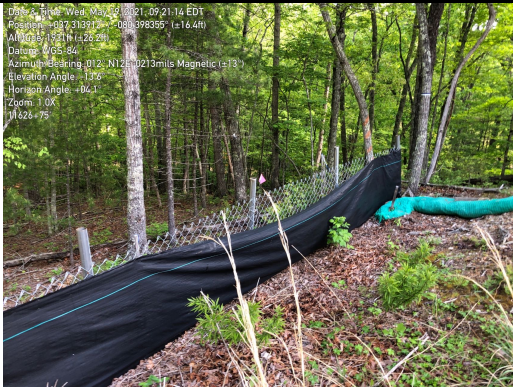
GPS Location		On photo		GPS Location		On photo	
Field Station#		11626+75		Field Station#		11669+00	
Pic 1 Desc.		Communication; fabric will be re-attached to chain link SSF.		Pic 2 Desc.		Top of Brush Mountain at FS188 is stable.

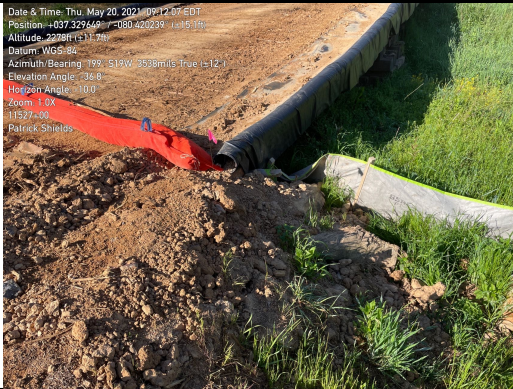
Date & Time: Thu, May 20, 2021 09:12:57 EDT Position: +037.223144° / -080.420239° / 1149.18' Altitude: 2239ft (+11.4m) Datum: WGS 84 Azimuth/Bearing: 129° S15W 35.8mils True (+12.1°) Elevation Angle: -36.0° Horizon Angle: -10.0° Zoom: 1.0x 11527+00 Patrick Shields				Date & Time: Thu, May 20, 2021 09:15:01 EDT Position: +037.223276° / -080.418771° / 1149.18' Altitude: 2239ft (+11.4m) Datum: WGS 84 Azimuth/Bearing: 028° N28E 0498mils True (+12.1°) Elevation Angle: -16.1° Horizon Angle: -01.0° Zoom: 1.0x 11533+00 Patrick Shields											
GPS Location				See photo				GPS Location				See photo			
Field Station#				11527+00				Field Station#				15333+00			
Pic 1 Desc.				P1 full and damaged				Pic 2 Desc.				Stone inlet protection in place
