Visual Site Inspection Report

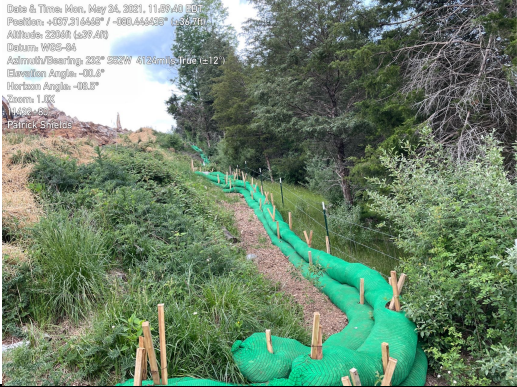
GPS Location		See photo		GPS Location	
Field Station#		11432+80		Field Station#	
Pic 7 Desc.		CFS triple stack perimeter control in place		Pic 8 Desc.	
				Clean water drainage features restored	
<p>Date & Time: Mon, May 24, 2021, 12:31:03 EDT Position: +037.320111° / -080.433379° (+13.11ft) Altitude: 2220ft (+19.7ft) Datum: WGS-84 Azimuth/Bearing: 354° N04°W 6293mils True (+12°) Elevation Angle: -14.8° Horizon Angle: -03.2° Zoom: 1.0X 11468+25 Patrick Shields</p>

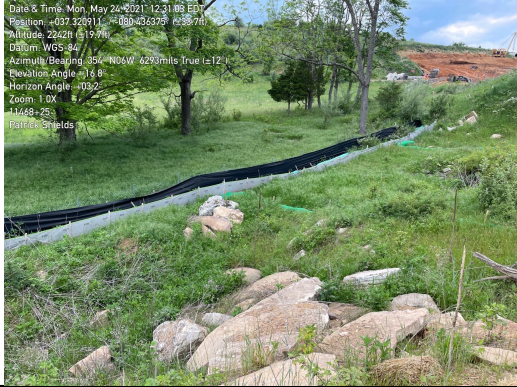
GPS Location		See photo		GPS Location	
Field Station#		11468+25		Field Station#	
Pic 9 Desc.		Triple protection in place at karst feature		Pic 10 Desc.	
				Waterbars in place	
<p>Date & Time: Mon, May 24, 2021, 12:54:41 EDT Position: +037.324826° / -080.431359° (+13.11ft) Altitude: 2145ft (+11.7ft) Datum: WGS-84 Azimuth/Bearing: 236° S50°W 4196mils True (+12°) Elevation Angle: -03.1° Horizon Angle: -02.9° Zoom: 1.0X 11489+60 Patrick Shields</p>

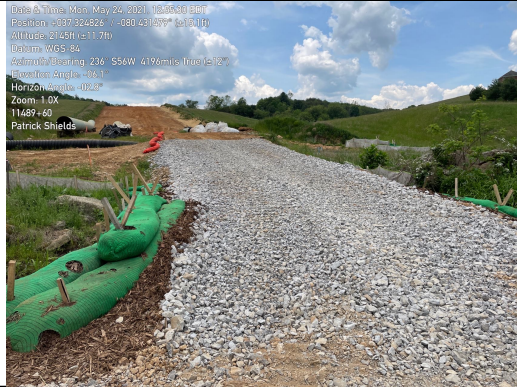
GPS Location		See photo		GPS Location	
Field Station#		11489+60		Field Station#	
Pic 11 Desc.		RCE in place		Pic 12 Desc.	
				Buffer in place

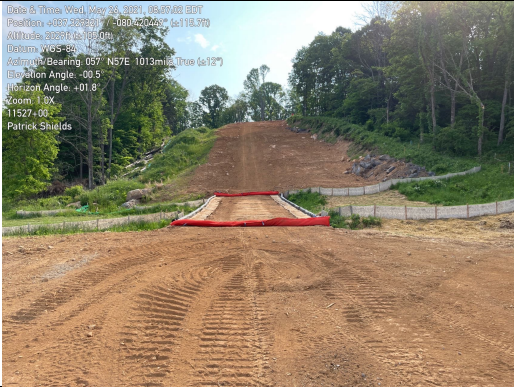
GPS Location	See photo		GPS Location	See photo	
Field Station#	11527+00		Field Station#	11532+00	
Pic 1 Desc.	Clean water drainage feature in place		Pic 2 Desc.	Good vegetation on topsoil piles

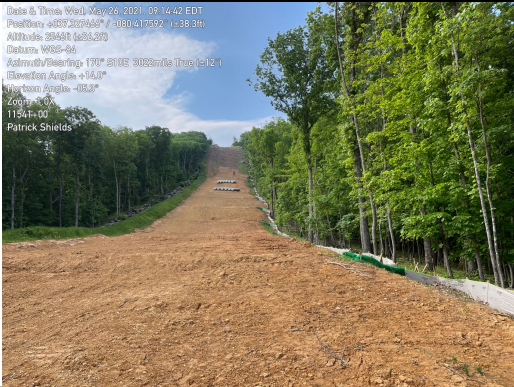
GPS Location	See photo		GPS Location	See photo	
Field Station#	11541+00		Field Station#	11561+00	
Pic 3 Desc.	End treatments in place		Pic 4 Desc.	Waterbars in place

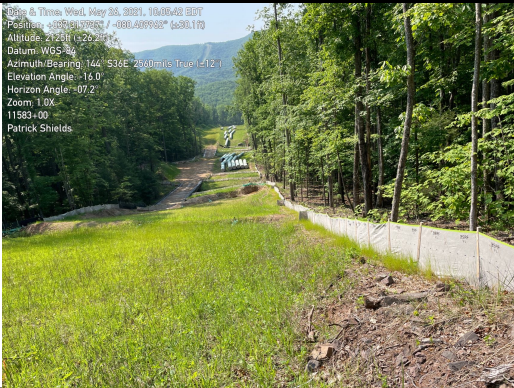
GPS Location	See photo		GPS Location	See photo	
Field Station#	11583+00		Field Station#	11589+00	
Pic 5 Desc.	P1 perimeter control in place		Pic 6 Desc.	Stream Buffer in place

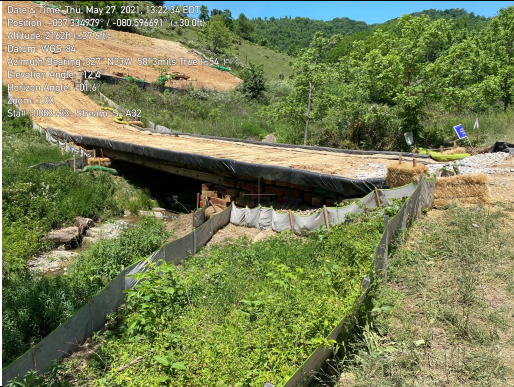
GPS Location	See photo GPS	GPS Location	See photo GPS		
Field Station#	10883+33	Field Station#	10927+06		
Pic 1 Desc.	Stream S- A32- ECD's, equipment bridge.	Pic 2 Desc.	P1 buffer damaged, punch listed.

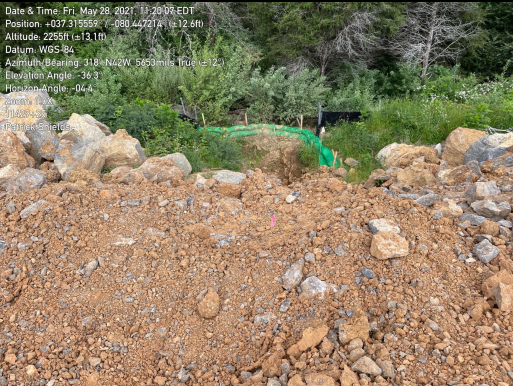
GPS Location	See photo	GPS Location	See photo		
Field Station#	11442+00	Field Station#	11429+25		
Pic 5 Desc.	Clean water drainage feature in place	Pic 6 Desc.	Slope drain needed
