# Visual Site Inspection Report

<b>Project Name</b>	H-600 Pipeline Spread G	<b>AFE</b>	124300137	<b>Spread</b>	H-600 Pipeline Spread G
<b>Contractor</b>	Precision			<b>Report #</b>	22933
<b>Inspector</b>	Patrick Shields			<b>Date/Time</b>	5/3/2021 8:30 AM
<b>Permit #</b>	TBD	<b>Inspection Type</b>	VA SWPP	<b>Station Begin</b>	11670+00
<b>State</b>	VA	<b>Inspection Area</b>	Partial	<b>Station End</b>	11788+52
<b>County</b>	Montgomery	<b>Ground</b>	Wet	<b>Temperature (°F)</b>	65.00
<b>Municipality</b>	N/A	<b>Weather</b>	Light Rain	<b>Rain Gauge (in)</b>	0.00
				<b>Rain Accumulation Time (days)</b>	1.00

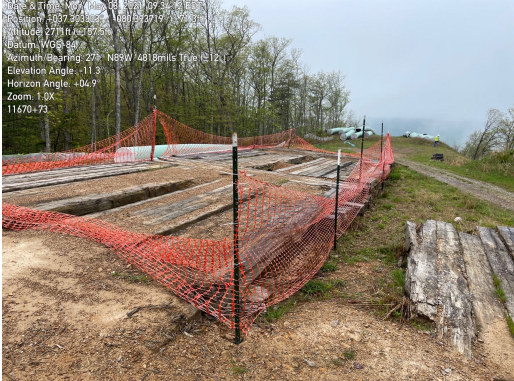
<b>GPS Location</b>	See photo	<b>GPS Location</b>	See photo		
<b>Field Station#</b>	11670+73	<b>Field Station#</b>	11686+80		
<b>Pic 1 Desc.</b>	Orange safety fence down	<b>Pic 2 Desc.</b>	P1 silt fence across travel lane for added protection

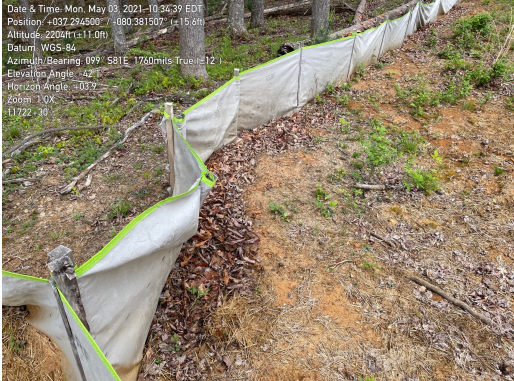
<b>GPS Location</b>	See photo	<b>GPS Location</b>	See photo		
<b>Field Station#</b>	11722+30	<b>Field Station#</b>	11732+33		
<b>Pic 3 Desc.</b>	P1 damaged by wildlife	<b>Pic 4 Desc.</b>	P1 silt fence perimeter control

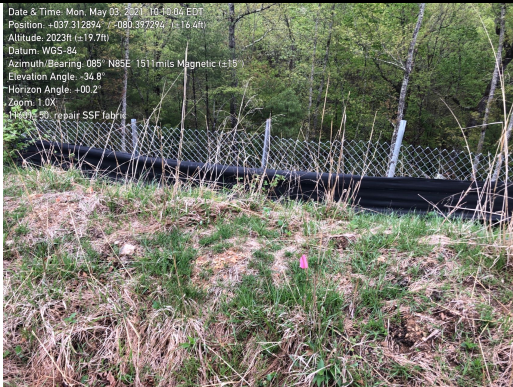
AFE 124300137		Date/Time 5/3/2021 1:15 PM		Report #			
Pictures							
<p>Date &amp; Time: Mon, May 03, 2021, 1:15:00 EDT Position: +037.312847 / -080.317294 (+16.4ft) Altitude: 2023ft (+19.7ft) Datum: WGS-84 Azimuth/Bearing: 085° N85E 1511mits Magnetic (+15°) Elevation Angle: -34.8° Horizon Angle: +00.2° Zoom: 1.0X 11631+50 repair SSF fabric</p>

GPS Location		On photo		GPS Location		On photo	
Field Station#		11631+50		Field Station#		11626+25	
Pic 1 Desc.		Communication; SSF fabric down at 11625+10, 11631+00 and 11631+50.		Pic 2 Desc.		Communication; P1 silt fence down at S-HH18 crossing.	
<p>Date &amp; Time: Mon, May 03, 2021, 10:55:12 EDT Position: +037.313547 / -080.406747 (+32.8ft) Altitude: 1881ft (+78.7ft) Datum: WGS-84 Azimuth/Bearing: 186° S06W 1807mits Magnetic (+15°) Elevation Angle: -00.3° Horizon Angle: -06.9° Zoom: 1.0X 11624+00 repair orange barricade fence</p>

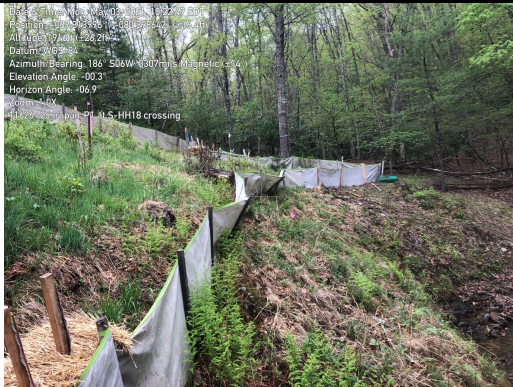
<p>Date &amp; Time: Mon, May 03, 2021, 1:25:00 EDT Position: +037.313547 / -080.406747 (+32.8ft) Altitude: 1881ft (+78.7ft) Datum: WGS-84 Azimuth/Bearing: 186° S06W 1807mits Magnetic (+15°) Elevation Angle: -00.3° Horizon Angle: -06.9° Zoom: 1.0X 11626+25 P1 silt fence crossing</p>

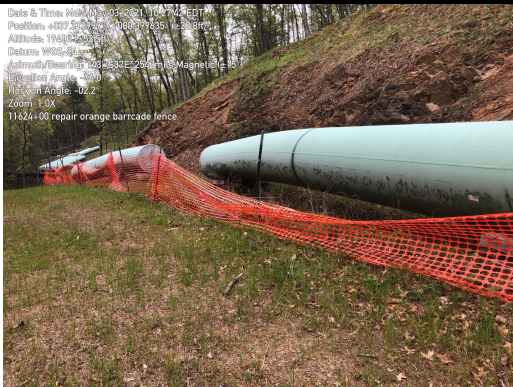
GPS Location		On photo		GPS Location		On photo	
Field Station#		11624+00		Field Station#		11600+75	
Pic 3 Desc.		Communication; orange barricade fence down.		Pic 4 Desc.		Perimeter controls are in place and functional.	
<p>Date &amp; Time: Mon, May 03, 2021, 10:40:18 EDT Position: +037.313147 / -080.404028 (+13.4ft) Altitude: 1960ft (+78.7ft) Datum: WGS-84 Azimuth/Bearing: 234° S56W 419mits Magnetic (+15°) Elevation Angle: -08.5° Horizon Angle: -02.8° Zoom: 1.0X 11608+17 S-006 crossing</p>

E&S BMPs	Compliance Level	Corrective Action	Corrective Time Frame	Date Repaired
Cleanwater Diversion Berm	Acceptable			
Cleanwater Diversion Pipe	Acceptable			
Compost Filter Sock	Acceptable			
Plunge Pool	Acceptable			
Sensitive Resource Buffer	Acceptable			
Silt Fence (Filter Fabric Fence)	Communication	P1 down at 11626+25	24 Hours	
Silt Fence (Reinforce Filter Fence)	Communication	SSF fabric down at 3 locations	24 Hours	
Other - Explain in Comments	Communication	Orange barricade fence down	24 Hours	
Waterbar End Treatment	Acceptable

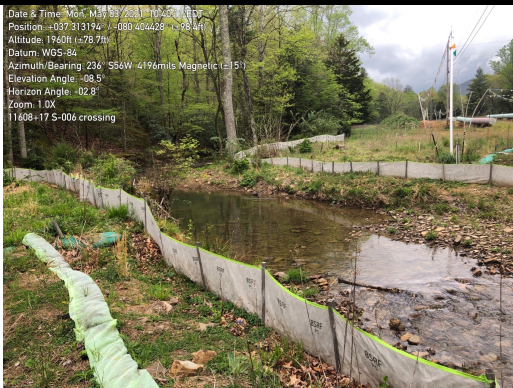
GPS Location		On photo		GPS Location		On photo	
Field Station#		11608+17		Field Station#		11614+20	
Pic 5 Desc.		The S-006 crossing is stable.		Pic 6 Desc.		The S-RR14 crossing is stable.

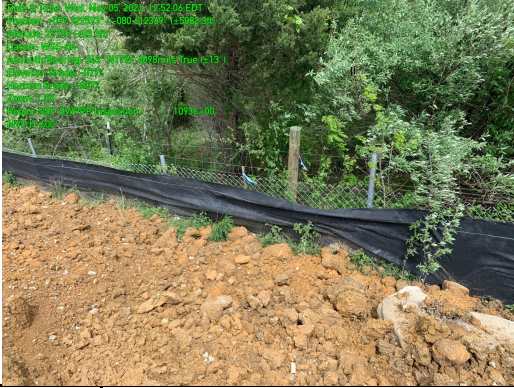
<b>GPS Location</b>	See photo	<b>GPS Location</b>	See photo		
<b>Field Station#</b>	10936+00	<b>Field Station#</b>	10939+72		
<b>Pic 1 Desc.</b>	Repair SSF.	<b>Pic 2 Desc.</b>	Install ECDs to protect top soil.

E&S BMPs	Compliance Level	Corrective Action	Corrective Time Frame	Date Repaired
Cleanwater Diversion Berm	Communication	complete install of diversion pipe		
Compost Filter Berm	Communication	Remove soil against CFS		
Waterbar End Treatment	Communication	Complete install of end treatment		
Equipment Bridge	Communication	Repair side boards remove sed.		
Silt Fence (Filter Fabric Fence)	Communication	Repair fence		
Sensitive Resource Buffer	Communication	Pull soil back f/P1 fence on Karst		
Silt Fence (Reinforce Filter Fence)	Communication	Repair SSF

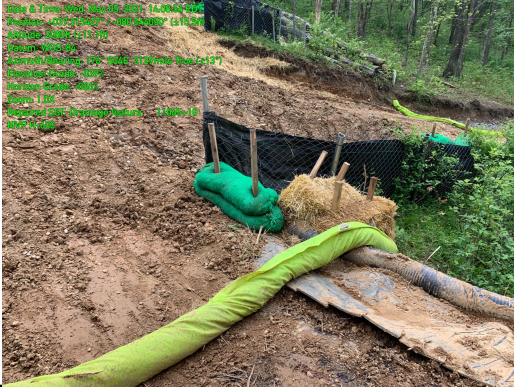
<b>GPS Location</b>	See photo	<b>GPS Location</b>	See photo		
<b>Field Station#</b>	11065+10	<b>Field Station#</b>	10952+75		
<b>Pic 3 Desc.</b>	CFS added to equipment bridge over drainage feature. BMPs	<b>Pic 4 Desc.</b>	Pic 1 equipment bridge needs runner mats replaced.

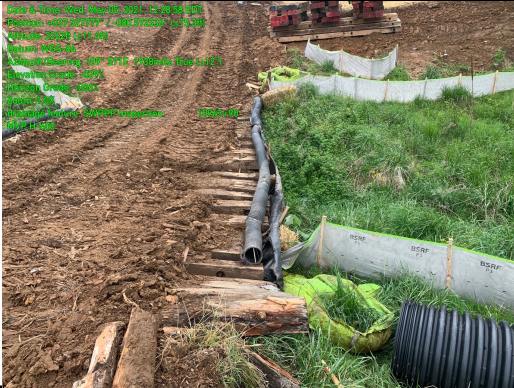
<b>GPS Location</b>	See photo	<b>GPS Location</b>	See photo		
<b>Field Station#</b>	10963+90	<b>Field Station#</b>	10952+75		
<b>Pic 5 Desc.</b>	Bridge over drainage feature needs repaired.	<b>Pic 6 Desc.</b>	Pic 2 side boards need repaired on bridge.

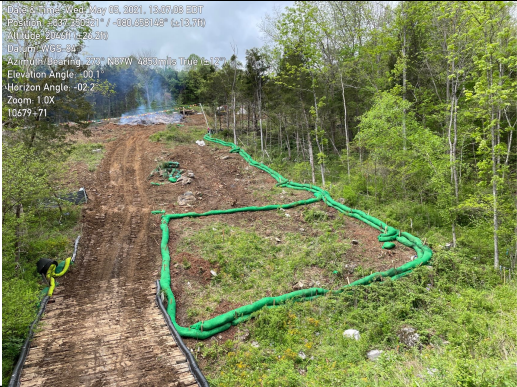
<b>GPS Location</b>	See photo	<b>GPS Location</b>	See photo		
<b>Field Station#</b>	10720+00	<b>Field Station#</b>	10679+71		
<b>Pic 11 Desc.</b>	Northern building brush piles	<b>Pic 12 Desc.</b>	Replaced CFS buffer
