Visual Site Inspection Report

Project Name	H-600 Pipeline Spread G	AFE	124300137	Spread	H-600 Pipeline Spread G
Contractor	Precision			Report #	23992
Inspector	Len Kruizenga			Date/Time	6/1/2021 5:23 PM
Permit #	TBD	Inspection Type	VA SWPP	Station Begin	11788+53
State	VA	Inspection Area	Full	Station End	12005+00
County	Montgomery	Ground	Dry	Temperature (°F)	71.00
Municipality	N/A	Weather	Sunny	Rain Gauge (in)	0.60
				Rain Accumulation Time (days)	2.00

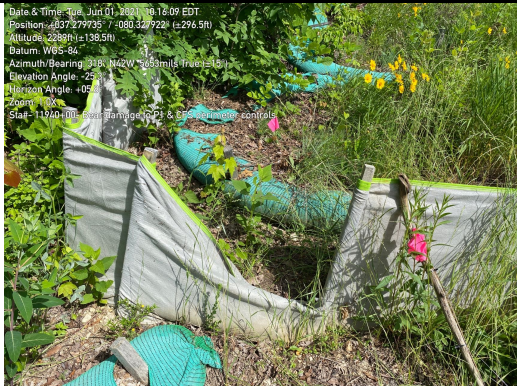
GPS Location		See photo GPS		GPS Location	
Field Station#		11940+00		Field Station#	
Pic 9 Desc.		P1 and CFS perimeter controls damaged by bear.		Pic 10 Desc.	
<p>Date & Time: Tue, Jun 01, 2021 10:49:23 EDT Position: +037.283324° / -080.300387° (+317.1M) Altitude: 2069ft (+34.7m) Datum: WGS-84 Azimuth/Bearing: 169° S31E 24.9mils True (+15°) Elevation Angle: +17.1° Horizon Angle: +06.8° Zoom: 1.0x Stat: 11977+00 - Karst ECD's & signage</p>

E&S BMPs	Compliance Level	Corrective Action	Corrective Time Frame	Date Repaired
Broad-Based Dip	Acceptable			
Compost Filter Sock	Communication	Repair damaged sock	24 Hours	
Rock Check Dam	Acceptable			
Rock Construction Entrance	Acceptable			
Sensitive Resource Signage	Acceptable			
Silt Fence (Filter Fabric Fence)	Communication	Repair damaged silt fence	24 Hours	
Vegetative Stabilization (Permanent)	Acceptable			
Waterbar	Acceptable			
Waterbar Outlet Protection	Acceptable

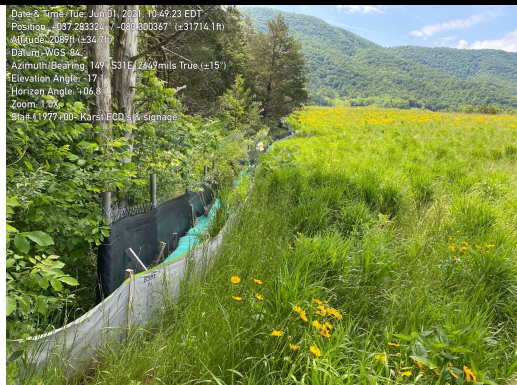
<p>Date & Time: Tue, Jun 01, 2021 10:55:03 EDT Position: +037.288771° / -080.321038° (+26.2M) Altitude: 4659ft (+59.5m) Datum: WGS-84 Azimuth/Bearing: 160° S30E 19.5mils True (+15°) Elevation Angle: +24.9° Horizon Angle: +09.2° Zoom: 1.0x Stat: 11983+50 - Triple stack perimeter controls damaged by bear</p>

GPS Location		See photo GPS		GPS Location	
Field Station#		11977+00		Field Station#	
Pic 11 Desc.		Karst ECD's and signage.		Pic 12 Desc.	
				Triple stack perimeter controls damaged by bear.

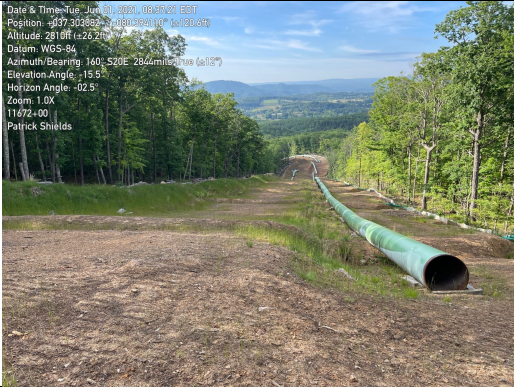
GPS Location	See photo	GPS Location	See photo		
Field Station#	11672+00	Field Station#	11703+00		
Pic 1 Desc.	Waterbars in place	Pic 2 Desc.	Stream buffer in place		
<p>Date & Time: Tue Jun 01, 2021, 09:25:16 EDT Position: -037.226289, -080.362517 (+16.21) Altitude: 2345ft (+15.5ft) Datum: WGS-84 Azimuth/Bearing: -172° S07E 3076mils True (+12°) Elevation Angle: -12.1° Horizon Angle: -05.2° Zoom: 1.0X 11718+00 Patrick Shields</p>

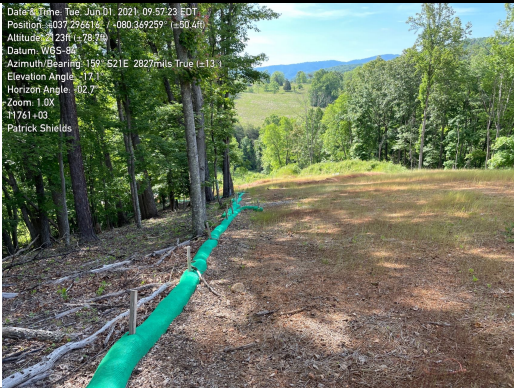
GPS Location	See photo	GPS Location	See photo		
Field Station#	11761+03	Field Station#	11788+00		
Pic 5 Desc.	CFS perimeter control in place	Pic 6 Desc.	RCE in place

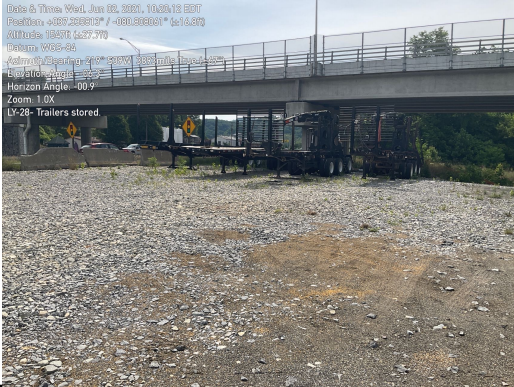
GPS Location	See photo GPS	GPS Location	See photo GPS		
Field Station#	12005+00	Field Station#	12005+00		
Pic 3 Desc.	LY -28- Trailers stored.	Pic 4 Desc.	LY-28- CFS perimeter controls are in acceptable condition.

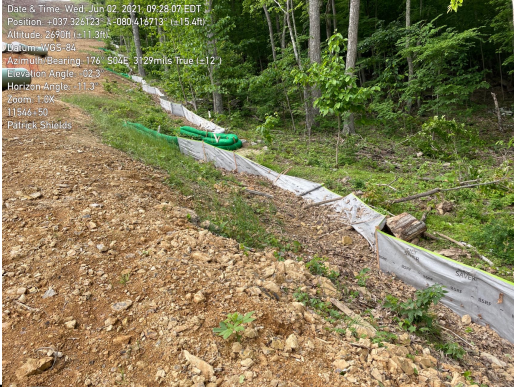
GPS Location	See photo	GPS Location	See photo		
Field Station#	11546+50	Field Station#	11559+50		
Pic 3 Desc.	P1 perimeter control damaged	Pic 4 Desc.	Waterbars in place
