# Visual Site Inspection Report

<b>Project Name</b>	H-600 Pipeline Spread G	<b>AFE</b>	124300137	<b>Spread</b>	H-600 Pipeline Spread G
<b>Contractor</b>	Precision			<b>Report #</b>	24186
<b>Inspector</b>	Rob Robertson			<b>Date/Time</b>	6/7/2021 7:03 AM
<b>Permit #</b>	TBD	<b>Inspection Type</b>	VA SWPP	<b>Station Begin</b>	11600+01
<b>State</b>	VA	<b>Inspection Area</b>	Full	<b>Station End</b>	11670+00
<b>County</b>	Montgomery	<b>Ground</b>	Damp	<b>Temperature (°F)</b>	77.00
<b>Municipality</b>	N/A	<b>Weather</b>	Cloudy	<b>Rain Gauge (in)</b>	0.05
				<b>Rain Accumulation Time (days)</b>	1.00

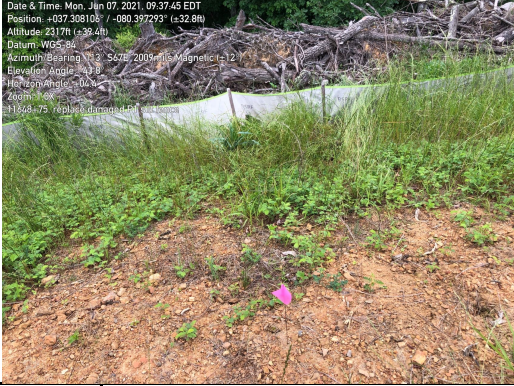
<b>AFE</b>	124300137	<b>Date/Time</b>	6/7/2021 7:03 AM	<b>Report #</b>	
<b>Pictures</b>					
<p>Date &amp; Time: Mon, Jun 07, 2021, 09:37:45 EDT  Position: +037.328103 / -080.377293 (±32.8ft)  Altitude: 2317ft (±39.4ft)  Datum: WGS-84  Azimuth/Bearing: 112.547W, 2009mils Magnetic (±12°)  Elevation Angle: -01.9°  Horizon Angle: -01.3°  Zoom: 1.0X  11648+75 replace down and worn P1 silt fencing</p>

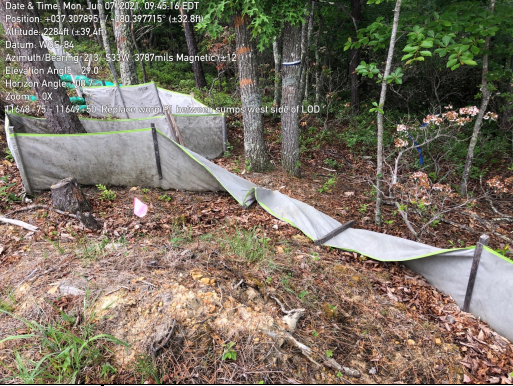
<p>Date &amp; Time: Mon, Jun 07, 2021, 09:45:18 EDT  Position: +037.330895 / -080.377215 (±32.8ft)  Altitude: 2284ft (±39.4ft)  Datum: WGS-84  Azimuth/Bearing: 213.531W, 3787mils Magnetic (±12°)  Elevation Angle: -02.0°  Horizon Angle: -01.7°  Zoom: 1.0X  11648+75 - 11649+50 Replace silt fence, install sump, west side of LOD</p>

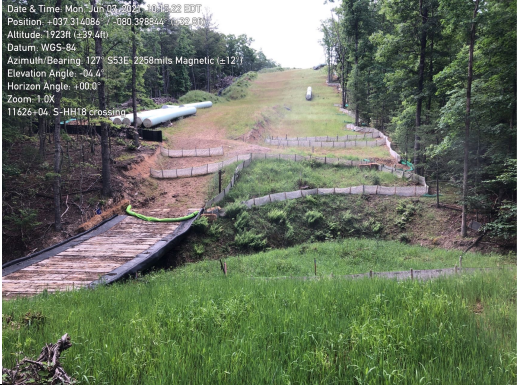
<p><small>Date &amp; Time: Mon, Jun 07, 2021, 10:30:29 EDT Position: +037.314086 / -080.398544 (+98.4ft) Altitude: 1923ft (+39.4ft) Datum: WGS-84 Azimuth/Bearing: 127° S31E 288mils Magnetic (+12°) Elevation Angle: +36.4° Horizon Angle: +00.0° Zoom: 1.0X 11626+04, S-HH18 crossing</small></p>

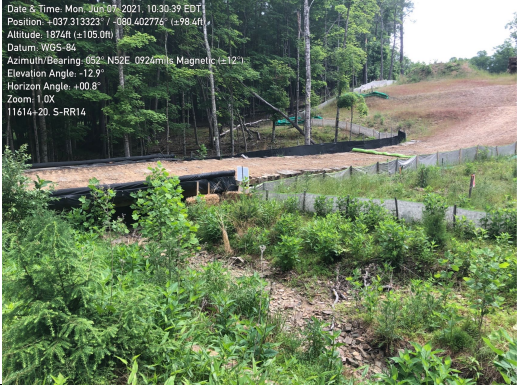
<p><small>Date &amp; Time: Mon, Jun 07, 2021, 10:30:39 EDT Position: +037.313323 / -080.402776 (+98.4ft) Altitude: 1874ft (+105.0ft) Datum: WGS-84 Azimuth/Bearing: 692° N52E 0926mils Magnetic (+12°) Elevation Angle: +12.9° Horizon Angle: +00.8° Zoom: 1.0X 11614+20, S-RR14</small></p>			
<b>GPS Location</b>	On photo	<b>GPS Location</b>	On photo		
<b>Field Station#</b>	11626+04	<b>Field Station#</b>	11614+20		
<b>Pic 7 Desc.</b>	The S-HH18 crossing is stable.	<b>Pic 8 Desc.</b>	The S-RR14 crossing is stable.

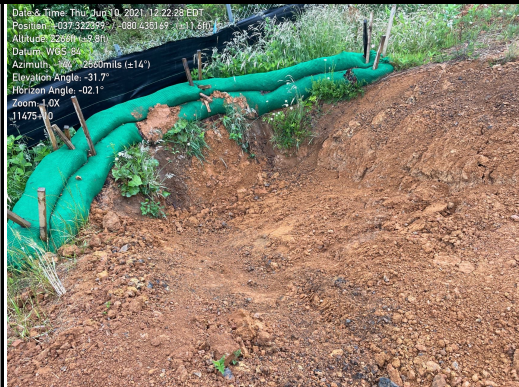
<p>Date &amp; Time: Thu, Jun 10, 2021, 12:22:28 EDT Position: +037.312225° / -080.430169° (+11.81) Altitude: 2201ft (+9.91) Datum: WGS-84 Azimuth/Bearing: 286°/SSW, 6179mils True (+14°) Elevation Angle: -02.1° Horizon Angle: -02.1° Zoom: 1.0X 11475+00</p>			
GPS Location	See photo		GPS Location	See photo	
Field Station#	11448+50		Field Station#	11475+00	
Pic 7 Desc.	Torn geo needs replaced		Pic 8 Desc.	Sump needs maintenance and end treatment needs cleaned off and holes repaired

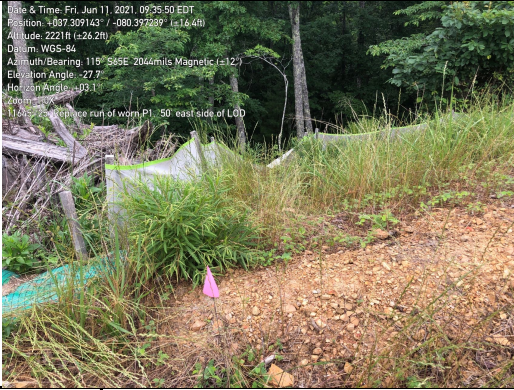
<p>Date &amp; Time: Fri, Jun 11, 2021, 09:35:50 EDT Position: +397.329143° / -080.377239° (+16.4ft) Altitude: 2221ft (+26.2ft) Datum: WGS-84 Azimuth/Bearing: 119° S45E 2044mils Magnetic (+12°) Elevation Angle: -27.7° Horizon Angle: -07.1° Zoom: 1.0x 11645+25, replace worn P1, 50' east side of LOD</p>

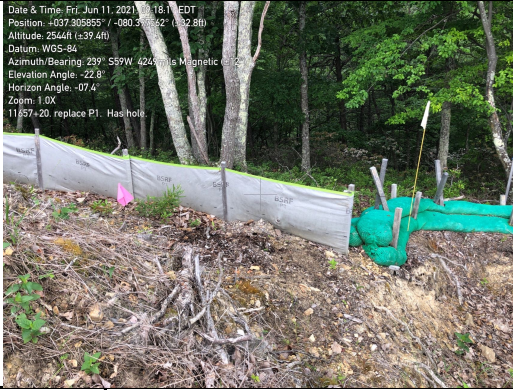
<p>Date &amp; Time: Fri, Jun 11, 2021, 09:18:17 EDT Position: +397.305855° / -080.376142° (+16.4ft) Altitude: 2544ft (+39.4ft) Datum: WGS-84 Azimuth/Bearing: 239° S59W 4245mils Magnetic (+12°) Elevation Angle: -22.8° Horizon Angle: -07.4° Zoom: 1.0x 11657+20, replace P1. Has hole.</p>			
<b>GPS Location</b>	On photo	<b>GPS Location</b>	On photo		
<b>Field Station#</b>	11645+25	<b>Field Station#</b>	11657+20		
<b>Pic 1 Desc.</b>	Communication; replace worn silt fence located on east side of LOD.	<b>Pic 2 Desc.</b>	Communication; Replace worn silt fence. West side of LOD.

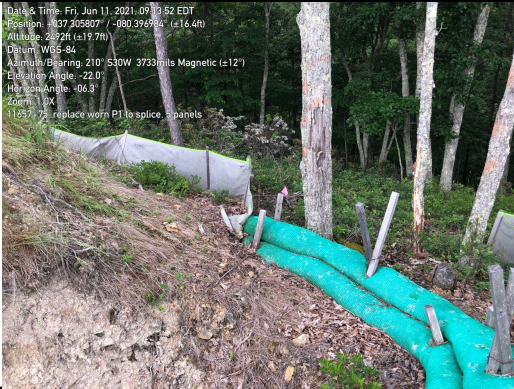
<p>Date &amp; Time: Fri, Jun 11, 2021, 09:15:52 EDT Position: +397.305807° / -080.376194° (+16.4ft) Altitude: 2429ft (+19.7ft) Datum: WGS-84 Azimuth/Bearing: 210° S30W 3733mils Magnetic (+12°) Elevation Angle: -22.0° Horizon Angle: -06.3° Zoom: 1.0x 11657+75, replace worn P1 to splice 3 panels</p>

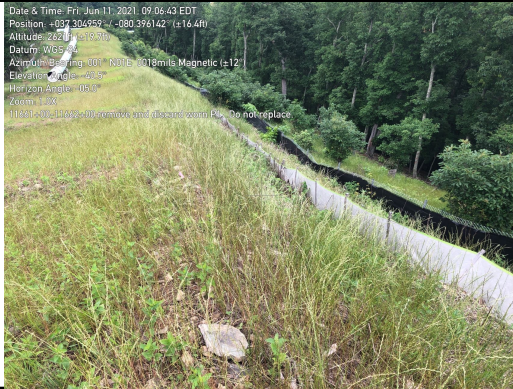
<p>Date &amp; Time: Fri, Jun 11, 2021, 09:06:43 EDT Position: +397.306459° / -080.376142° (+16.4ft) Altitude: 2521ft (+19.7ft) Datum: WGS-84 Azimuth/Bearing: 301° N31E 3018mils Magnetic (+12°) Elevation Angle: -06.5° Horizon Angle: -05.8° Zoom: 1.0x 11661+00, P1 is torn and needs to be replaced. Do not replace.</p>			
<b>GPS Location</b>	On photo	<b>GPS Location</b>	On photo		
<b>Field Station#</b>	11657+75	<b>Field Station#</b>	11661+00		
<b>Pic 3 Desc.</b>	Communication; Replace worn silt fencing. West side of LOD.	<b>Pic 4 Desc.</b>	Communication; Remove worn P1 silt fence. It was placed during construction to keep rock from rolling onto SSF. Do not replace.

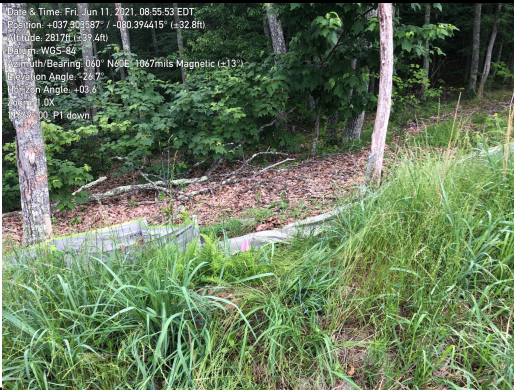
<p>Date &amp; Time: Fri, Jun 11, 2021, 08:55:53 EDT Position: +397.293397° / -080.374419° (+16.4ft) Altitude: 2617ft (+32.4ft) Datum: WGS-84 Azimuth/Bearing: 040° N56E 1067mils Magnetic (+13°) Elevation Angle: -25.7° Horizon Angle: -03.8° Zoom: 1.0x 11669+00, P1 down</p>

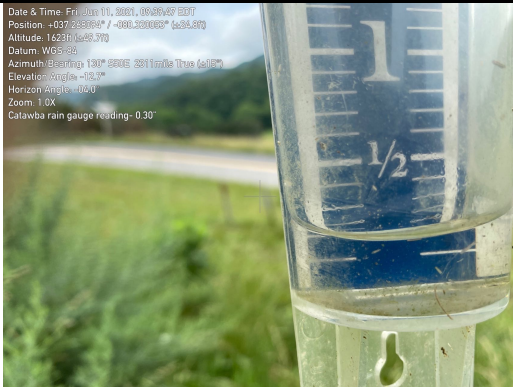
GPS Location				See photo GPS				GPS Location				See photo GPS			
Field Station#				11989+00				Field Station#				11931+00			
Pic 1 Desc.				Catawba rain gauge reading- 0.30"				Pic 2 Desc.				AR-266.00- Tree fallen across access rd. Item punch listed.			
<p>Date &amp; Time: Fri Jun 11, 2021, 10:00:15 EDT Position: +037.272590° / -080.328419° (-58.57m) Altitude: 1960ft (-59.0m) Datum: WGS-84 Azimuth/Bearing: 162° 53'00" S254mils True (-18°) Elevation Angle: -23.5° Horizon Angle: +02.3 Zoom: 1.0X AR-266.00- Tree down across rd. &amp; gutter.</p>

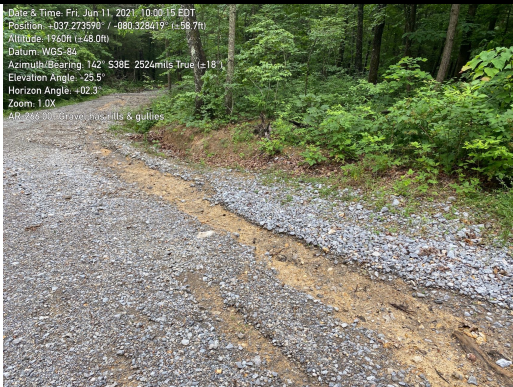
GPS Location				See photo GPS				GPS Location				See photo GPS			
Field Station#				11931+00				Field Station#				11788+00			
Pic 3 Desc.				AR-266.00- Access rd rock washed out, item added to the punch list.				Pic 4 Desc.				Mt. Tabor RCE			
<p>Date &amp; Time: Fri Jun 11, 2021, 11:00:00 EDT Position: +037.283450° / -080.343600° (-60.98m) Altitude: 2030ft (-62.7m) Datum: WGS-84 Azimuth/Bearing: 330° 00'00" S330mils True (-18°) Elevation Angle: +02.7° Horizon Angle: +00.2 Zoom: 1.0X Sta# 11788+00- Mt Tabor road RCE</p>
