Visual Site Inspection Report

Project Name H-600 Pipeline Spread H		AFE 124300138	Spread H-600 Pipeline Spread H
Contractor Precision		Report # 21352	
Inspector John Brcic		Date/Time 3/22/2021 2:55 PM	
Permit # TBD	Inspection Type VA SWPP	Station Begin 12443+75	
State VA	Inspection Area Partial	Station End 12544+06	
County Montgomery	Ground Dry	Temperature (°F) 50.00	
Municipality N/A	Weather Sunny	Rain Gauge (in) 0.00	
Rain Accumulation Time (days)			3.00

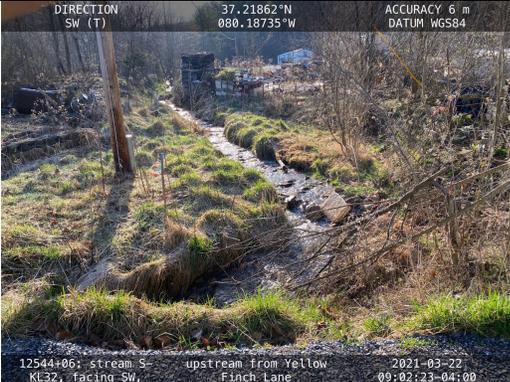
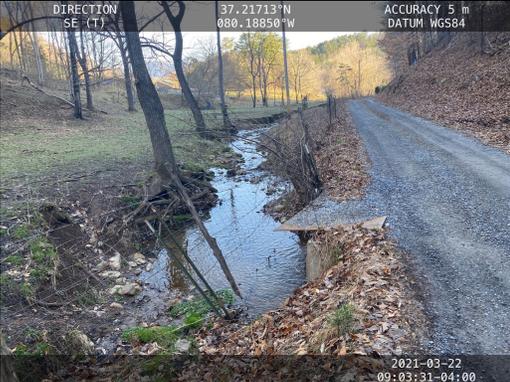
GPS Location	See photo		GPS Location	See photo	
Field Station#	12544+06		Field Station#	12544+06	
Pic 1 Desc.	Stream S-KL32, facing southwest, upstream from Yellow Finch Lane		Pic 2 Desc.	Stream S-EF20b, facing southeast, downstream from Yellow Finch Lane

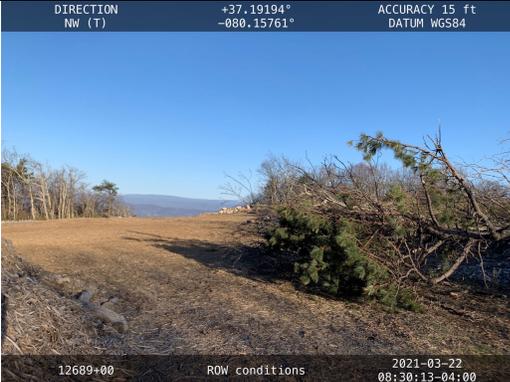
GPS Location		See photo for gps location data.		GPS Location	
Field Station#		12689+00		Field Station#	
Pic 1 Desc.		Photo shows the ROW condition from about 12686+00 to 12689+00.		Pic 2 Desc.

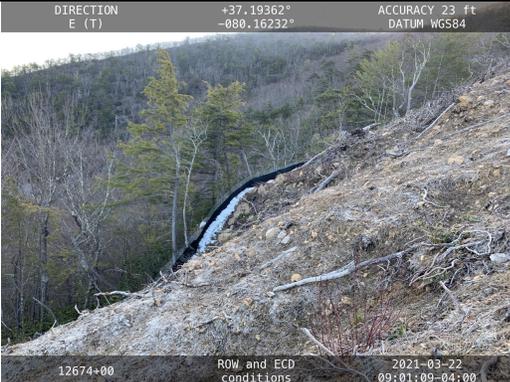
GPS Location		See photo for gps location data.		GPS Location	
Field Station#		12674+00		Field Station#	
Pic 3 Desc.		Photo shows the ECDs from about 12674+00 to 12676+00.		Pic 4 Desc.

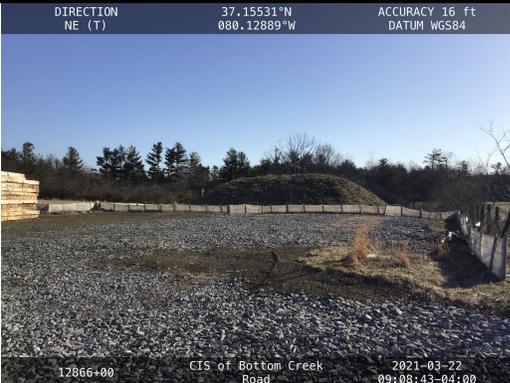
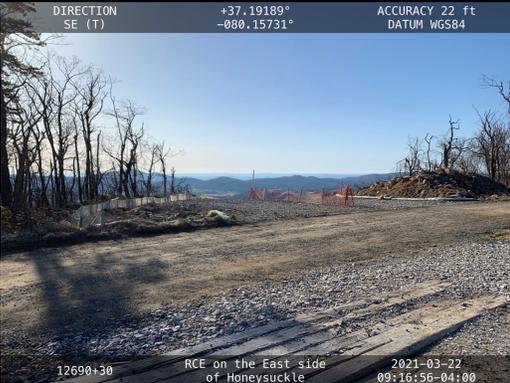
GPS Location		See photo for gps location data.		GPS Location	
Field Station#		12866+00		Field Station#	
Pic 5 Desc.		Photo shows the ECDs on the west side of Bottom Creek Road.		Pic 6 Desc.	
				Photo shows the RCE on the east side of Honeysuckle Road.

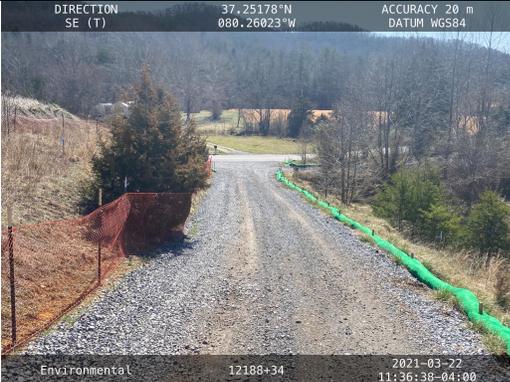
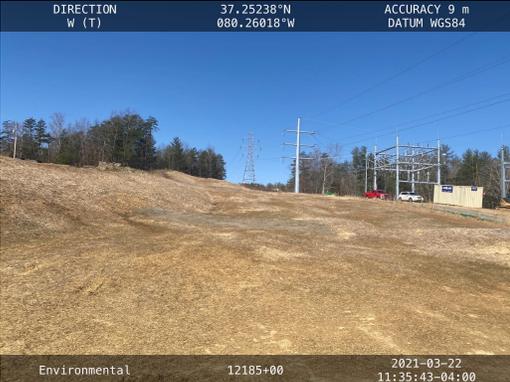
<p>DIRECTION W (T) 37.25238°N 080.26018°W ACCURACY 9 m DATUM WGS84 Environmental 12185+00 2021-03-22 11:35:43-04:00</p>			
GPS Location	See photo	GPS Location	See photo		
Field Station#	12188+34	Field Station#	12185+00		
Pic 1 Desc.	Access Road MVP-MN-274 in acceptable condition	Pic 2 Desc.	Stabilized ROW in acceptable condition

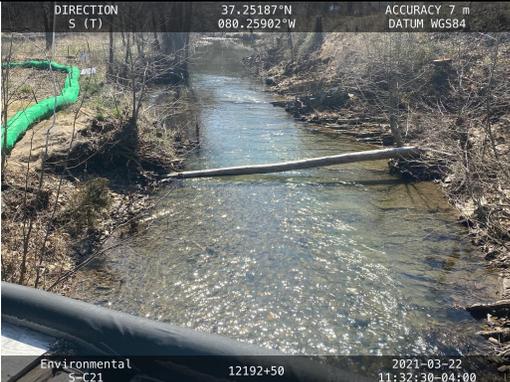
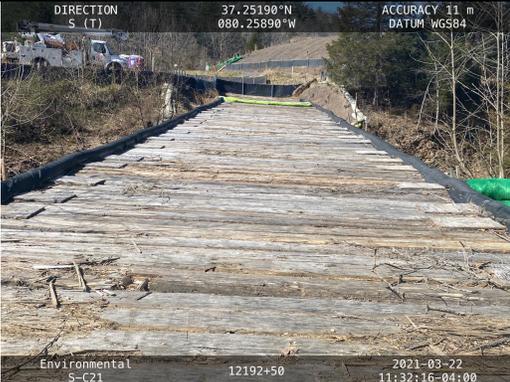
<p>DIRECTION S (T) 37.25190°N 080.25890°W ACCURACY 11 m DATUM WGS84 Environmental S-C21 12192+50 2021-03-22 11:32:16-04:00</p>			
GPS Location	See photo	GPS Location	See photo		
Field Station#	12192+50	Field Station#	12192+50		
Pic 3 Desc.	Down stream of stream crossing S-C21 in acceptable condition with no signs of impacts	Pic 4 Desc.	Bridge and ECDs crossing stream S-C21 in acceptable condition

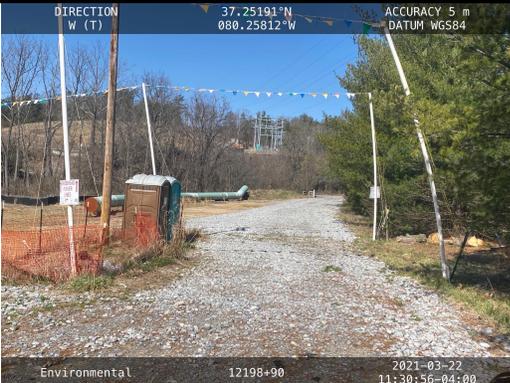
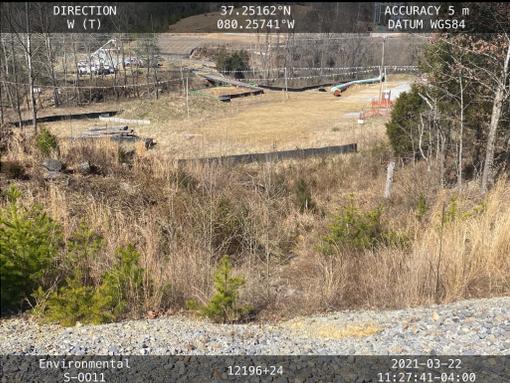
<p>DIRECTION W (T) 37.25162°N 080.25741°W ACCURACY 5 m DATUM WGS84 Environmental S-0011 12196+24 2021-03-22 11:27:41-04:00</p>			
GPS Location	See photo	GPS Location	See photo		
Field Station#	12198+90	Field Station#	12196+24		
Pic 5 Desc.	Access Road MVP-MN-275 in acceptable condition	Pic 6 Desc.	Stream S-0011 on the west side of the railroad tracks in acceptable condition

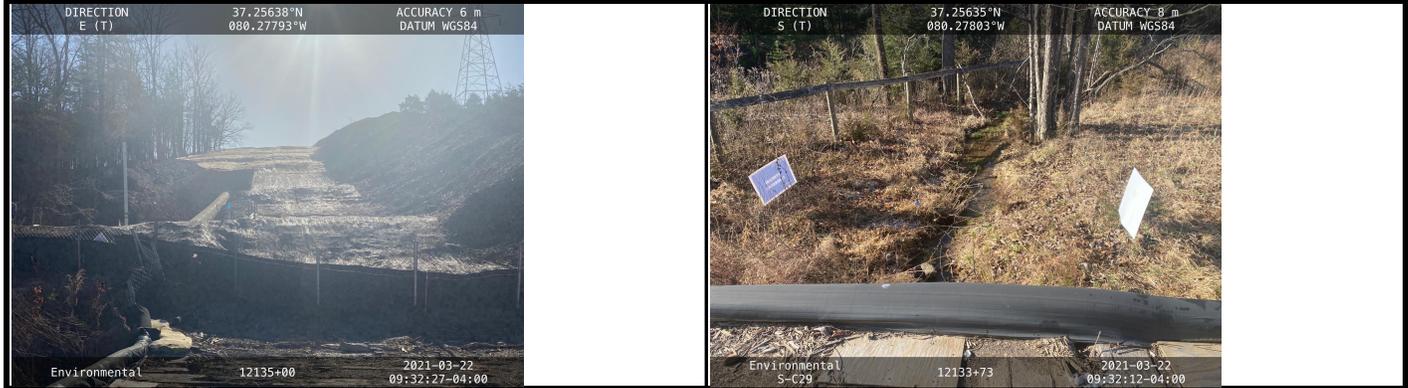
GPS Location	See photo	GPS Location	See photo
Field Station#	12135+00	Field Station#	12133+73
Pic 13 Desc.	Stabilized slope in acceptable condition	Pic 14 Desc.	S-C21 down stream in acceptable condition with no signs of impact.

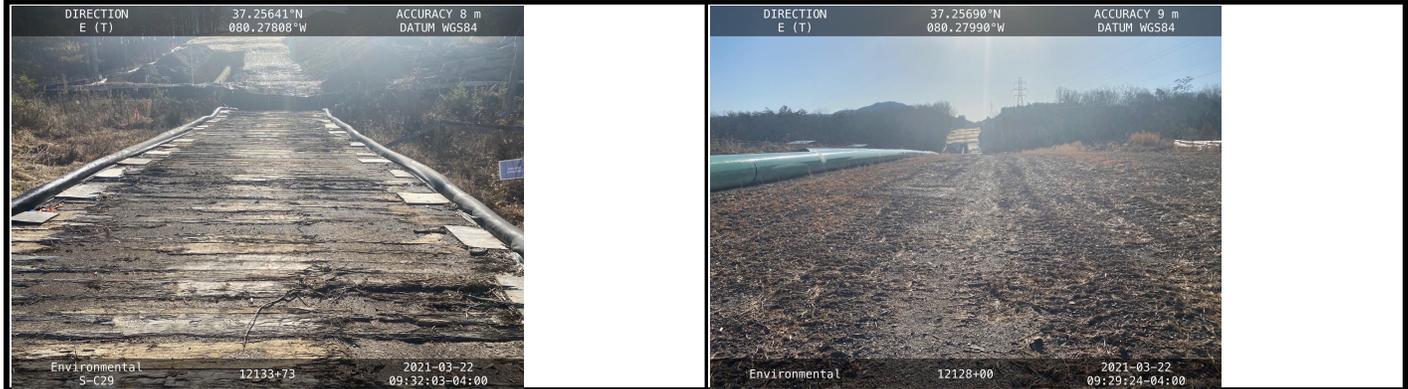
GPS Location	See photo	GPS Location	See photo
Field Station#	12133+73	Field Station#	12128+00
Pic 15 Desc.	Bridge and ECDs at stream crossing S-C21 in acceptable condition	Pic 16 Desc.	Stabilized ROW in acceptable condition

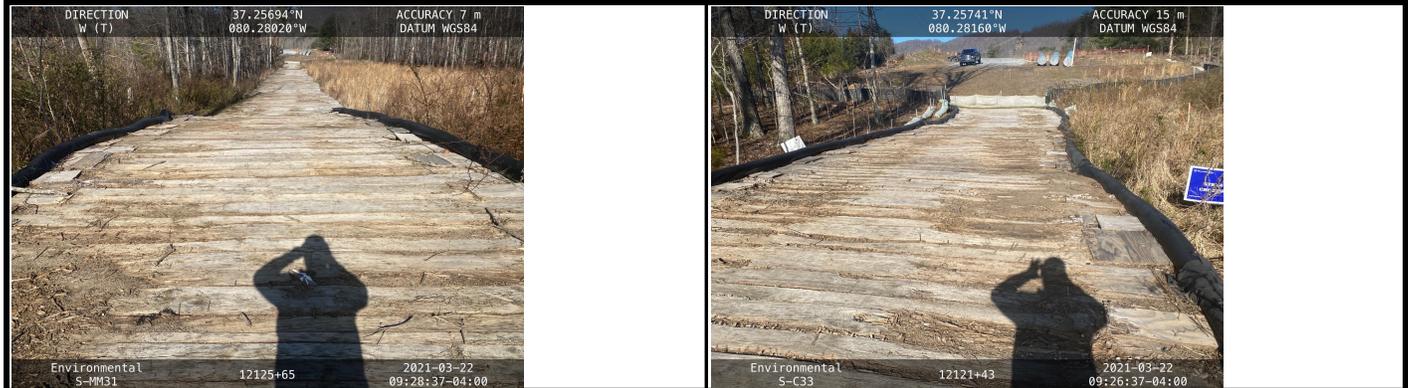
GPS Location	See photo	GPS Location	See photo
Field Station#	12125+65	Field Station#	12121+43
Pic 17 Desc.	Bridge and ECDs at stream crossing S-MM31 in acceptable condition	Pic 18 Desc.	Bridge and ECDs at stream crossing S-C33 in acceptable condition

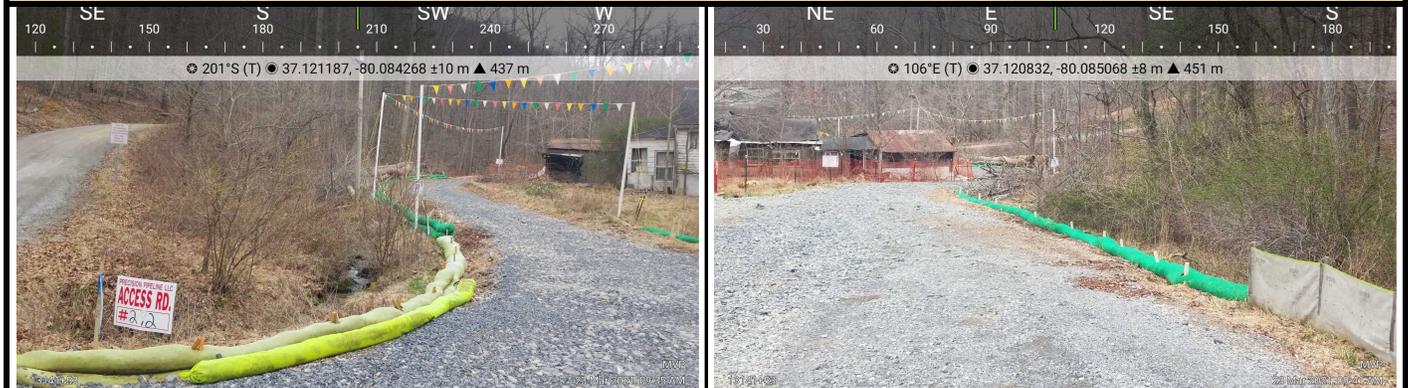
GPS Location	See photo for coordinates.	GPS Location	See photo for coordinates.
Field Station#	13141+53	Field Station#	13141+53
Pic 1 Desc.	MVP-FR-292, access road in acceptable condition, ECDs functioning acceptably.	Pic 2 Desc.	MVP-FR-292, access road in acceptable condition, ECDs functioning acceptably.

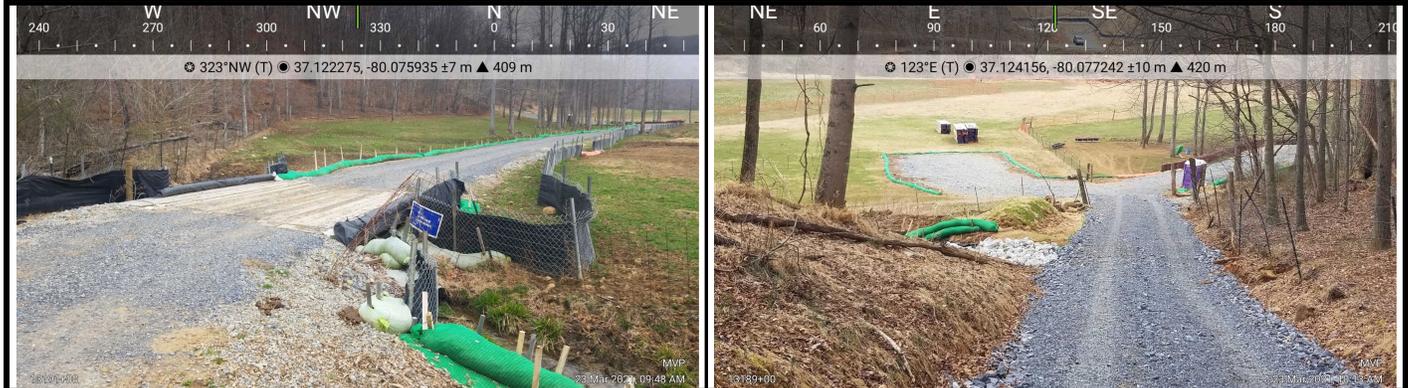
GPS Location	See photo for coordinates.	GPS Location	See photo for coordinates.
Field Station#	13191+00	Field Station#	13189+00
Pic 3 Desc.	MVP-MLV-AR-29, S-D10, access road in acceptable condition, air bridge over stream and culver in acceptable condition.	Pic 4 Desc.	MVP-FR-292.01, access road in acceptable condition.

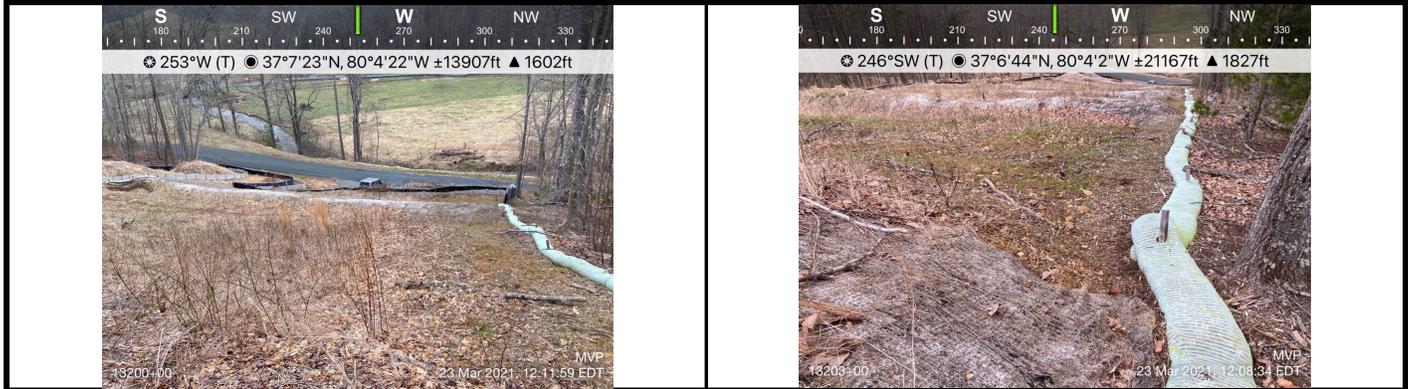
GPS Location	See photo for coordinates.	GPS Location	See photo for coordinates.
Field Station#	13200+00	Field Station#	13203+00
Pic 5 Desc.	ROW stable with vegetative cover from the last growing season.	Pic 6 Desc.	ROW stable with vegetative cover from the last growing season, CFS showing signs of degradation.

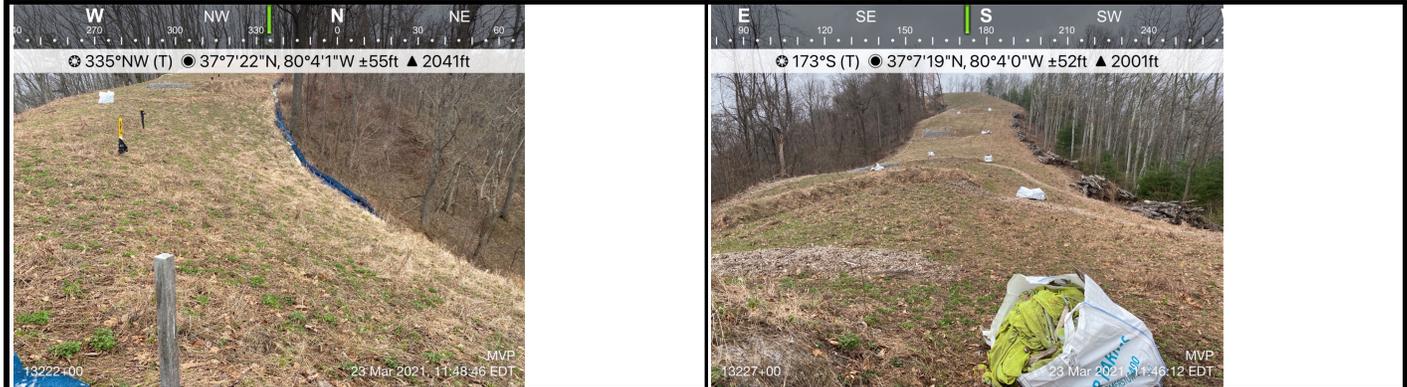
GPS Location	See photo for coordinates.	GPS Location	See photo for coordinates.
Field Station#	13222+00	Field Station#	13227+00
Pic 9 Desc.	ROW stable with vegetative cover across LOD, no changes noted at slip location.	Pic 10 Desc.	ROW stable with vegetative cover across LOD.

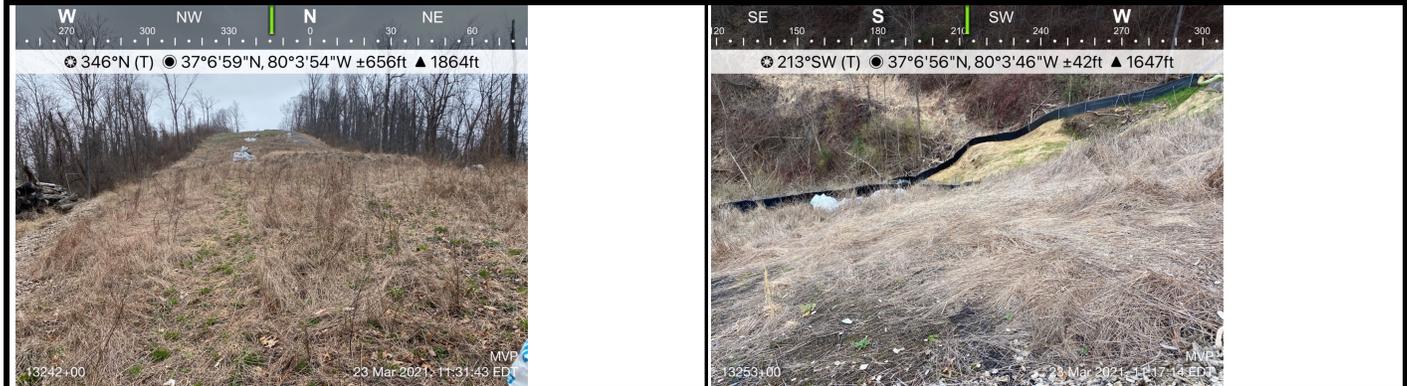
GPS Location	See photo for coordinates.	GPS Location	See photo for coordinates.
Field Station#	13242+00	Field Station#	13253+00
Pic 11 Desc.	ROW stable with vegetative cover across LOD.	Pic 12 Desc.	ROW appeared stable with vegetative cover and erosion control blanket across LOD, no notable changes noted at slip.

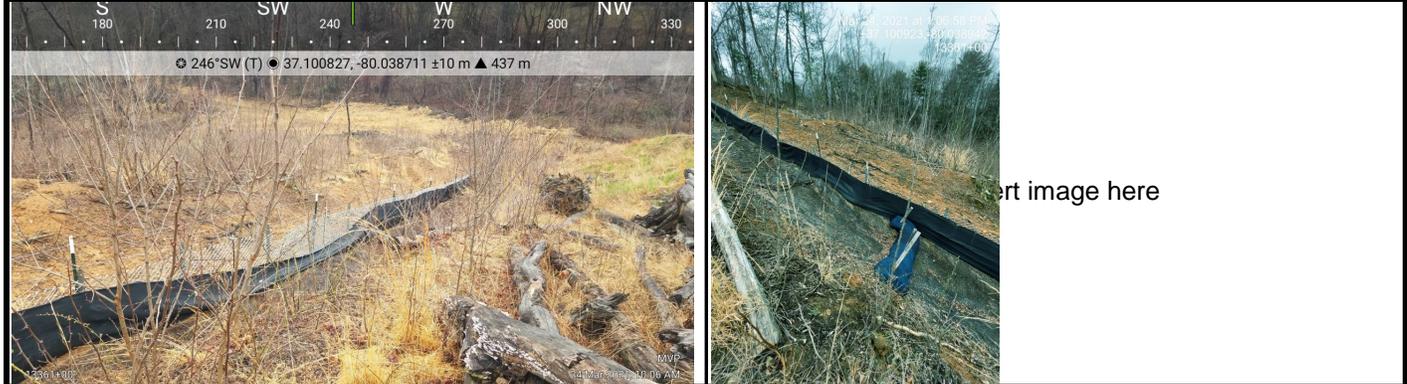
GPS Location	See Above	GPS Location	See Above
Field Station#	13361+00	Field Station#	13361+00
Pic 7 Desc.	Punchlist item: Repair super silt fence.	Pic 8 Desc.	Punchlist item: Super silt fence repaired.

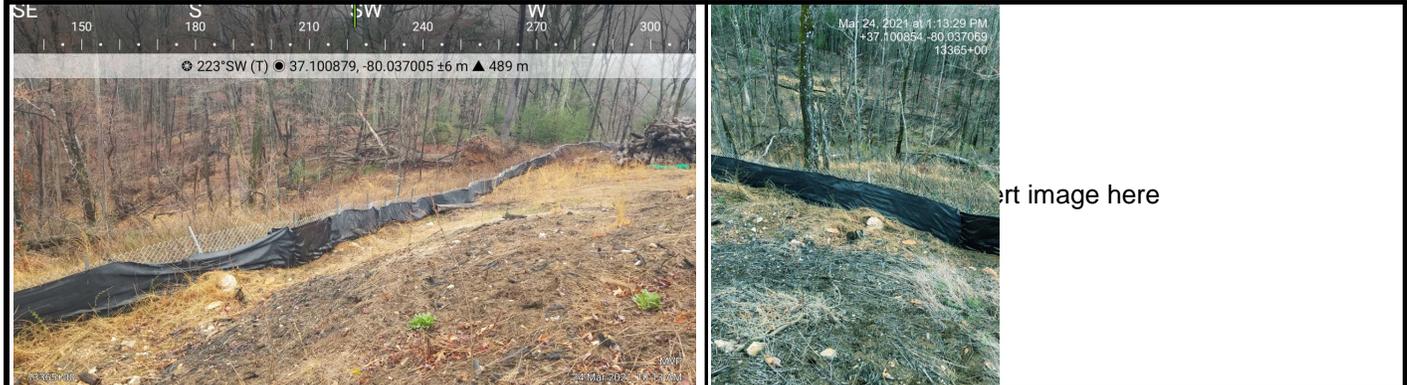
GPS Location	See Above	GPS Location	See Above
Field Station#	13365+00	Field Station#	13365+00
Pic 9 Desc.	Punchlist item: Repair super silt fence.	Pic 10 Desc.	Punchlist item: Super silt fence repaired.

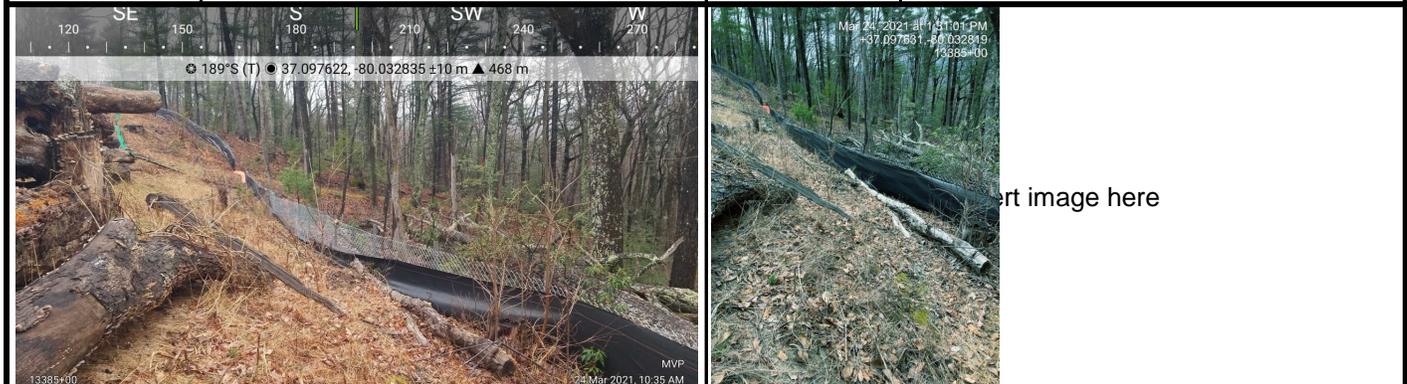
GPS Location	See Above	GPS Location	See Above
Field Station#	13385+00	Field Station#	13385+00
Pic 11 Desc.	Punchlist item: Repair super silt fence.	Pic 12 Desc.	Punchlist item: Super silt fence repaired.

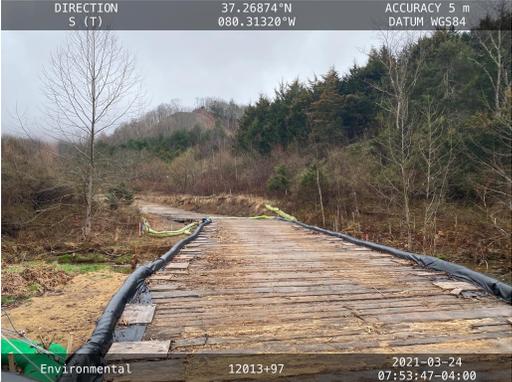
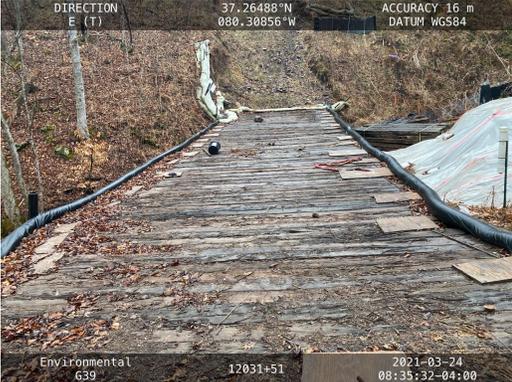
GPS Location See photo			GPS Location See photo		
Field Station# 12013+97			Field Station# 12031+51		
Pic 3 Desc. Bridge and ECDs crossing stream S-G36 along access road MVP-MN-268 in acceptable condition			Pic 4 Desc. Bridge and ECDs at stream crossing S-G39 in acceptable condition

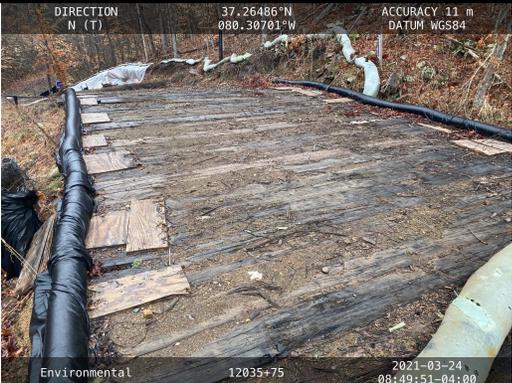
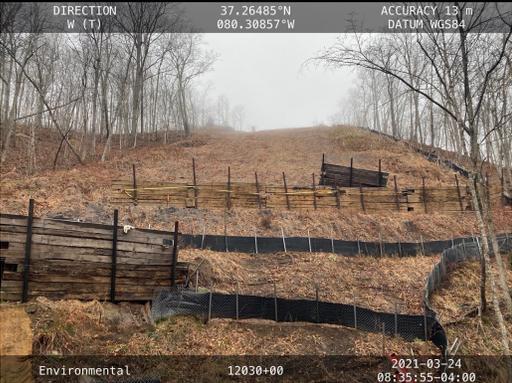
GPS Location See photo			GPS Location See photo		
Field Station# 12035+75			Field Station# 12030+00		
Pic 5 Desc. Bridge and ECDs at stream crossing S-PP23 in acceptable condition			Pic 6 Desc. Stabilized slope in acceptable condition

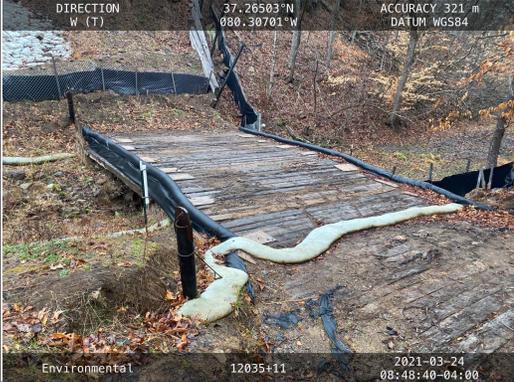
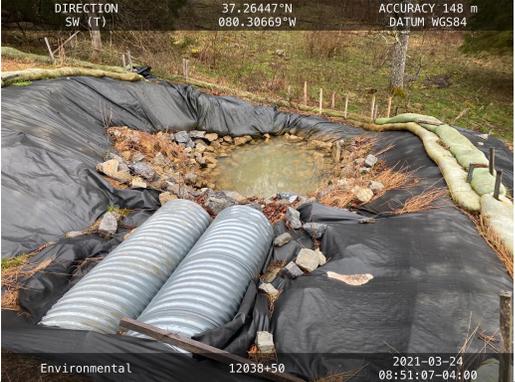
GPS Location See photo	GPS Location See photo
Field Station# 12035+11	Field Station# 12038+50
Pic 7 Desc. Bridge and ECDs at stream crossing S-G40 in acceptable condition	Pic 8 Desc. Clean water crossing pipe outlet in acceptable condition

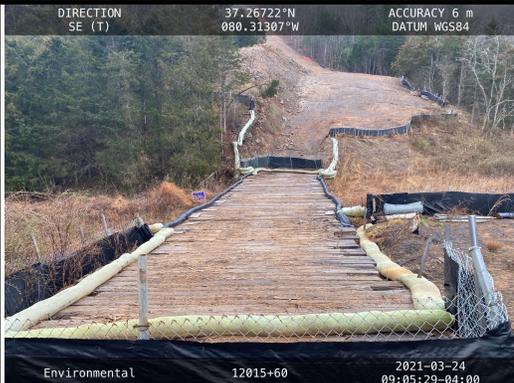
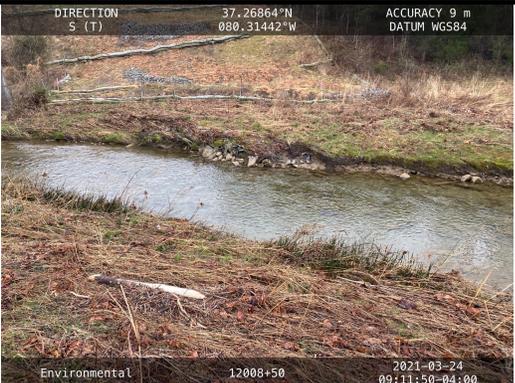
GPS Location See photo	GPS Location See photo
Field Station# 12015+60	Field Station# 12008+50
Pic 9 Desc. Bridge and ECDs at stream crossing S-G38 in acceptable condition	Pic 10 Desc. Stream crossing S-G36 in acceptable condition

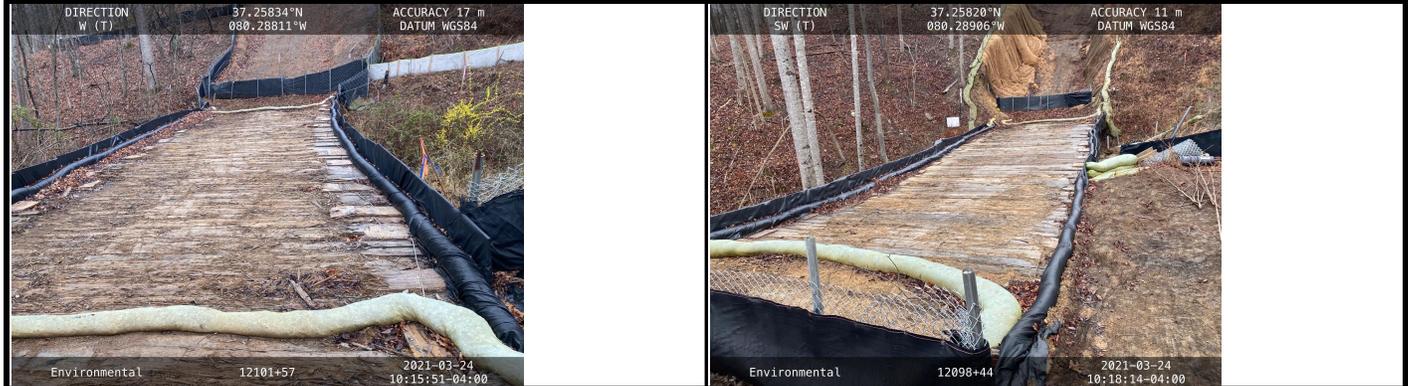
GPS Location	See photo	GPS Location	See photo
Field Station#	12101+57	Field Station#	12098+44
Pic 13 Desc.	Bridge and ECDs at stream crossing S-MM11 in acceptable condition	Pic 14 Desc.	Bridge and ECDs at stream crossing S-MM13 in acceptable condition

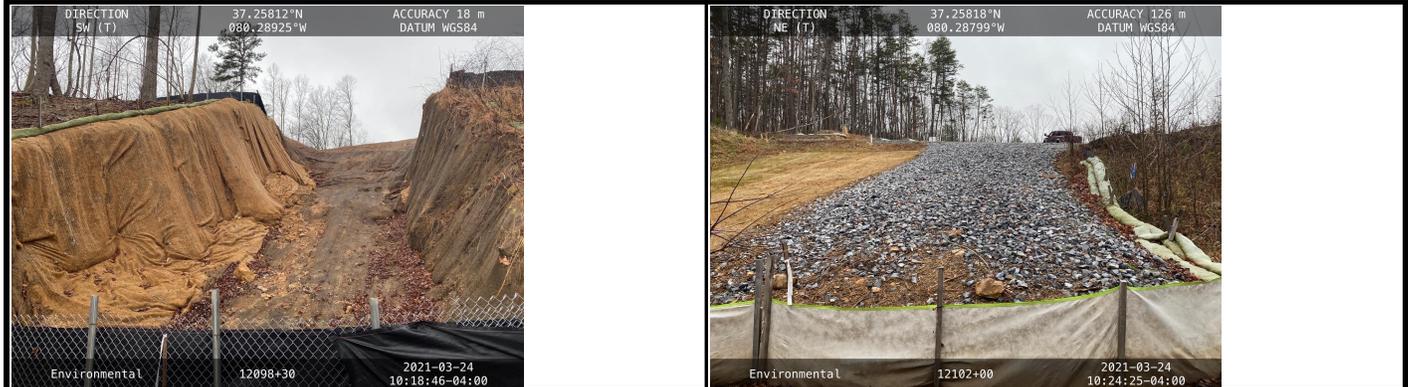
GPS Location	See photo	GPS Location	See photo
Field Station#	12098+30	Field Station#	12102+00
Pic 15 Desc.	Stabilized cut bank in acceptable condition	Pic 16 Desc.	RCE on the cis of access road MVP-MN-270.01 in acceptable condition

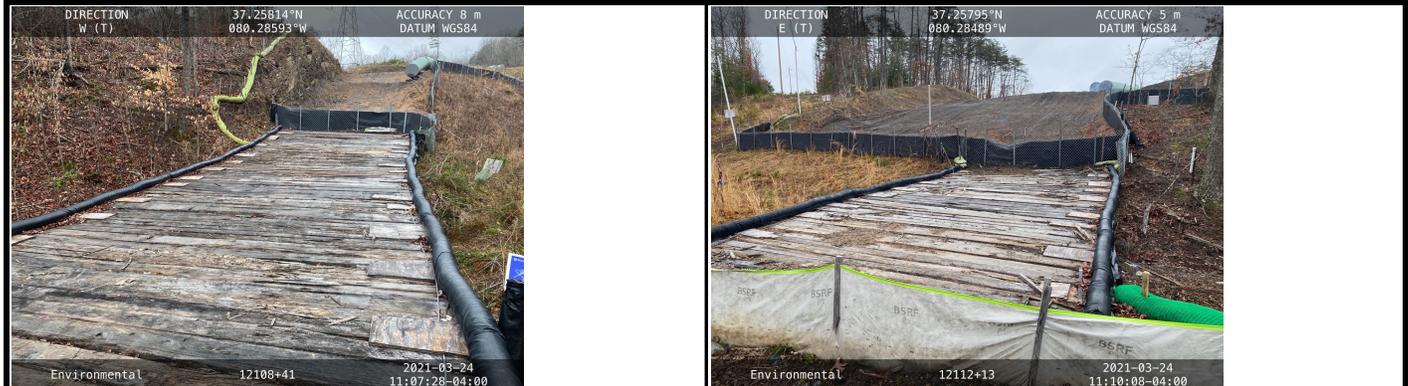
GPS Location	See photo	GPS Location	See photo
Field Station#	12108+41	Field Station#	12112+13
Pic 17 Desc.	Bridge and ECDs at stream crossing S-F15 in acceptable condition	Pic 18 Desc.	Bridge and ECDs at stream crossing S-F16 in acceptable condition

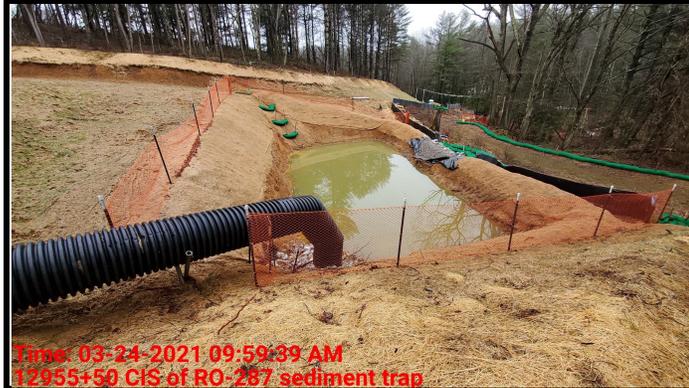
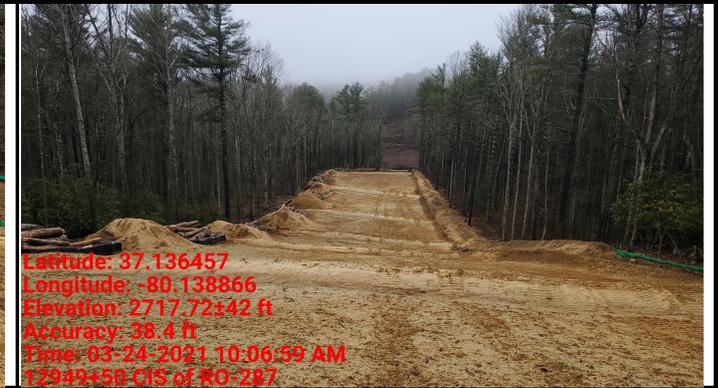
GPS Location	See pic for GPS location
Field Station#	12955+50
Pic 13 Desc.	Sediment trap on the CIS of RO-287.

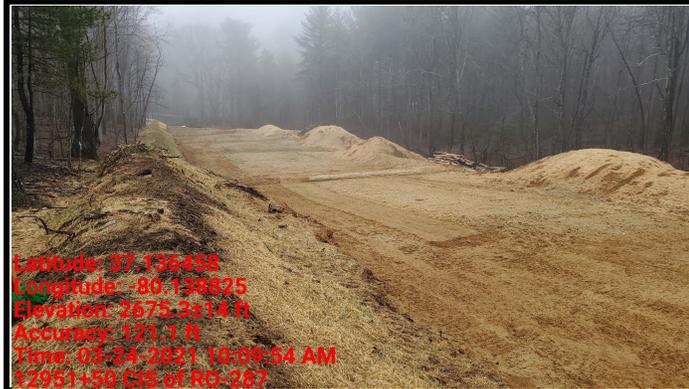
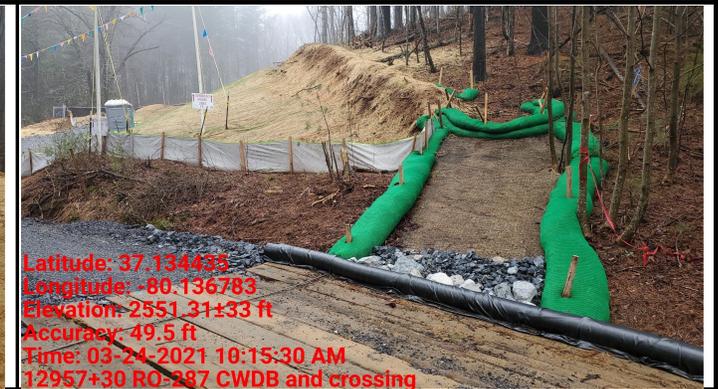
GPS Location	See pic for GPS location
Field Station#	12951+50
Pic 15 Desc.	ROW conditions on the CIS of RO-287.

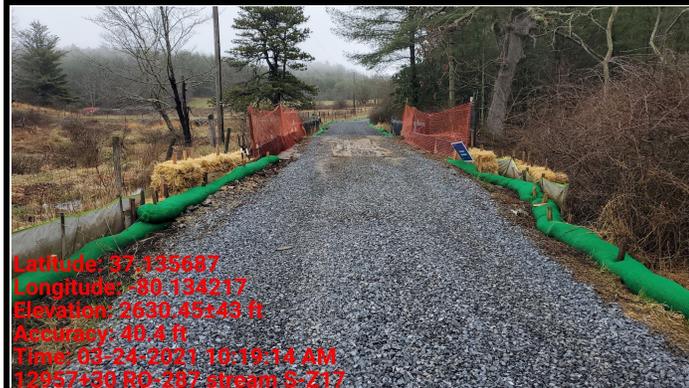
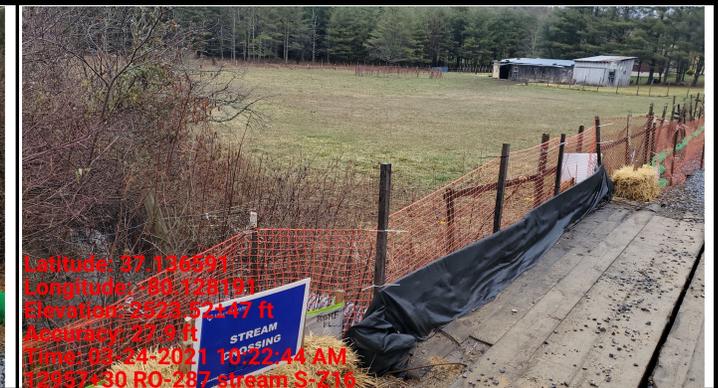
GPS Location	See pic for GPS location
Field Station#	12957+30
Pic 17 Desc.	RO-287 at stream S-Z17.

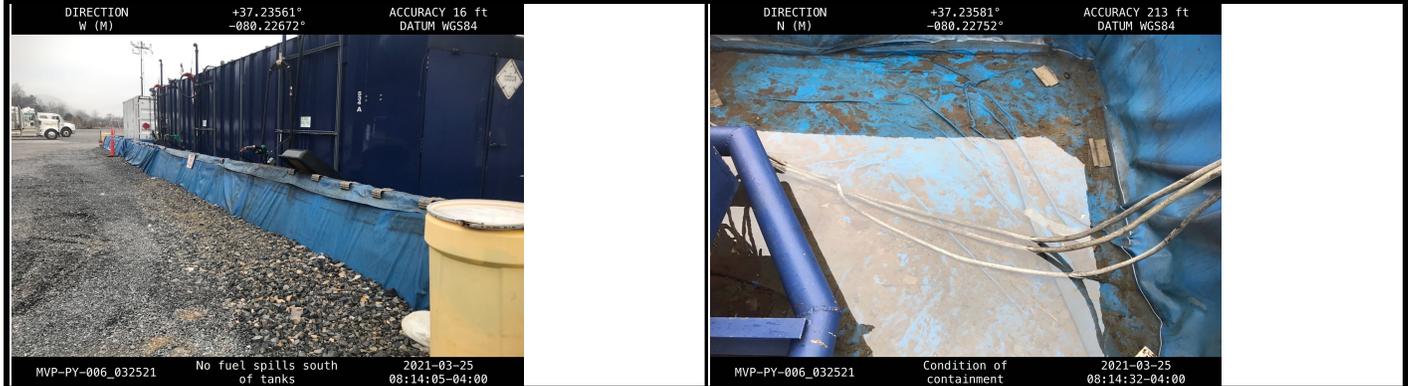
GPS Location MVP-PY-006 See photo fo gps data	GPS Location MVP-PY-006 See photo fo gps data
Field Station# +0	Field Station# +0
Pic 13 Desc. No fuel spills south of the Blue Bulk fuel tanks. Looking W.	Pic 14 Desc. Blue Bulk Fuel tanks containment holding stormwater p, sheen present. Looking N.

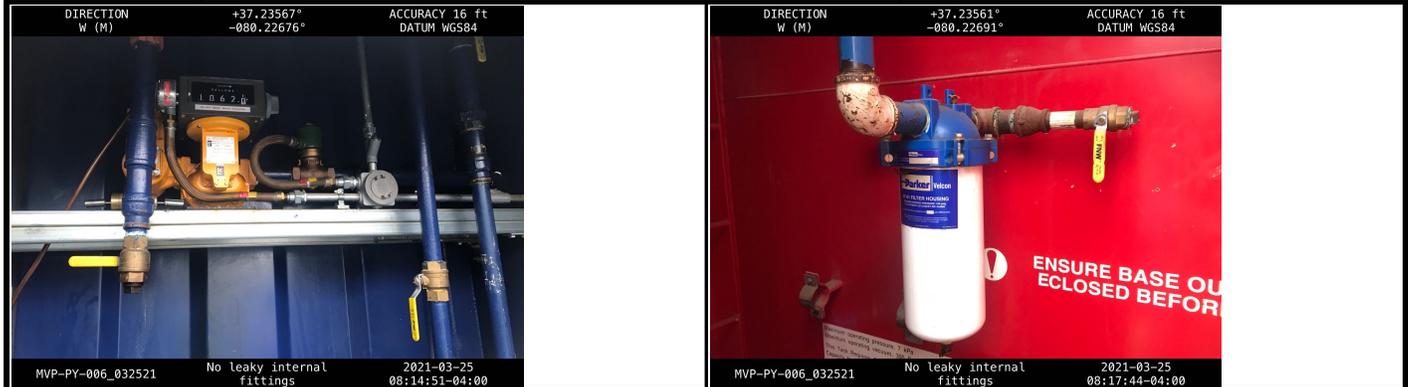
GPS Location MVP-PY-006 See photo fo gps data	GPS Location MVP-PY-006 See photo fo gps data
Field Station# +0	Field Station# +0
Pic 15 Desc. Blue Bulk Fuel tanks no leaky internal fittings. Looking W.	Pic 16 Desc. Off Road Fuel unit no leaky internal fittings. Looking W.

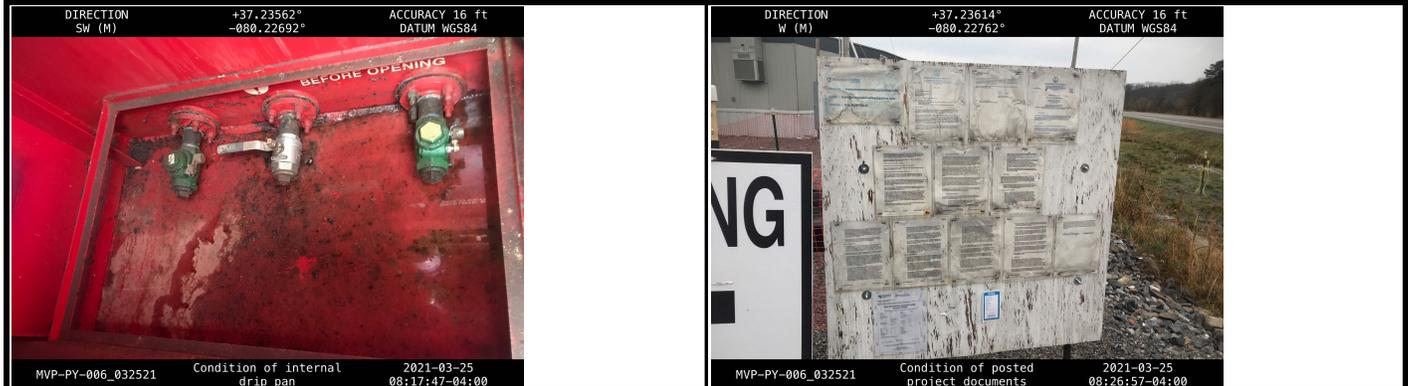
GPS Location MVP-PY-006 See photo fo gps data	GPS Location MVP-PY-006 See photo fo gps data
Field Station# +0	Field Station# +0
Pic 17 Desc. Off Road Fuel unit condition of internal drip pan. Looking SW.	Pic 18 Desc. Condition of posted project documents at main entrance. Looking W.

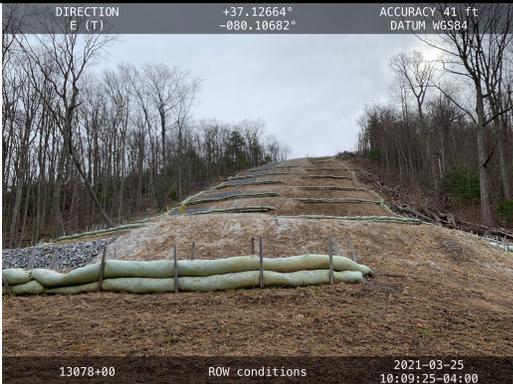
<p>DIRECTION E (T) +37.12664° -080.10682° ACCURACY 41 ft DATUM WGS84 13078+00 ROW conditions 2021-03-25 10:09:25-04:00</p>	
GPS Location	See photo for gps location data.	GPS Location	See photo for gps location data.
Field Station#	13062+96	Field Station#	13078+00
Pic 11 Desc.	Photo shows stream S-G27 downstream from the bridge.	Pic 12 Desc.	Photo shows the ROW and ECD conditions from about 13078+00 to 13081+00.

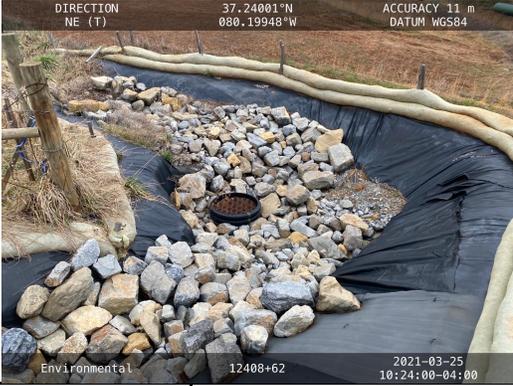
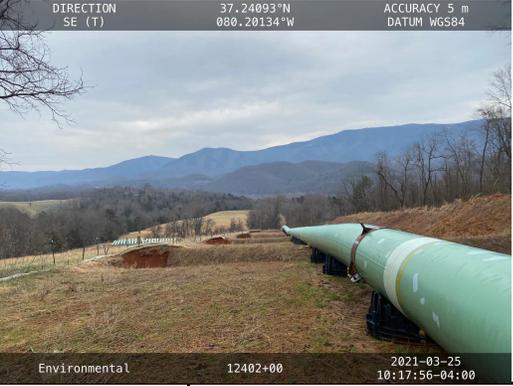
GPS Location	See photo	GPS Location	See photo
Field Station#	12408+62	Field Station#	12402+00
Pic 7 Desc.	Clean water crossing pipe inlet in acceptable condition	Pic 8 Desc.	Stabilized ROW In Acceptable acceptable condition

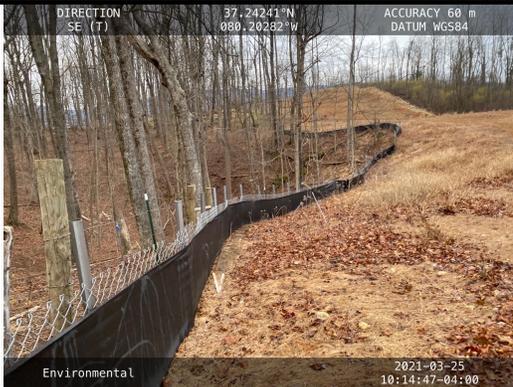
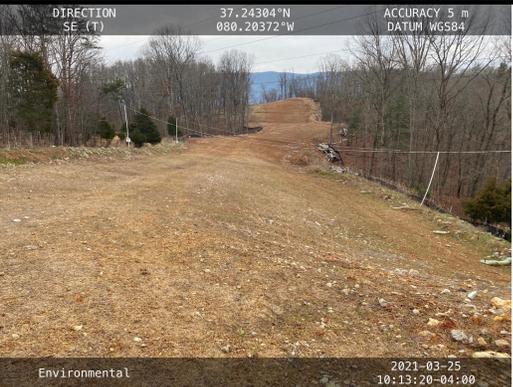
GPS Location	See photo	GPS Location	See photo
Field Station#	12396+45	Field Station#	12393+00
Pic 9 Desc.	SSF perimeter controls protecting off ROW Karst Features in acceptable condition	Pic 10 Desc.	Stabilized ROW in acceptable condition

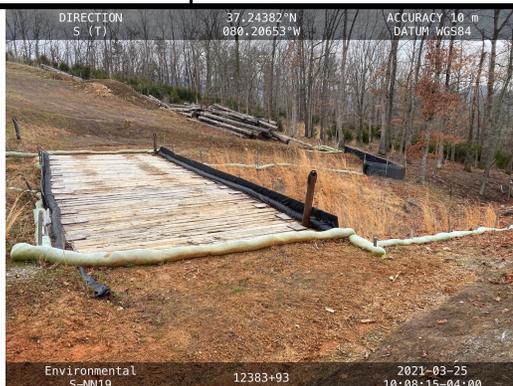
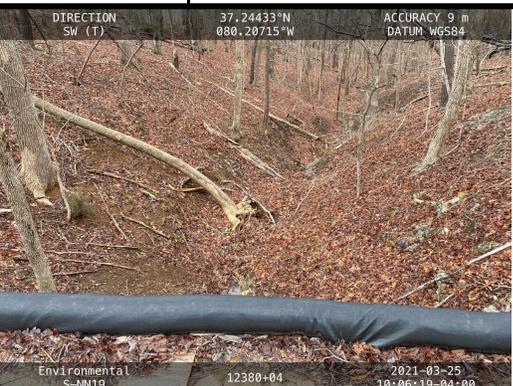
GPS Location	See photo	GPS Location	See photo
Field Station#	1283+93	Field Station#	12380+04
Pic 11 Desc.	Clean water crossing in acceptable condition	Pic 12 Desc.	Down stream of stream crossing S-NN19 in acceptable condition

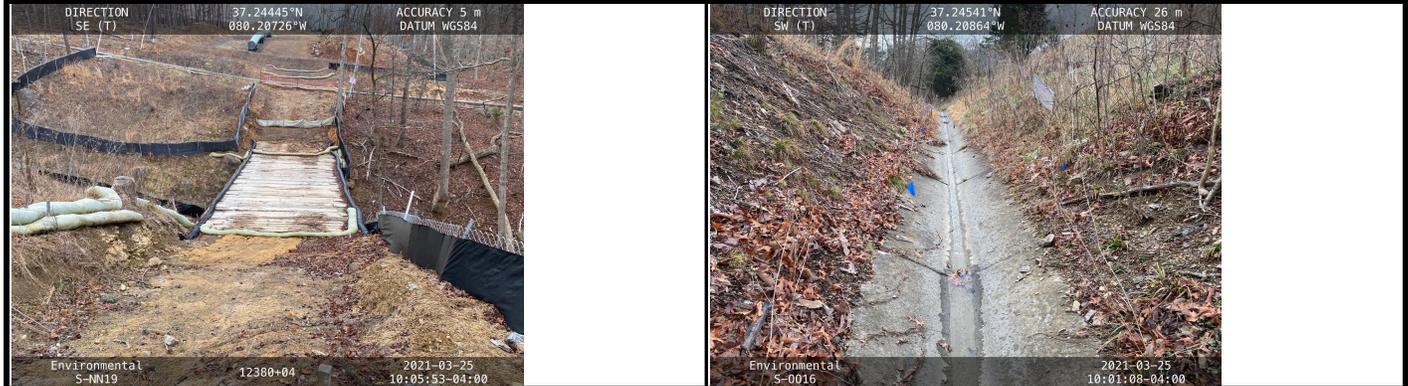
GPS Location	See photo	GPS Location	See photo
Field Station#	12380+04	Field Station#	12374+16
Pic 13 Desc.	Bridge and ECDs at stream crossing S-NN19 in acceptable condition	Pic 14 Desc.	Stream crossing S-OO16 in acceptable condition

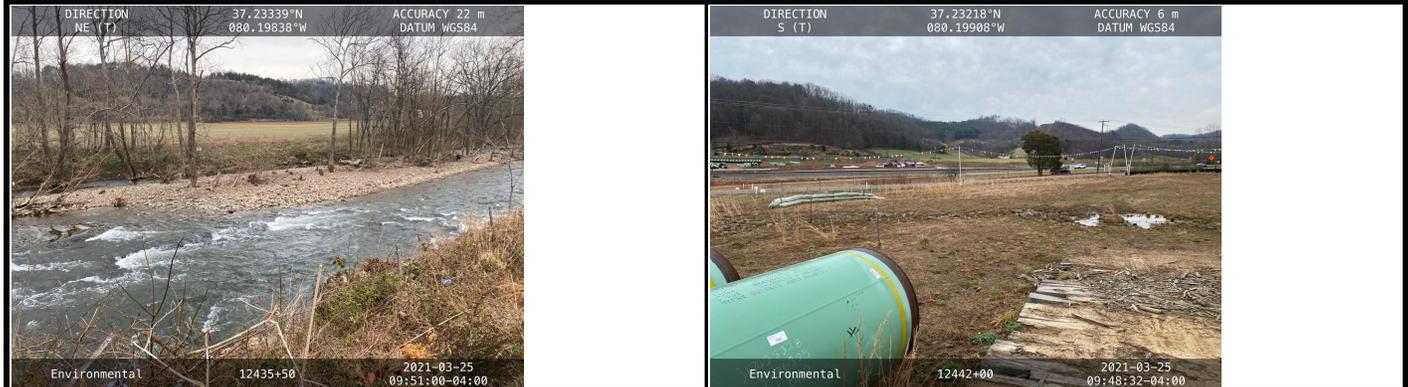
GPS Location	See photo	GPS Location	See photo
Field Station#	12435+50	Field Station#	12442+00
Pic 15 Desc.	Stream crossing S-NN16 in acceptable condition	Pic 16 Desc.	Stabilized ROW in acceptable condition

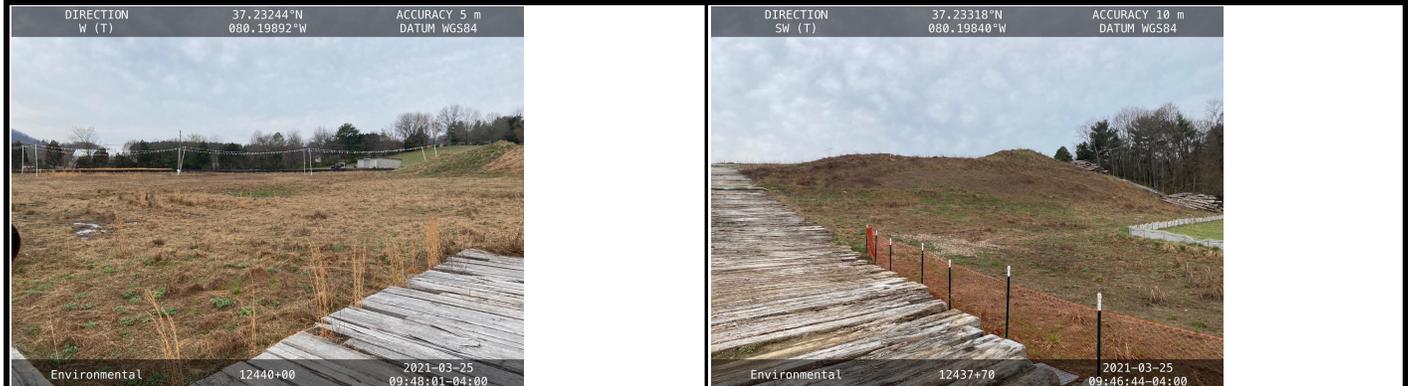
GPS Location	See photo	GPS Location	See photo
Field Station#	12440+00	Field Station#	12437+70
Pic 17 Desc.	Stabilized ROW in acceptable condition	Pic 18 Desc.	Stabilized slope in acceptable condition

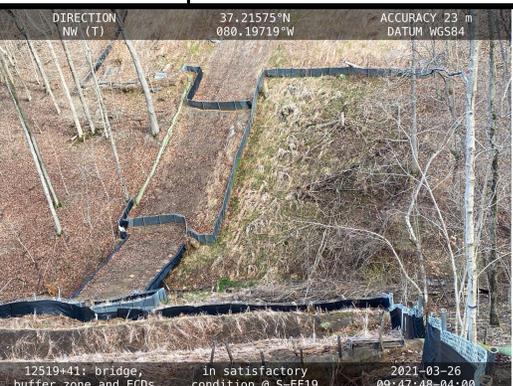
<p>DIRECTION NW (T) 37.21575°N 080.19719°W ACCURACY 23 m DATUM WGS84</p> <p>12519+41: bridge, buffer zone and ECDs in satisfactory condition @ S-EF19 2021-03-26 09:47:48-04:00</p>	
GPS Location	See photo	GPS Location	See photo
Field Station#	12517+00	Field Station#	12519+41
Pic 11 Desc.	Slope stable on coming in side of stream S-EF19.	Pic 12 Desc.	Bridge, buffer zone and ECDs in satisfactory condition at stream S-EF19.

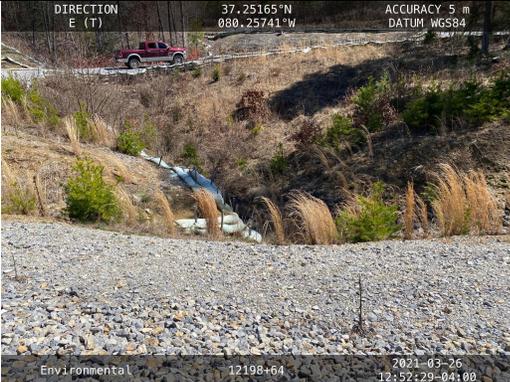
GPS Location		See photo		GPS Location	
Field Station#		12198+64		Field Station#	
Pic 1 Desc.		Stream crossing S-0011 on the east side of the railroad tracks in acceptable condition		Pic 2 Desc.

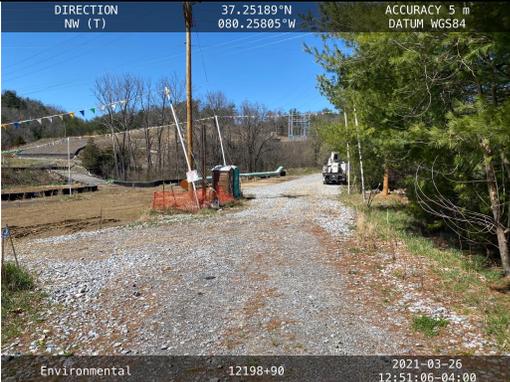
GPS Location		See photo		GPS Location	
Field Station#		12198+90		Field Station#	
Pic 3 Desc.		Access Road MVP-MN-275 in acceptable condition		Pic 4 Desc.

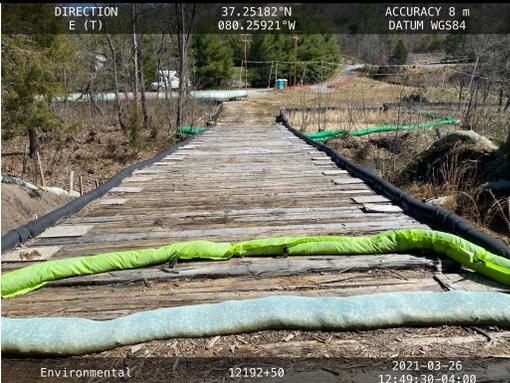
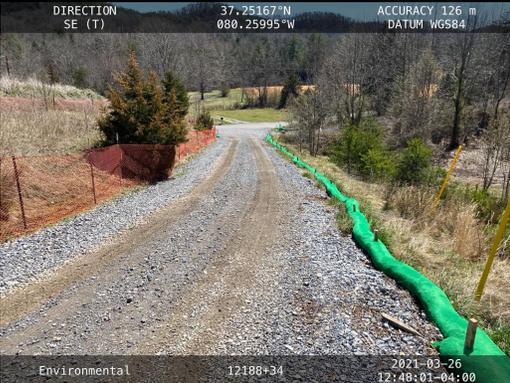
GPS Location		See photo		GPS Location	
Field Station#		12192+50		Field Station#	
Pic 5 Desc.		Bridge and ECDs crossing stream S-C21 in acceptable condition		Pic 6 Desc.	
				Access Road MVP-MN-275 in acceptable condition
