# Visual Site Inspection Report

<b>Project Name</b>	H-600 Pipeline Spread H	<b>AFE</b>	124300138	<b>Spread</b>	H-600 Pipeline Spread H
<b>Contractor</b>	Precision			<b>Report #</b>	22165
<b>Inspector</b>	Pat Davis			<b>Date/Time</b>	4/12/2021 4:00 PM
<b>Permit #</b>	TBD	<b>Inspection Type</b>	VA SWPP	<b>Station Begin</b>	+0
<b>State</b>	VA	<b>Inspection Area</b>	Partial	<b>Station End</b>	+0
<b>County</b>	Roanoke	<b>Ground</b>	Wet	<b>Temperature (°F)</b>	59.00
<b>Municipality</b>	N/A	<b>Weather</b>	Sunny	<b>Rain Gauge (in)</b>	0.00
				<b>Rain Accumulation Time (days)</b>	0.00

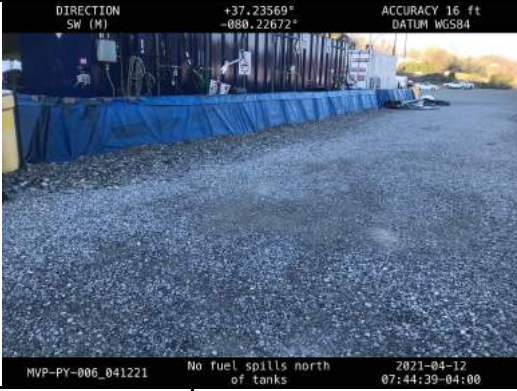
<p>DIRECTION SW (M) +37.23569° -080.22672° ACCURACY 16 ft DATUM WGS84 MVP-PY-006_041221 No fuel spills north of tanks 2021-04-12 07:44:39-04:00</p>

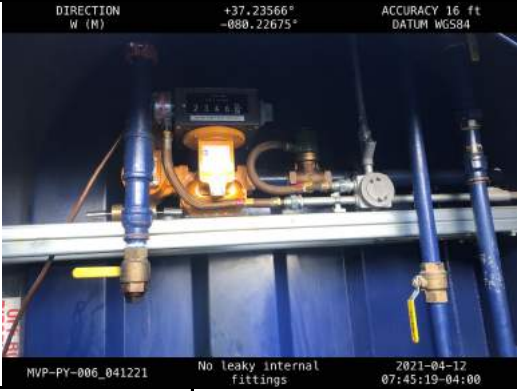
<p>DIRECTION W (M) +37.23566° -080.22675° ACCURACY 16 ft DATUM WGS84 MVP-PY-006_041221 No leaky internal fittings 2021-04-12 07:45:19-04:00</p>			
<b>GPS Location</b>	MVP-PY-006 See photo for gps data		<b>GPS Location</b>	MVP-PY-006 See photo for gps data	
<b>Field Station#</b>	+0		<b>Field Station#</b>	+0	
<b>Pic 7 Desc.</b>	Blue Bulk Fuel tanks no fuel spills north of tanks. Looking SW.		<b>Pic 8 Desc.</b>	Blue Bulk Fuel tanks no leaky internal fittings. Looking W.

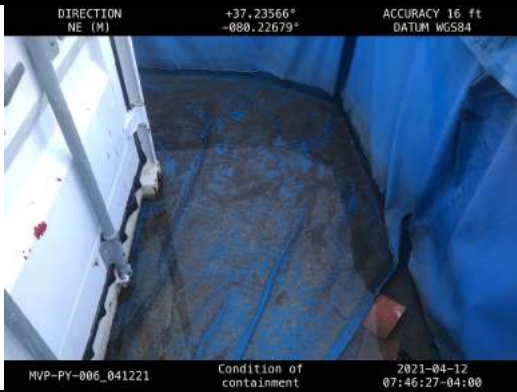
<p>DIRECTION NE (M) +37.23566° -080.22679° ACCURACY 16 ft DATUM WGS84 MVP-PY-006_041221 Condition of containment 2021-04-12 07:46:27-04:00</p>

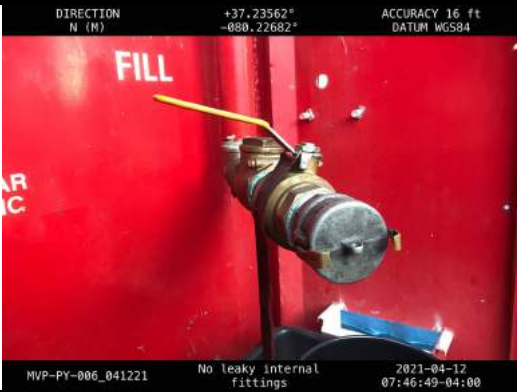
<p>DIRECTION N (M) +37.23562° -080.22682° ACCURACY 16 ft DATUM WGS84 MVP-PY-006_041221 No leaky internal fittings 2021-04-12 07:46:49-04:00</p>

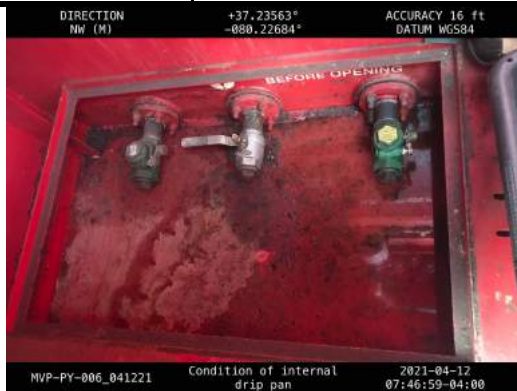
<p>DIRECTION NW (M) +37.23563° -080.22684° ACCURACY 16 ft DATUM WGS84 MVP-PY-006_041221 Condition of internal drip pan 2021-04-12 07:46:59-04:00</p>

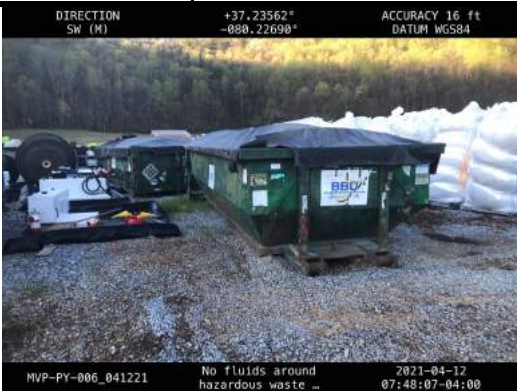
<p>DIRECTION SW (M) +37.23562° -080.22690° ACCURACY 16 ft DATUM WGS84 MVP-PY-006_041221 No fluids around hazardous waste 2021-04-12 07:48:07-04:00</p>			
<b>GPS Location</b>	MVP-PY-006 See photo for gps data		<b>GPS Location</b>	MVP-PY-006 See photo for gps data	
<b>Field Station#</b>	+0		<b>Field Station#</b>	+0	
<b>Pic 11 Desc.</b>	Off Road Fuel unit condition of internal drip pan. Looking NW.		<b>Pic 12 Desc.</b>	No fluids or deposits around hazardous waste dumpsters. Looking SW.

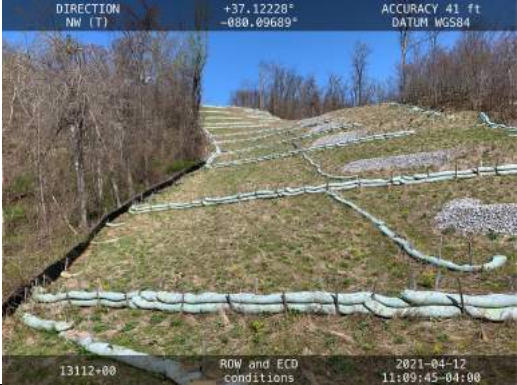
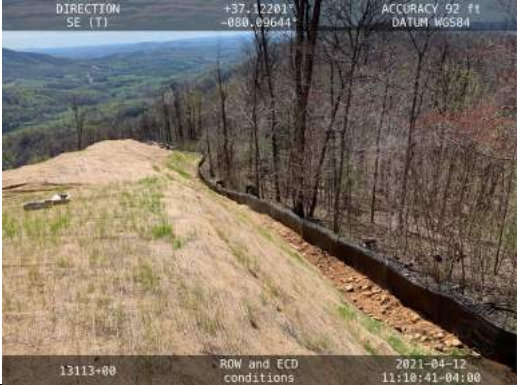
<b>GPS Location</b>	See pic for GPS location		<b>GPS Location</b>	See pic for GPS location	
<b>Field Station#</b>	13112+00		<b>Field Station#</b>	13113+00	
<b>Pic 7 Desc.</b>	Current ROW conditions on the CIS of FR-291 where restoration has been performed.		<b>Pic 8 Desc.</b>	Perimeter SSF on the CIS of FR-291.

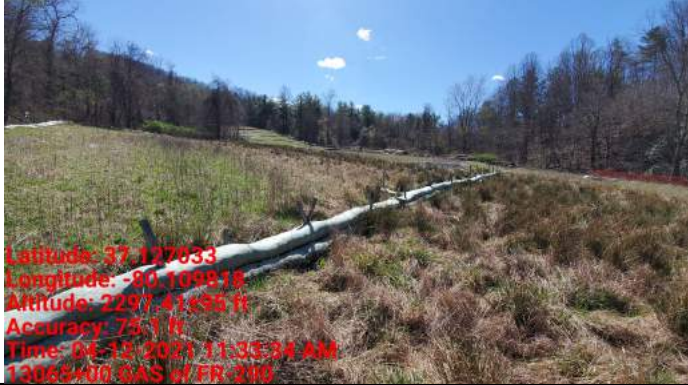
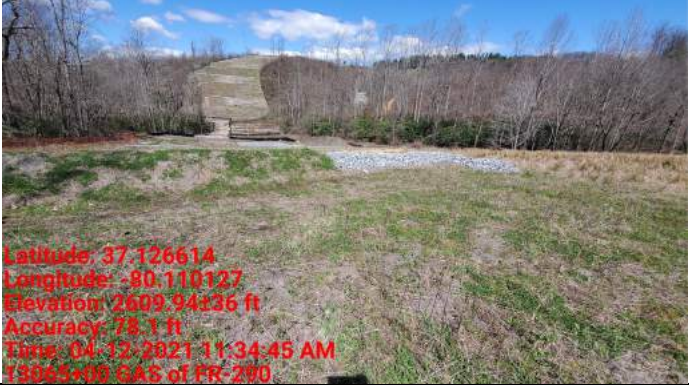
<b>GPS Location</b>	See pic for GPS location		<b>GPS Location</b>	See pic for GPS location	
<b>Field Station#</b>	13065+00		<b>Field Station#</b>	13065+00	
<b>Pic 9 Desc.</b>	Current ROW conditions on the GAS of FR-290.		<b>Pic 10 Desc.</b>	Permanent Slope Breaker and Rock Level Spreader on the GAS of FR-290.

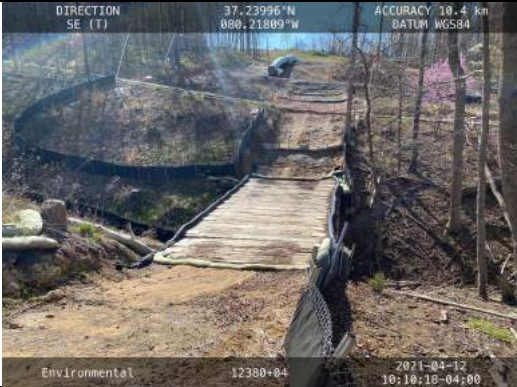
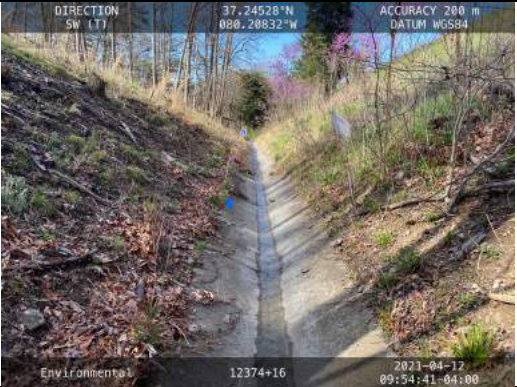
<b>GPS Location</b>	See photo		<b>GPS Location</b>	See photo	
<b>Field Station#</b>	12380+04		<b>Field Station#</b>	12374+16	
<b>Pic 13 Desc.</b>	Bridge and ECDs crossing Stream S-NN19 in acceptable condition		<b>Pic 14 Desc.</b>	Stream crossing S-OO16 in acceptable condition

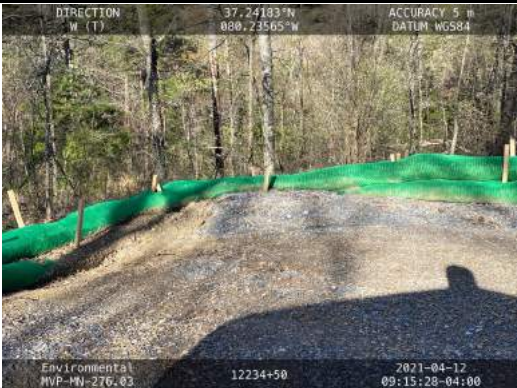
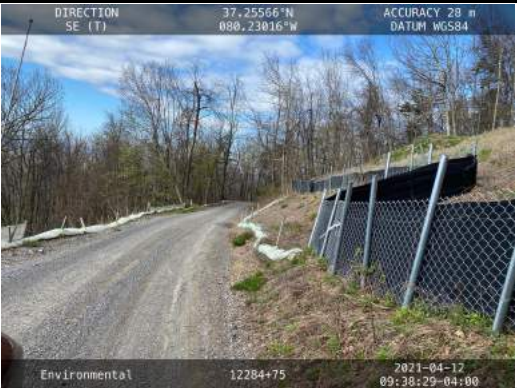
<b>GPS Location</b>	See photo		<b>GPS Location</b>	See photo	
<b>Field Station#</b>	12234+50		<b>Field Station#</b>	12283+75	
<b>Pic 15 Desc.</b>	Outlet along access road MVP-MN-276.03 full of road materials		<b>Pic 16 Desc.</b>	Access Road MVP-MN-276.03 ROW crossing in acceptable condition

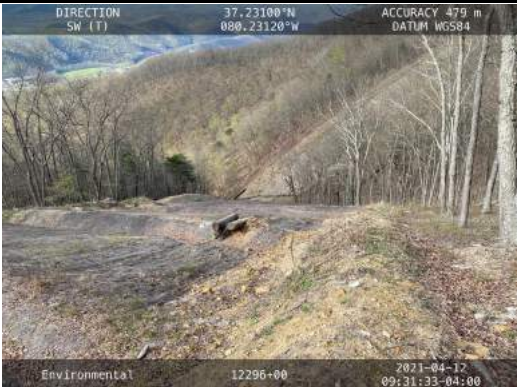
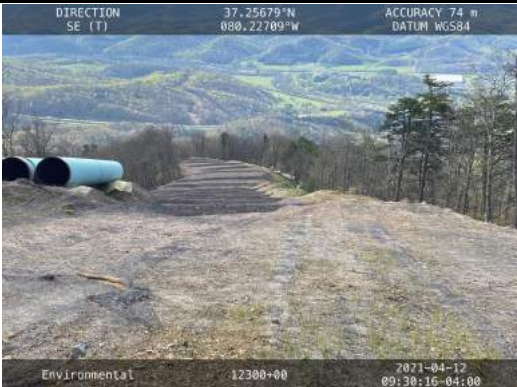
<b>GPS Location</b>	See photo		<b>GPS Location</b>	See photo	
<b>Field Station#</b>	12296+00		<b>Field Station#</b>	12300+00	
<b>Pic 17 Desc.</b>	Stabilized slope in acceptable condition		<b>Pic 18 Desc.</b>	Stabilized ROW in acceptable condition

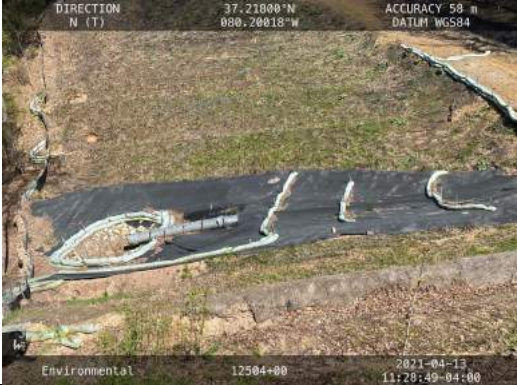
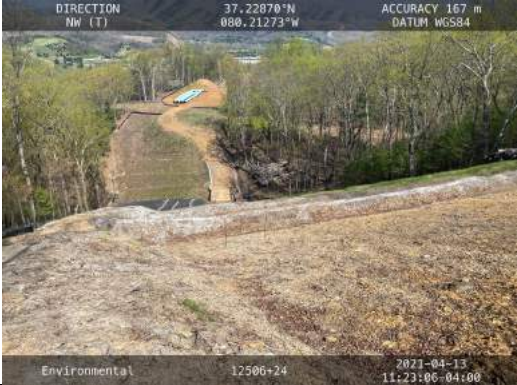
<b>GPS Location</b>	See photo		<b>GPS Location</b>	See photo	
<b>Field Station#</b>	12504+00		<b>Field Station#</b>	12506+24	
<b>Pic 7 Desc.</b>	Clean water crossing pipe in acceptable condition		<b>Pic 8 Desc.</b>	Stabilized slope in acceptable condition

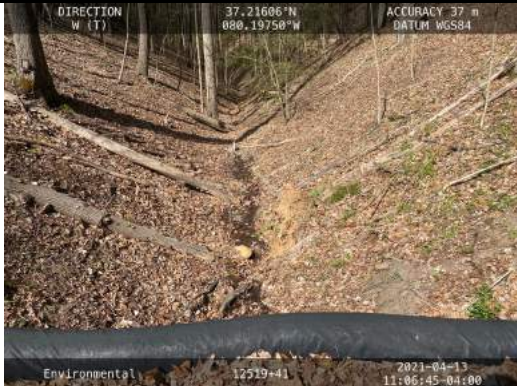
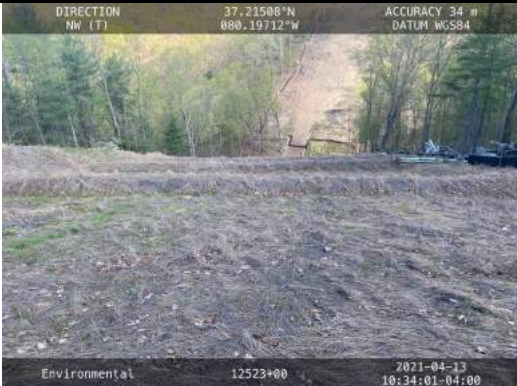
<b>GPS Location</b>	See photo		<b>GPS Location</b>	See photo	
<b>Field Station#</b>	12519+41		<b>Field Station#</b>	12523+00	
<b>Pic 9 Desc.</b>	Down stream of stream crossing S-EF19 in acceptable condition with no signs of impacts.		<b>Pic 10 Desc.</b>	Stabilized slope in acceptable condition

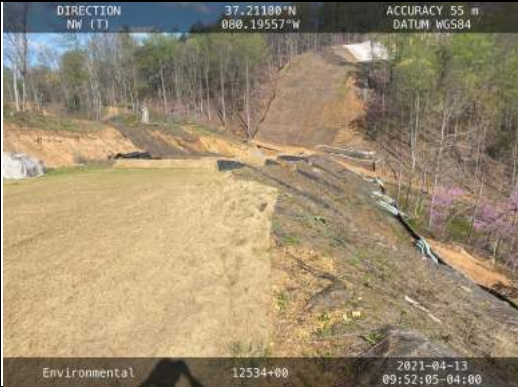
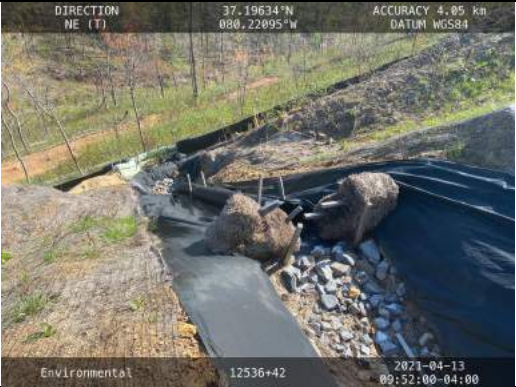
<b>GPS Location</b>	See photo		<b>GPS Location</b>	See photo	
<b>Field Station#</b>	12534+00		<b>Field Station#</b>	12536+42	
<b>Pic 13 Desc.</b>	Stabilized slope in acceptable condition		<b>Pic 14 Desc.</b>	Fill slope drain in acceptable condition

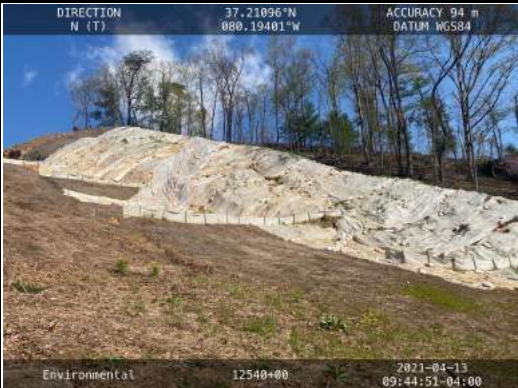
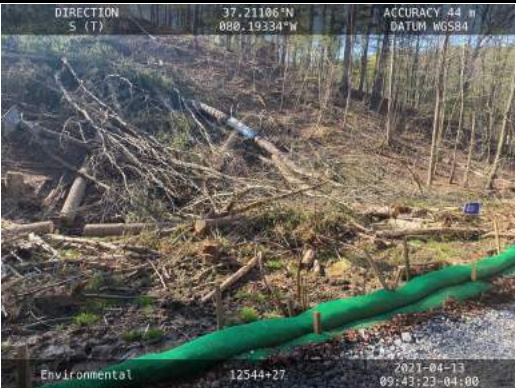
<b>GPS Location</b>	See photo		<b>GPS Location</b>	See photo	
<b>Field Station#</b>	12540+00		<b>Field Station#</b>	12544+27	
<b>Pic 15 Desc.</b>	Plastic remains in place and spoil pile remains stable		<b>Pic 16 Desc.</b>	Area where the opposition had camp remains stable after felling of the trees.

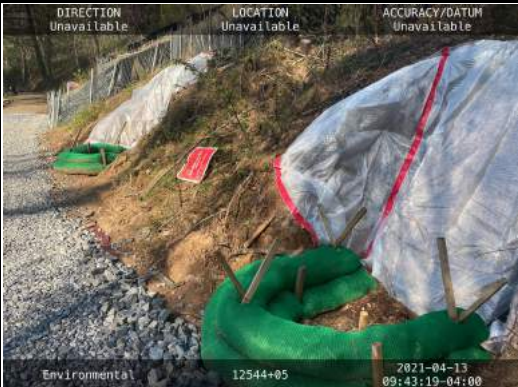
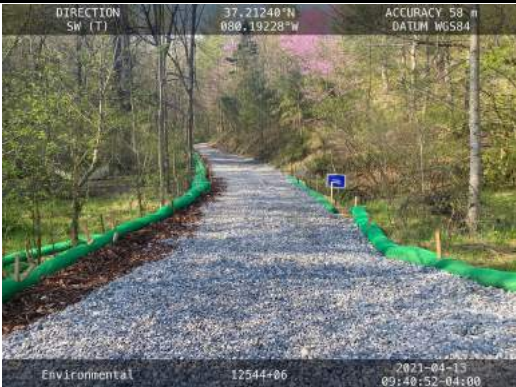
<b>GPS Location</b>	See photo		<b>GPS Location</b>	See photo	
<b>Field Station#</b>	12544+05		<b>Field Station#</b>	12544+06	
<b>Pic 17 Desc.</b>	Area where the footers were setting from police machines remains stable		<b>Pic 18 Desc.</b>	Access Road MVP-MN-278.01 is in acceptable condition

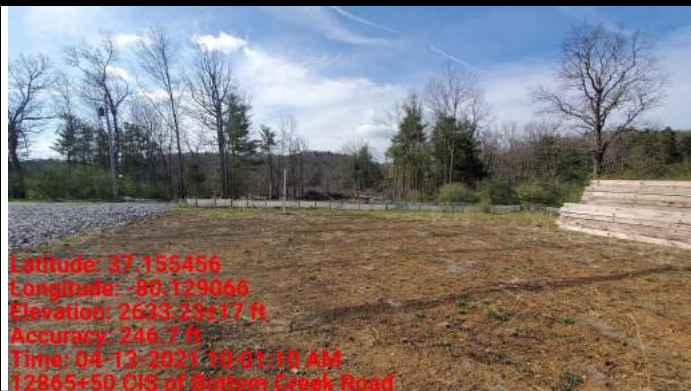
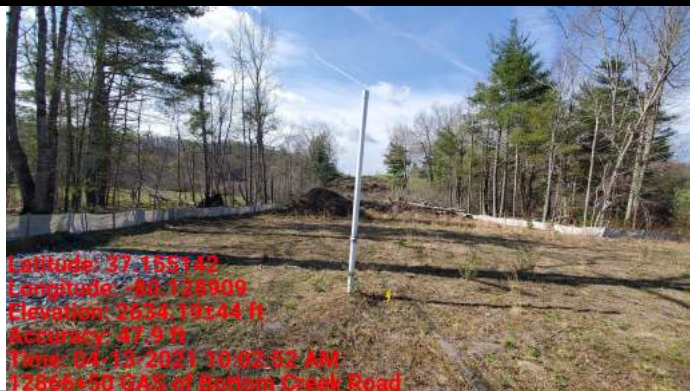
GPS Location	See pic for GPS location		GPS Location	See pic for GPS location	
Field Station#	12865+50		Field Station#	12866+50	
Pic 3 Desc.	Current conditions of the ROW on the CIS of Bottom Creek Road.		Pic 4 Desc.	Current conditions of the ROW on the GAS of Bottom Creek Road.

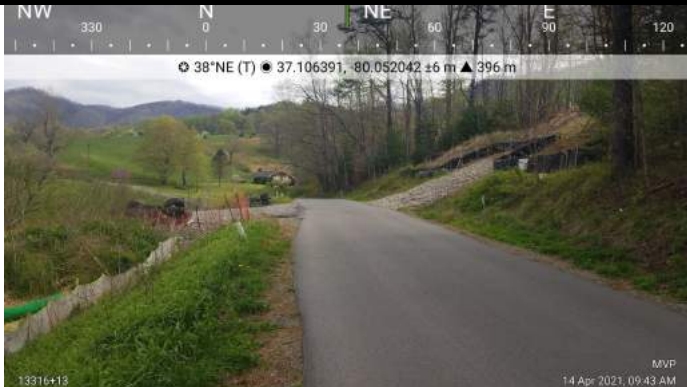
<b>GPS Location</b>	See photo for coordinates.		<b>GPS Location</b>	See photo for coordinates.	
<b>Field Station#</b>	13316+13		<b>Field Station#</b>	13309+09	
<b>Pic 1 Desc.</b>	Wades Gap, road crossing clean of ROW sediment and debris.		<b>Pic 2 Desc.</b>	S-GH7, upstream, no changes observed to stream bed or banks, banks vegetated.

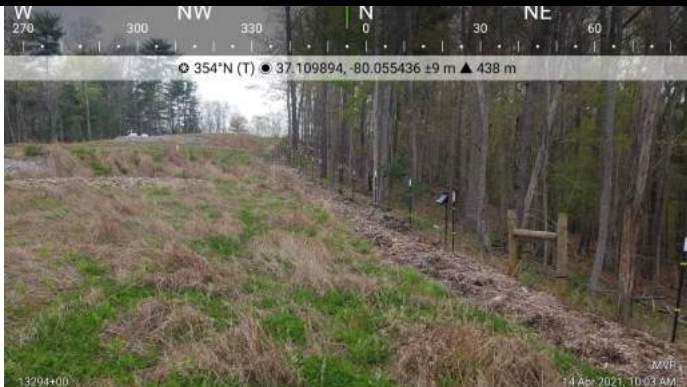
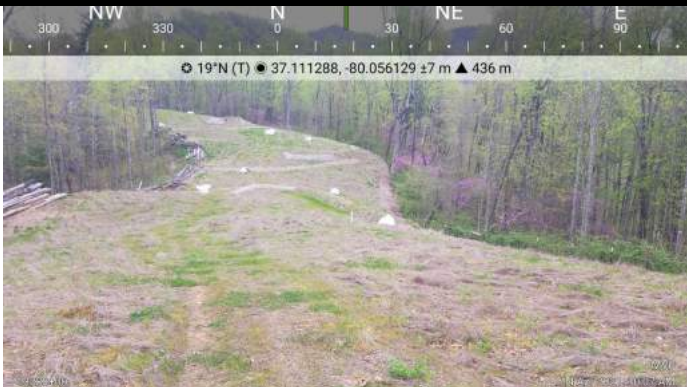
<b>GPS Location</b>	See photo for coordinates.		<b>GPS Location</b>	See photo for coordinates.	
<b>Field Station#</b>	13294+00		<b>Field Station#</b>	13288+00	
<b>Pic 3 Desc.</b>	ROW stable with vegetative cover noted across LOD.		<b>Pic 4 Desc.</b>	ROW stable with vegetative cover noted across LOD.

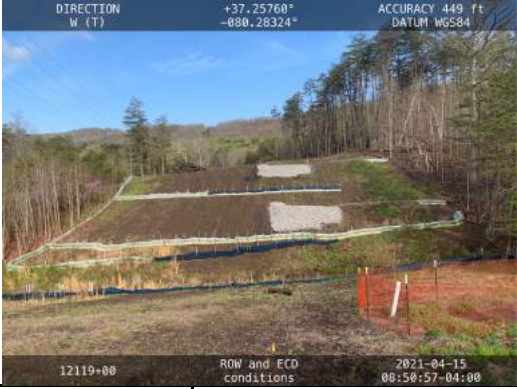
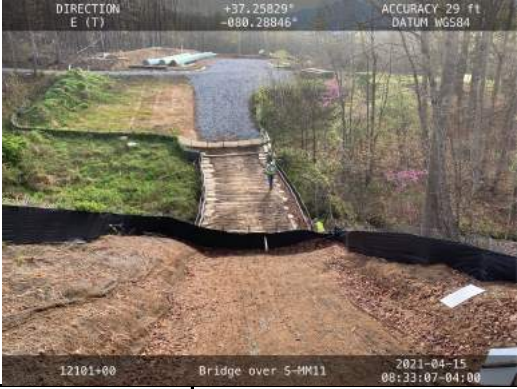
<b>GPS Location</b>	See photo for gps location data.		<b>GPS Location</b>	See photo for gps location data.	
<b>Field Station#</b>	12119+00		<b>Field Station#</b>	12101+00	
<b>Pic 7 Desc.</b>	Photo shows the ROW and ECD conditions from about 12116+00 to 12119+00.		<b>Pic 8 Desc.</b>	Photo shows the bridge over stream S-MM11.

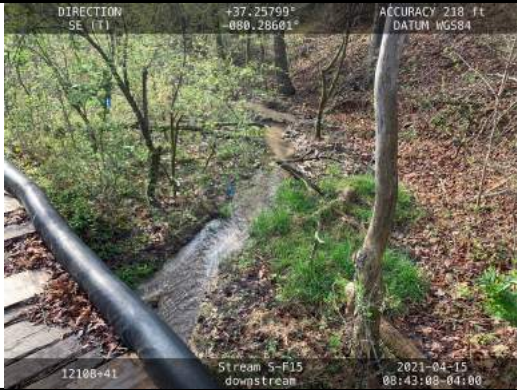
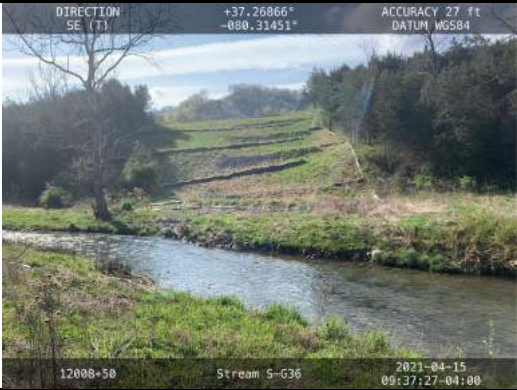
<b>GPS Location</b>	See photo for gps location data.		<b>GPS Location</b>	See photo for gps location data.	
<b>Field Station#</b>	12108+41		<b>Field Station#</b>	12008+50	
<b>Pic 9 Desc.</b>	Photo shows stream S-F15 downstream from the bridge.		<b>Pic 10 Desc.</b>	Photo shows stream S-G36.

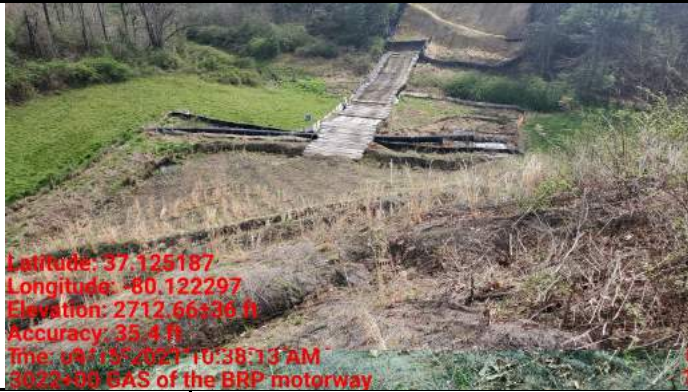
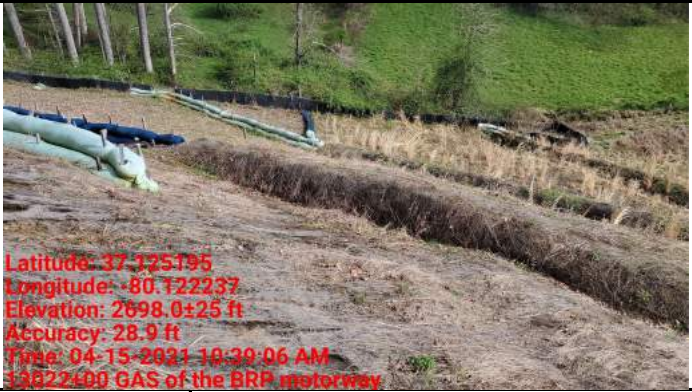
GPS Location	See pic for GPS location		GPS Location	See pic for GPS location	
Field Station#	13022+00		Field Station#	13022+00	
Pic 1 Desc.	CWDB, CWDP and plunge pool remain in acceptable condition on the GAS of the BRP.		Pic 2 Desc.	Permanent restoration meets temporary at edge of BRP property.

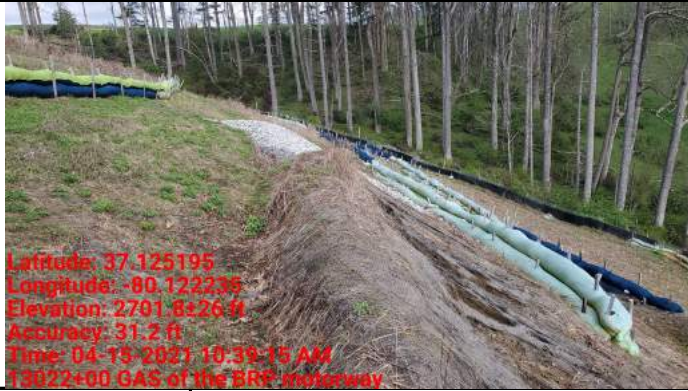
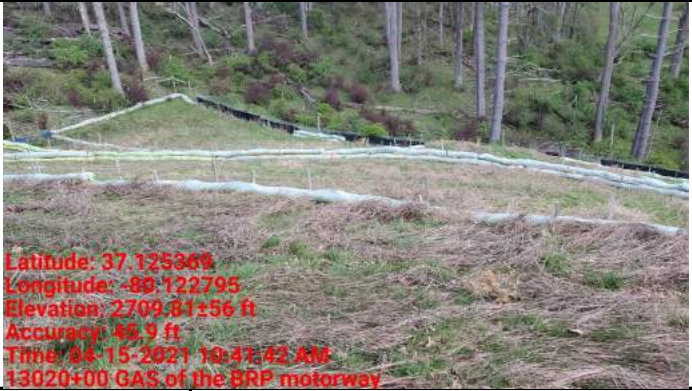
GPS Location	See pic for GPS location		GPS Location	See pic for GPS location	
Field Station#	13022+00		Field Station#	13020+00	
Pic 3 Desc.	Permanent Slope Breaker and Rock Level Spreader in the wooded portion of the BRP.		Pic 4 Desc.	CFS waterbar extensions in the wooded portion of the BRP.

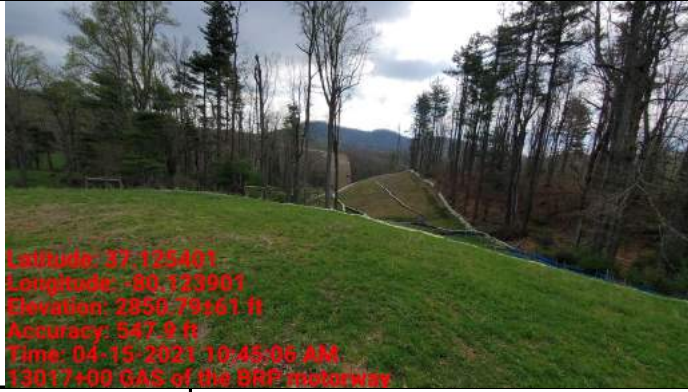
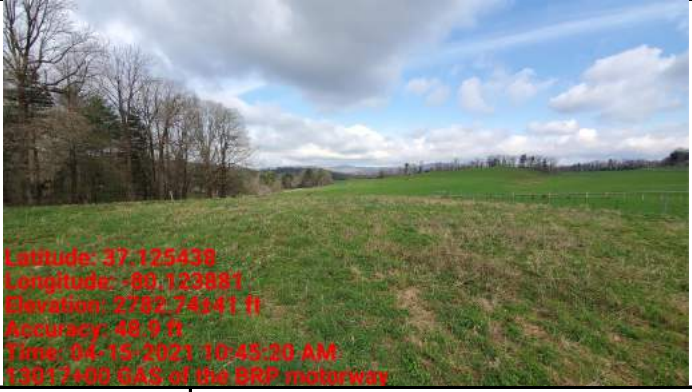
GPS Location	See pic for GPS location		GPS Location	See pic for GPS location	
Field Station#	13017+00		Field Station#	13017+00	
Pic 5 Desc.	Current ROW conditions on the GAS of the BRP motorway.		Pic 6 Desc.	Current ROW conditions on the GAS of the BRP motorway.

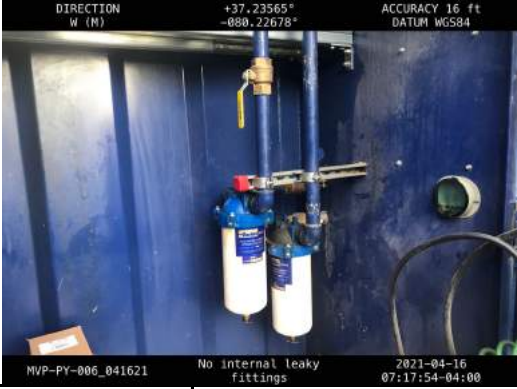
<p>DIRECTION W (M) +37.23565° -080.22678° ACCURACY 16 ft DATUM WGS84 MVP-PY-006_041621 No internal leaky fittings 2021-04-16 07:17:54-04:00</p>

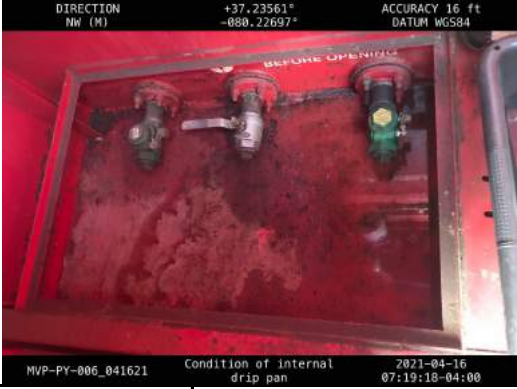
<p>DIRECTION NW (M) +37.23561° -080.22697° ACCURACY 16 ft DATUM WGS84 MVP-PY-006_041621 Condition of internal drip pan 2021-04-16 07:19:18-04:00</p>			
<b>GPS Location</b>	MVP-PY-006 See photo for gps data		<b>GPS Location</b>	MVP-PY-006 See photo for gps data	
<b>Field Station#</b>	+0		<b>Field Station#</b>	+0	
<b>Pic 7 Desc.</b>	Blue Bulk Fuel tanks no leaky internal fittings. Looking W.		<b>Pic 8 Desc.</b>	Off Road Fuel unit condition of internal drip pan. Looking W.

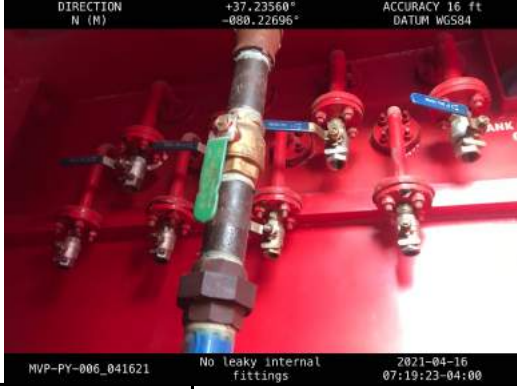
<p>DIRECTION N (M) +37.23560° -080.22696° ACCURACY 16 ft DATUM WGS84 MVP-PY-006_041621 No leaky internal fittings 2021-04-16 07:19:23-04:00</p>

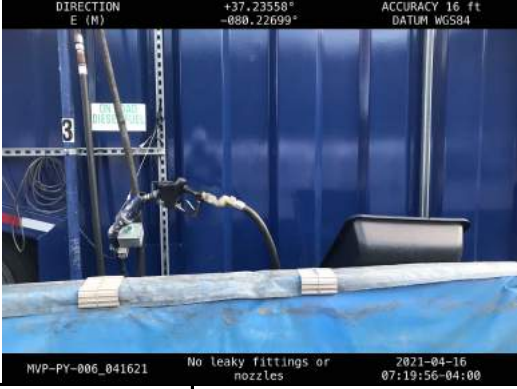
<p>DIRECTION E (M) +37.23558° -080.22699° ACCURACY 16 ft DATUM WGS84 MVP-PY-006_041621 No leaky fittings or nozzles 2021-04-16 07:19:56-04:00</p>

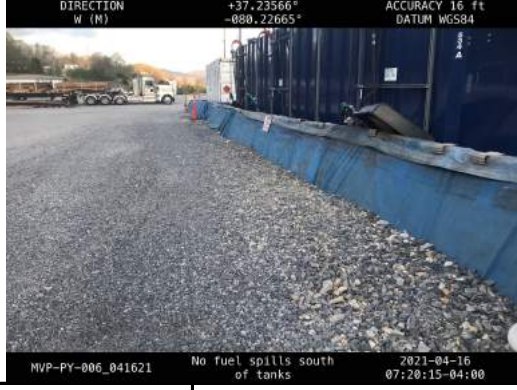
<p>DIRECTION W (M) +37.23566° -080.22665° ACCURACY 16 ft DATUM WGS84 MVP-PY-006_041621 No fuel spills south of tanks 2021-04-16 07:20:15-04:00</p>

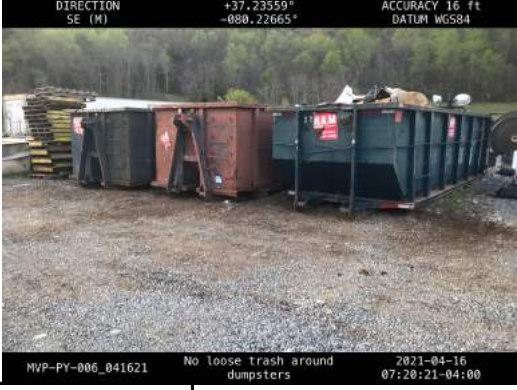
<p>DIRECTION SE (M) +37.23559° -080.22665° ACCURACY 16 ft DATUM WGS84 MVP-PY-006_041621 No loose trash around dumpsters 2021-04-16 07:20:21-04:00</p>			
<b>GPS Location</b>	MVP-PY-006 See photo for gps data		<b>GPS Location</b>	MVP-PY-006 See photo for gps data	
<b>Field Station#</b>	+0		<b>Field Station#</b>	+0	
<b>Pic 11 Desc.</b>	Blue Bulk Fuel tanks no fuel spills south of the tanks. Looking W.		<b>Pic 12 Desc.</b>	No loose trash around dumpsters. Looking SE.

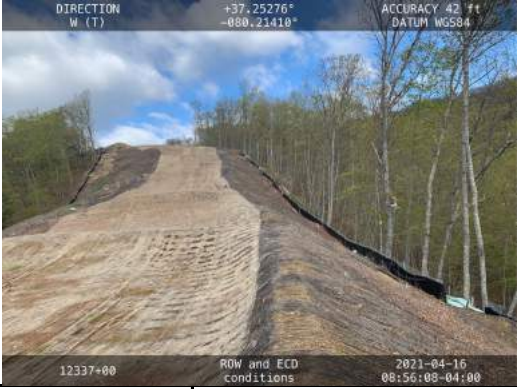
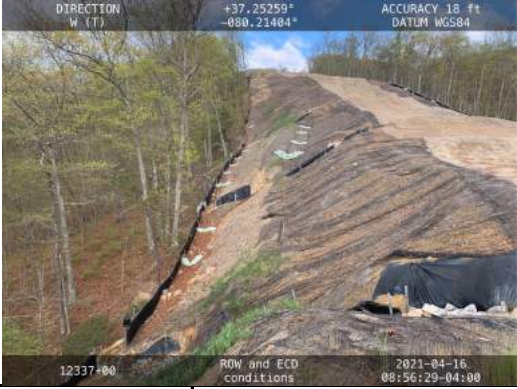
<b>GPS Location</b>	See photo for gps location data.		<b>GPS Location</b>	See photo for gps location data.	
<b>Field Station#</b>	13337+00		<b>Field Station#</b>	12337+00	
<b>Pic 7 Desc.</b>	Photo shows ROW and ECD conditions.		<b>Pic 8 Desc.</b>	Photo shows ROW and ECD conditions.

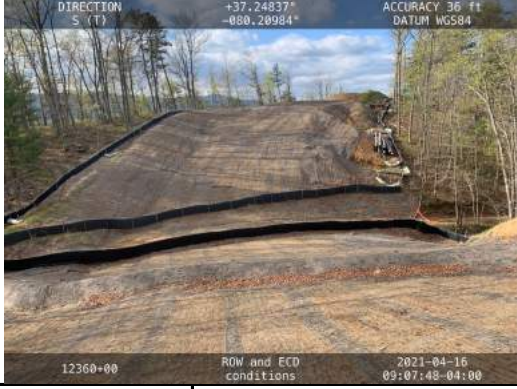
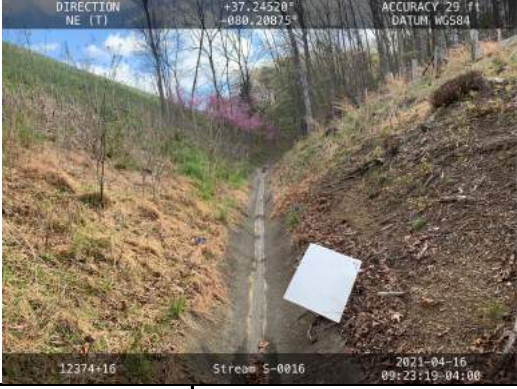
<b>GPS Location</b>	See photo for gps location data.		<b>GPS Location</b>	See photo for gps location data.	
<b>Field Station#</b>	12360+00		<b>Field Station#</b>	12374+16	
<b>Pic 9 Desc.</b>	Photo shows ROW and ECD conditions. Also shows the landowners crossing.		<b>Pic 10 Desc.</b>	Photo shows stream S-0016.

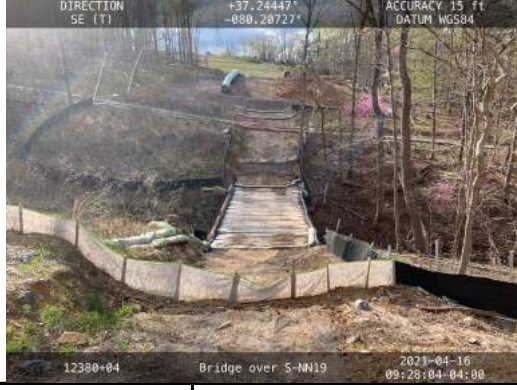
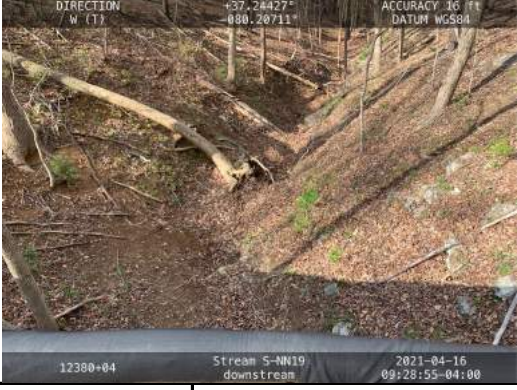
<b>GPS Location</b>	See photo for gps location data.		<b>GPS Location</b>	See photo for gps location data.	
<b>Field Station#</b>	12380+04		<b>Field Station#</b>	12380+04	
<b>Pic 11 Desc.</b>	Photo shows the bridge over stream S-NN19.		<b>Pic 12 Desc.</b>	Photo shows stream S-NN19 downstream from the bridge.
