Visual Site Inspection Report

Project Name	H-600 Pipeline Spread H	AFE	124300138	Spread	H-600 Pipeline Spread H
Contractor	Precision			Report #	22700
Inspector	Dawn McCullough			Date/Time	4/26/2021 3:33 PM
Permit #	TBD	Inspection Type	VA SWPP	Station Begin	13141+65
State	VA	Inspection Area	Partial	Station End	13316+21
County	Franklin	Ground	Damp	Temperature (°F)	74.00
Municipality	N/A	Weather	Sunny	Rain Gauge (in)	0.00
				Rain Accumulation Time (days)	1.00

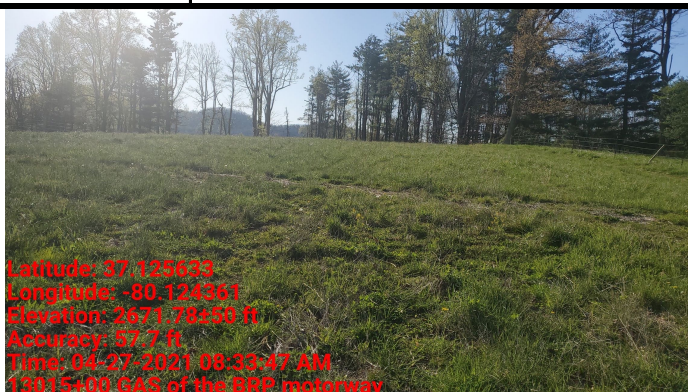
<p>Latitude: 37.125633 Longitude: -80.124361 Elevation: 2671.78±55 ft Accuracy: 57.7 ft Time: 04-27-2021 08:33:47 AM 13015+00 GAS of the BRP motorway</p>

<p>Latitude: 37.125684 Longitude: -80.12442 Elevation: 2738.48±21 ft Accuracy: 18.4 ft Time: 04-27-2021 08:34:19 AM 13015+00 GAS of the BRP motorway</p>		
GPS Location	See pic for GPS location		GPS Location	See pic for GPS location	
Field Station#	13015+00		Field Station#	13015+00	
Pic 5 Desc.	Current ROW conditions on the GAS of the BRP motorway.		Pic 6 Desc.	BRP motorway from the GAS.

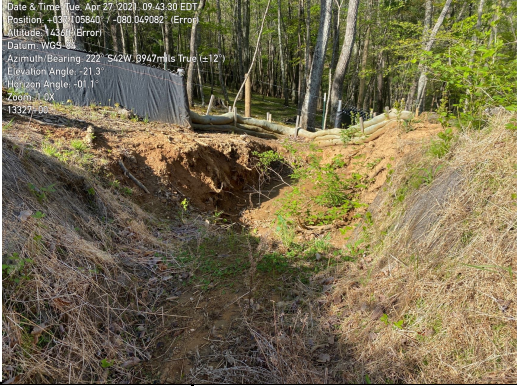
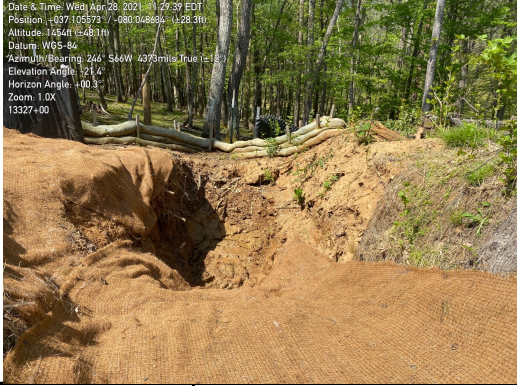
Field Station#	13327+00		Field Station#	13327+00	
Pic 17 Desc.	Accumulated sediment noted in sump and added to the Punch List as 72 hour maintenance item.		Pic 18 Desc.	Punch list item completed.

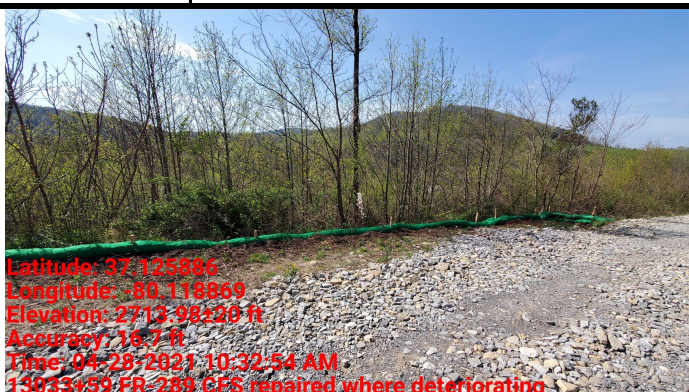
<p>Latitude: 37.125866 Longitude: -80.119869 Elevation: 2713.98±20 ft Accuracy: 18.7 ft Time: 04-28-2021 10:32:54 AM 13033+59 FR-289 CFS repaired where deteriorating</p>			  <p>Latitude: 37.125849 Longitude: -80.119025 Elevation: 2762.43±29 ft Accuracy: 25.3 ft Time: 04-28-2021 10:34:18 AM 13033+59 FR-289 CFS repaired where deteriorating</p>		
GPS Location	See pic for GPS location		GPS Location	See pic for GPS location	
Field Station#	13033+59		Field Station#	13033+59	
Pic 5 Desc.	CFS replaced along the access road where the fabric has deteriorated.		Pic 6 Desc.	CFS replaced along the access road where the fabric has deteriorated.

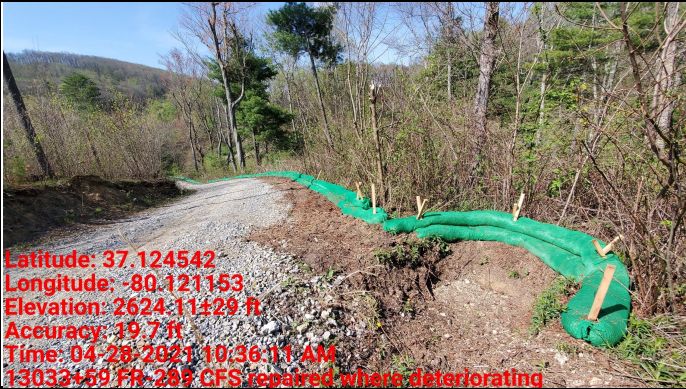
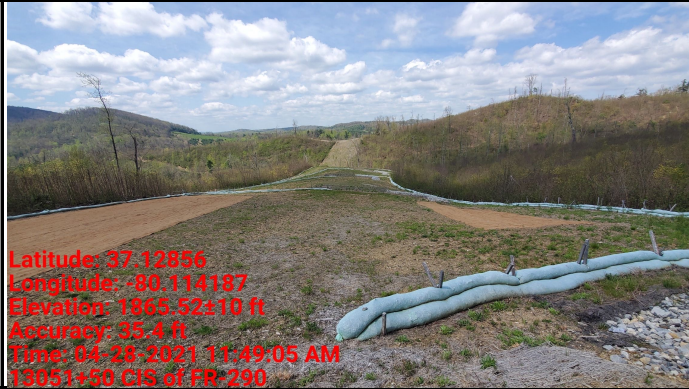
GPS Location	See pic for GPS location		GPS Location	See pic for GPS location	
Field Station#	13033+59		Field Station#	13051+50	
Pic 7 Desc.	CFS replaced along the access road where the fabric has deteriorated.		Pic 8 Desc.	Current ROW conditions on the CIS of FR-290.

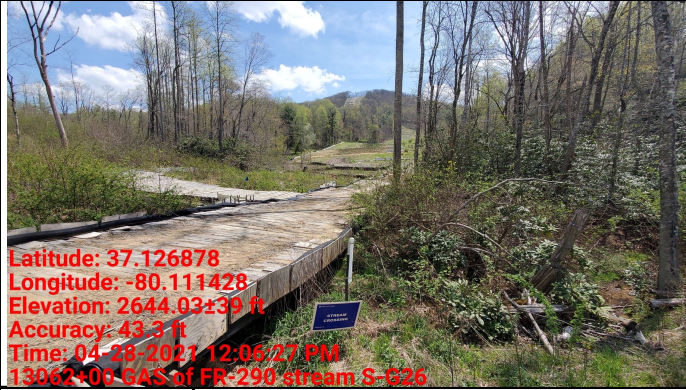
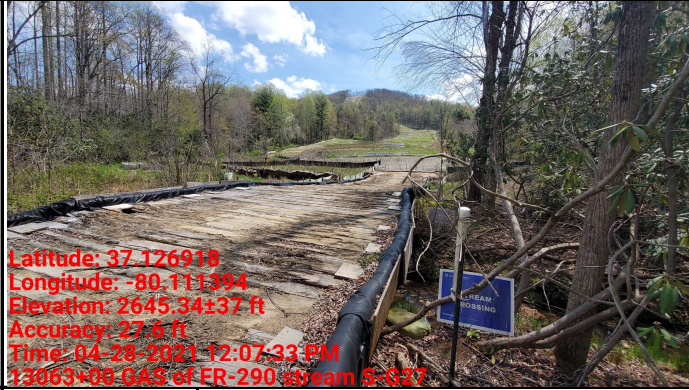
GPS Location	See pic for GPS location		GPS Location	See pic for GPS location	
Field Station#	13062+00		Field Station#	13063+00	
Pic 11 Desc.	Downstream side of stream S-G26.		Pic 12 Desc.	Downstream side of stream S-G27.

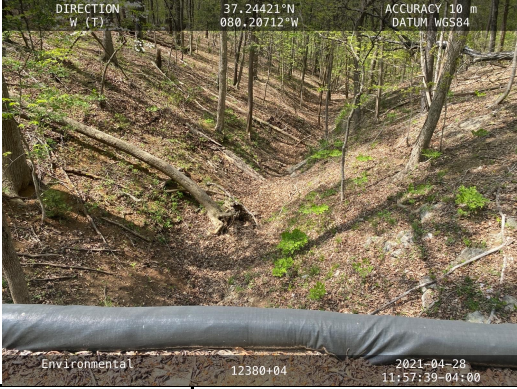
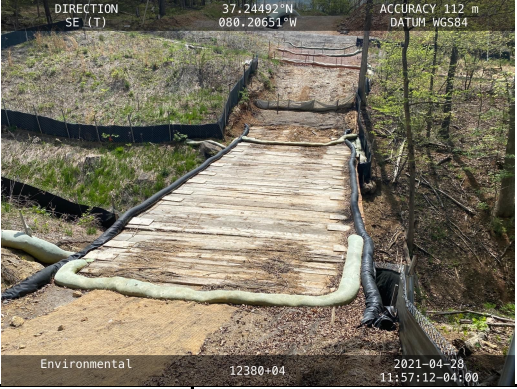
GPS Location	See photo		GPS Location	See photo	
Field Station#	12380+04		Field Station#	12380+04	
Pic 13 Desc.	Down stream of stream crossing S-NN19 in acceptable condition		Pic 14 Desc.	Bridge and ECDs crossing stream S-NN19 in acceptable condition

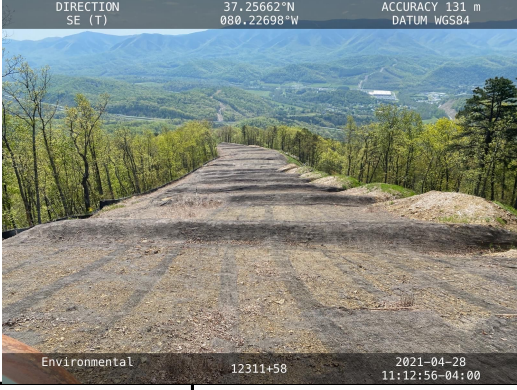
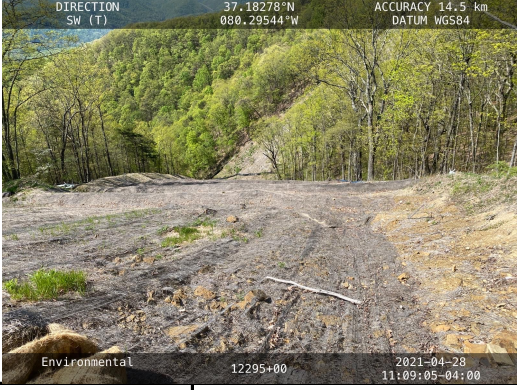
GPS Location	See photo		GPS Location	See photo	
Field Station#	12311+58		Field Station#	12295+00	
Pic 17 Desc.	Stabilized ROW in acceptable condition		Pic 18 Desc.	Stabilized slope in acceptable condition

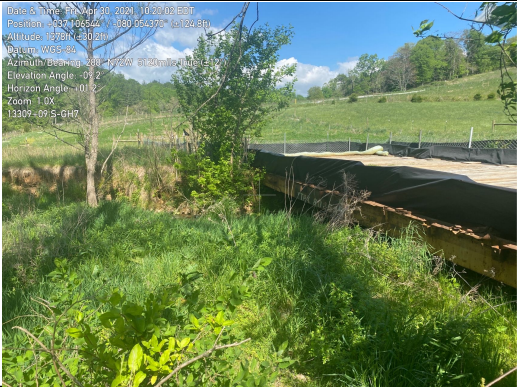
GPS Location		See photo for coordinates.		GPS Location	
Field Station#		13309+09		Field Station#	
Pic 17 Desc.		S-GH7, upstream, slight turbidity noted, no ROW impacts observed, banks well vegetated.		Pic 18 Desc.
