# Visual Site Inspection Report

<b>Project Name</b>	H-600 Pipeline Spread H	<b>AFE</b>	124300138	<b>Spread</b>	H-600 Pipeline Spread H
<b>Contractor</b>	Precision			<b>Report #</b>	21936
<b>Inspector</b>	Norm Kitchen			<b>Date/Time</b>	4/5/2021 5:00 PM
<b>Permit #</b>	TBD	<b>Inspection Type</b>	VA SWPP	<b>Station Begin</b>	13316+21
<b>State</b>	VA	<b>Inspection Area</b>	Partial	<b>Station End</b>	13422+00
<b>County</b>	Franklin	<b>Ground</b>	Damp	<b>Temperature (°F)</b>	68.00
<b>Municipality</b>	N/A	<b>Weather</b>	Sunny	<b>Rain Gauge (in)</b>	0.00
				<b>Rain Accumulation Time (days)</b>	1.00

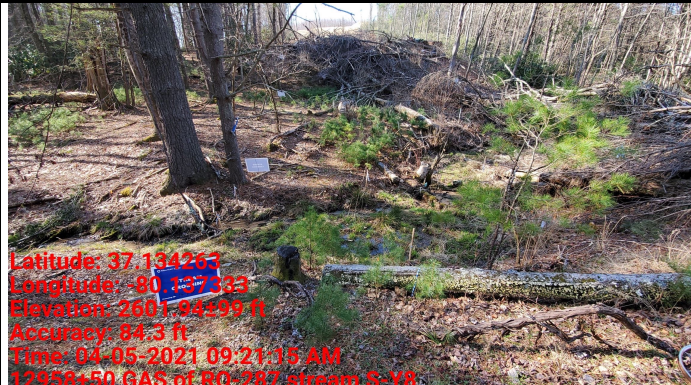
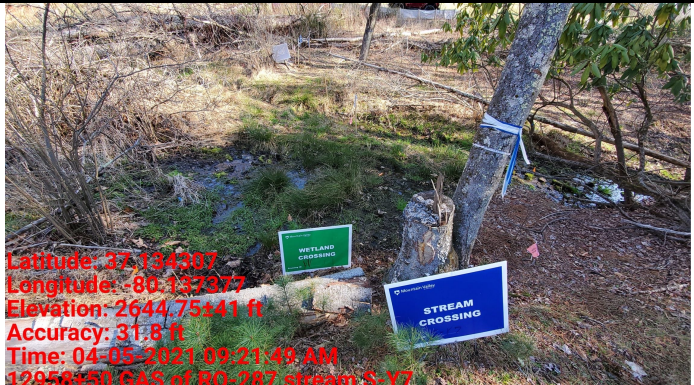
GPS Location	See pic for GPS location		GPS Location	See pic for GPS location	
Field Station#	12958+50		Field Station#	12958+50	
Pic 1 Desc.	Downstream side of stream S-Y8.		Pic 2 Desc.	Downstream side of stream S-Y7.

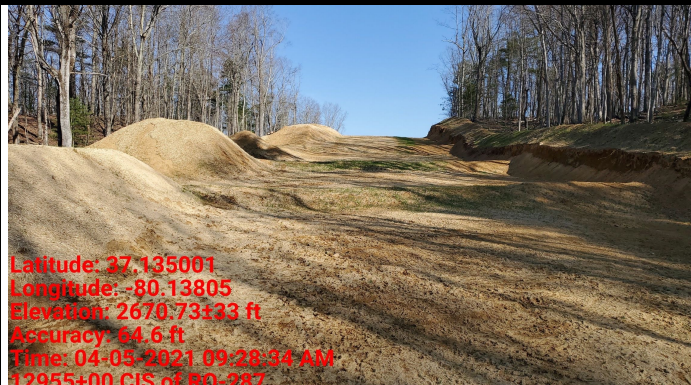
GPS Location	See pic for GPS location		GPS Location	See pic for GPS location	
Field Station#	12955+00		Field Station#	12956+00	
Pic 5 Desc.	Current ROW conditions on the CIS of RO-287.		Pic 6 Desc.	Current ROW conditions on the CIS of RO-287.

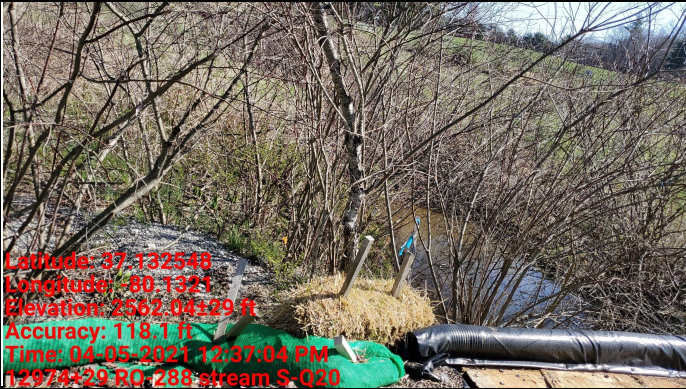
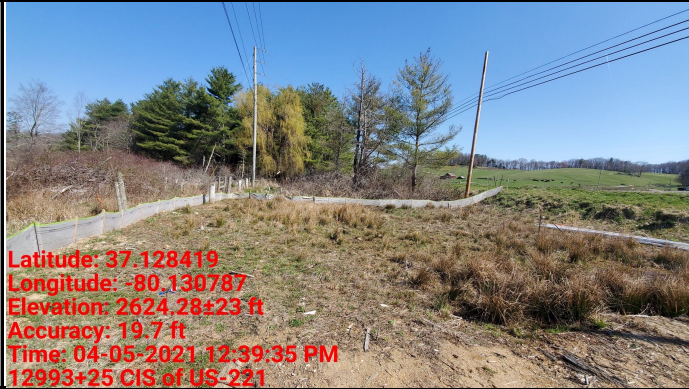
<b>GPS Location</b>	See pic for GPS location		<b>GPS Location</b>	See pic for GPS location	
<b>Field Station#</b>	12974+29		<b>Field Station#</b>	12993+25	
<b>Pic 13 Desc.</b>	Stream S-Q20 on access road RO-288.		<b>Pic 14 Desc.</b>	Current ROW conditions on the CIS of US-221.

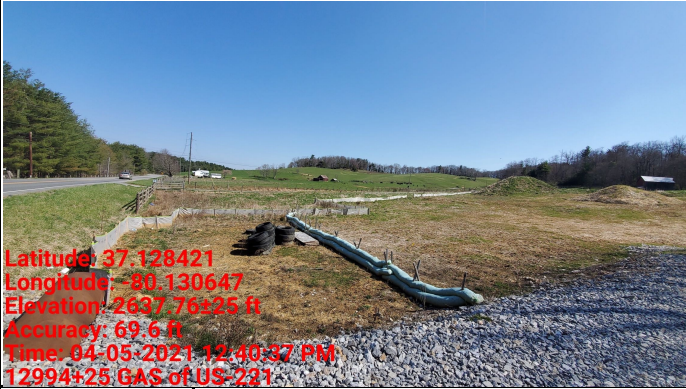
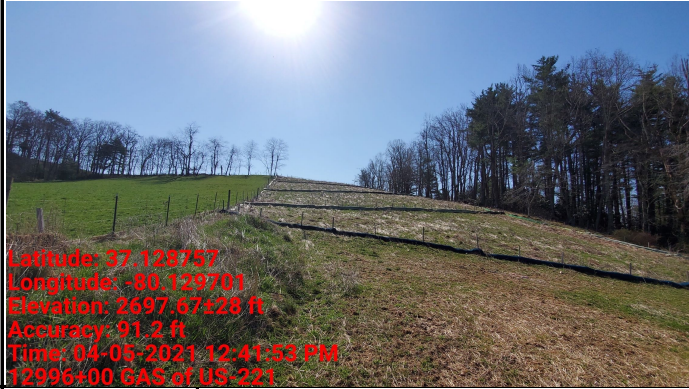
<b>GPS Location</b>	See pic for GPS location		<b>GPS Location</b>	See pic for GPS location	
<b>Field Station#</b>	12994+25		<b>Field Station#</b>	12996+00	
<b>Pic 15 Desc.</b>	GAS of US-221		<b>Pic 16 Desc.</b>	Restored portion of the ROW on the GAS of US-221.

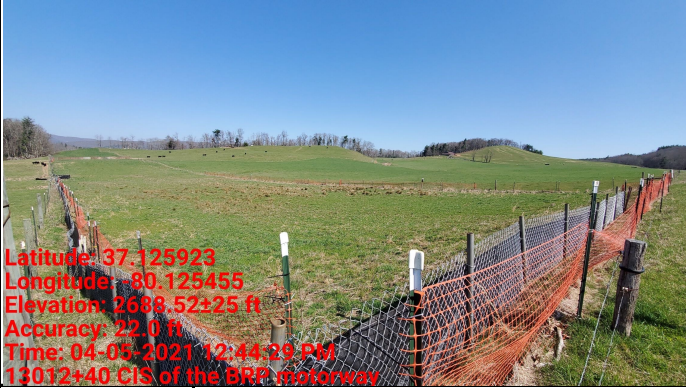
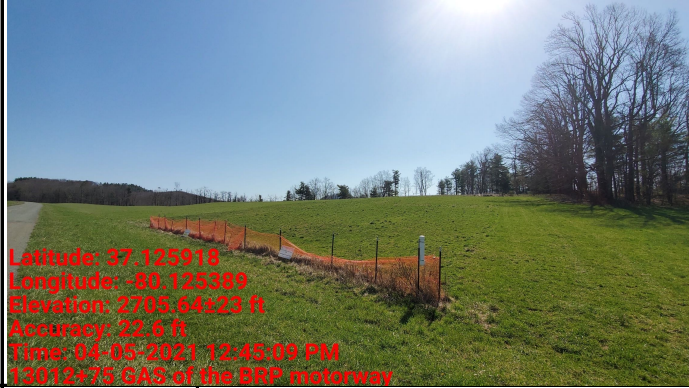
<b>GPS Location</b>	See pic for GPS location		<b>GPS Location</b>	See pic for GPS location	
<b>Field Station#</b>	13012+40		<b>Field Station#</b>	13012+75	
<b>Pic 17 Desc.</b>	Current conditions of the CIS of the BRP motorway.		<b>Pic 18 Desc.</b>	Current conditions of the GAS of the BRP motorway.

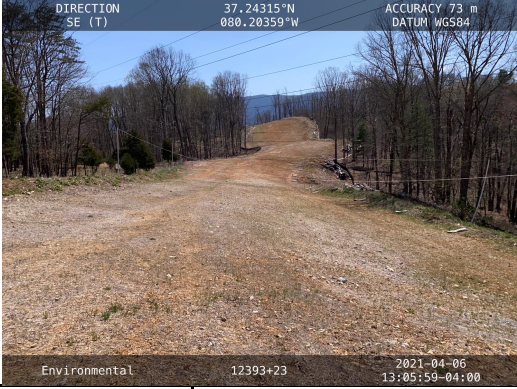
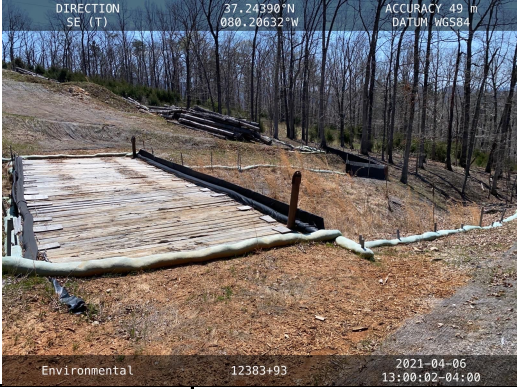
<b>GPS Location</b>	See photo		<b>GPS Location</b>	See photo	
<b>Field Station#</b>	12393+23		<b>Field Station#</b>	12383+93	
<b>Pic 7 Desc.</b>	Stabilized ROW in acceptable condition		<b>Pic 8 Desc.</b>	Bridge and ECDs at clean water crossing in acceptable condition

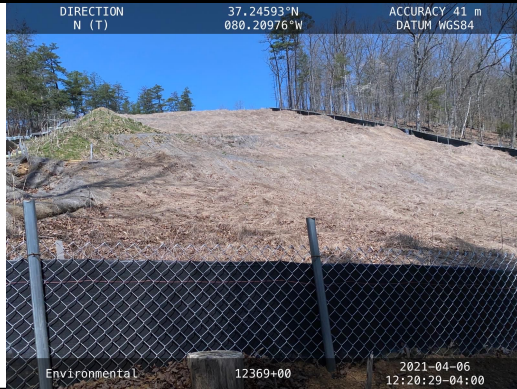
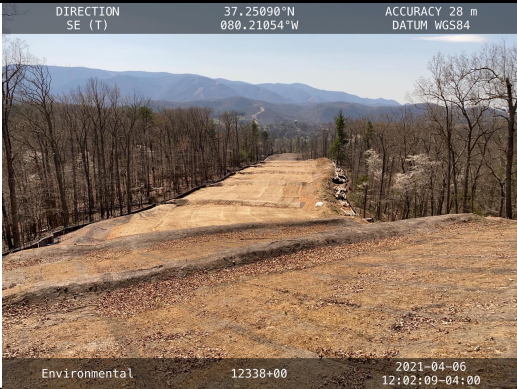
<b>GPS Location</b>	See photo		<b>GPS Location</b>	See photo	
<b>Field Station#</b>	12369+00		<b>Field Station#</b>	12338+00	
<b>Pic 11 Desc.</b>	Stabilized slope in acceptable condition		<b>Pic 12 Desc.</b>	Stabilized ROW in acceptable condition

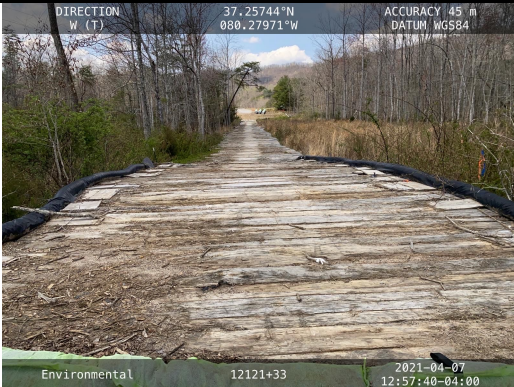
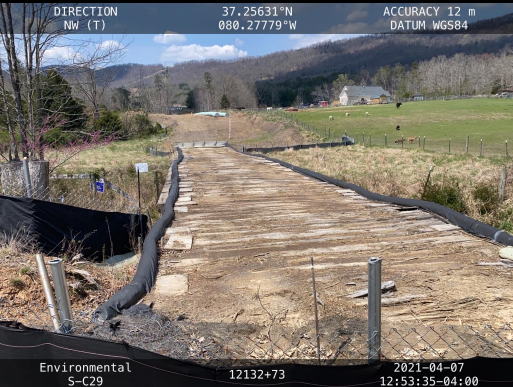
<b>GPS Location</b>	See photo		<b>GPS Location</b>	See photo	
<b>Field Station#</b>	12121+33		<b>Field Station#</b>	12132+73	
<b>Pic 1 Desc.</b>	Bridge and ECDs crossing multiple features in acceptable condition		<b>Pic 2 Desc.</b>	Bridge and ECDs at stream crossing S-C29 in acceptable condition

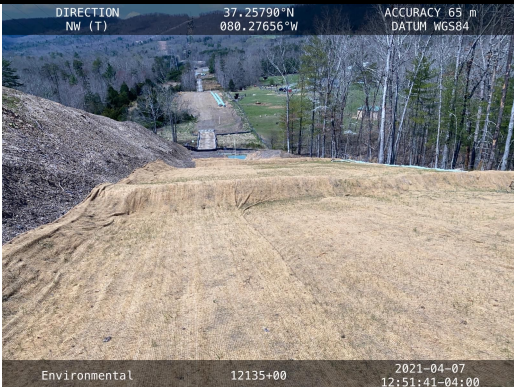
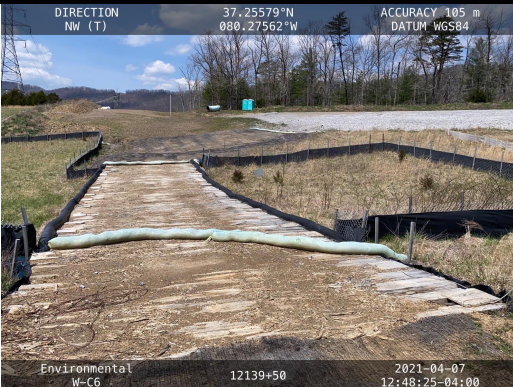
<b>GPS Location</b>	See photo		<b>GPS Location</b>	See photo	
<b>Field Station#</b>	12135+00		<b>Field Station#</b>	12139+50	
<b>Pic 3 Desc.</b>	Stabilized slope in acceptable condition		<b>Pic 4 Desc.</b>	Bridge and ECDs protecting wetland W-C6 in acceptable condition

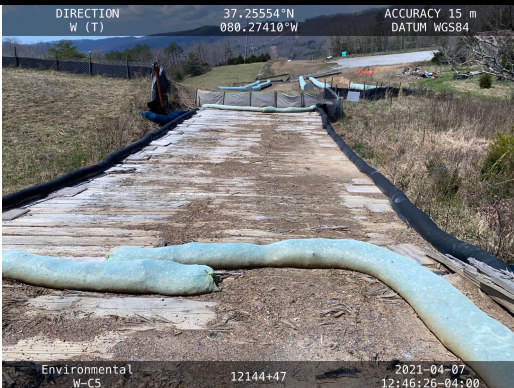
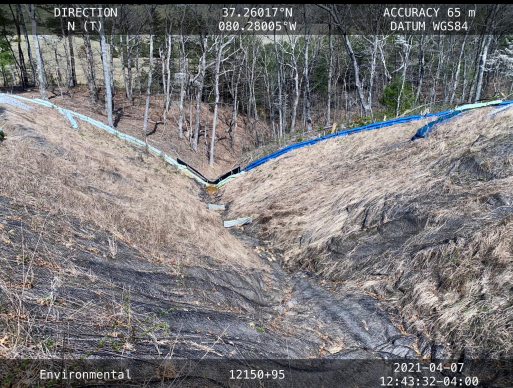
<b>GPS Location</b>	See photo		<b>GPS Location</b>	See photo	
<b>Field Station#</b>	12134+47		<b>Field Station#</b>	12150+95	
<b>Pic 5 Desc.</b>	Bridge and ECDs at wetland W-C5 in acceptable condition		<b>Pic 6 Desc.</b>	Stabilized drain in acceptable condition

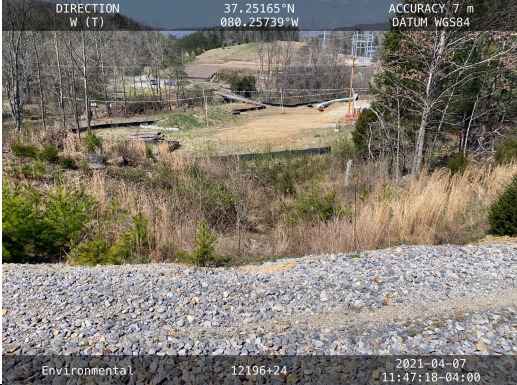
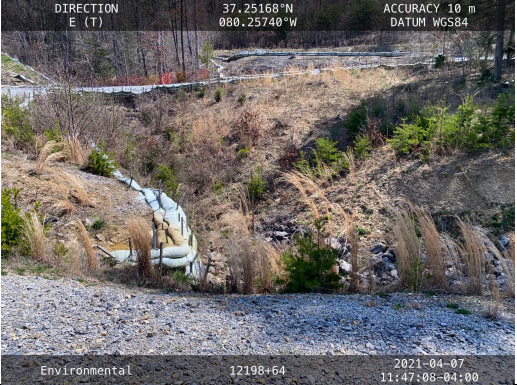
<b>GPS Location</b>	see photo		<b>GPS Location</b>	See photo	
<b>Field Station#</b>	12196+24		<b>Field Station#</b>	12198+64	
<b>Pic 13 Desc.</b>	S-0011 on the west side of railroad tracks in acceptable condition		<b>Pic 14 Desc.</b>	Stream crossing S-0011 on the east side of the railroad crossing in acceptable condition

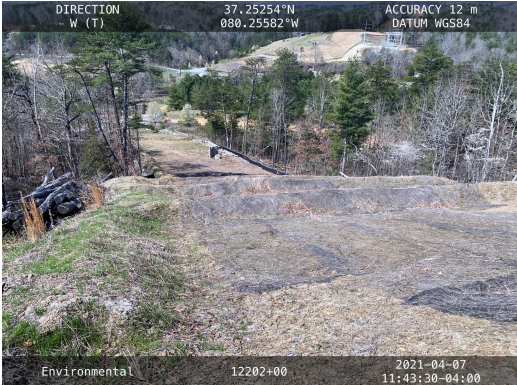
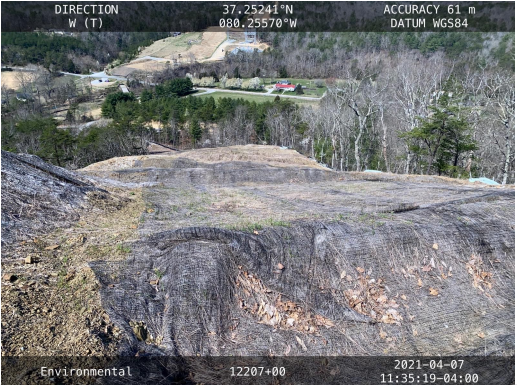
<b>GPS Location</b>	See photo		<b>GPS Location</b>	See photo	
<b>Field Station#</b>	122+02		<b>Field Station#</b>	12207+00	
<b>Pic 15 Desc.</b>	Stabilized ROW in acceptable condition		<b>Pic 16 Desc.</b>	Stabilized ROW in acceptable condition

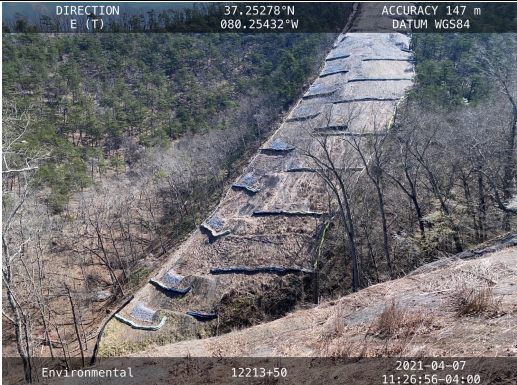
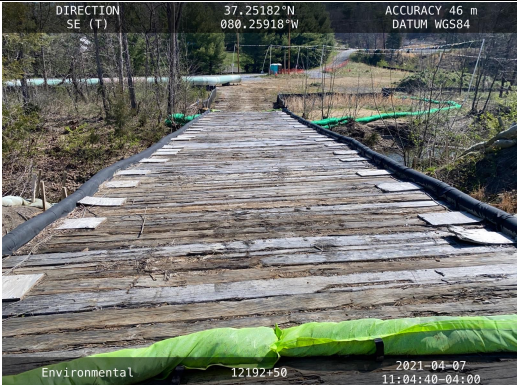
<b>GPS Location</b>	See photo		<b>GPS Location</b>	See photo	
<b>Field Station#</b>	12213+50		<b>Field Station#</b>	12192+50	
<b>Pic 17 Desc.</b>	Stabilized slope in acceptable condition		<b>Pic 18 Desc.</b>	Bridge and ECDs crossing S-C21 in acceptable condition

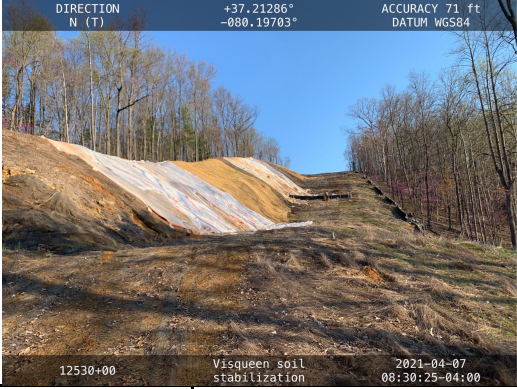
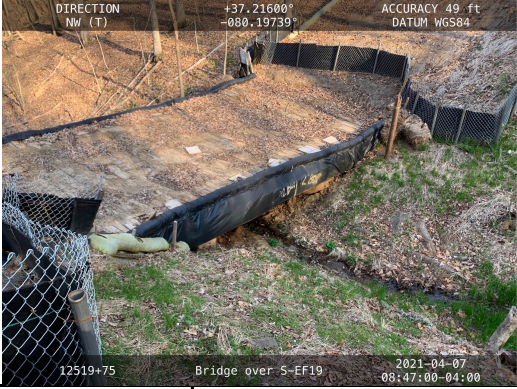
<b>GPS Location</b>	See photo for gps location data.		<b>GPS Location</b>	See photo for gps location data.	
<b>Field Station#</b>	12530+00		<b>Field Station#</b>	12519+75	
<b>Pic 7 Desc.</b>	Photo shows the slope stabilized with Visqueen.		<b>Pic 8 Desc.</b>	Photo shows the bridge over stream S-EF19.

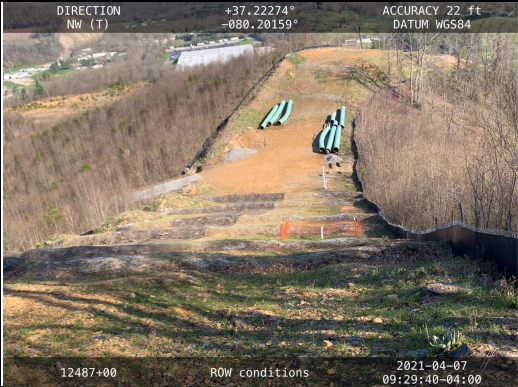
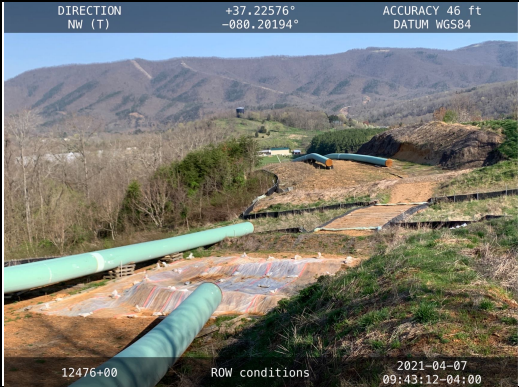
<b>GPS Location</b>	See photo for gps location data.		<b>GPS Location</b>	See photo for gps location data.	
<b>Field Station#</b>	12487+00		<b>Field Station#</b>	12476+00	
<b>Pic 13 Desc.</b>	Photo shows the ROW and ECD conditions from about 12487+00 to 12485+00.		<b>Pic 14 Desc.</b>	Photo shows the ROW condition from about 12474+00 to 12476+00.

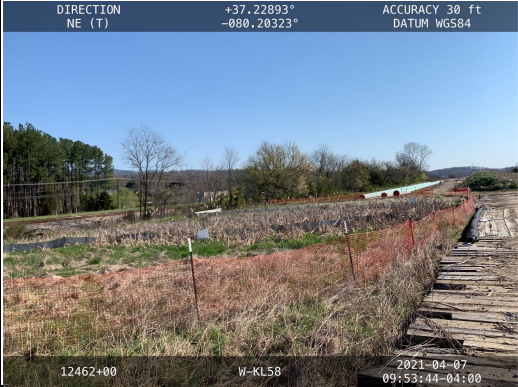
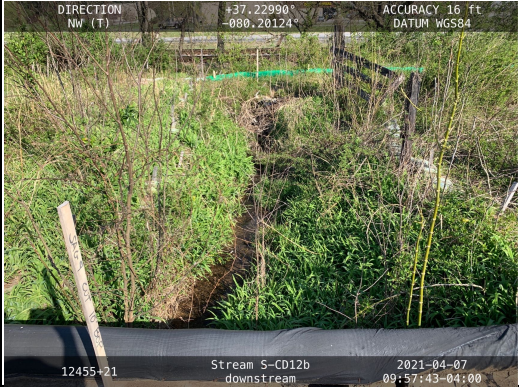
<b>GPS Location</b>	See photo for gps location data.		<b>GPS Location</b>	See photo for gps location data.	
<b>Field Station#</b>	12462+00		<b>Field Station#</b>	12455+21	
<b>Pic 15 Desc.</b>	Photo shows wetland W-KL58.		<b>Pic 16 Desc.</b>	Photo shows stream S-CD12b downstream from the bridge.

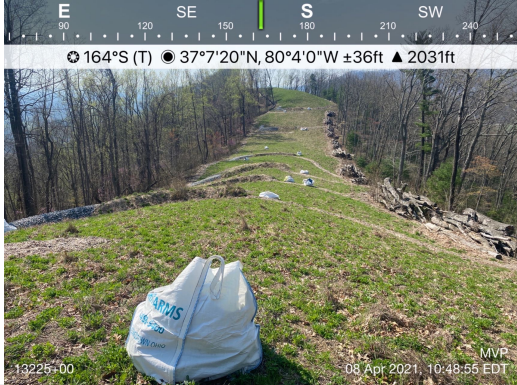
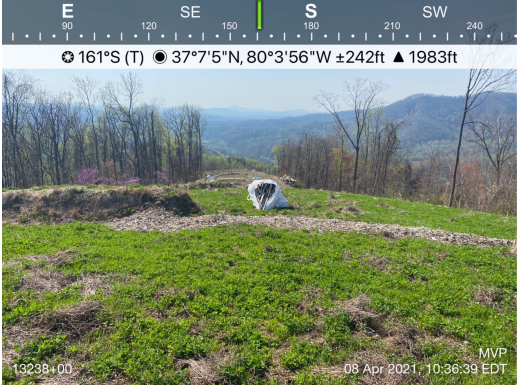
<b>GPS Location</b>	See photos for coordinates.		<b>GPS Location</b>	See photos for coordinates.	
<b>Field Station#</b>	13225+00		<b>Field Station#</b>	13238+00	
<b>Pic 9 Desc.</b>	ROW stable with vegetative cover noted across LOD.		<b>Pic 10 Desc.</b>	ROW stable with vegetative cover noted across LOD.

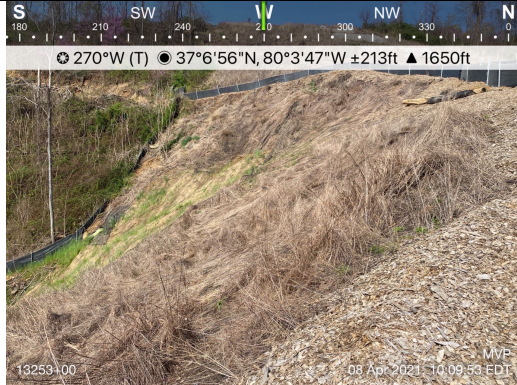
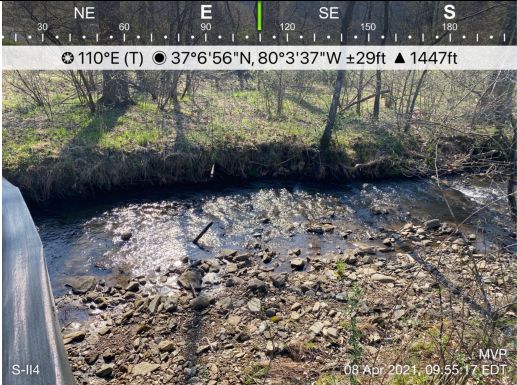
<b>GPS Location</b>	See photos for coordinates.		<b>GPS Location</b>	See photos for coordinates.	
<b>Field Station#</b>	13263+00		<b>Field Station#</b>	13260+60	
<b>Pic 11 Desc.</b>	No observable changes noted at documented slip, new vegetation establishing in most recent disturbed section.		<b>Pic 12 Desc.</b>	S-II4, downstream, no changes noted, no turbidity observed.

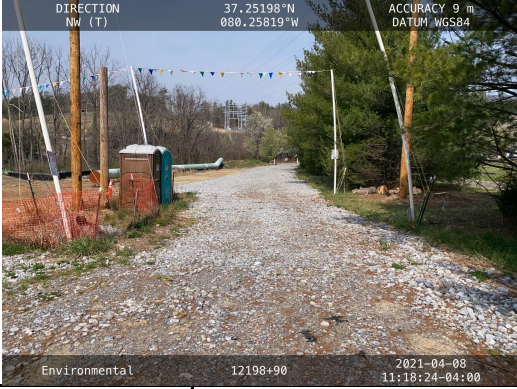
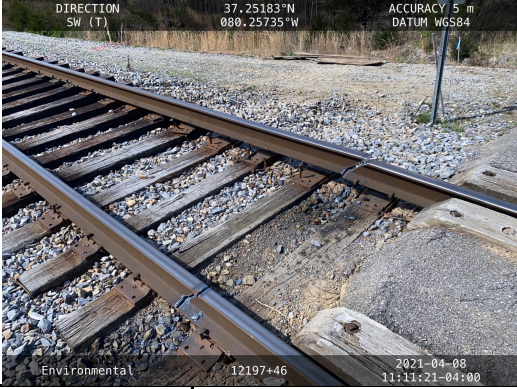
<b>GPS Location</b>	See photo		<b>GPS Location</b>	See photo	
<b>Field Station#</b>	12198+90		<b>Field Station#</b>	12197+46	
<b>Pic 7 Desc.</b>	Access Road MVP-MN-275 in acceptable condition		<b>Pic 8 Desc.</b>	Area where 3rd party's are beginning to cut the rails to begin construction of a road.

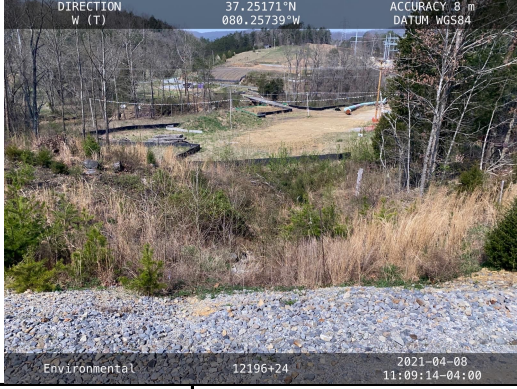
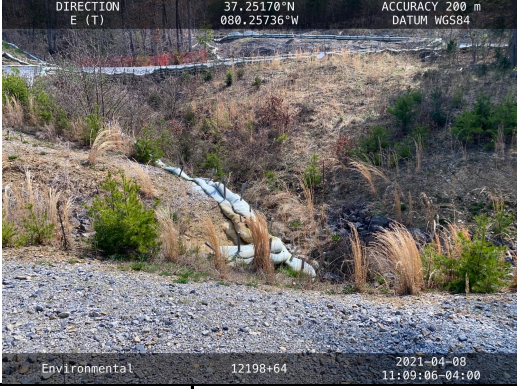
<b>GPS Location</b>	See photo		<b>GPS Location</b>	See photo	
<b>Field Station#</b>	12196+24		<b>Field Station#</b>	12198+64	
<b>Pic 9 Desc.</b>	Stream crossing S-0011 on the West side of the railroad tracks in acceptable condition		<b>Pic 10 Desc.</b>	Stream crossing S-0011 on the West side of the railroad tracks in acceptable condition

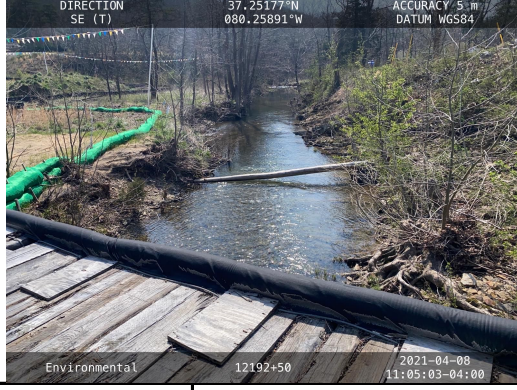
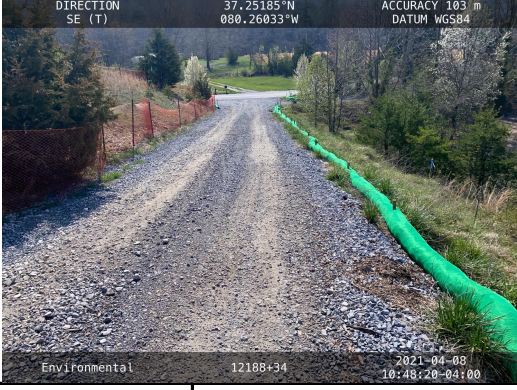
<b>GPS Location</b>	See photo		<b>GPS Location</b>	See photo	
<b>Field Station#</b>	12192+50		<b>Field Station#</b>	12188+34	
<b>Pic 11 Desc.</b>	Down stream of Stream crossing S-C21 in acceptable condition		<b>Pic 12 Desc.</b>	Access Road MVP-MN-274 in acceptable condition

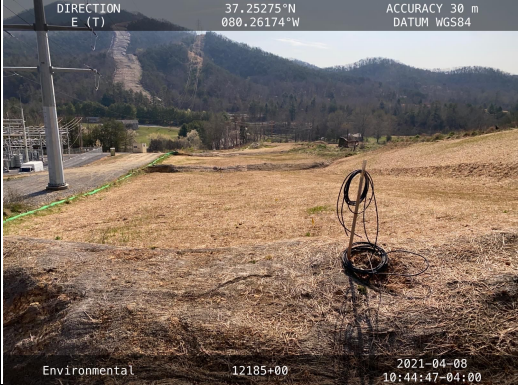
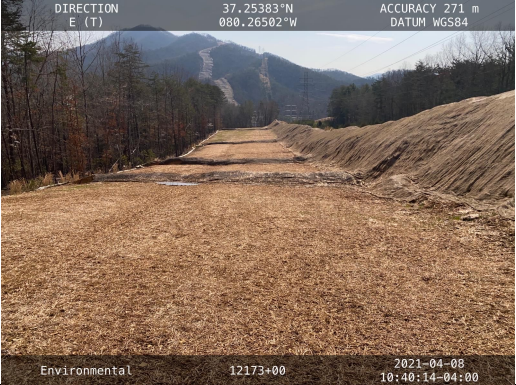
<b>GPS Location</b>	See photo		<b>GPS Location</b>	See photo	
<b>Field Station#</b>	12185+00		<b>Field Station#</b>	12173+00	
<b>Pic 13 Desc.</b>	Stabilized ROW in acceptable condition		<b>Pic 14 Desc.</b>	Stabilized ROW in acceptable condition

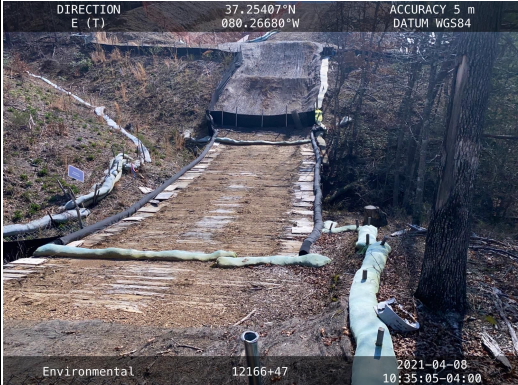
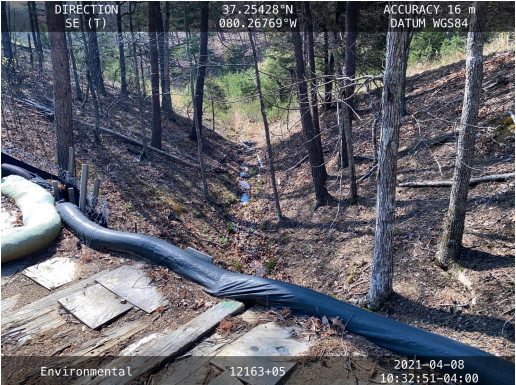
<b>GPS Location</b>	See photo		<b>GPS Location</b>	See photo	
<b>Field Station#</b>	12166+47		<b>Field Station#</b>	12163+05	
<b>Pic 15 Desc.</b>	Bridge crossing S-C24 in acceptable condition		<b>Pic 16 Desc.</b>	Down stream of stream crossing S-C25 in acceptable condition

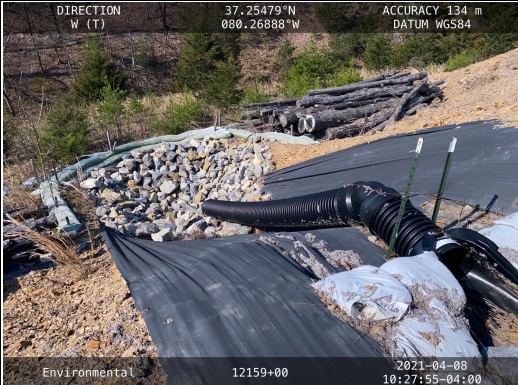
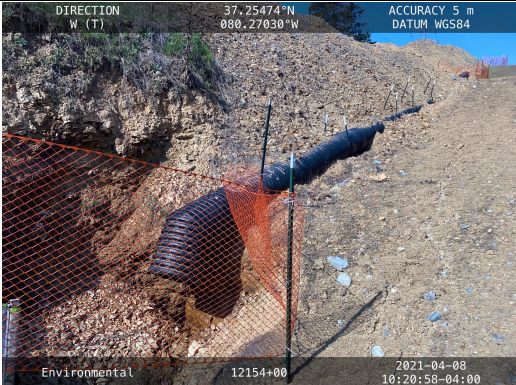
<b>GPS Location</b>	See photo		<b>GPS Location</b>	See photo	
<b>Field Station#</b>	12159+00		<b>Field Station#</b>	12154+00	
<b>Pic 17 Desc.</b>	Fill slope drain in acceptable condition		<b>Pic 18 Desc.</b>	End sump drains in acceptable condition

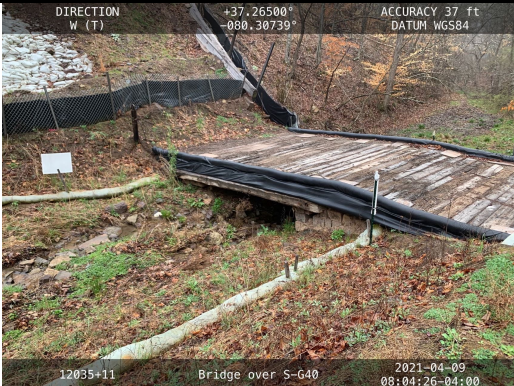
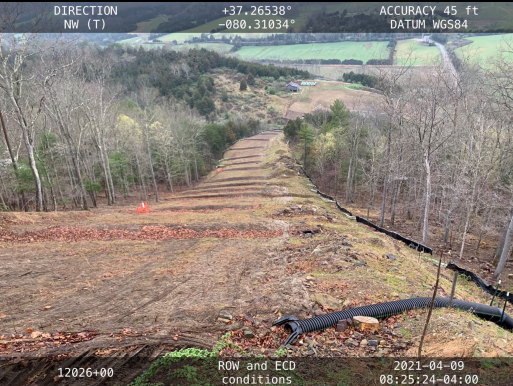
<b>GPS Location</b>	See photo		<b>GPS Location</b>	See photo	
<b>Field Station#</b>	12035+11		<b>Field Station#</b>	12026+00	
<b>Pic 5 Desc.</b>	Bridge and ECDs at stream crossing S-G40 in acceptable condition		<b>Pic 6 Desc.</b>	Stabilized slope in acceptable condition
