Visual Site Inspection Report

Project Name	H-600 Pipeline Spread H	AFE	124300138	Spread	H-600 Pipeline Spread H
Contractor	Precision			Report #	23186
Inspector	Dustin Lyons			Date/Time	5/10/2021 4:32 PM
Permit #	TBD	Inspection Type	VA SWPP	Station Begin	13024+00
State	VA	Inspection Area	Partial	Station End	13141+65
County	Franklin	Ground	Damp	Temperature (°F)	65.00
Municipality	N/A	Weather	Cloudy	Rain Gauge (in)	0.00
				Rain Accumulation Time (days)	1.00

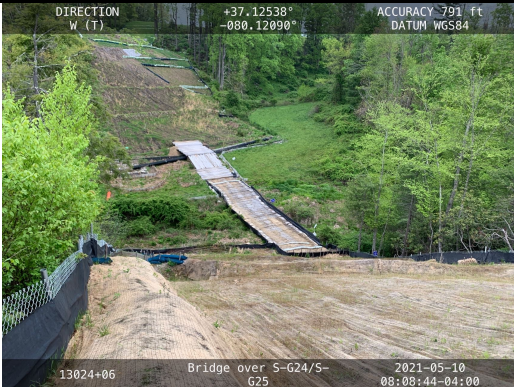
GPS Location	See photo for gps location data.		GPS Location	See photo for gps location data.	
Field Station#	13024+06		Field Station#	13030+00	
Pic 1 Desc.	Photo shows the bridge over streams S-G24 and S-G25.		Pic 2 Desc.	Photo shows the ROW and ECD conditions.

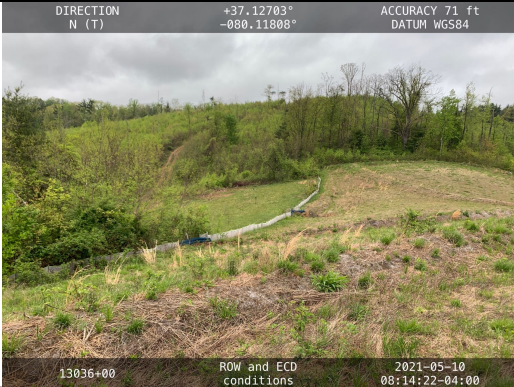
GPS Location	See photo for gps location data.		GPS Location	See photo for gps location data.	
Field Station#	13036+00		Field Station#	13042+61	
Pic 3 Desc.	Photo shows the ROW and ECD conditions.		Pic 4 Desc.	Photo shows the bridge over stream S-H1.

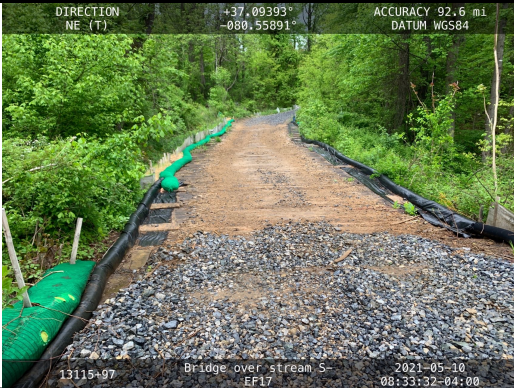
GPS Location	See photo for gps location data.		GPS Location	See photo for gps location data.	
Field Station#	13115+97		Field Station#	13115+97	
Pic 5 Desc.	Photo shows the bridge over stream S-EF17.		Pic 6 Desc.	Photo shows stream S-EF17 downstream from the access road.

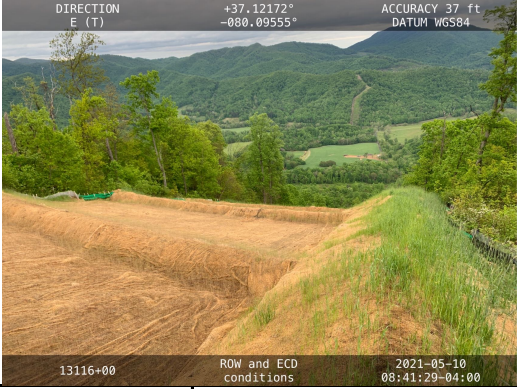
GPS Location	See photo for gps location data.		GPS Location	See photo for gps location data.	
Field Station#	13116+00		Field Station#	13110+00	
Pic 7 Desc.	Photo shows the ROW and ECD conditions.		Pic 8 Desc.	Photo shows the ROW and ECD conditions.

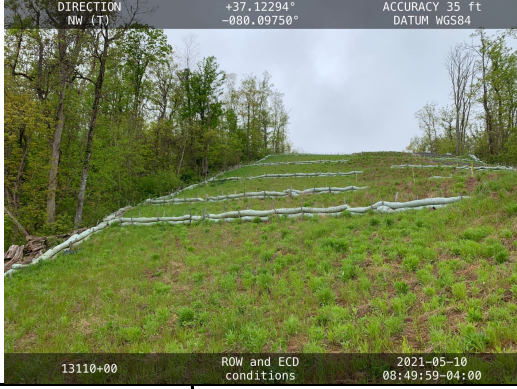
GPS Location	See photo for gps location data.		GPS Location	See photo for gps location data.	
Field Station#	12109+00		Field Station#	13097+50	
Pic 9 Desc.	Photo shows the ROW and ECD conditions.		Pic 10 Desc.	Photo shows the ROW and ECD conditions.

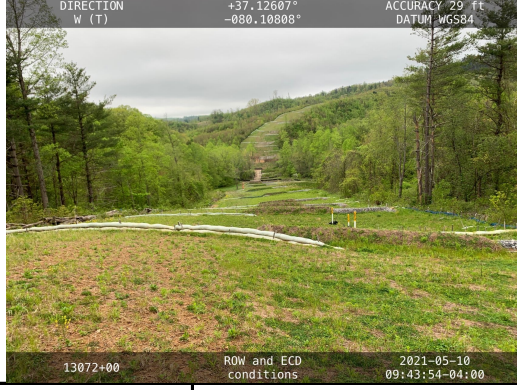
GPS Location	See photo for gps location data.		GPS Location	See photo for gps location data.	
Field Station#	13072+00		Field Station#	13064+00	
Pic 11 Desc.	Photo shows the ROW and ECD conditions.		Pic 12 Desc.	Photo shows the bridge over stream S-G27.

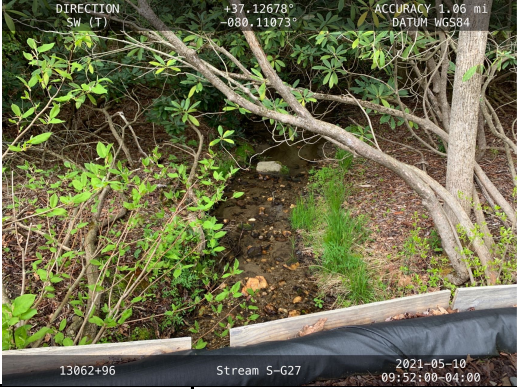
GPS Location	See photo for gps location data.		GPS Location	See photo for gps location data.	
Field Station#	13062+96		Field Station#	13061+89	
Pic 13 Desc.	Photo shows stream S-G27 downstream from the bridge.		Pic 14 Desc.	Photo shows stream S-G26 upstream from the bridge.

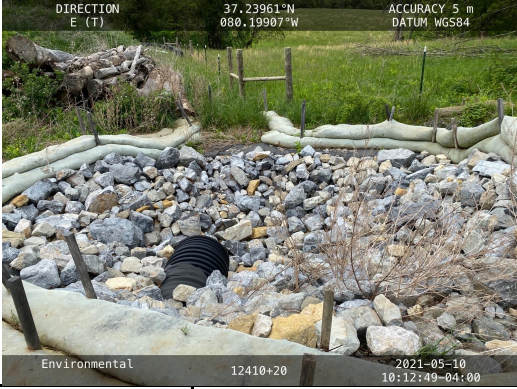
GPS Location	See photo		GPS Location	See photo	
Field Station#	12410+20		Field Station#	12408+65	
Pic 13 Desc.	Clean water crossing outlet in acceptable condition		Pic 14 Desc.	Clean water crossing inlet in acceptable condition

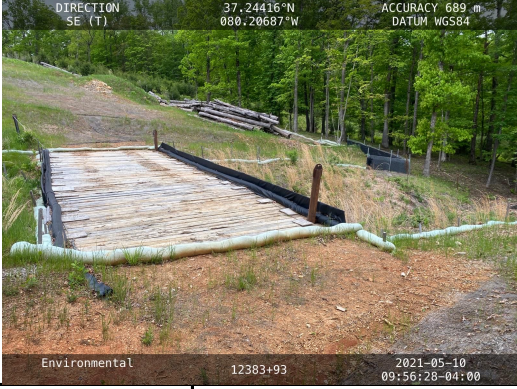
GPS Location	See photo		GPS Location	See photo	
Field Station#	12383+93		Field Station#	12380+04	
Pic 15 Desc.	Clean water crossing in acceptable condition		Pic 16 Desc.	Bridge and ECDs at stream crossing S-NN19 in acceptable condition

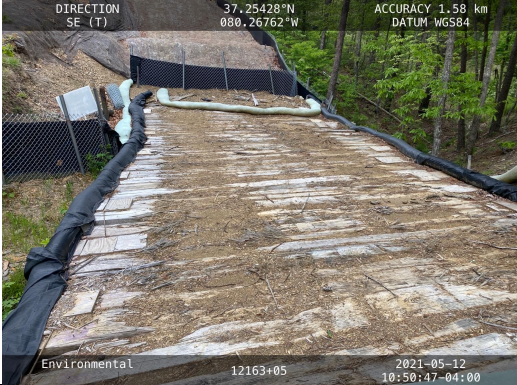
GPS Location	See photo		GPS Location	See photo	
Field Station#	12163+05		Field Station#	12166+47	
Pic 7 Desc.	Bridge and ECDs at stream crossing S-C25 in acceptable condition		Pic 8 Desc.	Bridge and ECDs at stream crossing S-C24 in acceptable condition

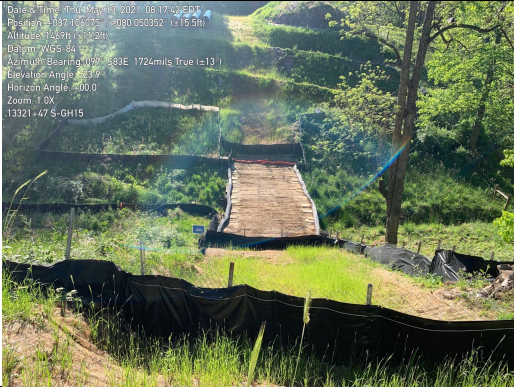
GPS Location	0	GPS Location	0		
Field Station#	13321+47	Field Station#	13325+30		
Pic 1 Desc.	S-GH15, in good condition		Pic 2 Desc.	S-GH14, in good condition

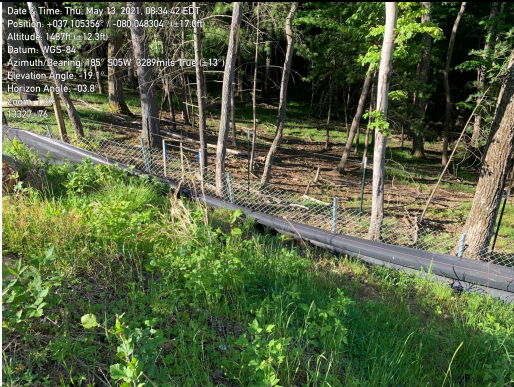
GPS Location	0	GPS Location	0		
Field Station#	13327+76	Field Station#	13334+17		
Pic 3 Desc.	SSF fabric loose from wind impact, punch listed for maintenance; repair due within 72 hours of discovery.		Pic 4 Desc.	S-GH11, in good condition

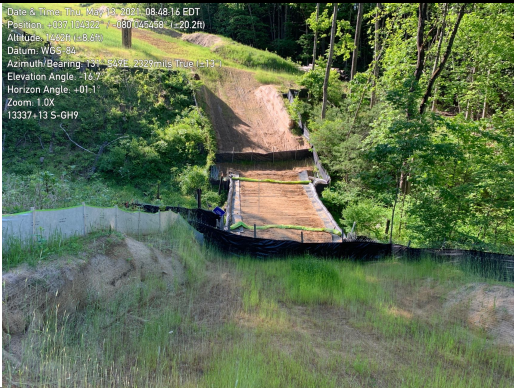
GPS Location	0	GPS Location	0		
Field Station#	13337+13	Field Station#	13344+67		
Pic 5 Desc.	S-GH9, in good condition		Pic 6 Desc.	Webster's Corner Road Crossing and RCE in good condition
