Visual Site Inspection Report

Project Name	H-600 Pipeline Spread H	AFE	124300138	Spread	H-600 Pipeline Spread H
Contractor	Precision			Report #	23722
Inspector	Logan Box			Date/Time	5/24/2021 3:21 PM
Permit #	TBD	Inspection Type	VA SWPP	Station Begin	13525+99
State	VA	Inspection Area	Partial	Station End	13670+00
County	Franklin	Ground	Dry	Temperature (°F)	85.00
Municipality	N/A	Weather	Sunny	Rain Gauge (in)	0.00
				Rain Accumulation Time (days)	0.00

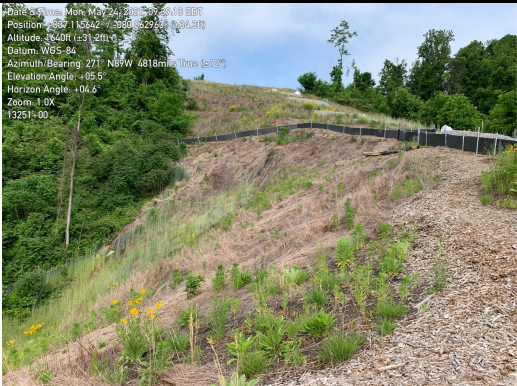
GPS Location	0	GPS Location	0		
Field Station#	13260+66	Field Station#	13251+00		
Pic 9 Desc.	MVP-S-II4 Downstream in good condition	Pic 10 Desc.	Slip observed to be stable, no notable changes, vegetation establishing.

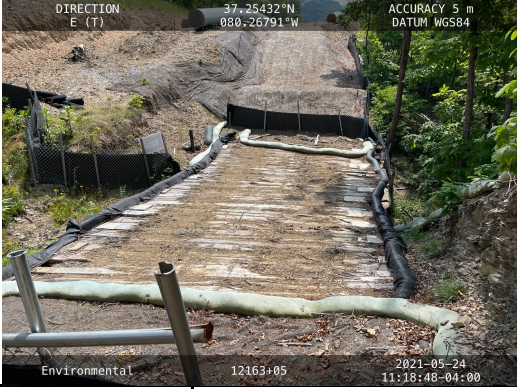
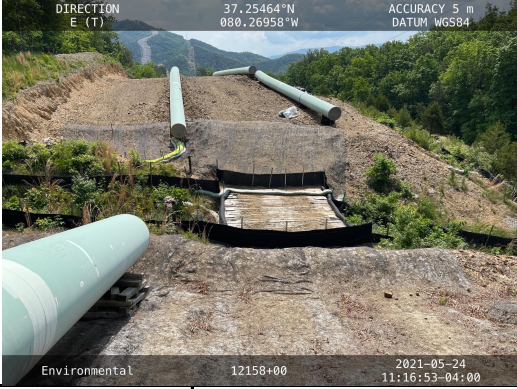
GPS Location	See photo		GPS Location	see photo	
Field Station#	12163+05		Field Station#	12158+00	
Pic 7 Desc.	Bridge and ECDs crossing stream S-C25		Pic 8 Desc.	Bridge and ECDs crossing clean water crossing

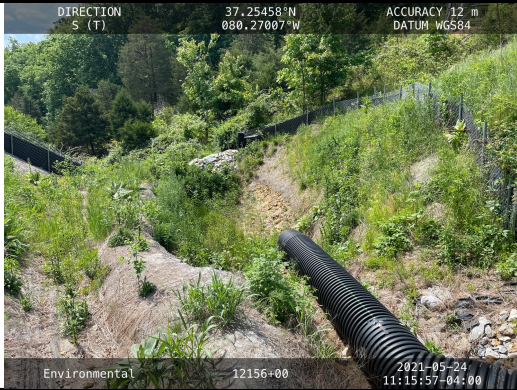
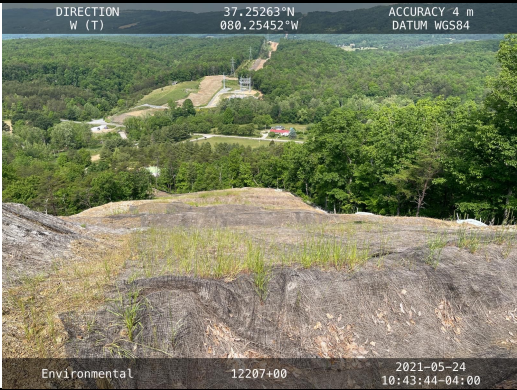
GPS Location	see photo		GPS Location	see photo	
Field Station#	12156+00		Field Station#	12207+00	
Pic 9 Desc.	End sump drain outlet in acceptable condition		Pic 10 Desc.	Stabilized ROW in acceptable condition

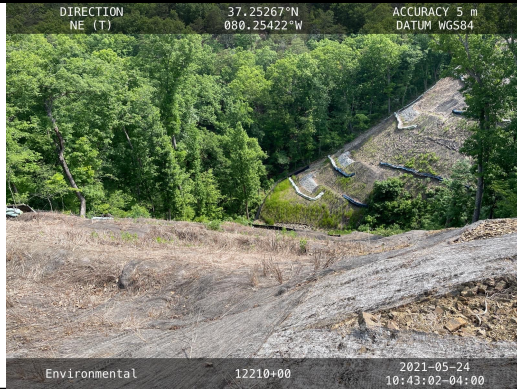
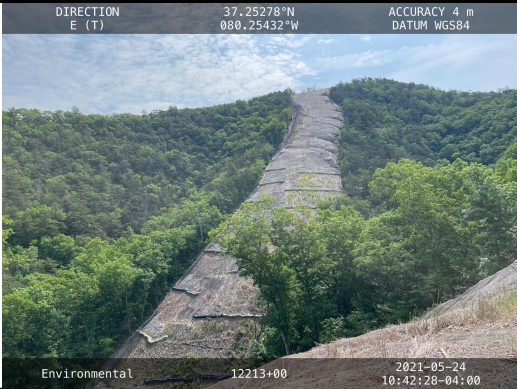
GPS Location	See photo		GPS Location	See photo	
Field Station#	12210+00		Field Station#	12213+00	
Pic 11 Desc.	Stabilized slope in acceptable condition		Pic 12 Desc.	Stabilized slope in acceptable condition

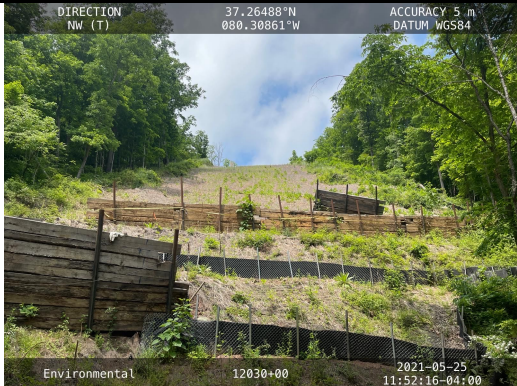
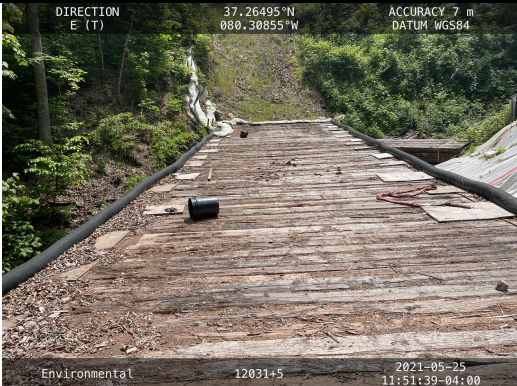
GPS Location	See photo		GPS Location	See photo	
Field Station#	12030+00		Field Station#	12031+50	
Pic 9 Desc.	Stabilized ROW in acceptable condition		Pic 10 Desc.	Bridge and ECDs crossing S-G39 in acceptable condition

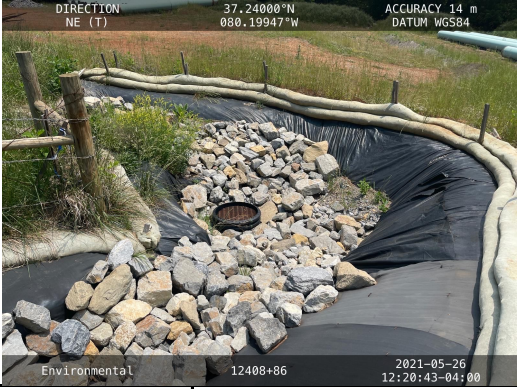
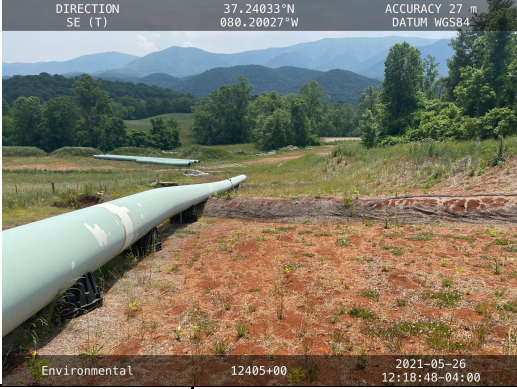
GPS Location	See photo		GPS Location	See photo	
Field Station#	12408+86		Field Station#	12405+00	
Pic 7 Desc.	Clean water crossing pipe inlet in acceptable condition		Pic 8 Desc.	Stabilized ROW in acceptable condition

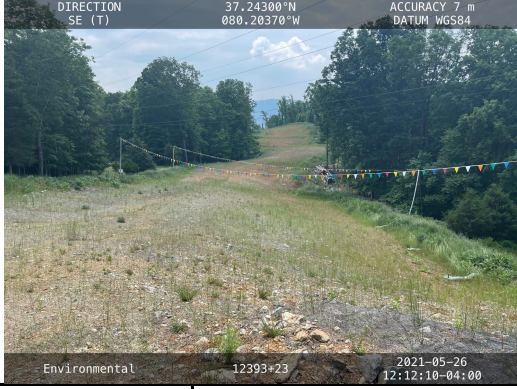
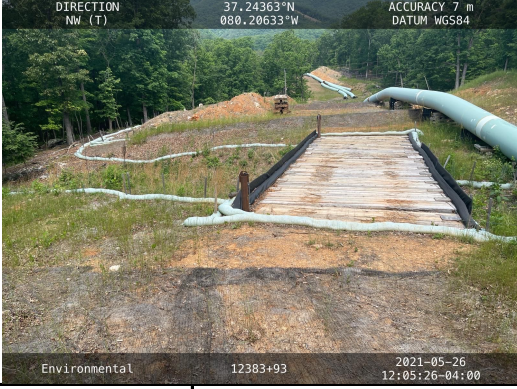
GPS Location	See photo		GPS Location	See photo	
Field Station#	12393+23		Field Station#	12383+93	
Pic 9 Desc.	Stabilized ROW in acceptable condition		Pic 10 Desc.	Clean water crossing in acceptable condition

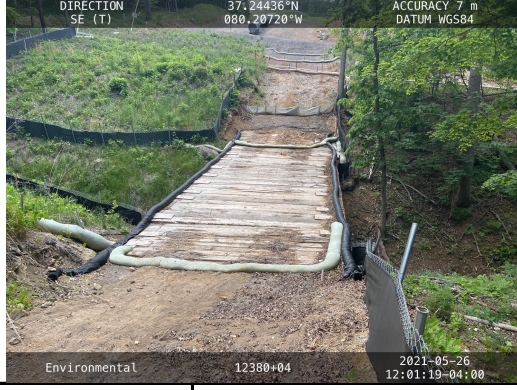
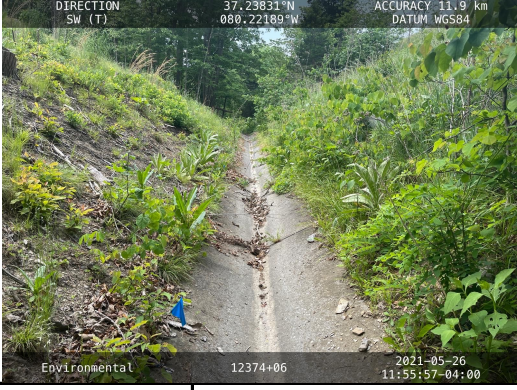
GPS Location	See photo		GPS Location	See photo	
Field Station#	12380+04		Field Station#	12374+06	
Pic 11 Desc.	Bridge and ECDs at stream crossing S-NN19 in acceptable condition		Pic 12 Desc.	Stream crossing S-OO16 in acceptable condition

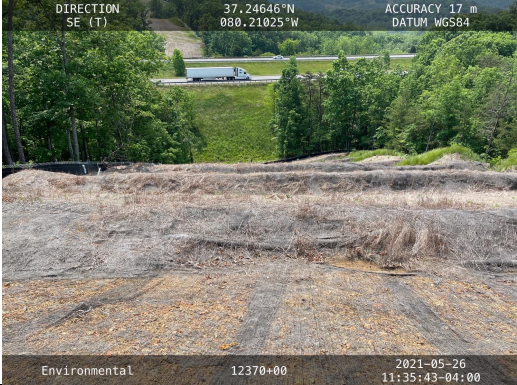
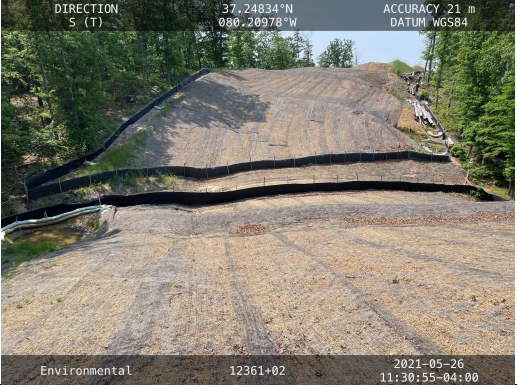
GPS Location	See photo		GPS Location	See photo	
Field Station#	12370+00		Field Station#	12361+02	
Pic 13 Desc.	Stabilized slope in acceptable condition		Pic 14 Desc.	Stabilized ROW and perimeter ECDs in acceptable condition

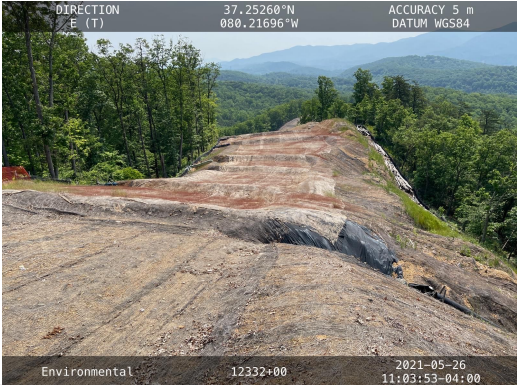
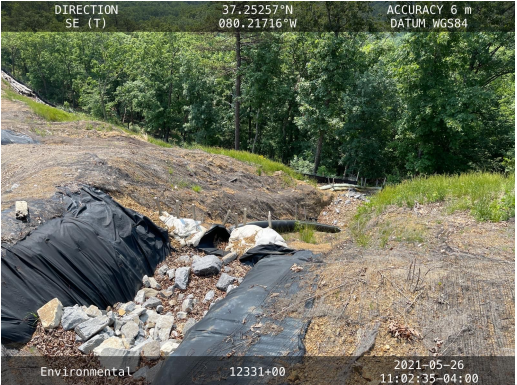
GPS Location	See photo		GPS Location	See photo	
Field Station#	12332+00		Field Station#	12331+00	
Pic 15 Desc.	Stabilized ROW in acceptable condition		Pic 16 Desc.	Fill slope drain in acceptable condition and

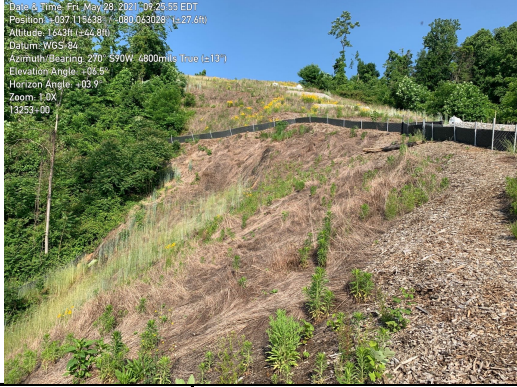
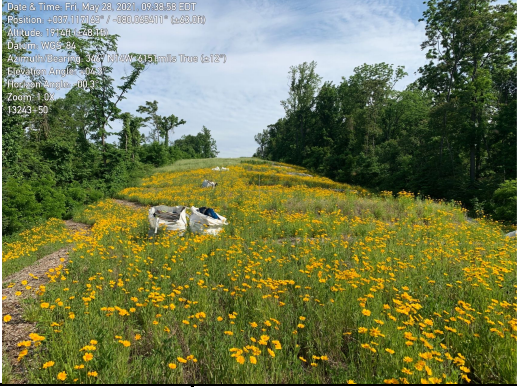
GPS Location 0		GPS Location 0			
Field Station# 13253+00		Field Station# 13243+50			
Pic 9 Desc. Slip observed to be stable, no notable changes, vegetation establishing.		Pic 10 Desc. ROW and ECDs in good condition, with good vegetation establishing across LOD			
<p>Date & Time: Fri, May 28, 2021, 10:18:25 EDT Position: +037.112669, -080.070443 (+39.5N) Altitude: 1822ft (+55.9m) Datum: WGS-84 Azimuth/Bearing: 291° N69W 5173mils True (+12°) Elevation Angle: +19.8° Horizon Angle: +00.2° Zoom: 1.0X 13210+00</p>
