Visual Site Inspection Report

Project Name	H-600 Pipeline Spread H	AFE	124300138	Spread	H-600 Pipeline Spread H
Contractor	Precision			Report #	24018
Inspector	Jason Nielsen			Date/Time	6/1/2021 6:46 PM
Permit #	TBD	Inspection Type	VA SWPP	Station Begin	12005+00
State	VA	Inspection Area	Partial	Station End	12119+17
County	Montgomery	Ground	Dry	Temperature (°F)	80.00
Municipality	N/A	Weather	Sunny	Rain Gauge (in)	0.00
				Rain Accumulation Time (days)	0.00

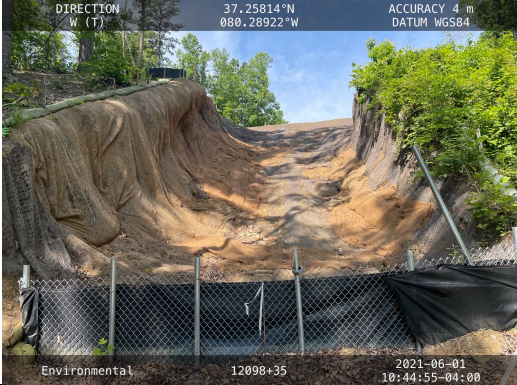
GPS Location	see photo		GPS Location	see photo	
Field Station#	12098+35		Field Station#	12086+56	
Pic 7 Desc.	Cut bank stabilized and in acceptable condition		Pic 8 Desc.	Bridge and ECDs crossing stream S-MM14 in acceptable condition

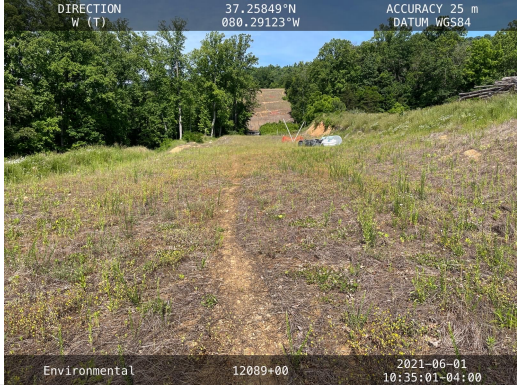
GPS Location	See photo		GPS Location	See photo	
Field Station#	12089+00		Field Station#	12093+00	
Pic 9 Desc.	Stabilized ROW in acceptable condition		Pic 10 Desc.	Clean water crossing outlet in acceptable condition

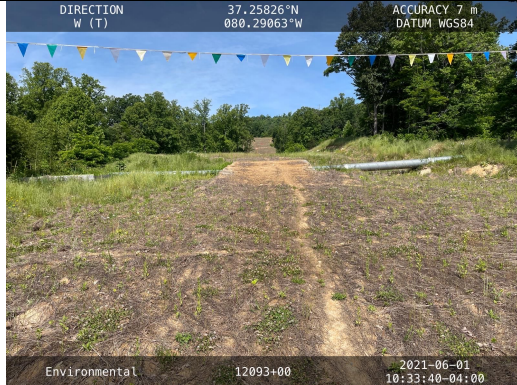
GPS Location	See photo		GPS Location	See photo	
Field Station#	12093+00		Field Station#	12098+44	
Pic 11 Desc.	Stabilized ROW with clean water crossing pipe in acceptable condition		Pic 12 Desc.	Bridge and ECDs at stream crossing S-MM13 in acceptable condition

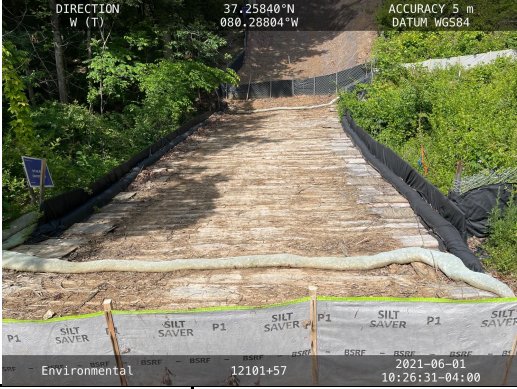
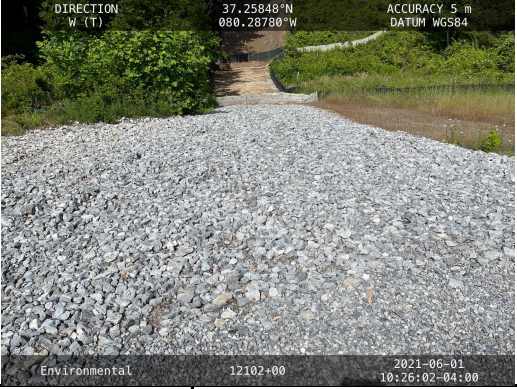
GPS Location	See photo		GPS Location	see photo	
Field Station#	12101+57		Field Station#	12102+00	
Pic 13 Desc.	Bridge and ECDs at stream crossing S-MM11 in acceptable condition		Pic 14 Desc.	RCE on the COS of access road MVP-MN-270.01

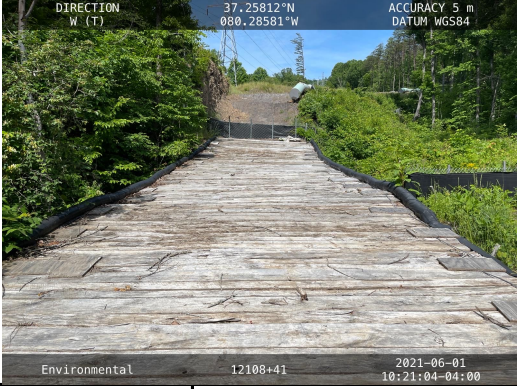
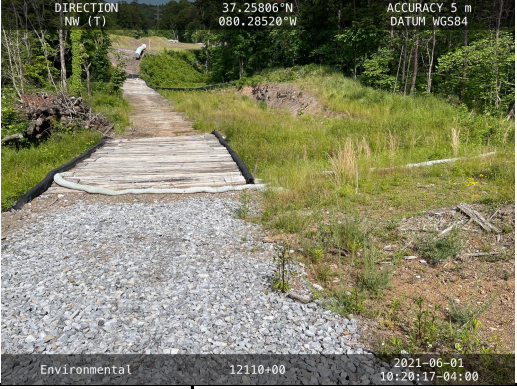
GPS Location	see photo		GPS Location	See photo	
Field Station#	12108+41		Field Station#	12110+00	
Pic 15 Desc.	Bridge and ECDs crossing S-F15 in acceptable condition		Pic 16 Desc.	Clean water crossing in acceptable condition

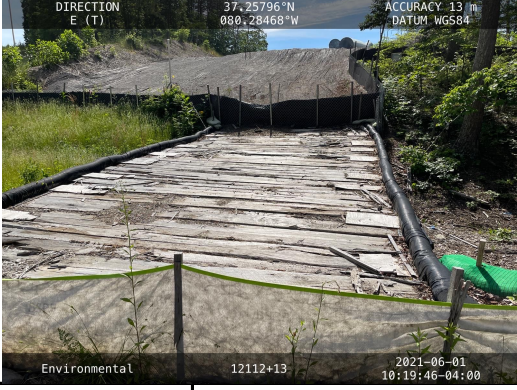
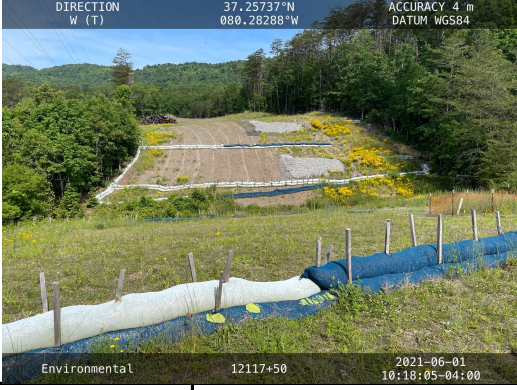
GPS Location	See photo		GPS Location	See photo	
Field Station#	12112+13		Field Station#	12117+50	
Pic 17 Desc.	Bridge and ECDs at stream crossing S-F16A/B in acceptable condition		Pic 18 Desc.	Stabilized ROW in acceptable condition

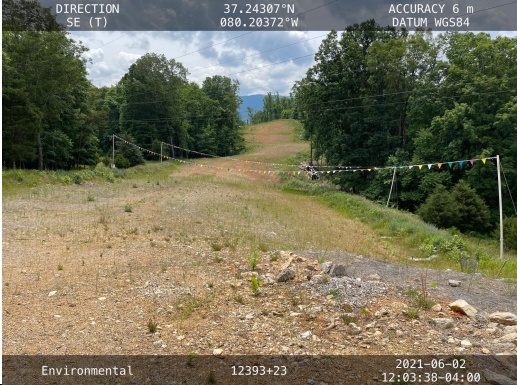
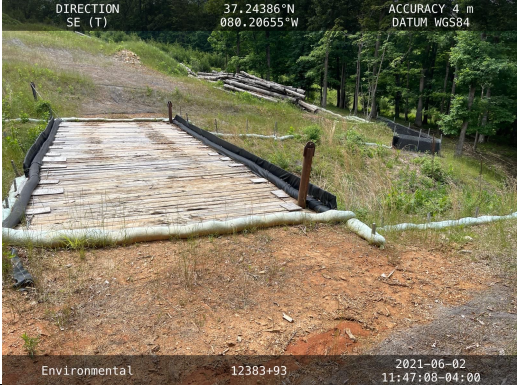
GPS Location	See photo		GPS Location	See photo	
Field Station#	12393+23		Field Station#	12383+93	
Pic 7 Desc.	Stabilized ROW in acceptable condition		Pic 8 Desc.	Clean water crossing crossing in acceptable condition

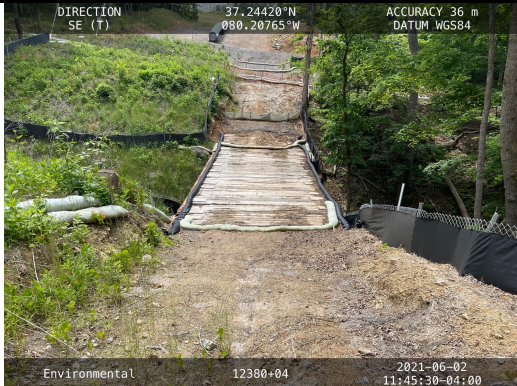
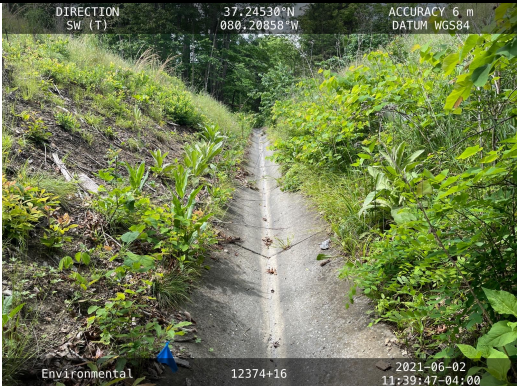
GPS Location	see photo		GPS Location	see photo	
Field Station#	12380+04		Field Station#	12374+16	
Pic 9 Desc.	Bridge and ECDs crossing S-NN19 in acceptable condition		Pic 10 Desc.	Stream crossing S-OO16 in acceptable condition

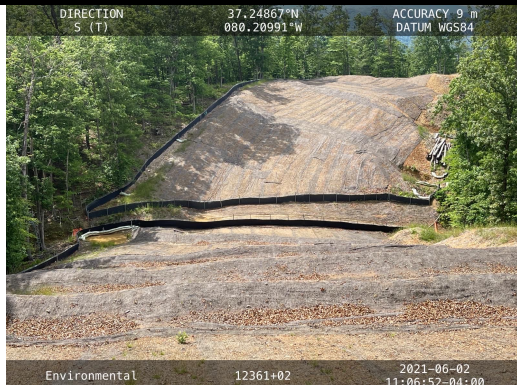
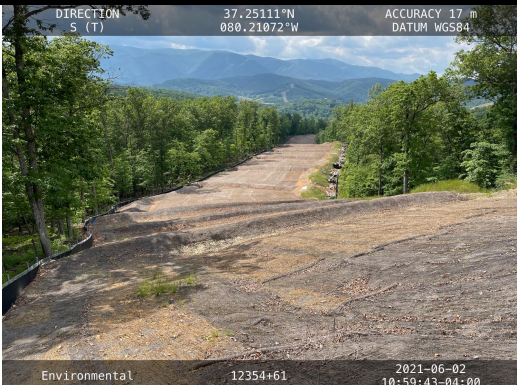
GPS Location	See photo		GPS Location	See photo	
Field Station#	12361+02		Field Station#	12354+61	
Pic 11 Desc.	Stabilized ROW in acceptable condition		Pic 12 Desc.	Stabilized ROW in acceptable condition

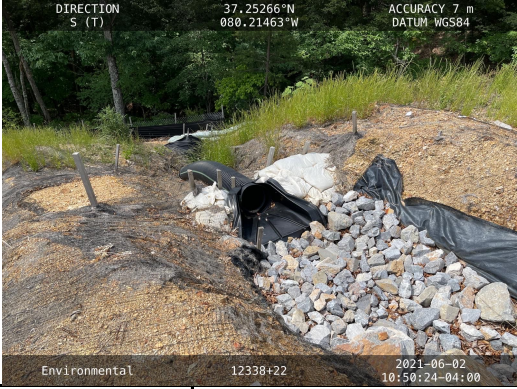
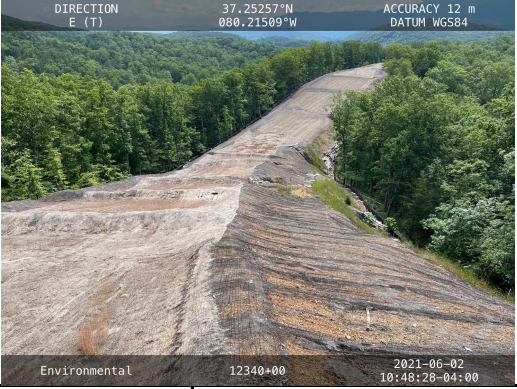
GPS Location	See photo		GPS Location	See photo	
Field Station#	12338+22		Field Station#	12340+00	
Pic 13 Desc.	Fill slope drain in acceptable condition		Pic 14 Desc.	Stabilized ROW in acceptable condition with fill slope drains

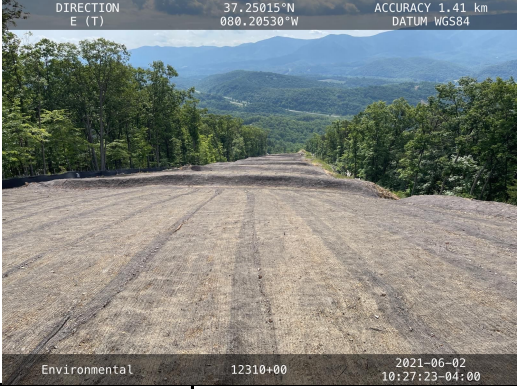
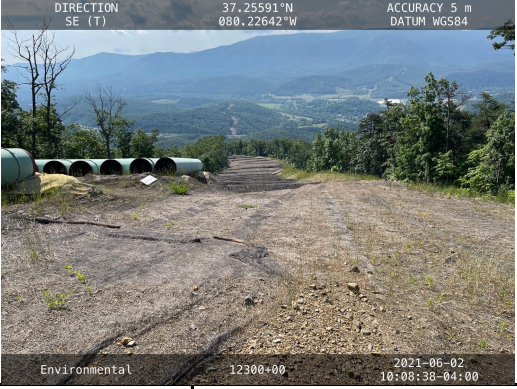
GPS Location	see photo		GPS Location	See photo	
Field Station#	12310+00		Field Station#	12300+00	
Pic 15 Desc.	Stabilized ROW in acceptable condition		Pic 16 Desc.	Stabilized ROW in acceptable condition

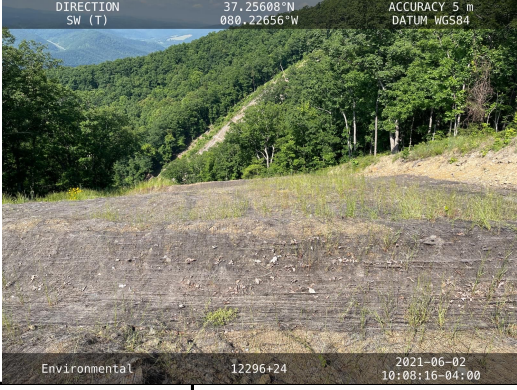
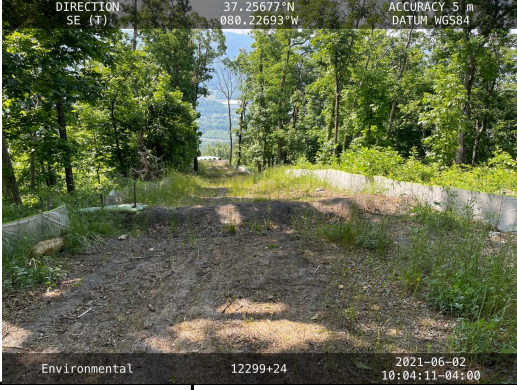
GPS Location	See photo		GPS Location	See photo	
Field Station#	12296+24		Field Station#	12299+24	
Pic 17 Desc.	Stabilized slope in acceptable condition		Pic 18 Desc.	Access Road MVP-amN-276.03 stabilized and in acceptable condition

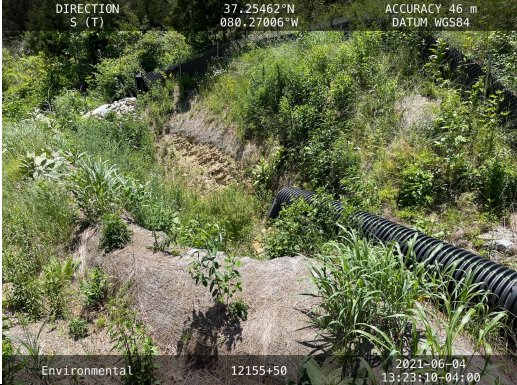
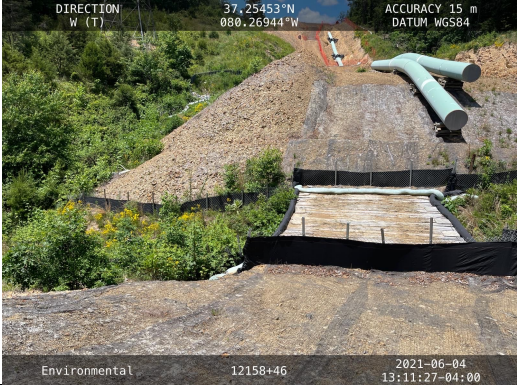
GPS Location	See photo		GPS Location	See photo	
Field Station#	12155+50		Field Station#	12158+46	
Pic 7 Desc.	End sump drains outlet in acceptable condition		Pic 8 Desc.	Clean water crossing in acceptable condition

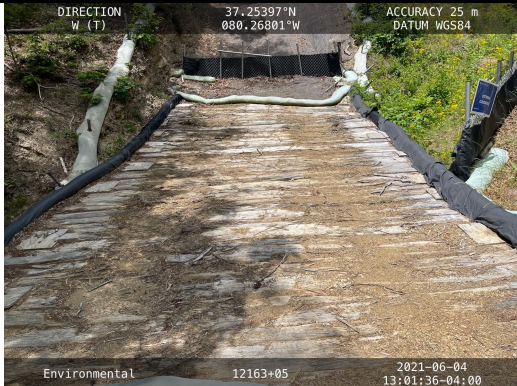
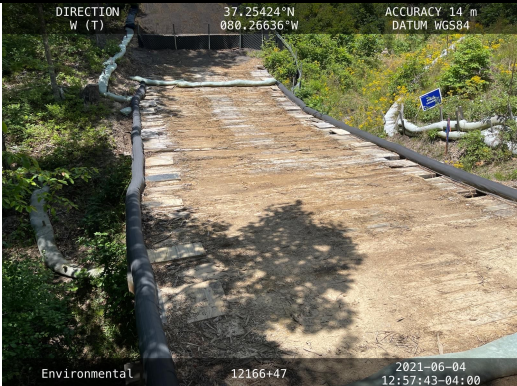
GPS Location	See photo		GPS Location	See photo	
Field Station#	12163+05		Field Station#	12166+47	
Pic 9 Desc.	Bridge and ECDs at stream crossing S-C25 in acceptable condition		Pic 10 Desc.	Bridge and ECDs crossing stream S-C24 in acceptable condition

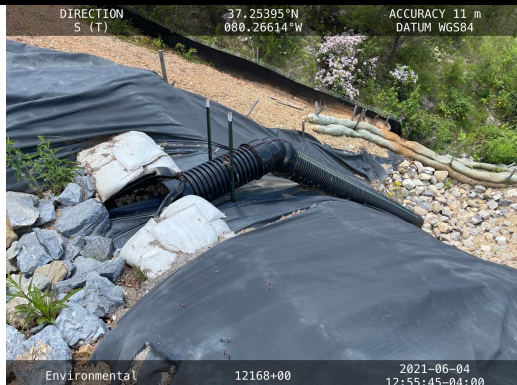
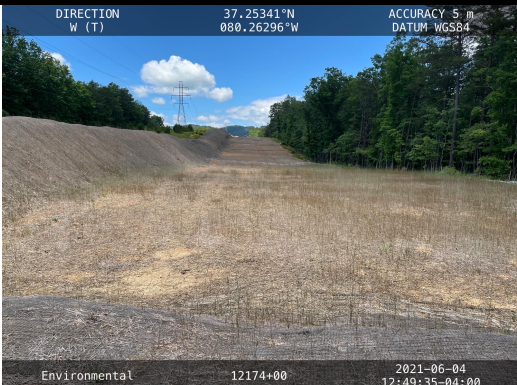
GPS Location	See photo		GPS Location	See photo	
Field Station#	12168+00		Field Station#	12174+00	
Pic 11 Desc.	Fill slope drain in acceptable condition		Pic 12 Desc.	Stabilized ROW in acceptable condition
