Visual Site Inspection Report

Project Name	H-600 Pipeline Spread H	AFE	124300138	Spread	H-600 Pipeline Spread H
Contractor	Precision			Report #	24204
Inspector	Stephen Fisher			Date/Time	6/7/2021 1:22 PM
Permit #	TBD	Inspection Type	VA SWPP	Station Begin	13316+21
State	VA	Inspection Area	Partial	Station End	13422+00
County	Franklin	Ground	Damp	Temperature (°F)	74.00
Municipality	N/A	Weather	Cloudy	Rain Gauge (in)	0.10
				Rain Accumulation Time (days)	1.00

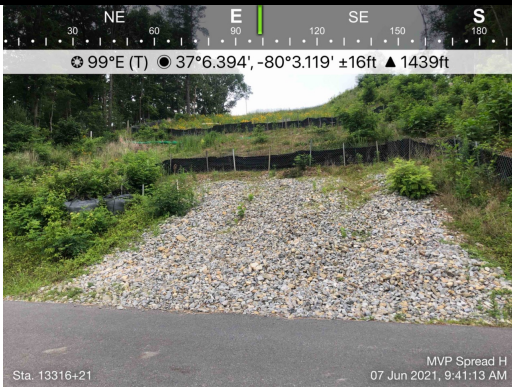
GPS Location	See Picture Watermark				
Field Station#	13316+21				
Pic 1 Desc.	RCE on GAS Wades Gap Rd. is in good condition, and no maintenance needed.

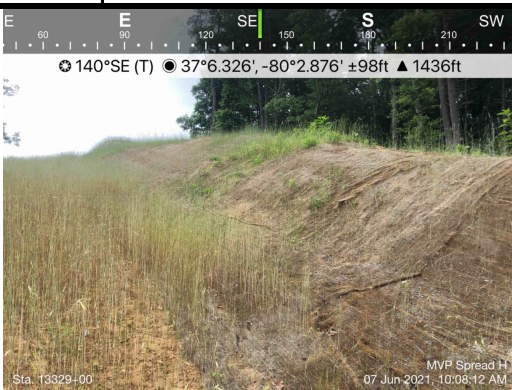
GPS Location	See Picture Watermark				
Field Station#	13329+00				
Pic 3 Desc.	Soil stockpiles remain stabilized and in good condition. No maintenance needed.

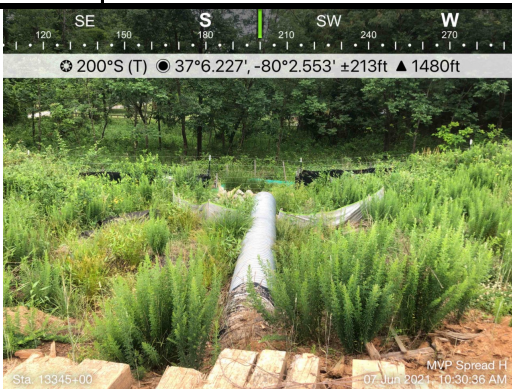
GPS Location	See Picture Watermark				
Field Station#	13345+00				
Pic 5 Desc.	CWD pipe and plunge pool are in good condition. No maintenance needed.				
GPS Location	See Picture Watermark				
Field Station#	13359+00				
Pic 6 Desc.	Equipment bridge spanning S-RR11 is in good condition with no excess sediment/material observed.

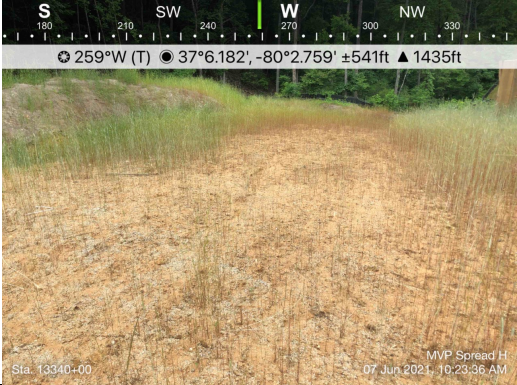
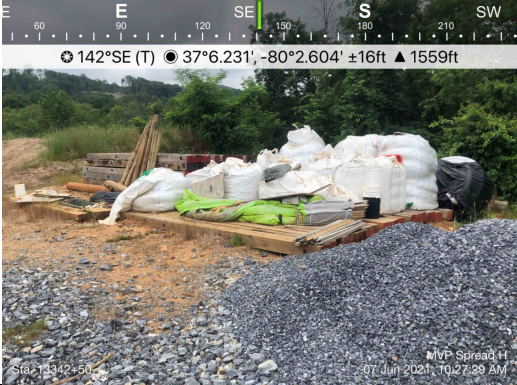
GPS Location	See Picture Watermark		GPS Location	See Picture Watermark	
Field Station#	13340+00		Field Station#	13342+50	
Pic 7 Desc.	Temporary stabilization in place. Recommend applying additional seed & stabilization to this area.		Pic 8 Desc.	E&S controls/material staged on site for misc. repairs.

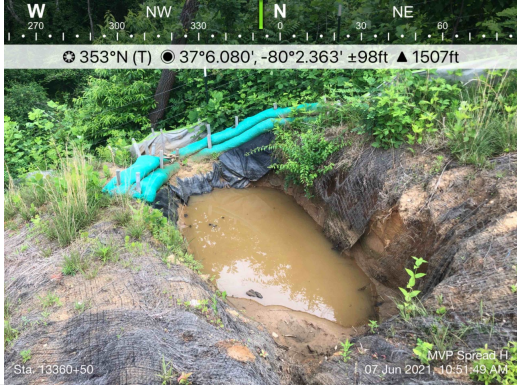
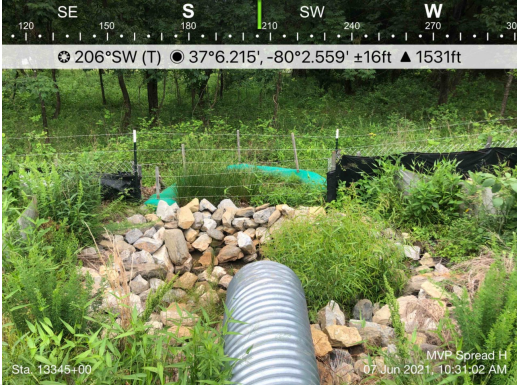
GPS Location	See Picture Watermark		GPS Location	See Picture Watermark	
Field Station#	13360+50		Field Station#	13345+00	
Pic 9 Desc.	Sump pit and waterbar end treatment are in good condition. No maintenance needed.		Pic 10 Desc.	CWD plunge pool installed and functional.

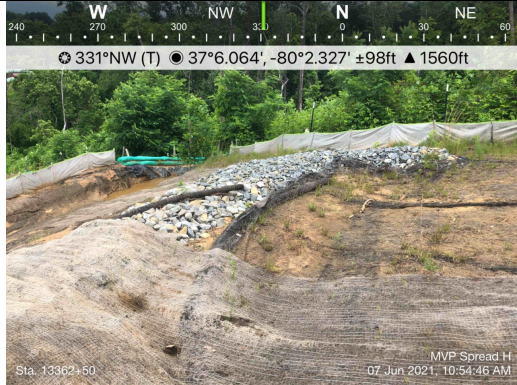
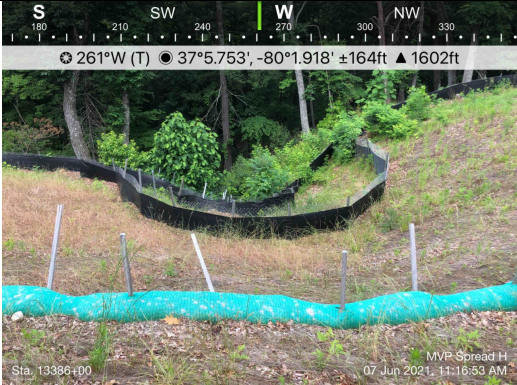
GPS Location	See Picture Watermark		GPS Location	See Picture Watermark	
Field Station#	13362+50		Field Station#	13386+00	
Pic 11 Desc.	Permanent waterbar and rock level spreader are in good condition. No maintenance needed.		Pic 12 Desc.	CFS & SSF are installed and in good condition. No maintenance needed.

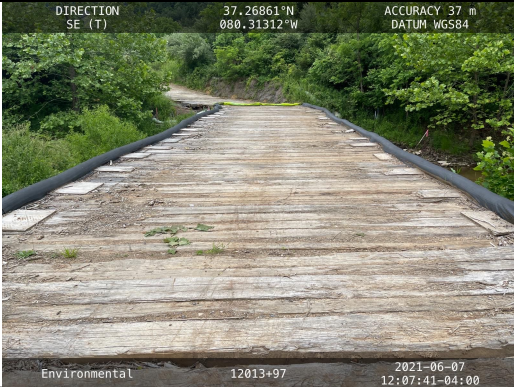
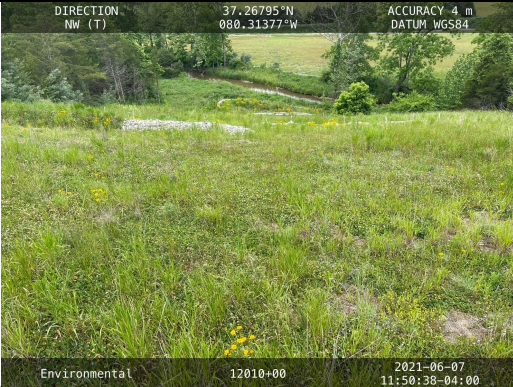
Pic 3 Desc.	Bridge and ECDs crossing stream S-G36 and n acceptable condition		Pic 4 Desc.	Stabilized slope in acceptable condition

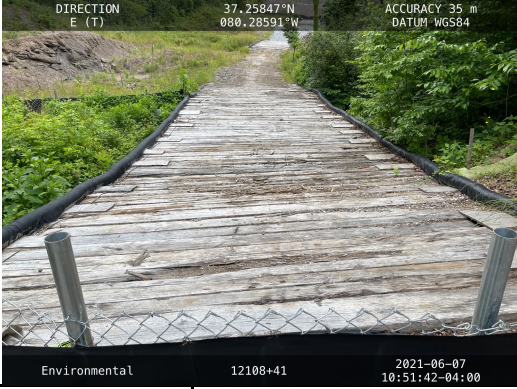
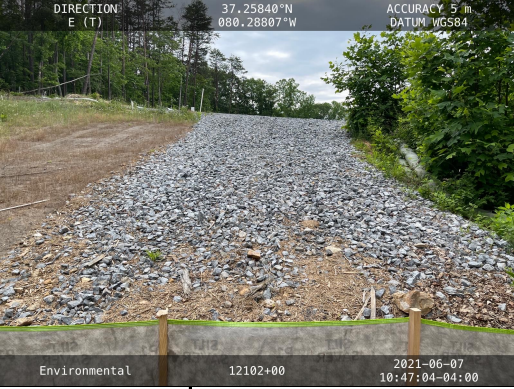
GPS Location	see photo		GPS Location	See photo	
Field Station#	12108+41		Field Station#	12102+00	
Pic 7 Desc.	Bridge and ECDs crossing S-F15		Pic 8 Desc.	RCE on the CIS of half acre rock in acceptable condition

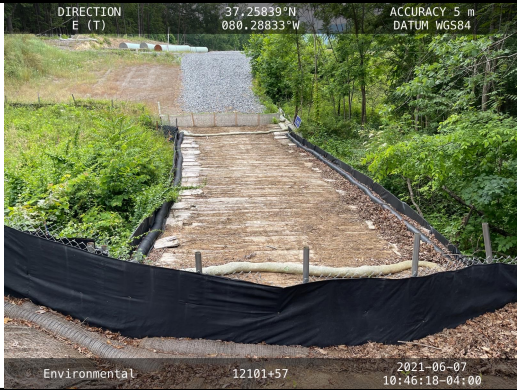
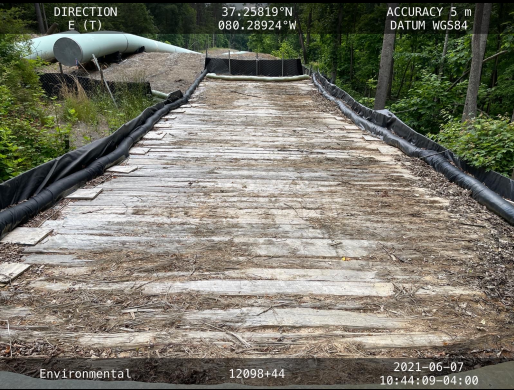
GPS Location	See photo		GPS Location	See photo	
Field Station#	12101+57		Field Station#	12098+44	
Pic 9 Desc.	Bridge and ECDs crossing stream S-MM11		Pic 10 Desc.	Bridge and ECDs crossing S-MM13

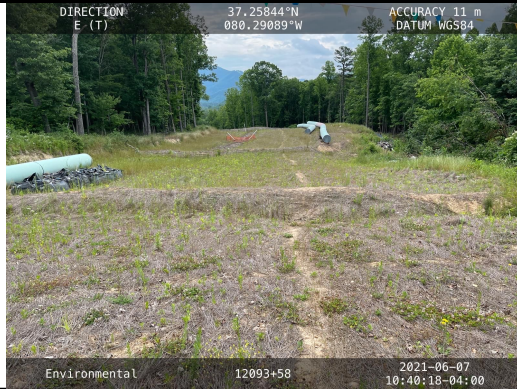
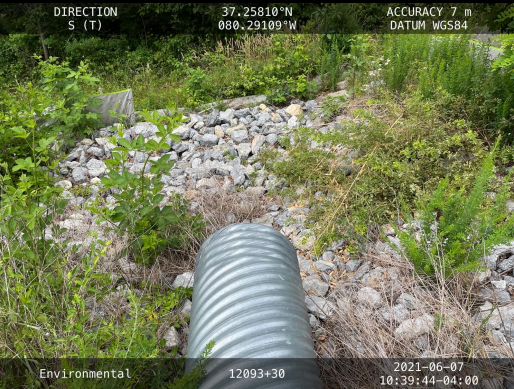
GPS Location	See photo		GPS Location	see photo	
Field Station#	12093+58		Field Station#	12093+30	
Pic 11 Desc.	Stabilized ROW in acceptable condition		Pic 12 Desc.	Clean water crossing pipe outlet in acceptable condition

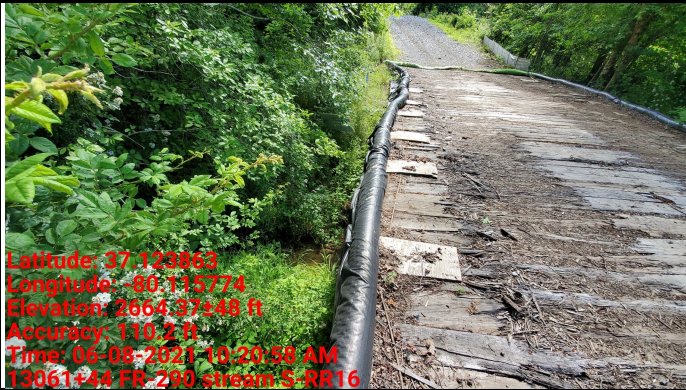
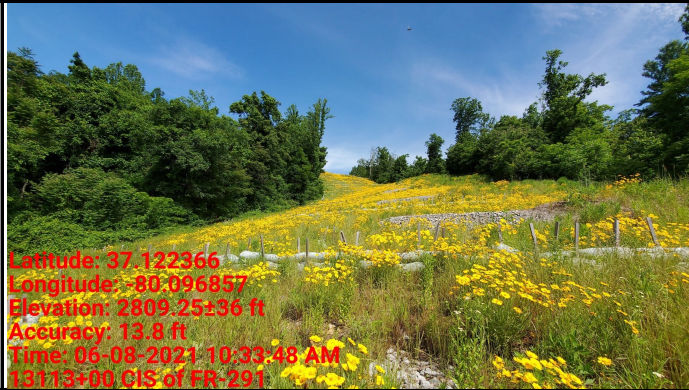
Pic 9 Desc.	Downstream side of stream S-RR16		Pic 10 Desc.	Current ROW conditions on the CIS of FR-291.

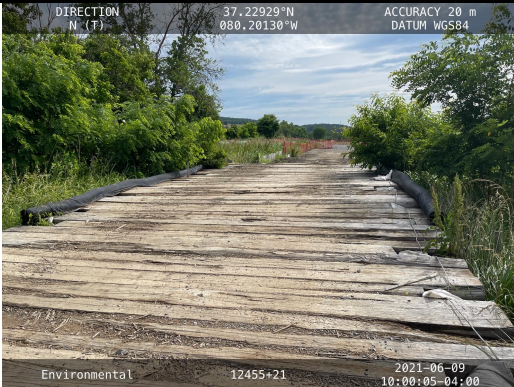
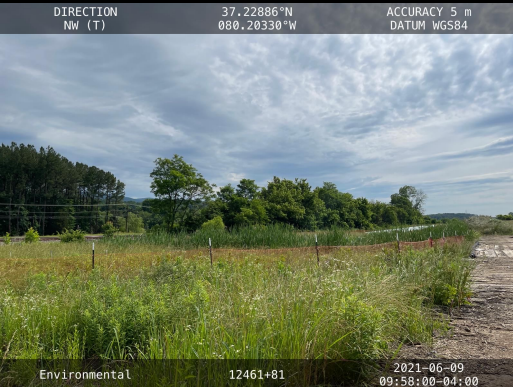
GPS Location	See photo		GPS Location	See photo	
Field Station#	12455+21		Field Station#	12461+81	
Pic 1 Desc.	Bridge and ECDs crossing stream S-CD12b in acceptable condition		Pic 2 Desc.	Wetland crossing W-KL58 in acceptable condition

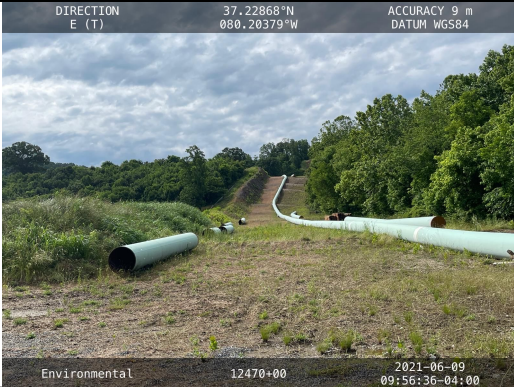
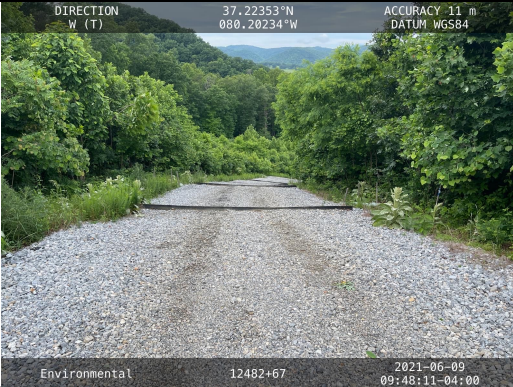
GPS Location	see photo		GPS Location	See photo	
Field Station#	12470+00		Field Station#	12482+67	
Pic 3 Desc.	Stabilized ROW in acceptable condition		Pic 4 Desc.	Water deflectors across access Road MVP-MLV-AR-28 in acceptable condition

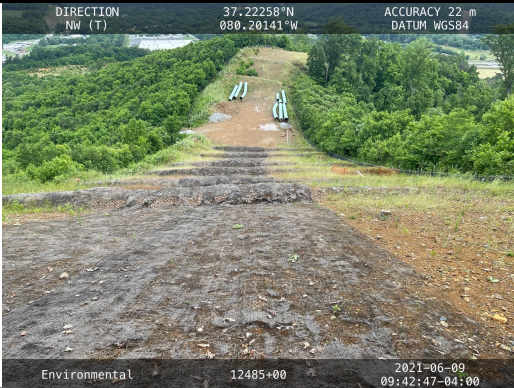
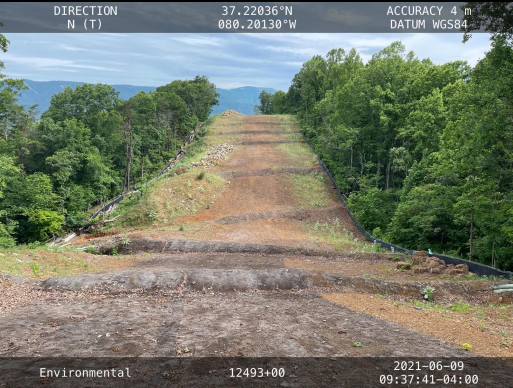
GPS Location	see photo		GPS Location	See photo	
Field Station#	12485+00		Field Station#	12493+00	
Pic 5 Desc.	Stabilized slope in acceptable condition		Pic 6 Desc.	Stabilized ROW in acceptable condition

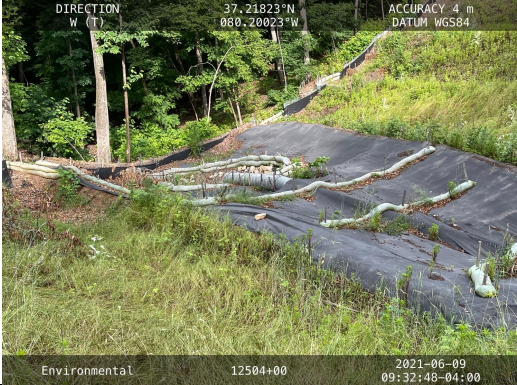
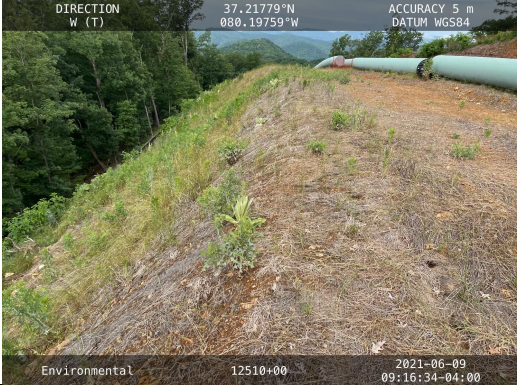
GPS Location	See photo		GPS Location	See photo	
Field Station#	12504+00		Field Station#	12510+00	
Pic 7 Desc.	Clean water crossing pipe outlet in acceptable condition		Pic 8 Desc.	Stabilized ROW in acceptable condition

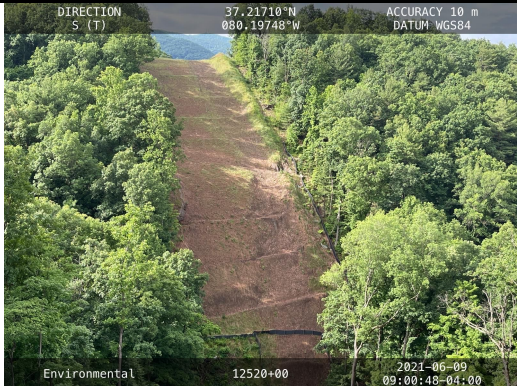
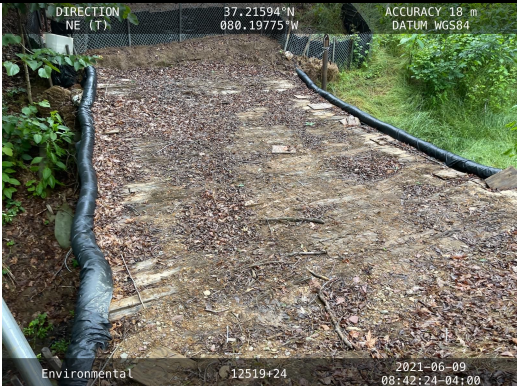
GPS Location	See photo		GPS Location	See photo	
Field Station#	12520+00		Field Station#	12519+24	
Pic 9 Desc.	Stabilized slope on GAS of stream S-EF19		Pic 10 Desc.	Bridge and ECDs crossing stream S-EF19

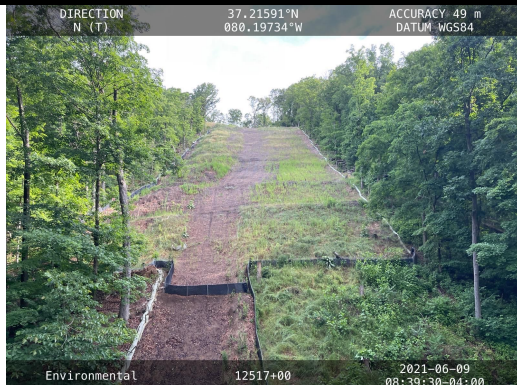
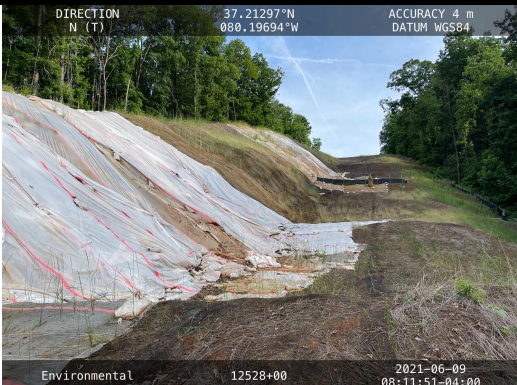
GPS Location	see photo		GPS Location	See photo	
Field Station#	12517+00		Field Station#	12528+00	
Pic 11 Desc.	Stabilized slope on the CIS of S-EF19 in acceptable condition		Pic 12 Desc.	Plastic covered spoil pile in acceptable condition

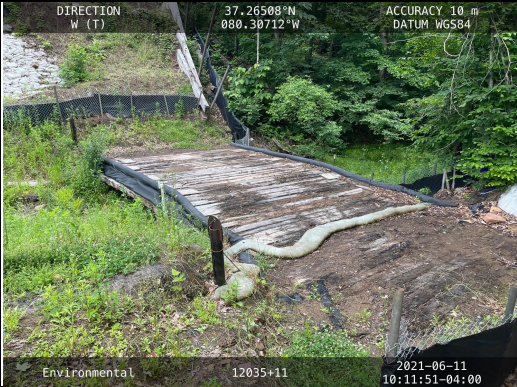
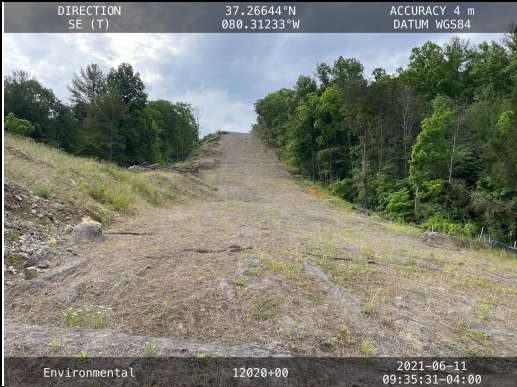
GPS Location	See photo		GPS Location	See photo	
Field Station#	12035+11		Field Station#	12020+00	
Pic 13 Desc.	Bridge and ECDs crossing S-G40 in acceptable condition		Pic 14 Desc.	Stabilized ROW in acceptable condition

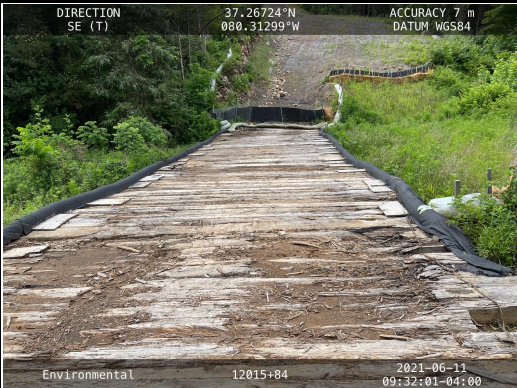
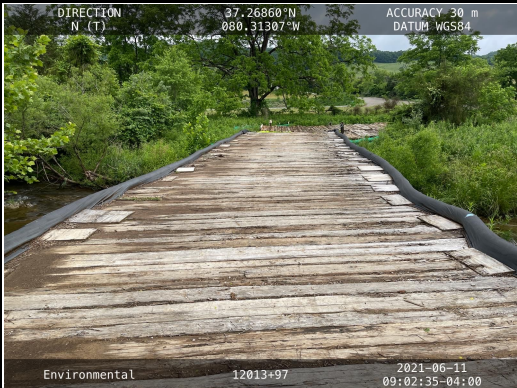
GPS Location	See photo		GPS Location	See photo	
Field Station#	12015+85		Field Station#	12013+97	
Pic 15 Desc.	Bridge and ECDs crossing S-G38 in acceptable condition		Pic 16 Desc.	Bridge and ECDs crossing stream S-G36 along access road MVP-MN-268.01

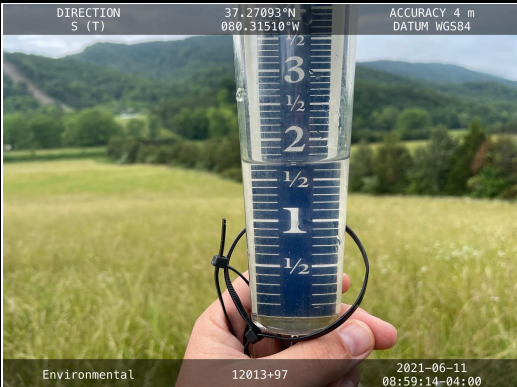
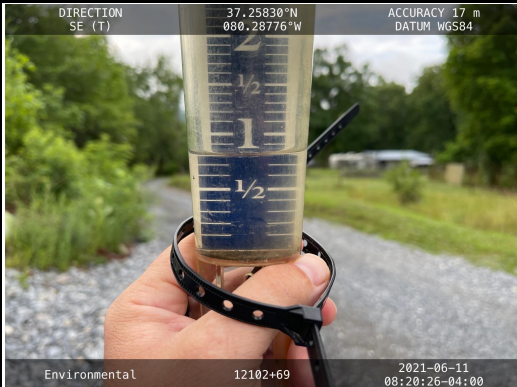
GPS Location	see photo		GPS Location	See photo	
Field Station#	12013+97		Field Station#	12102+69	
Pic 17 Desc.	Rain gauge totals for Catawba 1.7"		Pic 18 Desc.	Rain gauge totals for Half Acre of Rock .8"
