Visual Site Inspection Report

Project Name	H-600 Pipeline Spread I	AFE	124300139	Spread	H-600 Pipeline Spread I	
Contractor	Precision			Report #	22174	
Inspector	Glenn Mike Renfro			Date/Time	4/12/2021 9:18 AM	
Permit #	TBD	Inspection Type	VA SWPP	Station Begin	0000+00	
State	VA	Inspection Area	Full	Station End	0000+00	
County	Franklin	Ground	Damp	Temperature (°F)	60.00	
Municipality	N/A	Weather	Cloudy	Rain Gauge (in)	0.70	
				Rain Accumulation Time (days)	6.00

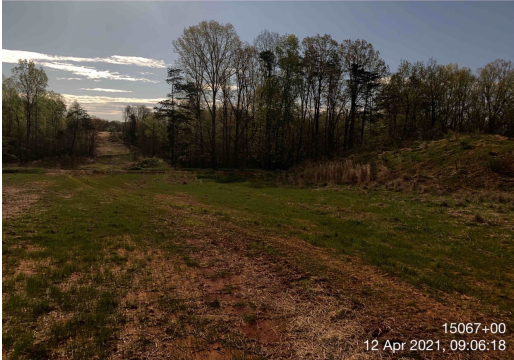
GPS Location	0		GPS Location	0	
Field Station#	15067+00		Field Station#	15073+00	
Pic 1 Desc.	Temporary vegetative stabilization in acceptable condition		Pic 2 Desc.	P1 silt fence in acceptable condition

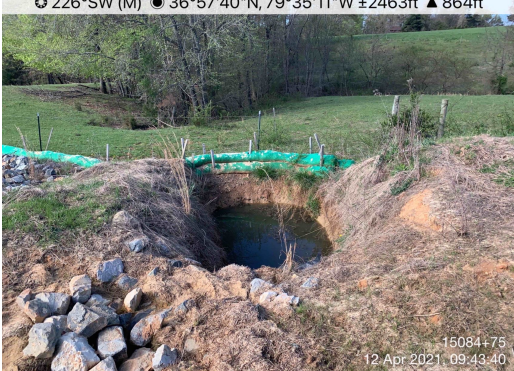
GPS Location	0		GPS Location	0	
Field Station#	15084+75		Field Station#	15090+00	
Pic 3 Desc.	Sump pit in acceptable condition		Pic 4 Desc.	Perimeter CFS in acceptable condition

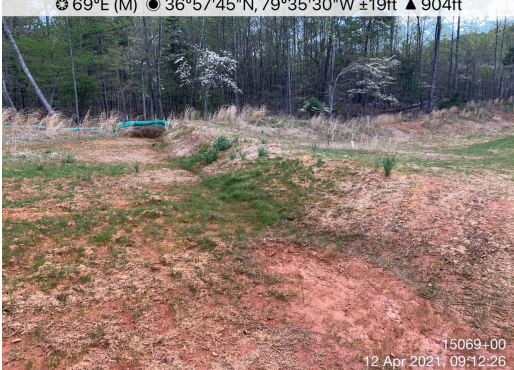
GPS Location	0		GPS Location	0	
Field Station#	15069+00		Field Station#	15102+00	
Pic 5 Desc.	Waterbar in acceptable condition		Pic 6 Desc.	Permanent vegetative stabilization in acceptable condition

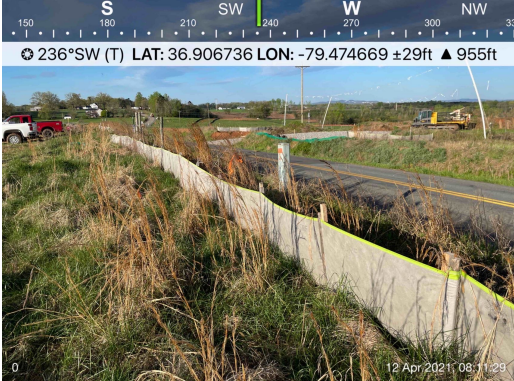
GPS Location	See photo		GPS Location	See photo	
Field Station#	15497+00		Field Station#	15497+50	
Pic 1 Desc.	P1 is degraded and needs to be replaced.		Pic 2 Desc.	CFS is degraded/damaged and needs to be replaced.

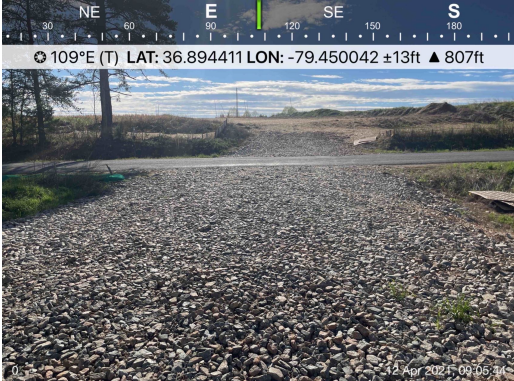
GPS Location	See photo		GPS Location	See photo	
Field Station#	15584+23		Field Station#	15580+00	
Pic 3 Desc.	RCEs are in good condition at all road crossings.		Pic 4 Desc.	Vegetation continues to fill in ROW.

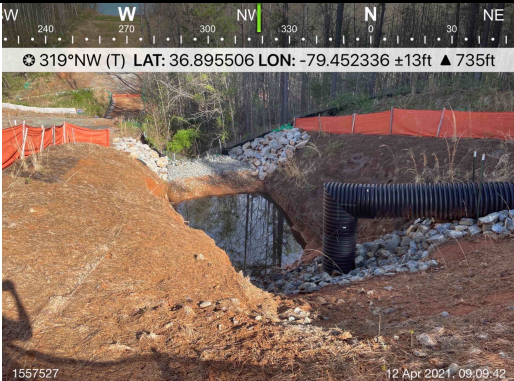
GPS Location	See photo		GPS Location	See photo	
Field Station#	15575+27		Field Station#	15572+87	
Pic 5 Desc.	Slope drain is in good condition and functioning.		Pic 6 Desc.	P1 is in good condition at all stream and wetland buffers.

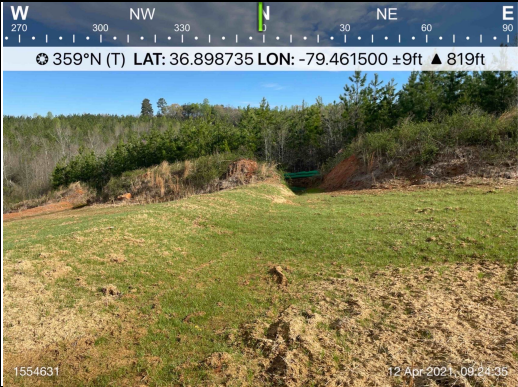
GPS Location	See photo		GPS Location	See photo	
Field Station#	15546+31		Field Station#	15540+39	
Pic 7 Desc.	Waterbars are in good condition throughout this section.		Pic 8 Desc.	Equipment bridge ECDs are inplace and functioning.

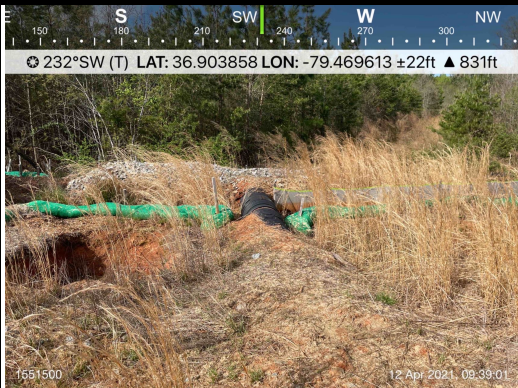
GPS Location	See photo		GPS Location	See photo	
Field Station#	15515+00		Field Station#	15506+41	
Pic 9 Desc.	CWDs are functioning as intended.		Pic 10 Desc.	Vegetation continues to fill in ROW.

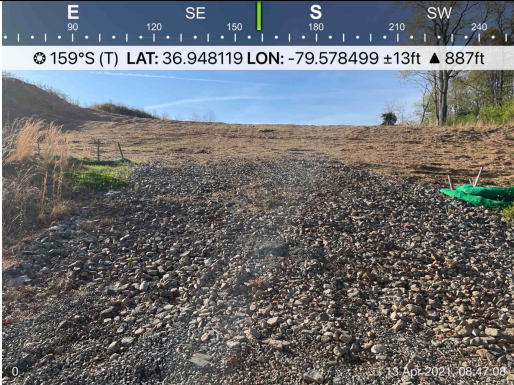
GPS Location	See photo		GPS Location	See photo	
Field Station#	15142+66		Field Station#	15143+50	
Pic 1 Desc.	RCE at Rockcreek Rd. is in good condition		Pic 2 Desc.	Road approach at Rockcreek Rd remains stabilized.

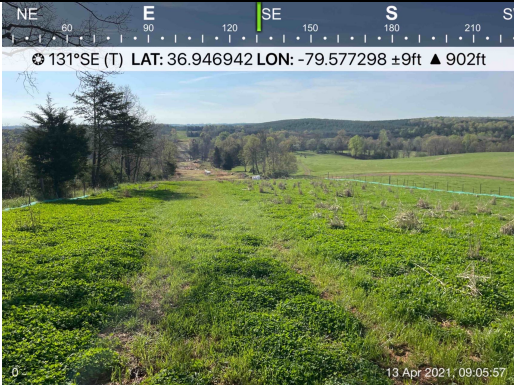
GPS Location	See photo		GPS Location	See photo	
Field Station#	15150+00		Field Station#	15165+57	
Pic 3 Desc.	Vegetation continues to fill in in this area.		Pic 4 Desc.	Diversion inlet remains in good condition.

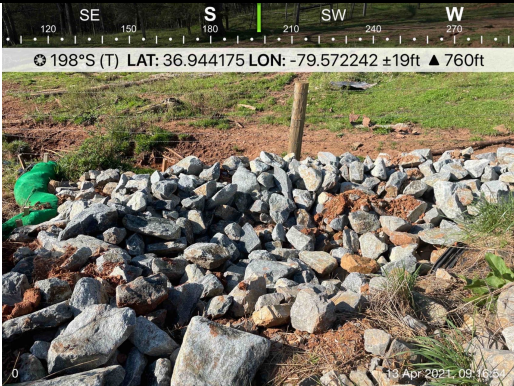
GPS Location	See photo		GPS Location	See photo	
Field Station#	15167+00		Field Station#	15167+95	
Pic 5 Desc.	Diversion outlet in good condition.		Pic 6 Desc.	Equipment bridge ECDs are in good condition.

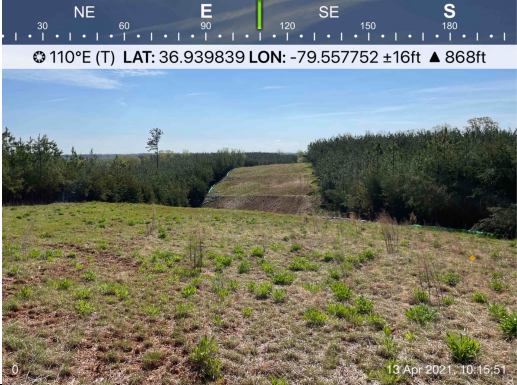
GPS Location	See photo	GPS Location			
Field Station#	15215+00	Field Station#			
Pic 13 Desc.	Vegetation continues to fill in in this area.	Pic 14 Desc.			
Insert image here		Insert image here			
GPS Location		GPS Location			
Field Station#		Field Station#			
Pic 15 Desc.		Pic 16 Desc.			
Insert image here		Insert image here			
GPS Location		GPS Location			
Field Station#		Field Station#			
Pic 17 Desc.		Pic 18 Desc.

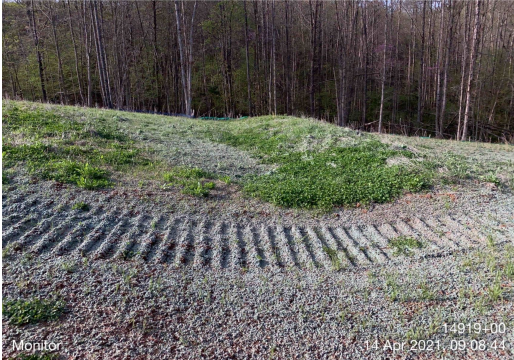
GPS Location	0	GPS Location	0		
Field Station#	14919+00	Field Station#	14861+00		
Pic 1 Desc.	Waterbar in acceptable condition	Pic 2 Desc.	Temporary vegetative stabilization in acceptable condition

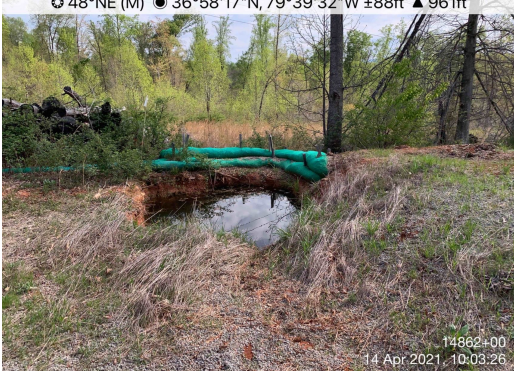
GPS Location	0	GPS Location	0		
Field Station#	14862+00	Field Station#	14889+00		
Pic 3 Desc.	Waterbar end treatment in acceptable condition	Pic 4 Desc.	Equipment bridge in acceptable condition

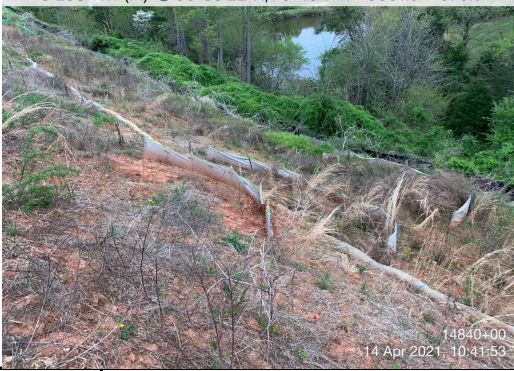
GPS Location	0	GPS Location	0		
Field Station#	14840+00	Field Station#	14810+00		
Pic 5 Desc.	P1 silt fence in acceptable condition	Pic 6 Desc.	Permanent vegetative stabilization in acceptable condition

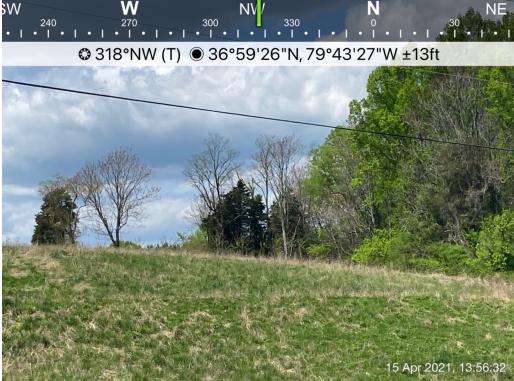
GPS Location	0	GPS Location	0		
Field Station#	14647+00	Field Station#	14568+10		
Pic 1 Desc.	Approximately 14647+00. Overview of ROW.	Pic 2 Desc.	Approximately 14568+10. Overview of stream crossing, equipment bridge and ECDs at stream S-E18.

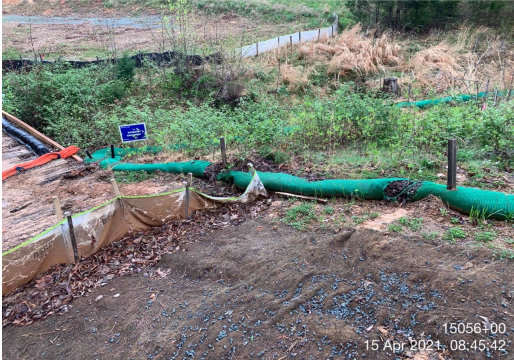
GPS Location	0	GPS Location	0		
Field Station#	15056+00	Field Station#	15050+00		
Pic 1 Desc.	P1 silt fence and CFS are damaged by livestock	Pic 2 Desc.	Temporary vegetative stabilization in acceptable condition

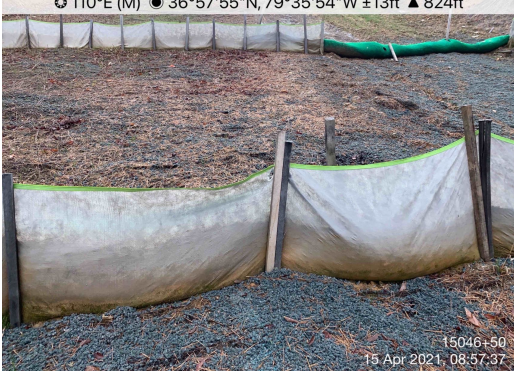
GPS Location	0	GPS Location	0		
Field Station#	15046+50	Field Station#	15021+85		
Pic 3 Desc.	P1 silt fence is torn at the top	Pic 4 Desc.	Waterbar in acceptable condition

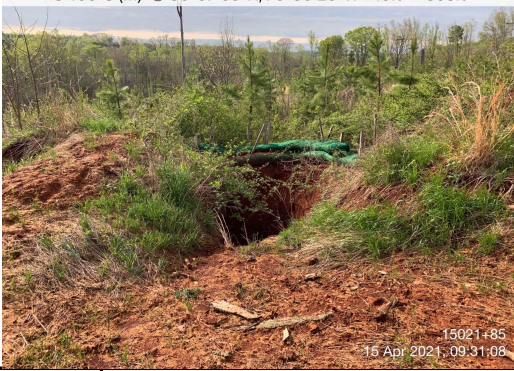
GPS Location	0	GPS Location	0		
Field Station#	15021+85	Field Station#	14992+00		
Pic 5 Desc.	Waterbar end treatment in acceptable condition	Pic 6 Desc.	Permanent vegetative stabilization in acceptable condition

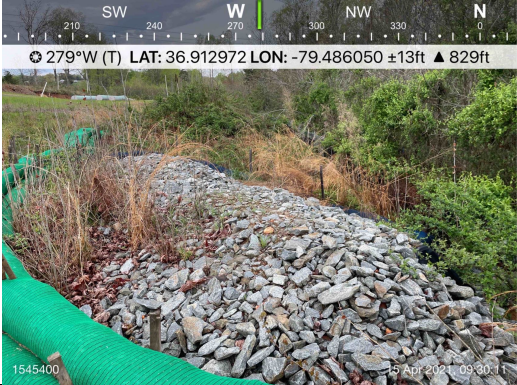
GPS Location	See photo		GPS Location	See photo	
Field Station#	15454+00		Field Station#	15457+00	
Pic 13 Desc.	CWD in good condition with no evidence of sedimentation.		Pic 14 Desc.	Drainage remains in good condition with no evidence of sedimentation.

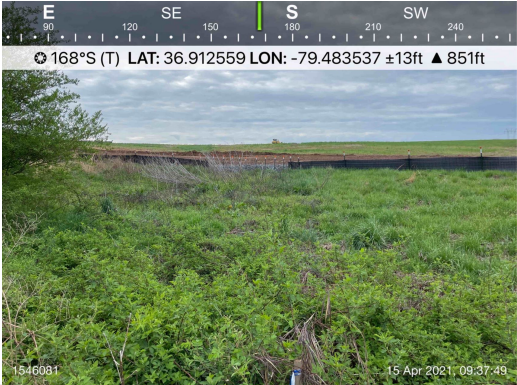
GPS Location	See photo		GPS Location	See photo	
Field Station#	15460+81		Field Station#	15460+81	
Pic 15 Desc.	CWD is free of sediment below this 3rd party rock outlet.		Pic 16 Desc.	CWD remains in good condition at this location.

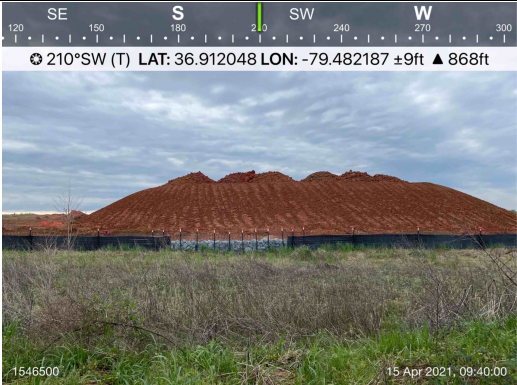
<div style="text-align: center; height: 150px;">Insert image here</div>			
GPS Location	See photo		GPS Location		
Field Station#	15465+00		Field Station#		
Pic 17 Desc.	No evidence of sediment discharge at this rock outlet location.		Pic 18 Desc.

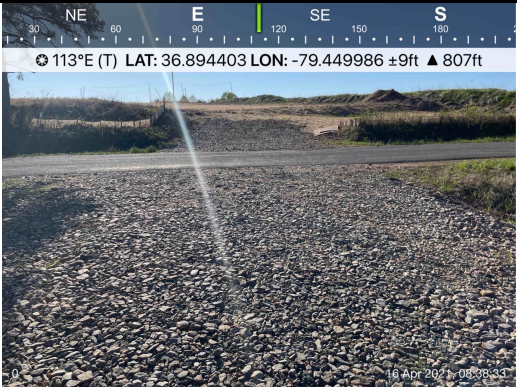
GPS Location	See photo		GPS Location	See photo	
Field Station#	15584+23		Field Station#	15580+00	
Pic 1 Desc.	RCEs are in good condition at all road crossings.		Pic 2 Desc.	Vegetation continues to fill in this section of ROW.

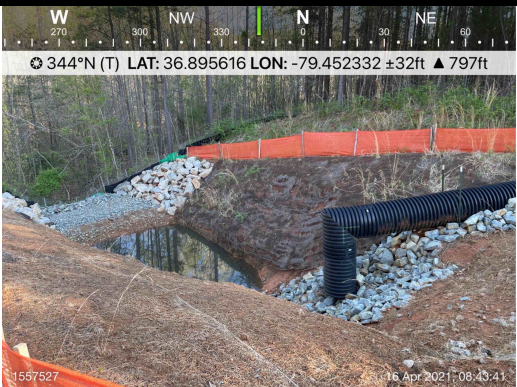
GPS Location	See photo		GPS Location	See photo	
Field Station#	15575+27		Field Station#	15563+57	
Pic 3 Desc.	Slope drain remains in good condition and functioning.		Pic 4 Desc.	CFS is in good condition throughout this section.

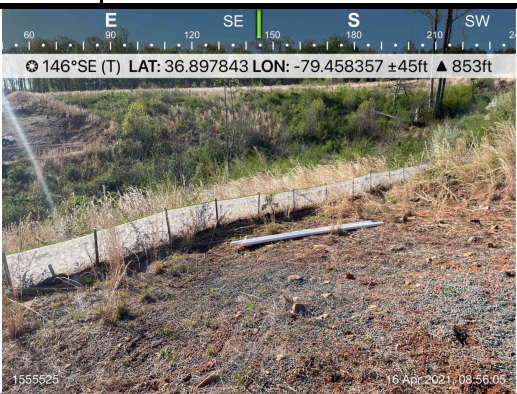
GPS Location	See photo		GPS Location	See photo	
Field Station#	15555+25		Field Station#	15551+00	
Pic 5 Desc.	P1 is in good condition at all stream and wetland buffers.		Pic 6 Desc.	Vegetation continues to fill in this section of ROW.

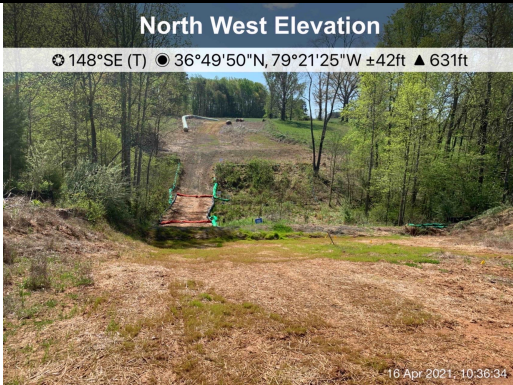
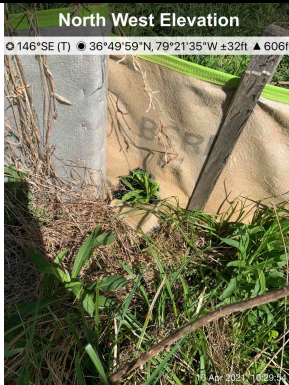
</div>			
GPS Location	O		GPS Location	O	
Field Station#	15977+35		Field Station#	15963+50	
Pic 1 Desc.	Observing temporary stabilization, water bar, erosion control blanket, signage, buffer, equipment crossing and ECD's		Pic 2 Desc.	Observing p1 that requires maintenance (Damaged by wildlife)	
<div>North East Elevation</div> <div>232°SW (T) 36°49'40"N, 79°20'58"W ±24540ft ▲ 641ft</div> <div>

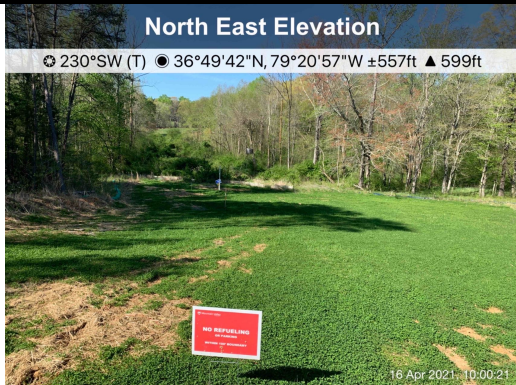
</div>			
GPS Location	O		GPS Location	O	
Field Station#	15963+50		Field Station#	16004+00	
Pic 3 Desc.	Observing p1 that requires maintenance (damaged by wildlife)		Pic 4 Desc.	Observing temporary stabilization, signage and buffer

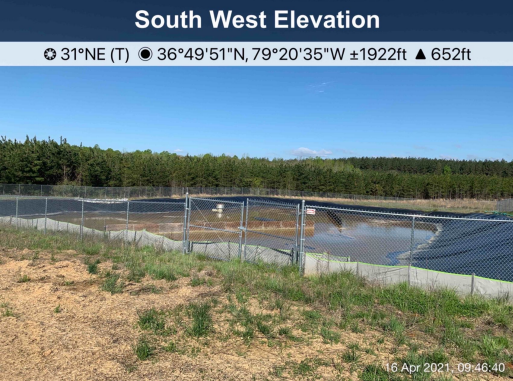
GPS Location	O	GPS Location	O		
Field Station#	00+00	Field Station#	00+00		
Pic 1 Desc.	Observing temporary stabilization and rock check dam		Pic 2 Desc.	Observing temporary stabilization, storm water pond and ECD's
