Visual Site Inspection Report

Project Name	H-600 Pipeline Spread I	AFE	124300139	Spread	H-600 Pipeline Spread I
Contractor	Precision			Report #	22416
Inspector	John White			Date/Time	4/19/2021 9:24 AM
Permit #	TBD	Inspection Type	VA SWPP	Station Begin	15584+23
State	VA	Inspection Area	Full	Station End	15647+03
County	Pittsylvania	Ground	Wet	Temperature (°F)	49.00
Municipality	Chatham	Weather	Light Rain	Rain Gauge (in)	0.70
				Rain Accumulation Time (days)	6.00

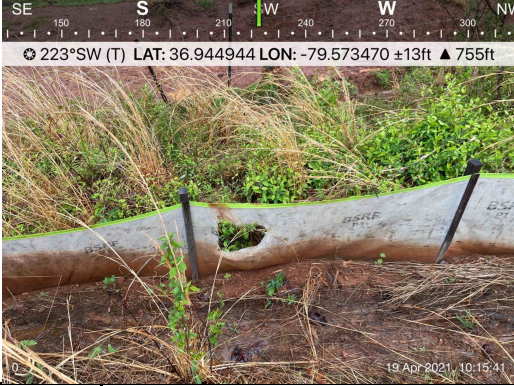
GPS Location	See photo	GPS Location	See photo		
Field Station#	15162+00	Field Station#	15370+62		
Pic 1 Desc.	P1 has been damaged by livestock and needs to be replaced.	Pic 2 Desc.	Rain gauge showing 15370+62

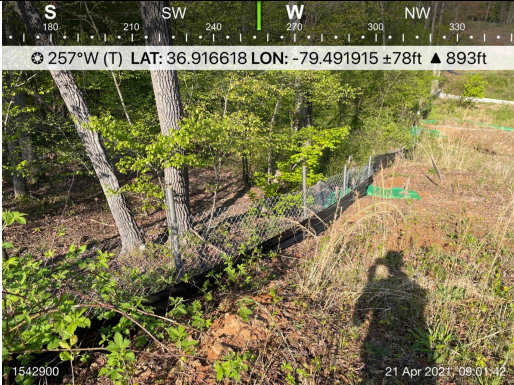
GPS Location	See photo		GPS Location	See photo	
Field Station#	15429+00		Field Station#	15429+00	
Pic 1 Desc.	SSF fabric needs to be reattached.		Pic 2 Desc.	Environmental crew has corrected this issue.

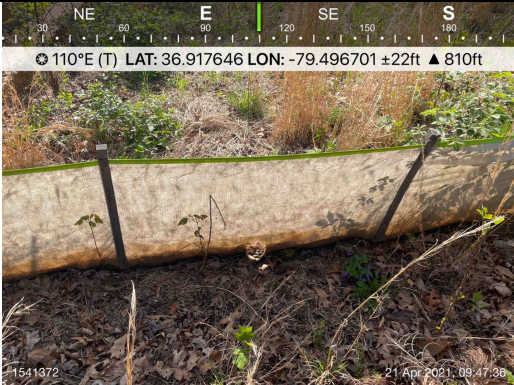
GPS Location	See photo		GPS Location	See photo	
Field Station#	15413+72		Field Station#	15413+72	
Pic 3 Desc.	P1 has been damaged and needs to be replaced.		Pic 4 Desc.	Environmental crew has corrected this issue.

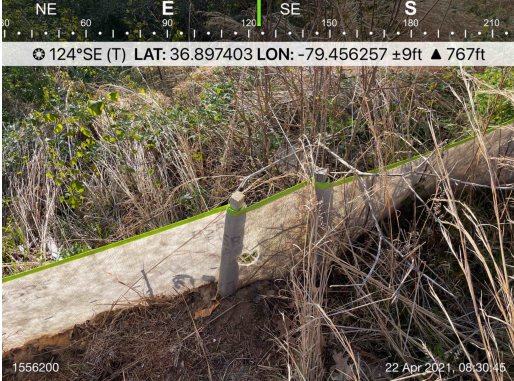
GPS Location	See photo		GPS Location	See photo	
Field Station#	15562+00		Field Station#	15562+00	
Pic 1 Desc.	P1 has been damaged/degraded and needs to be replaced.		Pic 2 Desc.	Environmental crew has corrected this issue

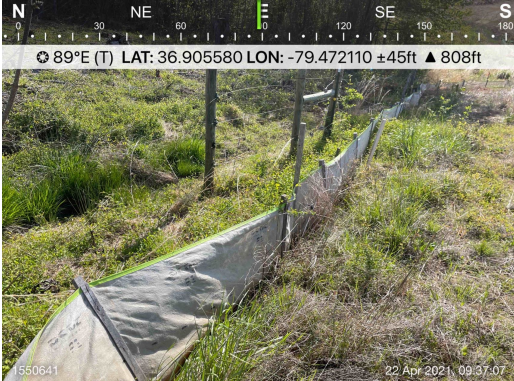
GPS Location	See photo		GPS Location	See photo	
Field Station#	15506+41		Field Station#	15506+41	
Pic 3 Desc.	P1 has been damaged/degraded and needs to be replaced.		Pic 4 Desc.	Environmental crew has corrected this issue.

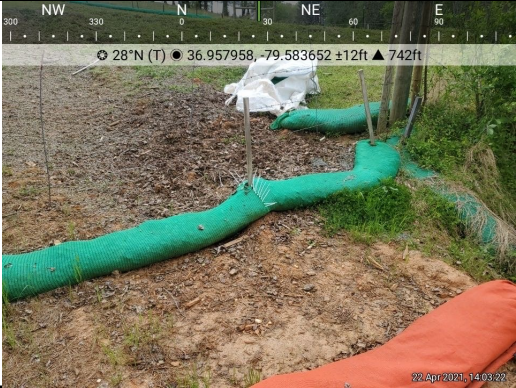
GPS Location	0	GPS Location	0		
Field Station#	15102+75	Field Station#	15111+00		
Pic 5 Desc.	CIS S-G8 CFS repaired	Pic 6 Desc.	Rock lined channel

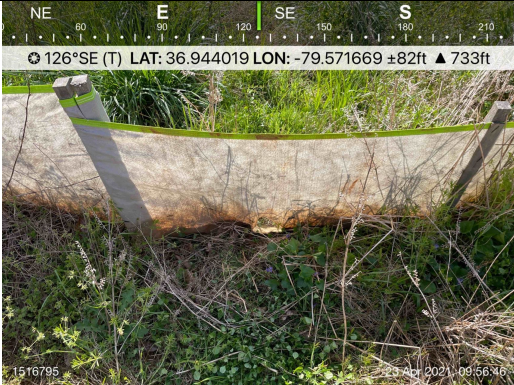
GPS Location	See photo		GPS Location	See photo	
Field Station#	15167+95		Field Station#	15195+00	
Pic 1 Desc.	P1 is degraded and needs to be replaced.		Pic 2 Desc.	CFS needs to be restaked along this drainage.

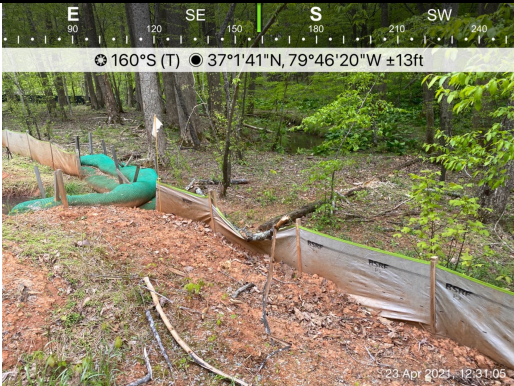
GPS Location	0	GPS Location	0		
Field Station#	14440+50	Field Station#	14451+00		
Pic 5 Desc.	Approximately 14440+50. P-1 requires maintenance. Damaged by broken limb. Crew repaired immediately.	Pic 6 Desc.	Approximately 14451+00. Overview of ROW.
