# Visual Site Inspection Report

<b>Project Name</b>	H-600 Pipeline Spread I	<b>AFE</b>	124300139	<b>Spread</b>	H-600 Pipeline Spread I
<b>Contractor</b>	Precision			<b>Report #</b>	22688
<b>Inspector</b>	Ben Davenport			<b>Date/Time</b>	4/26/2021 10:39 AM
<b>Permit #</b>	TBD	<b>Inspection Type</b>	VA SWPP	<b>Station Begin</b>	13958+31
<b>State</b>	VA	<b>Inspection Area</b>	Partial	<b>Station End</b>	14062+17
<b>County</b>	Franklin	<b>Ground</b>	Damp	<b>Temperature (°F)</b>	72.00
<b>Municipality</b>	N/A	<b>Weather</b>	Sunny	<b>Rain Gauge (in)</b>	0.00
				<b>Rain Accumulation Time (days)</b>	0.00

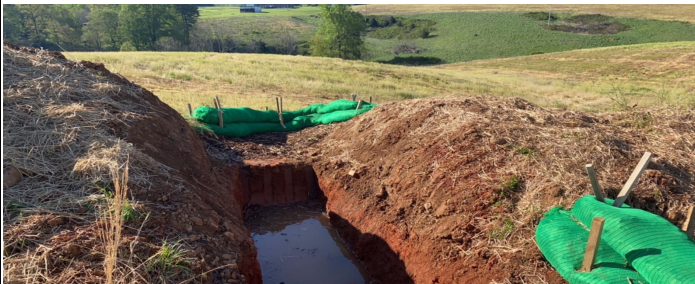
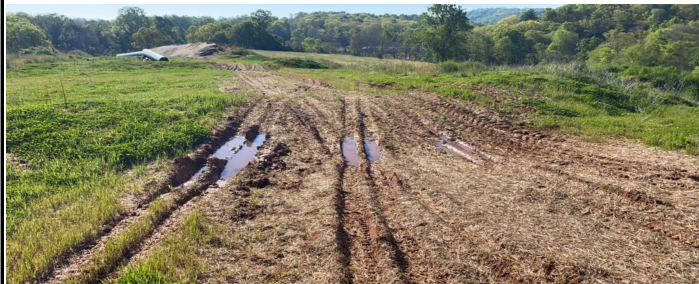
37°2'55" N 79°53'35" W 162°S COURSE 342° GPS Rocky Mount, VA 24151, United States 04.26.2021 09:04:15 Accur +/-34.0 Ft ALT 1102 Ft			37°37' N 79°53'19" W 142°SE COURSE 36° GPS Rocky Mount, VA 24151, United States 04.26.2021 09:12:01 Accur +/-54.6 Ft ALT 1142 Ft		
GPS Location	1	GPS Location	2		
Field Station#	13967+00	Field Station#	13979+00		
Pic 1 Desc.	Newly installed sump and CFS end treatment performing intended function.		Pic 2 Desc.	Minor rutting occurring on ROW where landowner took farm equipment across. Will monitor area.

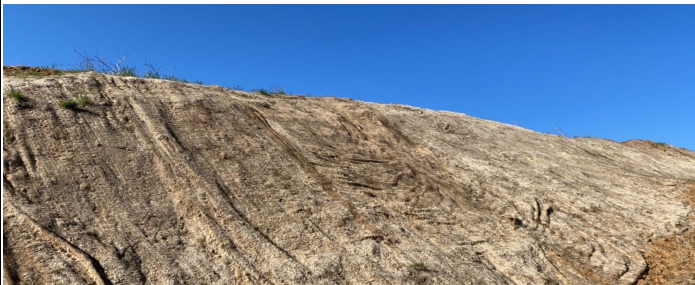
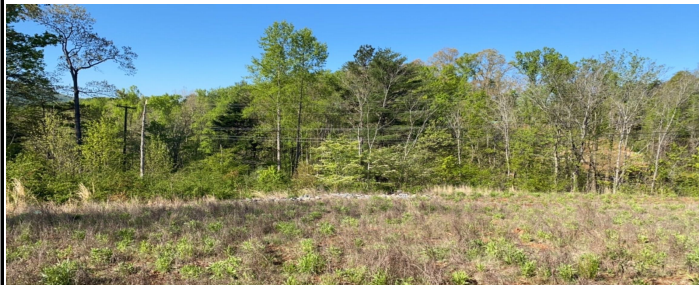
GPS Location	3	GPS Location	4		
Field Station#	13988+00	Field Station#	14014+00		
Pic 3 Desc.	Curlex on fill slope performing intended function.		Pic 4 Desc.	ROW in final cleanup area has some vegetation growing. Rock end treatment in good condition.

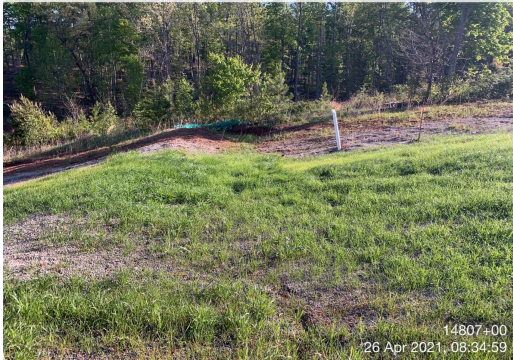
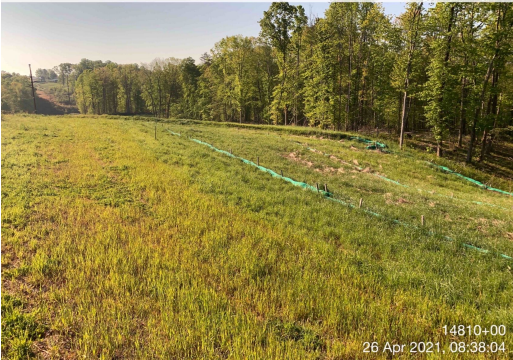
GPS Location	0		GPS Location	0	
Field Station#	14807+00		Field Station#	14810+00	
Pic 1 Desc.	Waterbar in acceptable condition		Pic 2 Desc.	Permanent vegetative stabilization in acceptable condition	
<div>15°N (M) 36°58'18"N, 79°39'37"W ±39ft ▲ 988ft</div>

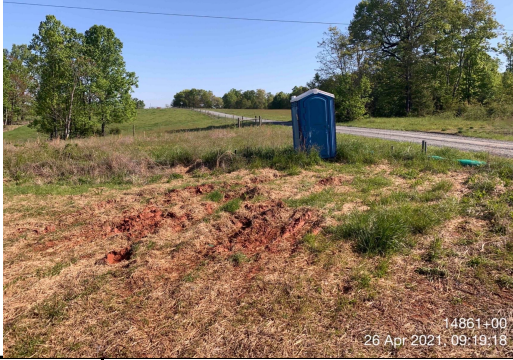
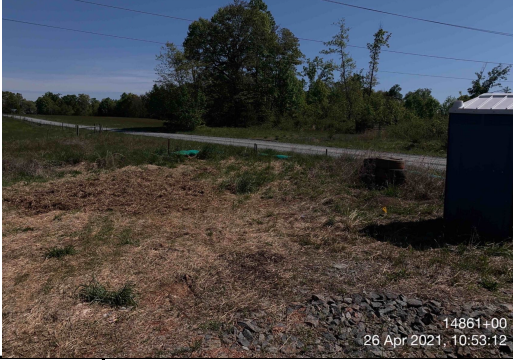
GPS Location	0		GPS Location	0	
Field Station#	14861+00		Field Station#	14861+00	
Pic 3 Desc.	ROW was rutted and stabilization was damaged by septic service truck. Item was addressed immediately.		Pic 4 Desc.	Rutted ROW and damaged stabilization was repaired immediately by contractor	
<div>142°SE (M) 36°57'55"N, 79°36'45"W ±16450ft ▲ 907ft</div>

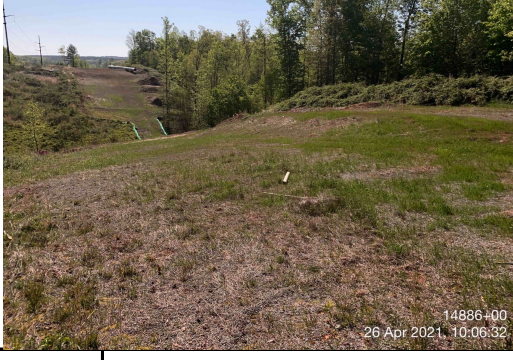
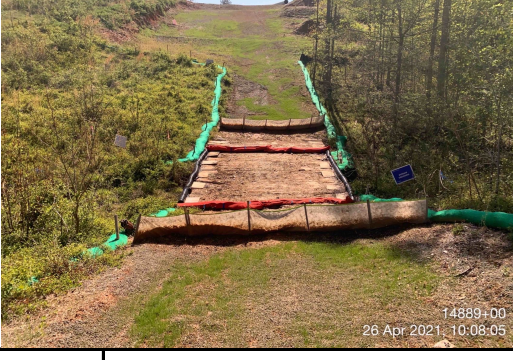
GPS Location	0		GPS Location	0	
Field Station#	14886+00		Field Station#	14889+00	
Pic 5 Desc.	Temporary vegetative stabilization in acceptable condition		Pic 6 Desc.	P1 silt fence in acceptable condition

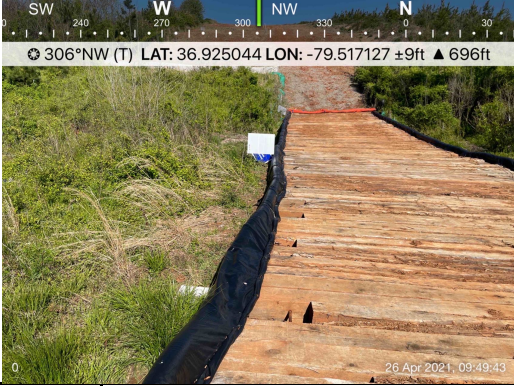
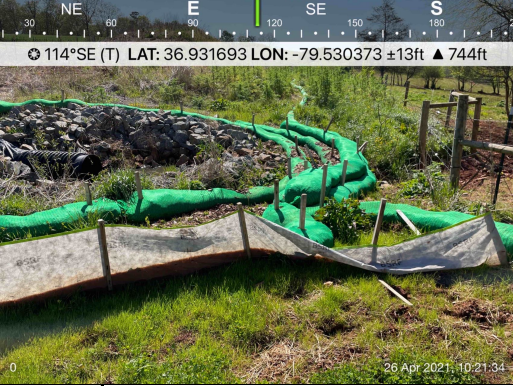
<b>GPS Location</b>	See photo		<b>GPS Location</b>	See photo	
<b>Field Station#</b>	15346+90		<b>Field Station#</b>	15299+00	
<b>Pic 1 Desc.</b>	Equipment bridge sideboard needs to be reattached.		<b>Pic 2 Desc.</b>	P1 has been damaged by livestock and needs to be repaired/replaced.

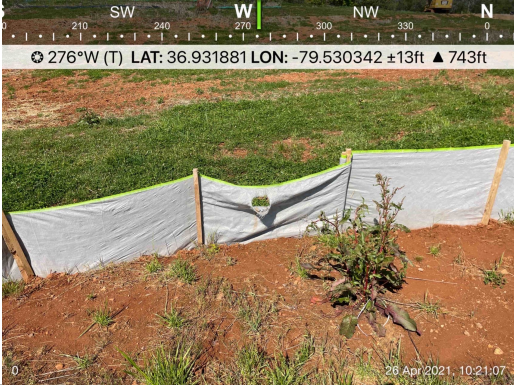
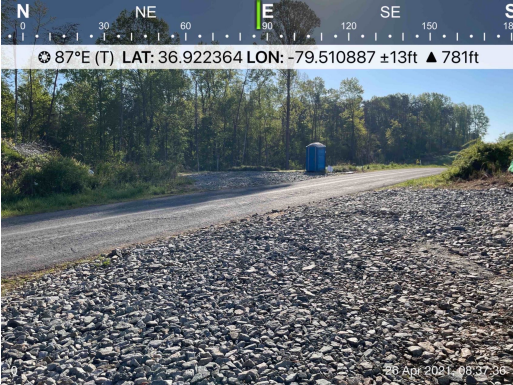
<b>GPS Location</b>	See photo		<b>GPS Location</b>	See photo	
<b>Field Station#</b>	15299+00		<b>Field Station#</b>	15370+62	
<b>Pic 3 Desc.</b>	P1 has been damaged by livestock and needs to be repaired/replaced.		<b>Pic 4 Desc.</b>	RCEs are in good condition at all road crossings.

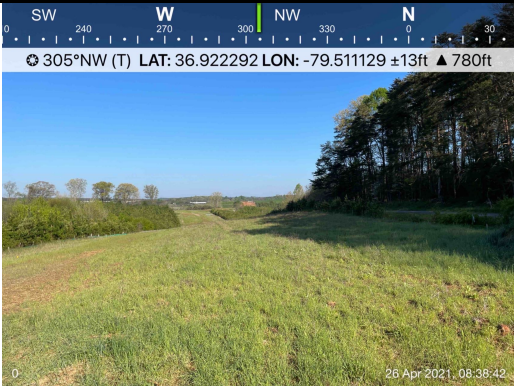
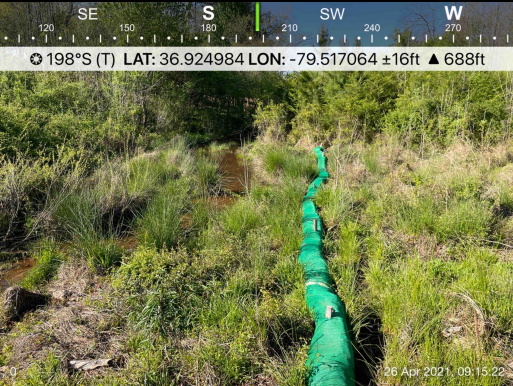
<b>GPS Location</b>	See photo		<b>GPS Location</b>	See photo	
<b>Field Station#</b>	15368+00		<b>Field Station#</b>	15348+21	
<b>Pic 5 Desc.</b>	Vegetation continues to fill in throughout this section of ROW.		<b>Pic 6 Desc.</b>	CFS is in good condition throughout this section.

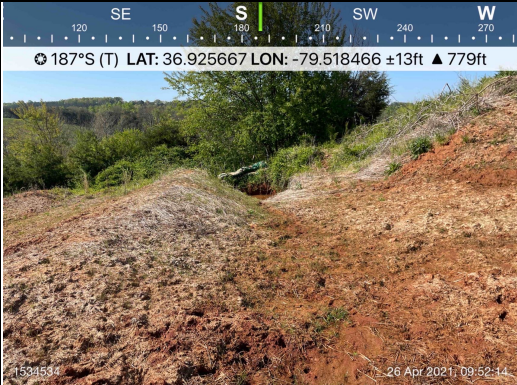
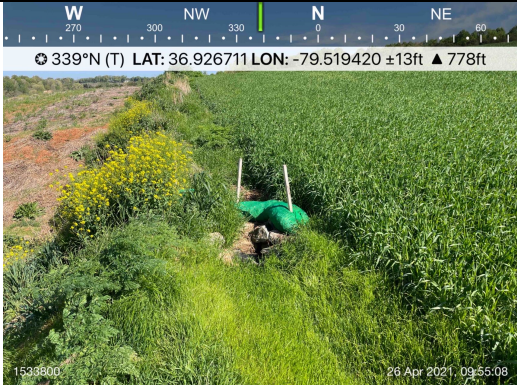
GPS Location	See photo		GPS Location	See photo	
Field Station#	15345+34		Field Station#	15338+00	
Pic 7 Desc.	Waterbars are in good condition and functioning.		Pic 8 Desc.	CWD inlet remains in good condition.

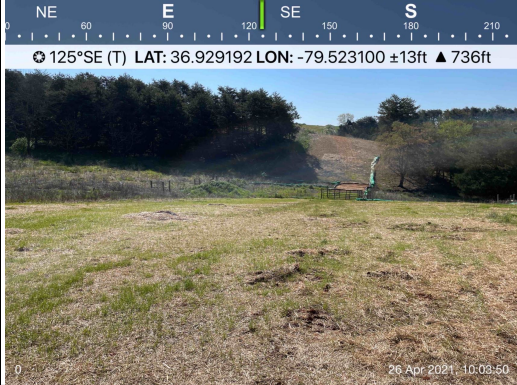
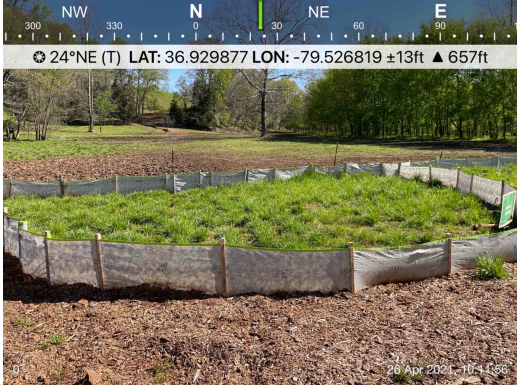
GPS Location	See photo		GPS Location	See photo	
Field Station#	15325+00		Field Station#	15311+78	
Pic 9 Desc.	Vegetation continues to fill in throughout this section of ROW.		Pic 10 Desc.	Wetland buffer P1 remains in good condition.

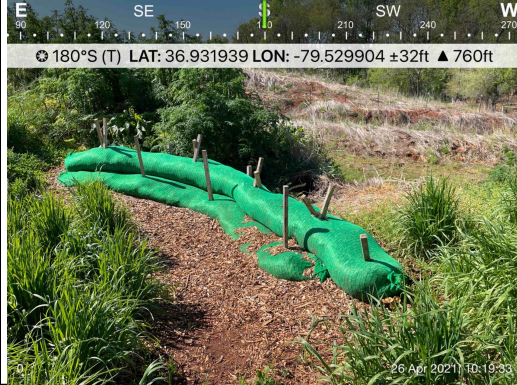
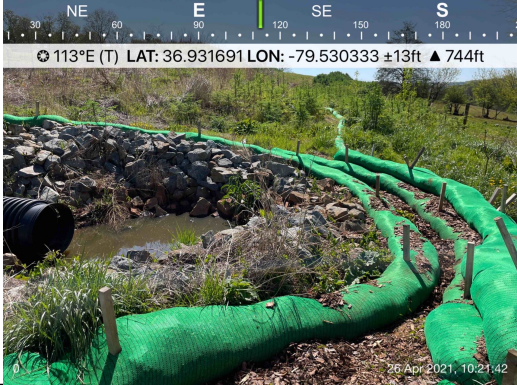
GPS Location	See photo		GPS Location	See photo	
Field Station#	15299+25		Field Station#	15299+25	
Pic 11 Desc.	CWD inlet is in good condition.		Pic 12 Desc.	CWD outlet remains in good condition.

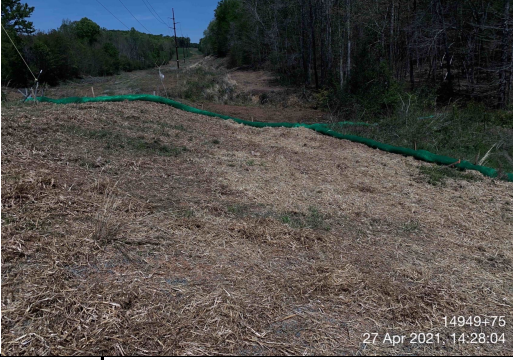
<b>GPS Location</b>	0	<b>GPS Location</b>	0		
<b>Field Station#</b>	14949+75	<b>Field Station#</b>	14949+75		
<b>Pic 3 Desc.</b>	CFS and vegetative stabilization were damaged by power company crew. Contractor addressed immediately.	<b>Pic 4 Desc.</b>	CFS and vegetative stabilization damaged by power company crew were repaired immediately by contractor

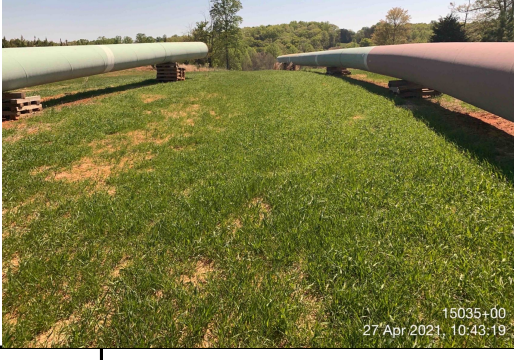
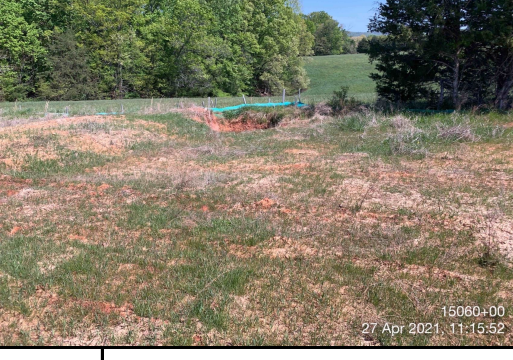
<b>GPS Location</b>	0	<b>GPS Location</b>	0		
<b>Field Station#</b>	15035+00	<b>Field Station#</b>	15060+00		
<b>Pic 5 Desc.</b>	Temporary vegetative stabilization in acceptable condition	<b>Pic 6 Desc.</b>	Waterbar end treatment in acceptable condition

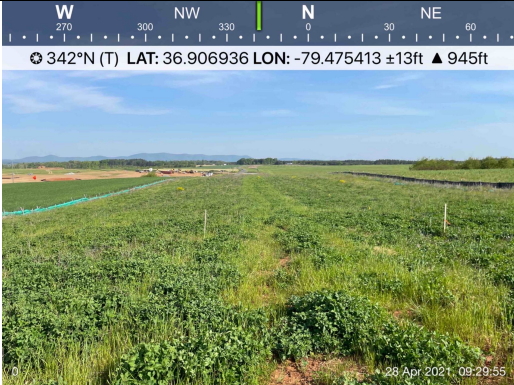
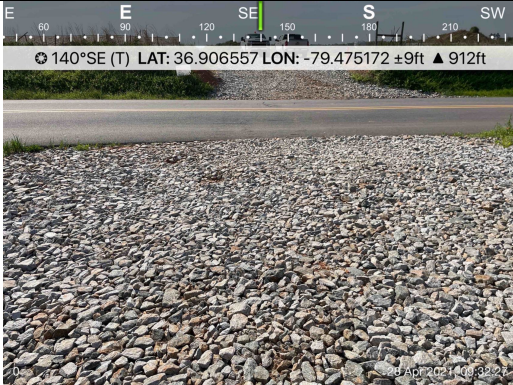
<b>GPS Location</b>	See photo		<b>GPS Location</b>	See photo	
<b>Field Station#</b>	15490+00		<b>Field Station#</b>	15496+70	
<b>Pic 1 Desc.</b>	Vegetation continues to fill in throughout this section.		<b>Pic 2 Desc.</b>	RCEs are in good condition at all road crossings.

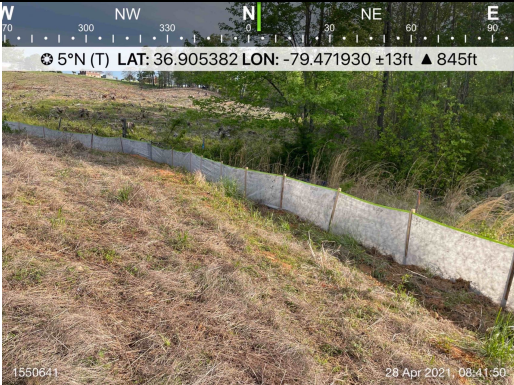
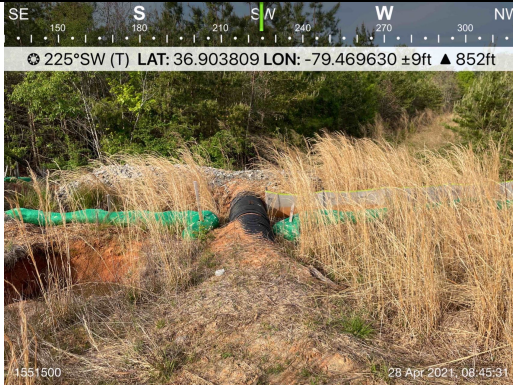
<b>GPS Location</b>	See photo		<b>GPS Location</b>	See photo	
<b>Field Station#</b>	15506+41		<b>Field Station#</b>	15515+00	
<b>Pic 3 Desc.</b>	P1 is in good condition at all stream and wetland buffers.		<b>Pic 4 Desc.</b>	CWDs are functioning as intended.

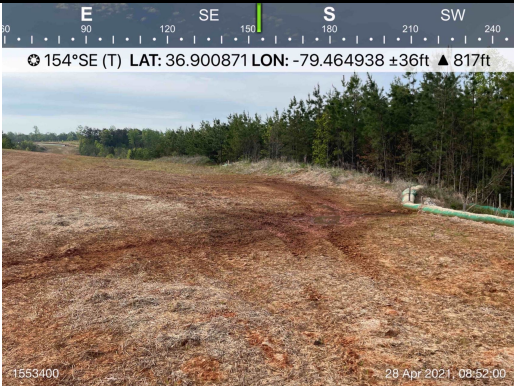
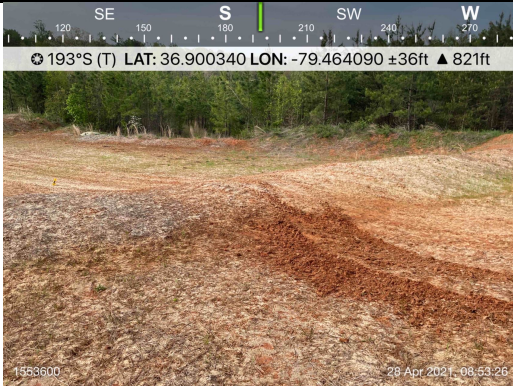
<b>GPS Location</b>	See photo		<b>GPS Location</b>	See photo	
<b>Field Station#</b>	15534+00		<b>Field Station#</b>	15536+00	
<b>Pic 5 Desc.</b>	Evidence of unauthorized ATV use by 3rd party		<b>Pic 6 Desc.</b>	Evidence of unauthorized ATV use by 3rd party

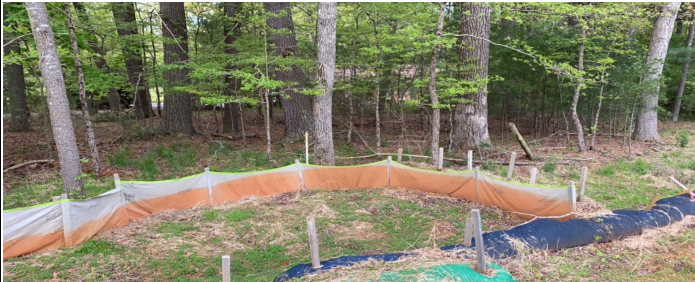
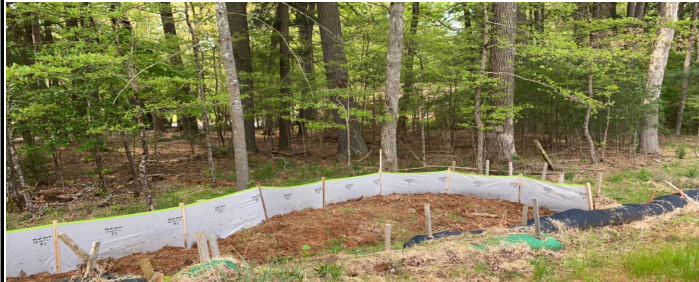
37°2'52" N 79°53'48" W 262°W COURSE 243° GPS 184 Foggy Ridge Rd, Rocky Mount, VA 24151, United States 04.29.2021 09:34:41 Accur +/-47.7 Ft ALT 1089 Ft			37°2'51" N 79°53'47" W 205°SW COURSE -1° GPS 356 Foggy Ridge Rd, Rocky Mount, VA 24151, United States 04.29.2021 10:29:08 Accur +/-69.2 Ft ALT 1015 Ft		
GPS Location	1	GPS Location	2		
Field Station#	13952+00	Field Station#	13952+00		
Pic 1 Desc.	Routine maintenance. P1 silt fence past effective lifespan. Holes in fabric, sediment-laden.		Pic 2 Desc.	Contractor replaced P1 silt fence per punch list item.

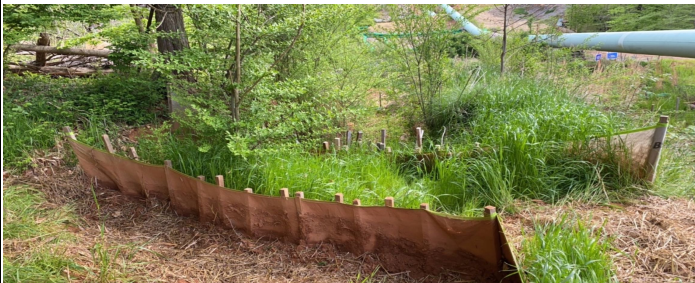
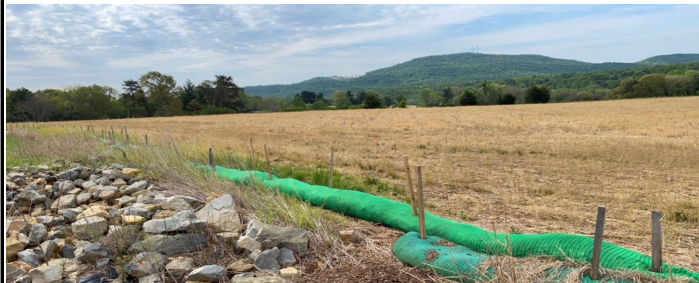
GPS Location	3	GPS Location	4		
Field Station#	13996+00	Field Station#	13943+00		
Pic 3 Desc.	Routine maintenance. Replace Sediment-laden rows of P1 silt fence. Past effective lifespan.		Pic 4 Desc.	Contractor replaced section of perimeter CFS per punch list item.

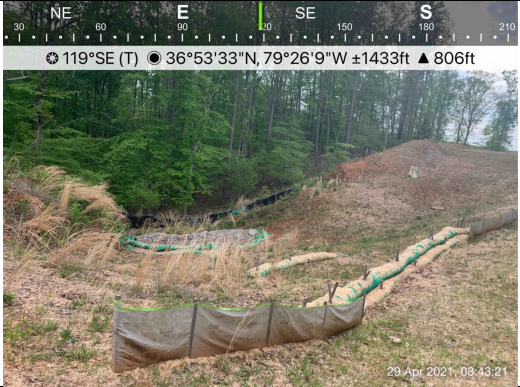
<b>GPS Location</b>	O	<b>GPS Location</b>	O		
<b>Field Station#</b>	15638+00	<b>Field Station#</b>	15633+00		
<b>Pic 1 Desc.</b>	Observing p1 that requires maintenance (damaged by livestock)	<b>Pic 2 Desc.</b>	Observing temporary stabilization,CWD outlet and ECD's

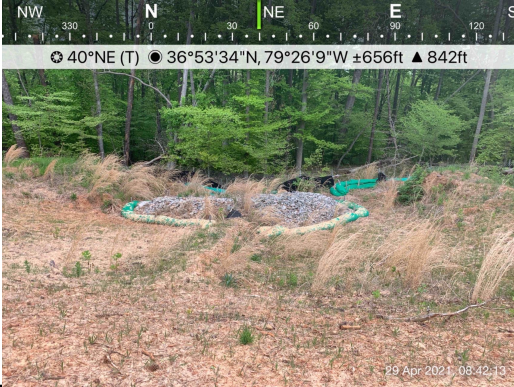
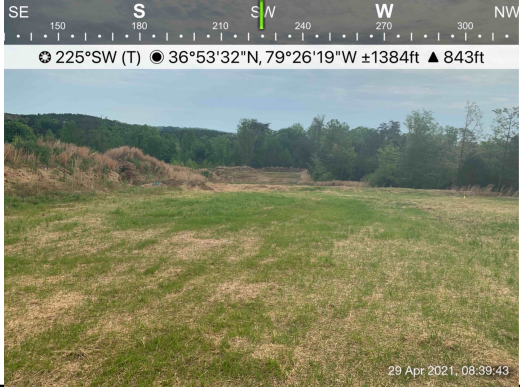
<b>GPS Location</b>	O	<b>GPS Location</b>	O		
<b>Field Station#</b>	15630+00	<b>Field Station#</b>	15590+00		
<b>Pic 3 Desc.</b>	Observing temporary stabilization,CWD outlet and ECD's	<b>Pic 4 Desc.</b>	Observing temporary stabilization and water bar

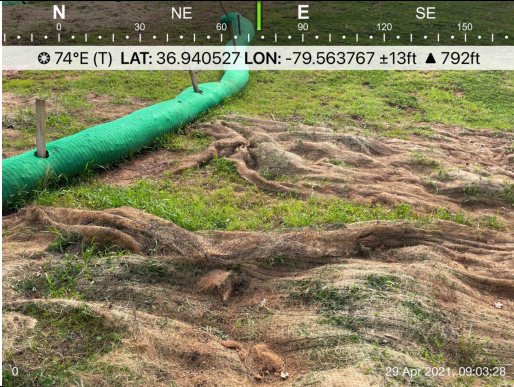
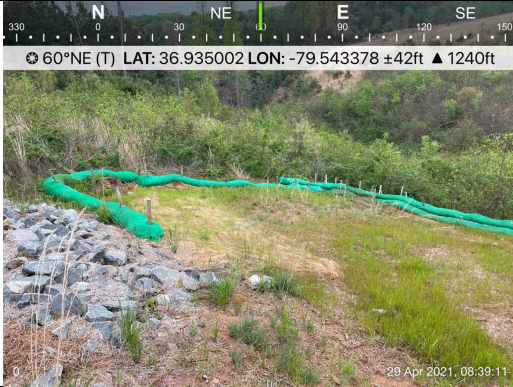
<b>GPS Location</b>	See photo		<b>GPS Location</b>	See photo	
<b>Field Station#</b>	15195+00		<b>Field Station#</b>	15260+00	
<b>Pic 1 Desc.</b>	Erosion control fabric has been displaced by livestock and needs to be re-pinned.		<b>Pic 2 Desc.</b>	Previous erosion repair remains in good condition.

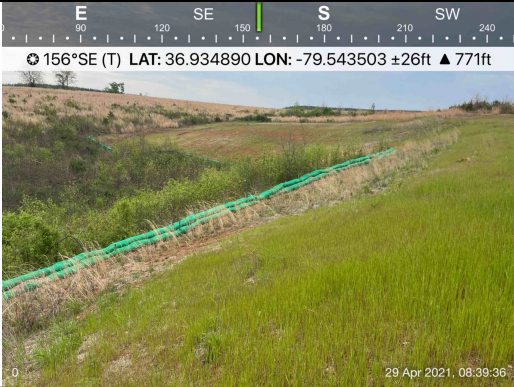
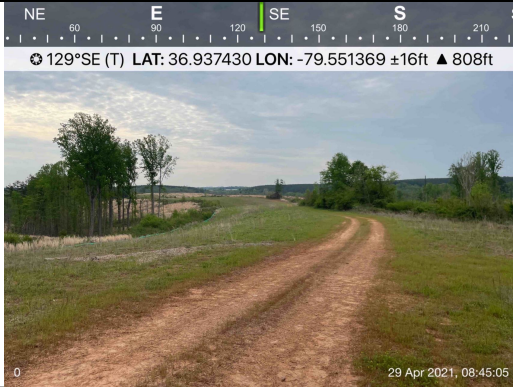
<b>GPS Location</b>	See photo		<b>GPS Location</b>	See photo	
<b>Field Station#</b>	15260+00		<b>Field Station#</b>	15230+00	
<b>Pic 3 Desc.</b>	CFS is in good condition throughout this section.		<b>Pic 4 Desc.</b>	Vegetation continues to fill in ROW.

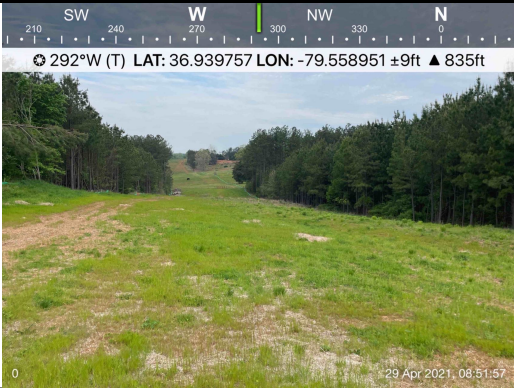
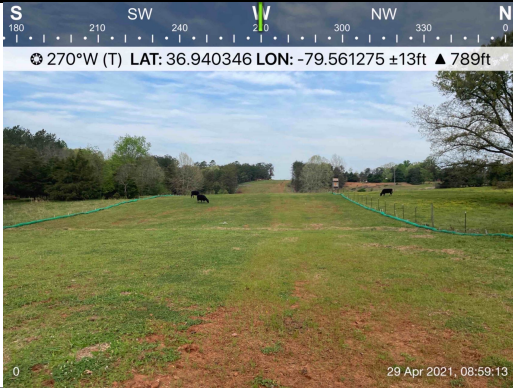
<b>GPS Location</b>	See photo		<b>GPS Location</b>	See photo	
<b>Field Station#</b>	15209+00		<b>Field Station#</b>	15200+00	
<b>Pic 5 Desc.</b>	Vegetation continues to fill in ROW.		<b>Pic 6 Desc.</b>	Livestock on ROW at this location.

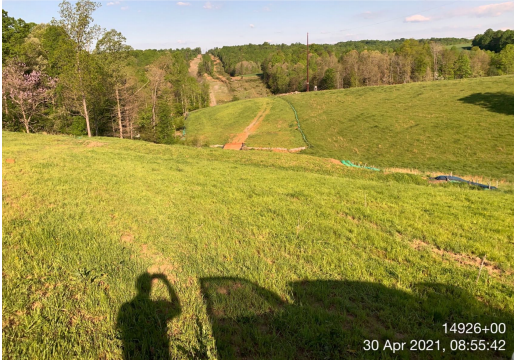
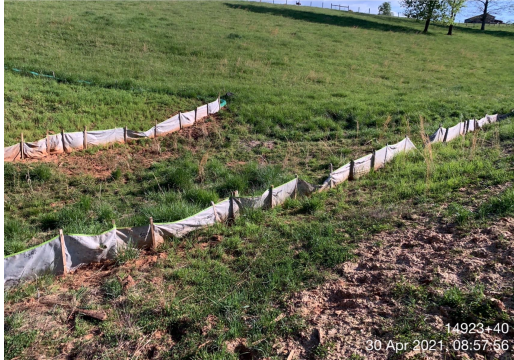
14923+40 30 Apr 2021, 08:57:56			
<b>GPS Location</b>	0	<b>GPS Location</b>	0		
<b>Field Station#</b>	14926+00	<b>Field Station#</b>	14923+40		
<b>Pic 1 Desc.</b>	Permanent vegetative stabilization in acceptable condition	<b>Pic 2 Desc.</b>	P1 silt fence damaged by livestock		
208°SW (M) 36°58'8"N, 79°38'42"W ±22ft ▲781ft

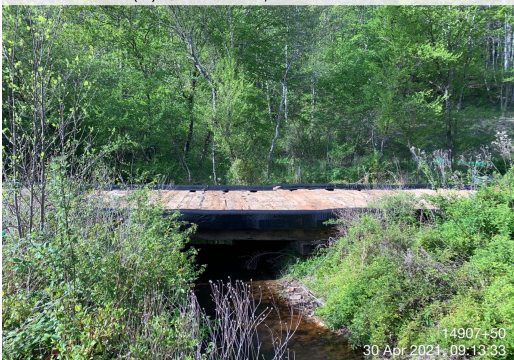
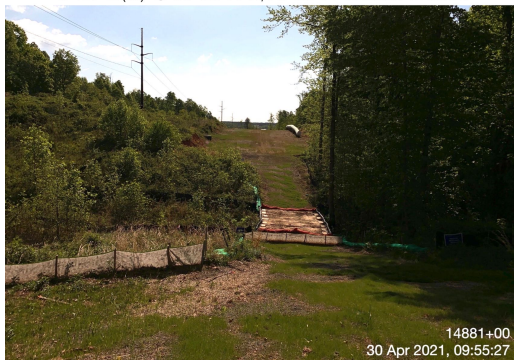
14881+00 30 Apr 2021, 09:55:27			
<b>GPS Location</b>	0	<b>GPS Location</b>	0		
<b>Field Station#</b>	14907+50	<b>Field Station#</b>	14881+00		
<b>Pic 3 Desc.</b>	Equipment bridge in acceptable condition	<b>Pic 4 Desc.</b>	Temporary vegetative stabilization in acceptable condition

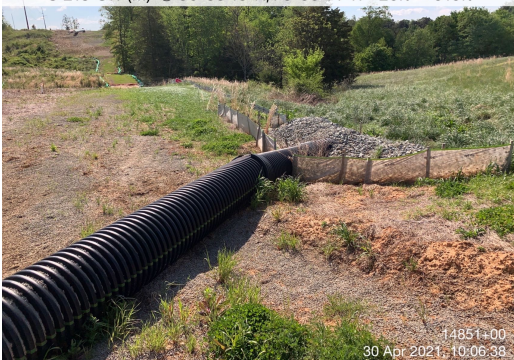
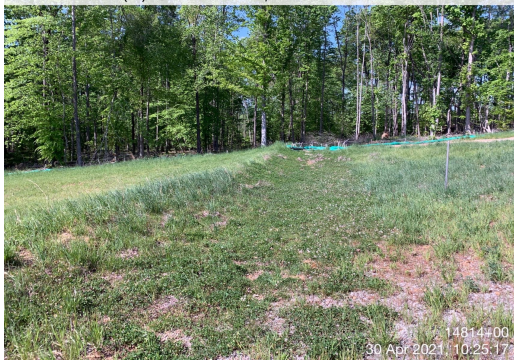
14814+00 30 Apr 2021, 10:25:17			
<b>GPS Location</b>	0	<b>GPS Location</b>	0		
<b>Field Station#</b>	14851+00	<b>Field Station#</b>	14814+00		
<b>Pic 5 Desc.</b>	Clean water diversion pipe in acceptable condition	<b>Pic 6 Desc.</b>	Waterbar in acceptable condition

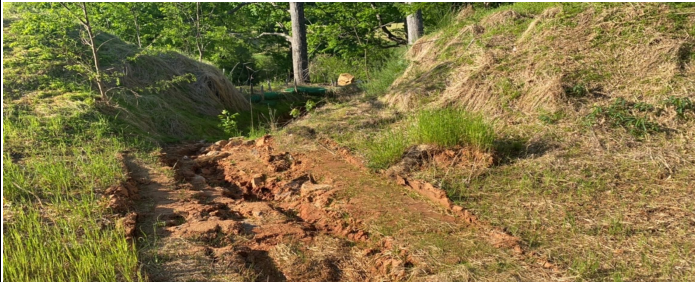
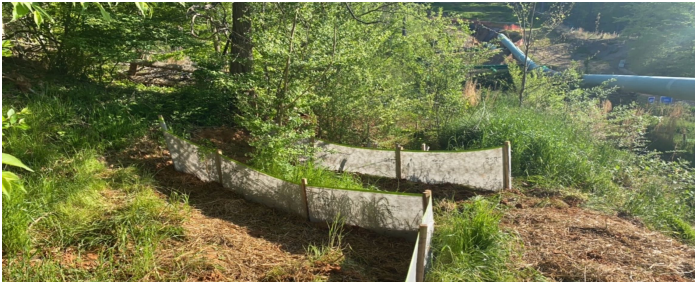
37°3'8" N 79°53'22" W 198°S COURSE 151° GPS Rocky Mount, VA 24151, United States 04.30.2021 08:28:52 Accur +/-45.3 Ft ALT 1110 Ft			37°37" N 79°53'19" W 57°NE COURSE 140° GPS Rocky Mount, VA 24151, United States 04.30.2021 08:39:17 Accur +/-656.2 Ft ALT 1088 Ft		
<b>GPS Location</b>	1	<b>GPS Location</b>	2		
<b>Field Station#</b>	13982+00	<b>Field Station#</b>	13996+00		
<b>Pic 1 Desc.</b>	Routine maintenance. Repair erosion rill occurring in throat of water bar and stabilize area. Recommend Curlex.		<b>Pic 2 Desc.</b>	Contractor replaced P1 silt fence per punch list item.

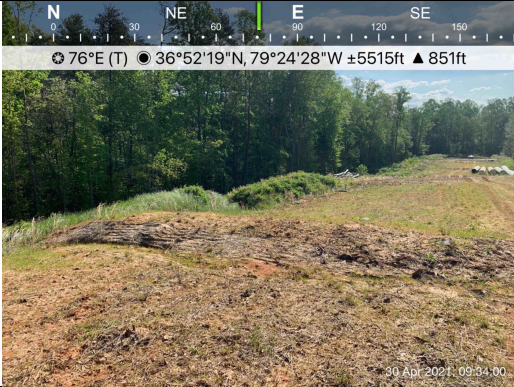
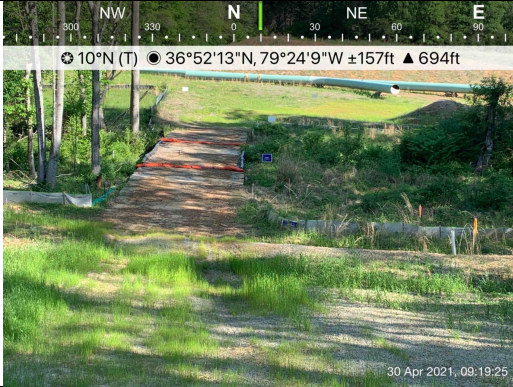
<b>GPS Location</b>	O	<b>GPS Location</b>	O		
<b>Field Station#</b>	15752+00	<b>Field Station#</b>	15763+80		
<b>Pic 1 Desc.</b>	Observing temporary stabilization, water bar and erosion control blanket	<b>Pic 2 Desc.</b>	Observing temporary stabilization, signage, buffer, equipment crossing and ECD's

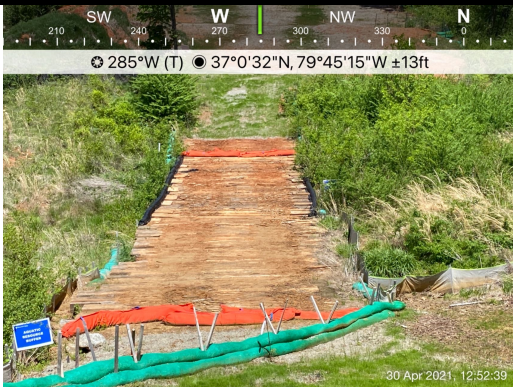
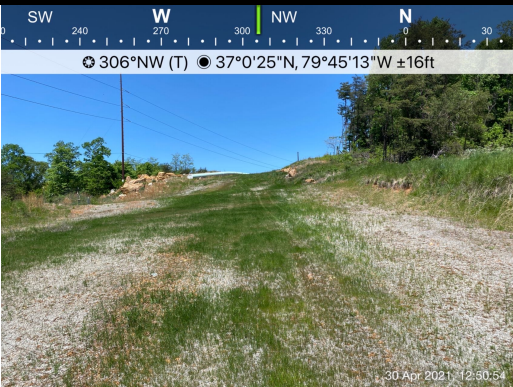
GPS Location	0		GPS Location	0	
Field Station#	14531+58		Field Station#	14537+00	
Pic 1 Desc.	Approximately 14531+58. Overview of stream crossing, equipment bridge and ECDs at stream S-G18.		Pic 2 Desc.	Approximately 14537+00. Overview of ROW.
