Visual Site Inspection Report

Project Name	H-600 Pipeline Spread I	AFE	124300139	Spread	H-600 Pipeline Spread I
Contractor	Precision			Report #	21917
Inspector	Ben Davenport			Date/Time	4/5/2021 10:34 AM
Permit #	TBD	Inspection Type	VA SWPP	Station Begin	14062+17
State	VA	Inspection Area	Partial	Station End	14171+36
County	Franklin	Ground	Dry	Temperature (°F)	74.00
Municipality	N/A	Weather	Sunny	Rain Gauge (in)	0.00
				Rain Accumulation Time (days)	0.00

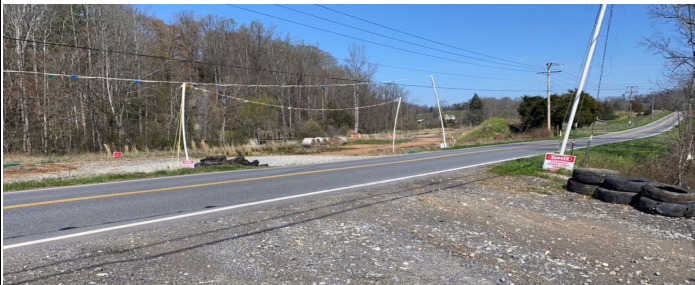
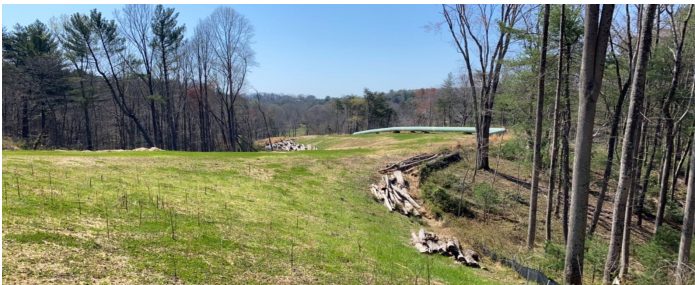
Pic 3 Desc.	RCE at Grassy Hill Rd in good condition		Pic 4 Desc.	Vegetation growing in recently seeded and stabilized area

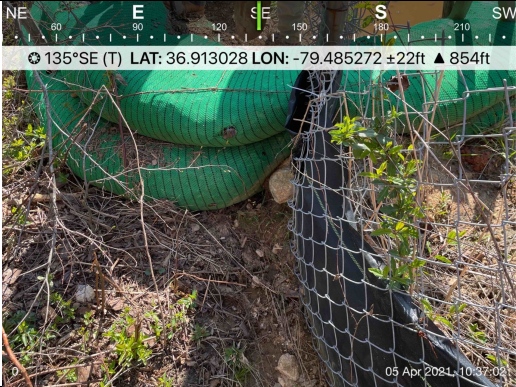
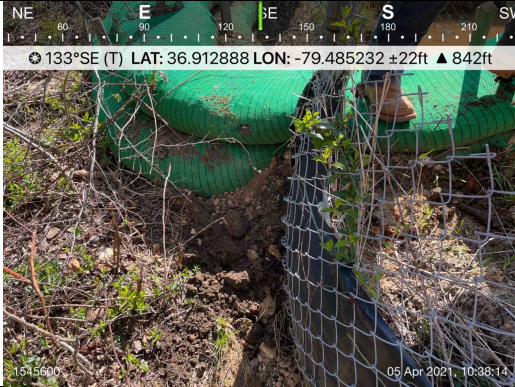
GPS Location	See photo	GPS Location	See photo		
Field Station#	15456+00	Field Station#	15456+00		
Pic 1 Desc.	CFS end treatment is undermined and needs to be keyed in.	Pic 2 Desc.	Environmental crew has corrected this issue.

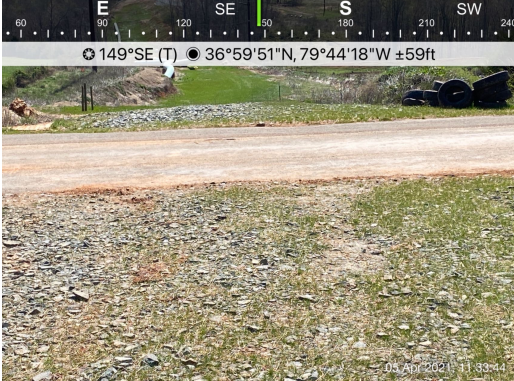
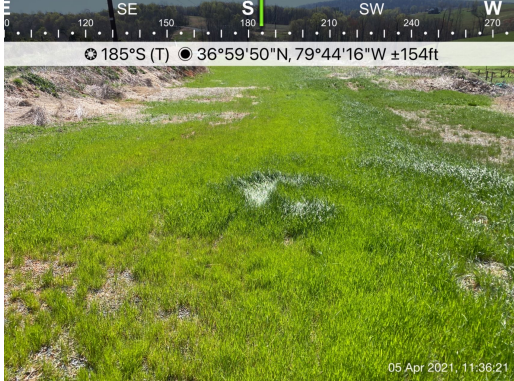
GPS Location	0	GPS Location	0		
Field Station#	14599+00	Field Station#	14603+00		
Pic 1 Desc.	Approximately 14599+00. Overview of road crossing and RCEs.	Pic 2 Desc.	Approximately 14603+00. Overview of ROW.

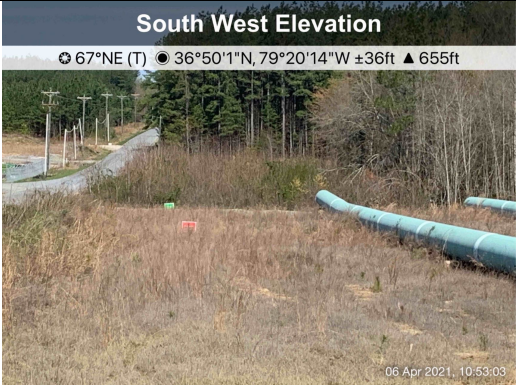
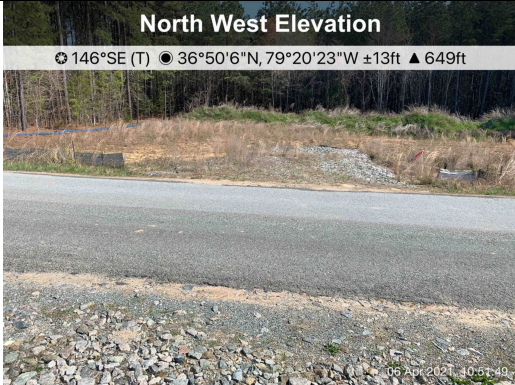
GPS Location	O	GPS Location	O		
Field Station#	20+00	Field Station#	13+86		
Pic 1 Desc.	Observing temporary vegetation, signage, buffer and ECD's	Pic 2 Desc.	Observing road crossing and RCE's

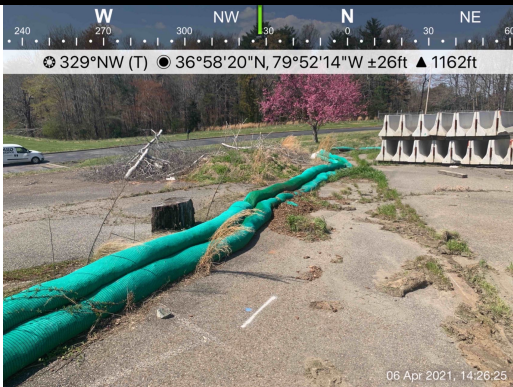
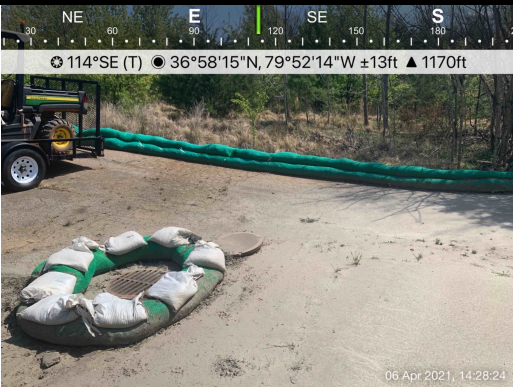
GPS Location	000000000000		GPS Location	000000000000	
Field Station#	0000+00		Field Station#	0000+00	
Pic 1 Desc.	Perimeter ECD issue at 046 observed during previous inspection addressed by contractor.		Pic 2 Desc.	Inlet protection and perimeter ECD's on south end of 046 in good condition.

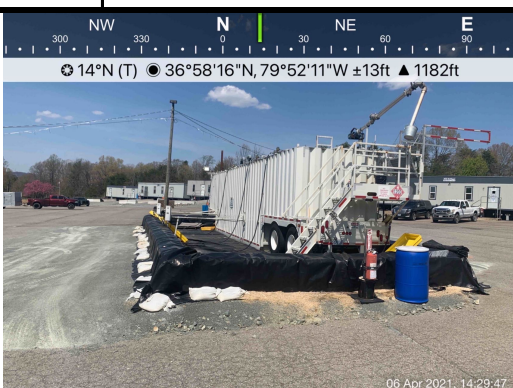
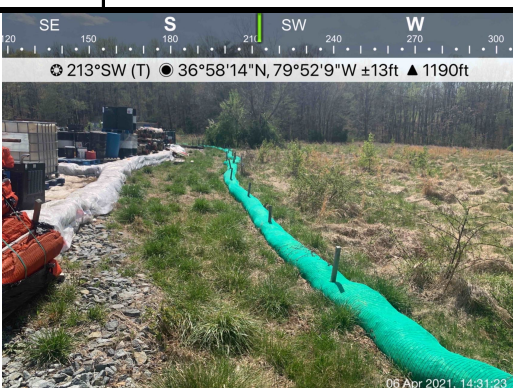
GPS Location	000000000000		GPS Location	000000000000	
Field Station#	0000+00		Field Station#	0000+00	
Pic 3 Desc.	Secondary containment structure for fuel cell at 046 in good condition.		Pic 4 Desc.	Perimeter ECD's on north end of 045 in acceptable condition.

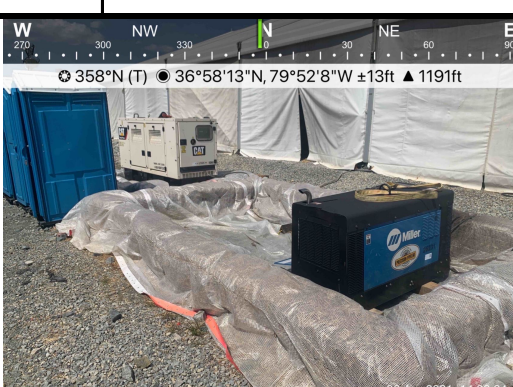
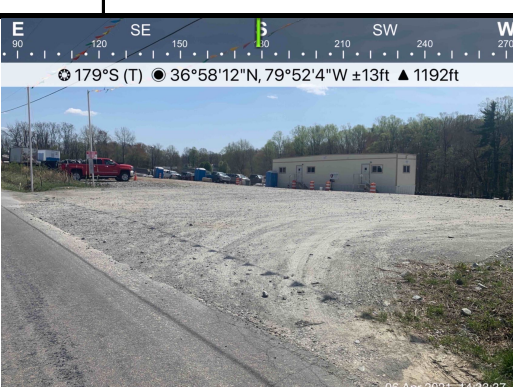
GPS Location	000000000000		GPS Location	000000000000	
Field Station#	0000+00		Field Station#	0000+00	
Pic 5 Desc.	Secondary containment structures for generators near tent at 045 in good condition.		Pic 6 Desc.	RCE at 045 in good condition.

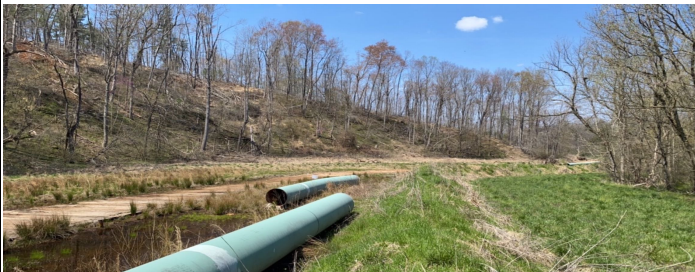
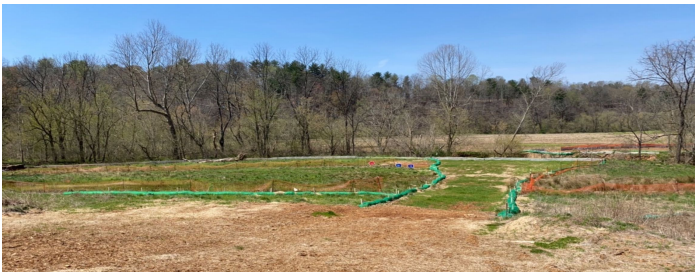
GPS Location	3		GPS Location	4	
Field Station#	13883+00		Field Station#	13918+00	
Pic 3 Desc.	Bridge mats in place in traditionally wet area of ROW. No issues observed.		Pic 4 Desc.	All ECDs in place and functional GAS S-II2

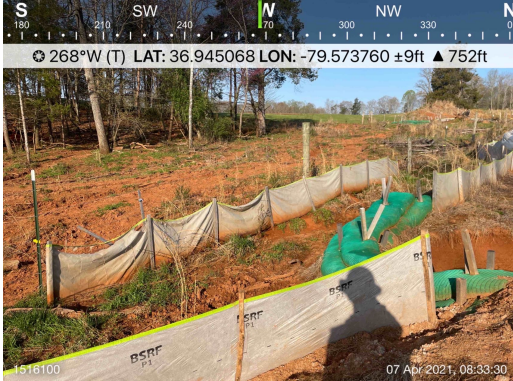
GPS Location	See photo		GPS Location	See photo	
Field Station#	15161+00		Field Station#	15165+57	
Pic 1 Desc.	P1 is damaged and needs to be replaced with CFS.		Pic 2 Desc.	Drainage inlet requires additional stone.

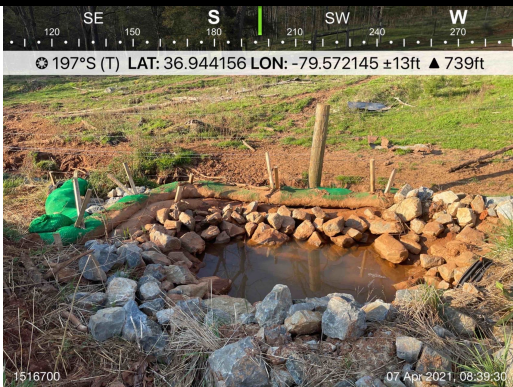
GPS Location	See photo		GPS Location	See photo	
Field Station#	15167+00		Field Station#	15260+00	
Pic 3 Desc.	Drainage outlet CFS needs to be removed and additional stone needs to be added.		Pic 4 Desc.	Sediment needs to be removed from CFS.

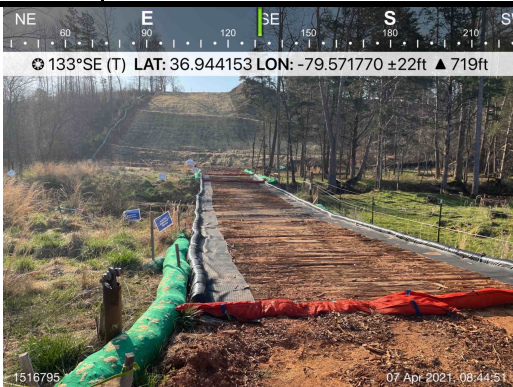
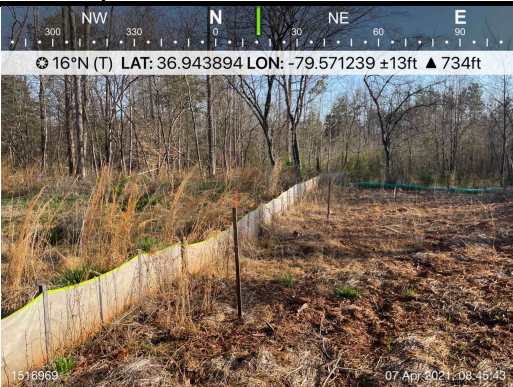
GPS Location	See photo		GPS Location	See photo	
Field Station#	15167+95		Field Station#	15169+69	
Pic 5 Desc.	Equipment bridge ECDs are in good condition.		Pic 6 Desc.	P1 is in good condition at stream buffer.

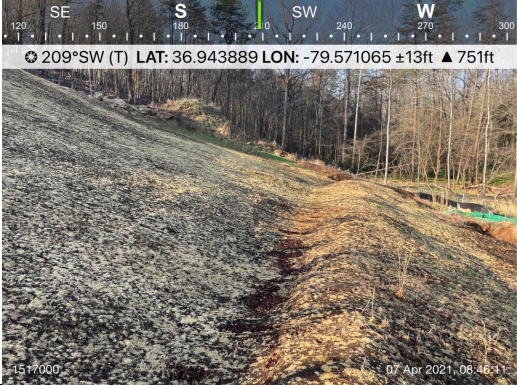
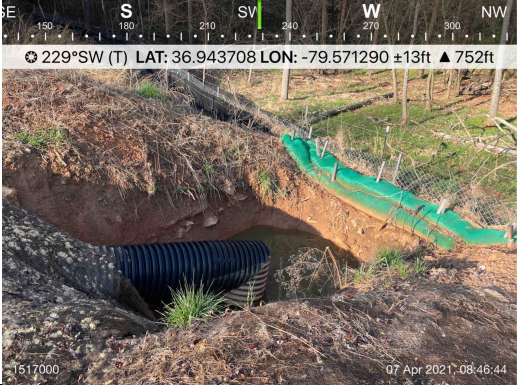
GPS Location	See photo		GPS Location	See photo	
Field Station#	15170+00		Field Station#	15170+00	
Pic 7 Desc.	Waterbars are in good condition throughout this section.		Pic 8 Desc.	Slope drain is functioning.

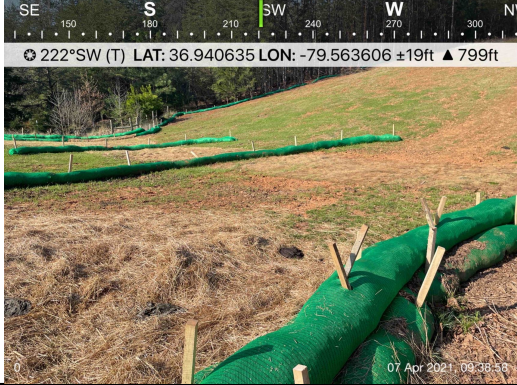
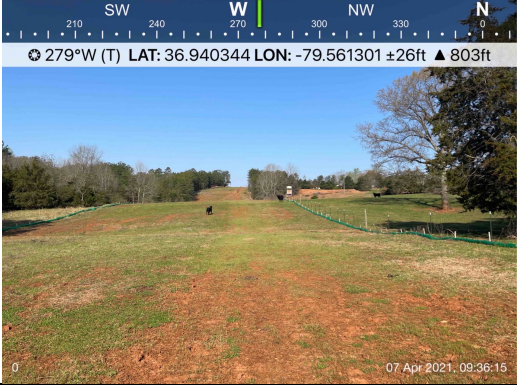
GPS Location	See photo		GPS Location	See photo	
Field Station#	15195+00		Field Station#	15197+00	
Pic 9 Desc.	Drainage ECDs are in place and functioning.		Pic 10 Desc.	Livestock on ROW.

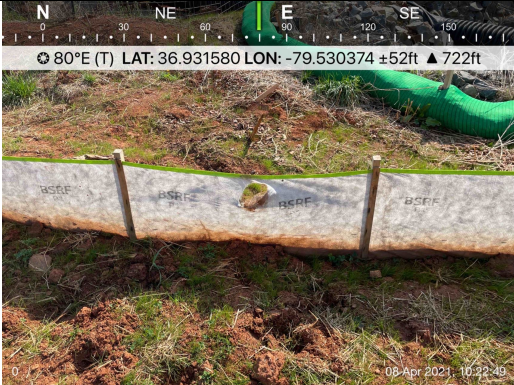
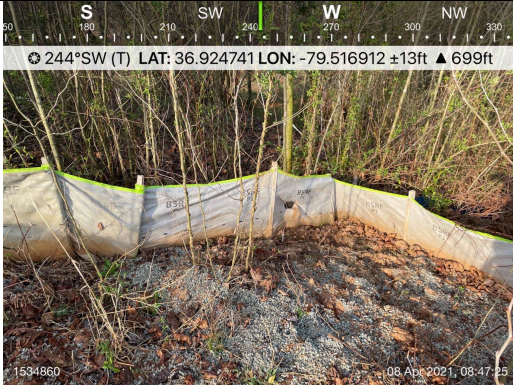
GPS Location	See photo		GPS Location	See photo	
Field Station#	15299+00		Field Station#	15348+60	
Pic 1 Desc.	P1 has been damaged by livestock and needs to be replaced.		Pic 2 Desc.	P1 has been damaged by livestock and needs to be replaced.

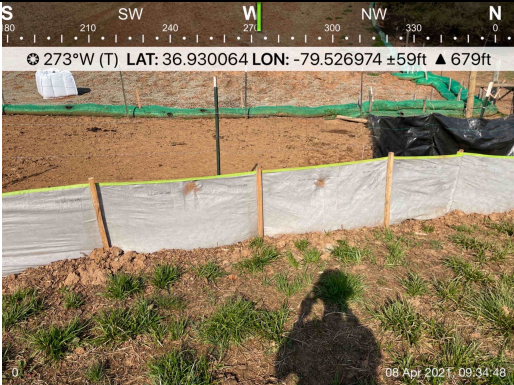
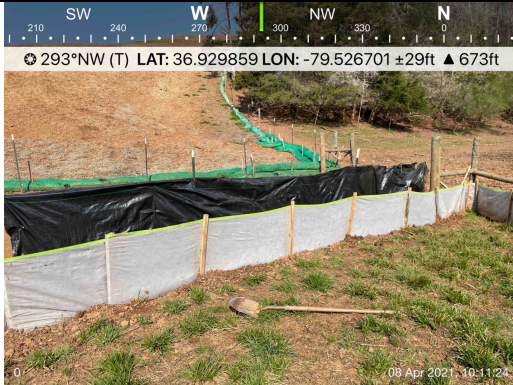
GPS Location	See photo		GPS Location	See photo	
Field Station#	15311+78		Field Station#	15311+78	
Pic 3 Desc.	P1 has been damaged by livestock and needs to be replaced.		Pic 4 Desc.	Environmental crew has corrected this issue

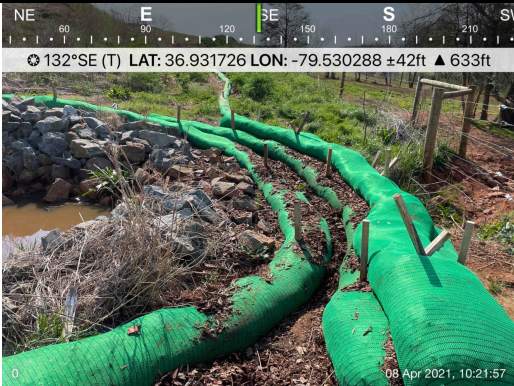
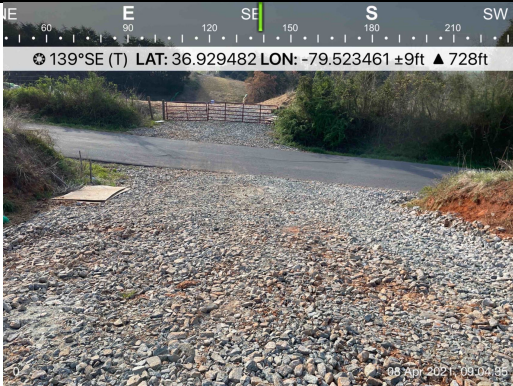
GPS Location	See photo		GPS Location	See photo	
Field Station#	15299+50		Field Station#	15323+24	
Pic 5 Desc.	CWD is in good condition and functioning.		Pic 6 Desc.	RCEs are in good condition at all road crossings.

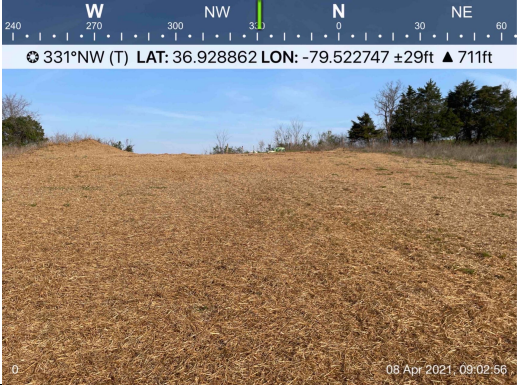
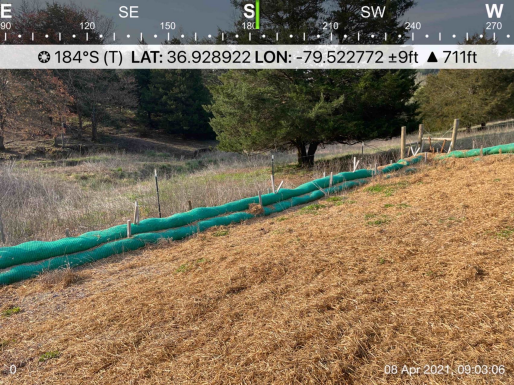
GPS Location	See photo		GPS Location	See photo	
Field Station#	15325+00		Field Station#	15325+50	
Pic 7 Desc.	Road approaches and work spaces have been stabilized at Lark Drive.		Pic 8 Desc.	Perimeter CFS is in good condition throughout this section.

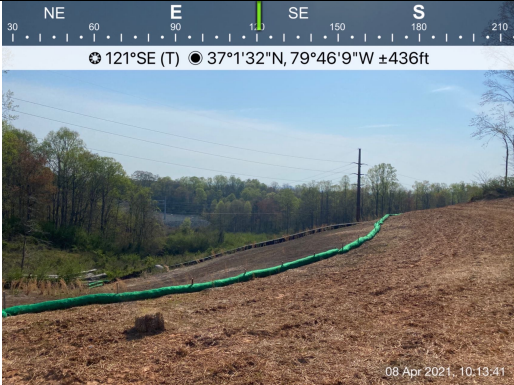
GPS Location	0	GPS Location	0		
Field Station#	14457+00	Field Station#	14484+57		
Pic 1 Desc.	Approximately 14457+00. Overview of ROW.		Pic 2 Desc.	Approximately 14484+57. P-1 requires maintenance. Damaged by livestock/wildlife.

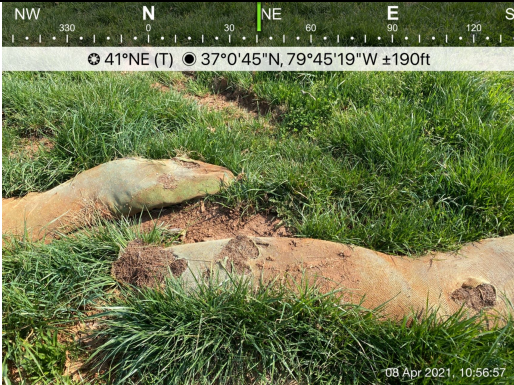
GPS Location	0	GPS Location	0		
Field Station#	14518+57	Field Station#	14510+00		
Pic 3 Desc.	Approximately 14518+57. CFS damaged by third party traffic.		Pic 4 Desc.	Approximately 14510+00. Overview of ROW.

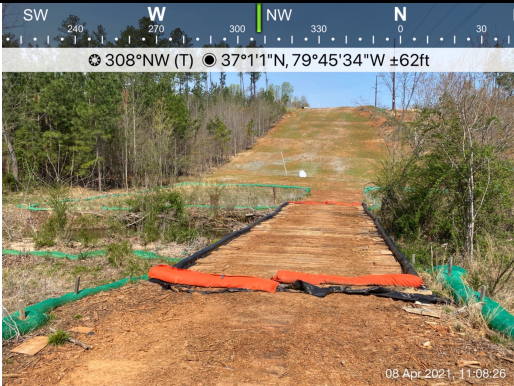
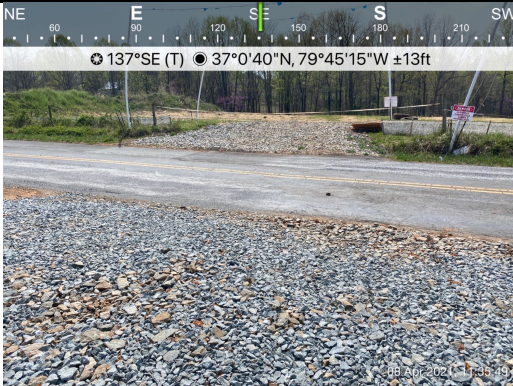
GPS Location	0	GPS Location	0		
Field Station#	14496+60	Field Station#	14524+50		
Pic 5 Desc.	Approximately 14496+60. Overview of stream crossing, equipment bridge and ECDs at stream S-G20.		Pic 6 Desc.	Approximately 14524+50. Overview of road crossing and RCEs.

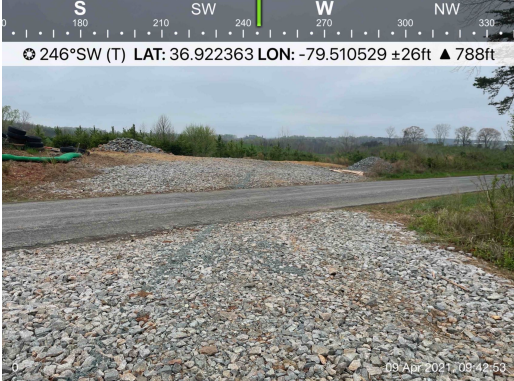
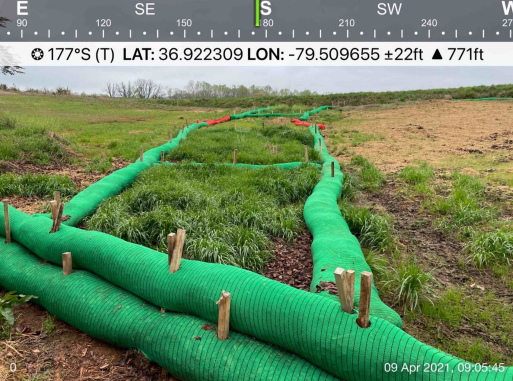
GPS Location	See photo		GPS Location	See photo	
Field Station#	15370+62		Field Station#	15375+00	
Pic 1 Desc.	RCEs are in good condition at all road crossings.		Pic 2 Desc.	Drainage ECDs are in good condition and functioning.

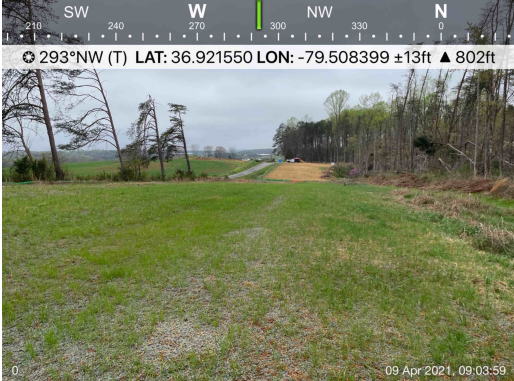
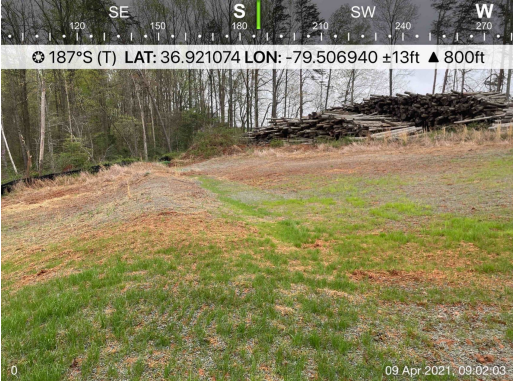
GPS Location	See photo		GPS Location	See photo	
Field Station#	15378+00		Field Station#	15380+00	
Pic 3 Desc.	This section remains temporarily stabilized.		Pic 4 Desc.	Waterbars are in good condition and functioning.

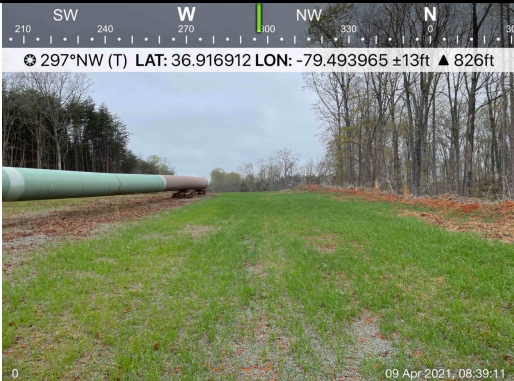
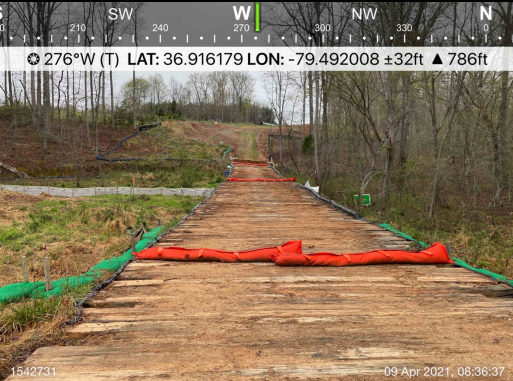
GPS Location	See photo		GPS Location	See photo	
Field Station#	15423+00		Field Station#	15427+31	
Pic 5 Desc.	This section remains temporarily stabilized.		Pic 6 Desc.	Equipment bridge ECDs are in place and functioning.

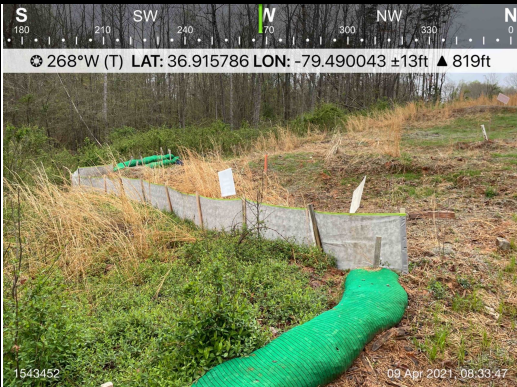
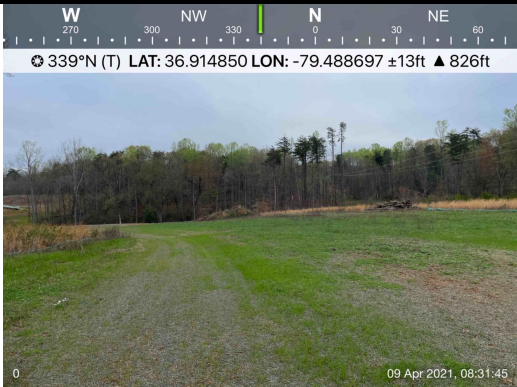
GPS Location	See photo		GPS Location	See photo	
Field Station#	15434+52		Field Station#	15442+00	
Pic 7 Desc.	P1 is in good condition at all stream and wetland buffers.		Pic 8 Desc.	This section remains temporarily stabilized.

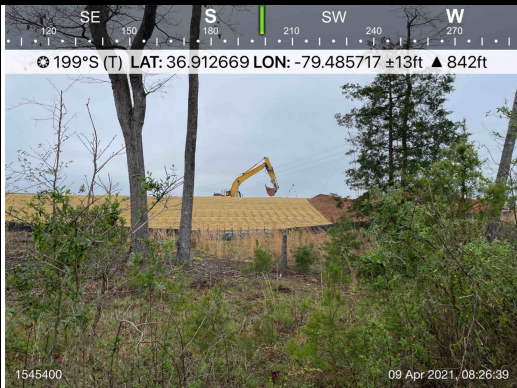
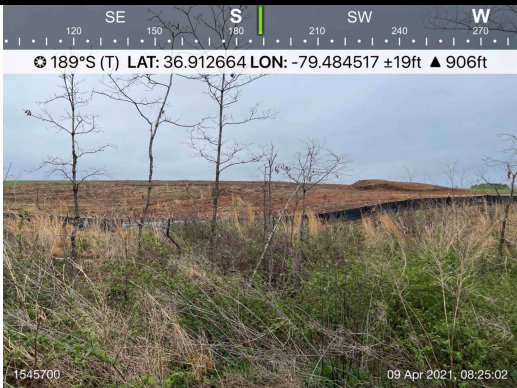
GPS Location	See photo		GPS Location	See photo	
Field Station#	15454+00		Field Station#	15457+00	
Pic 9 Desc.	3rd party disturbance occurring upslope from MVP clean water features.		Pic 10 Desc.	3rd party disturbance occurring upslope from MVP clean water features.

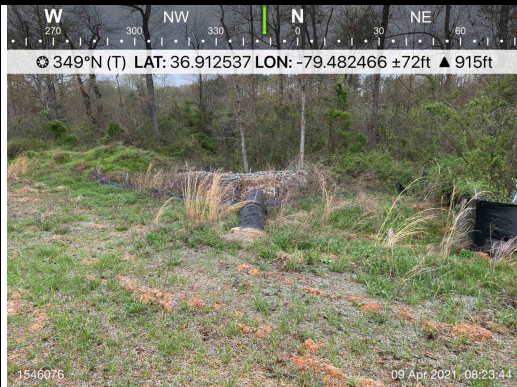
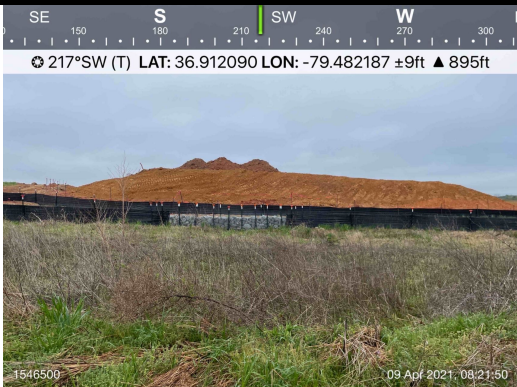
GPS Location	See photo		GPS Location	See photo	
Field Station#	15460+76		Field Station#	15465+00	
Pic 11 Desc.	CWDs are in good condition condition.		Pic 12 Desc.	3rd party disturbance occurring upslope at this location.

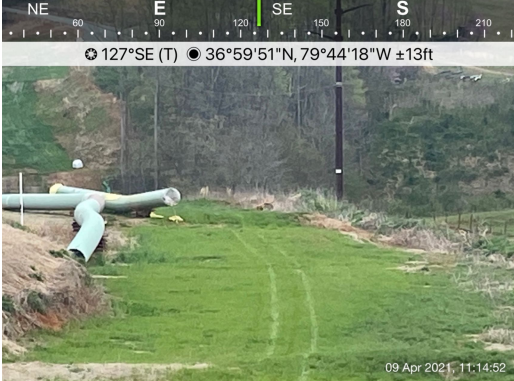
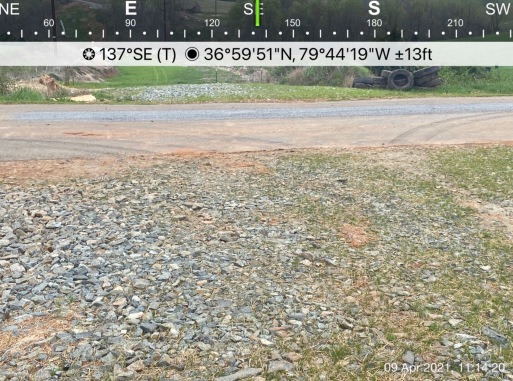
GPS Location	0	GPS Location	0		
Field Station#	14605+00	Field Station#	14599+00		
Pic 1 Desc.	Approximately 14605+00. Overview of ROW.	Pic 2 Desc.	Approximately 14599+00. Overview of road crossing and RCEs.
