# Visual Site Inspection Report

<b>Project Name</b>	H-600 Pipeline Spread I	<b>AFE</b>	124300139	<b>Spread</b>	H-600 Pipeline Spread I
<b>Contractor</b>	Precision			<b>Report #</b>	23175
<b>Inspector</b>	Ben Davenport			<b>Date/Time</b>	5/10/2021 8:20 AM
<b>Permit #</b>	TBD	<b>Inspection Type</b>	VA SWPP	<b>Station Begin</b>	15063+85
<b>State</b>	VA	<b>Inspection Area</b>	Partial	<b>Station End</b>	15142+66
<b>County</b>	Pittsylvania	<b>Ground</b>	Dry	<b>Temperature (°F)</b>	69.00
<b>Municipality</b>	Chatham	<b>Weather</b>	Cloudy	<b>Rain Gauge (in)</b>	0.00
				<b>Rain Accumulation Time (days)</b>	0.00

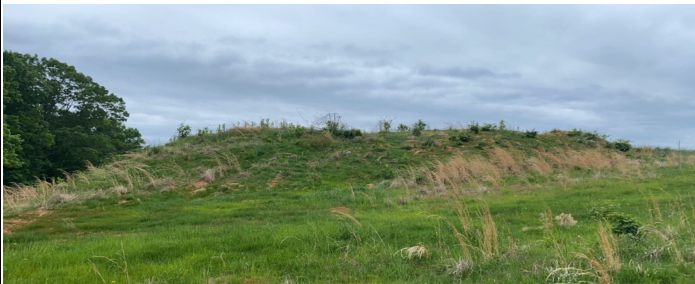
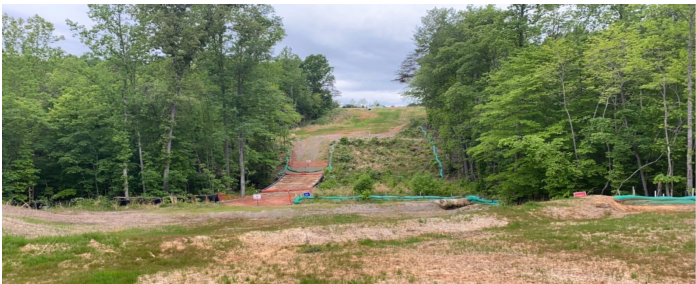
36°57'45" N 79°35'31" W 274°W COURSE 281° GPS Sandy Level, VA 24161, United States 05.10.2021 09:39:37 Accur +/-77.7 Ft ALT 874 Ft			36°57'44" N 79°35'23" W 309°NW COURSE 331° GPS Sandy Level, VA 24161, United States 05.10.2021 09:35:23 Accur +/-213.6 Ft ALT 871 Ft		
<b>GPS Location</b>	1	<b>GPS Location</b>	2		
<b>Field Station#</b>	15068+00	<b>Field Station#</b>	15072+86		
<b>Pic 1 Desc.</b>	Spoil pile stabilized and vegetated		<b>Pic 2 Desc.</b>	Equipment bridge and surrounding ECDs in place and functional at stream crossing. Bridge has safety fence surrounding it preventing equipment from crossing.

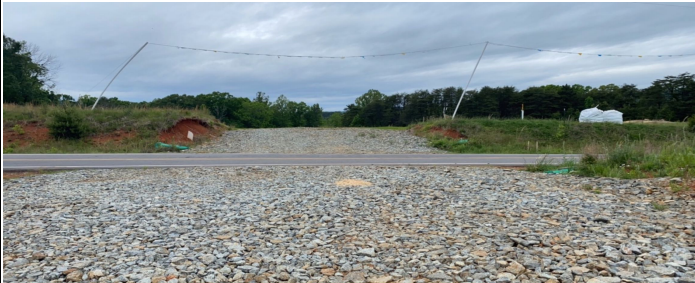
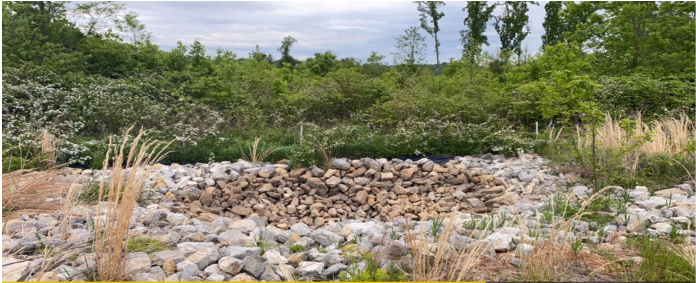
36°57'19" N 79°34'55" W 11°N COURSE 316° GPS Sandy Level, VA 24161, United States 05.10.2021 09:16:18 Accur +/-40.9 Ft ALT 933 Ft			36°57'13" N 79°34'50" W 51°NE COURSE 183° GPS Sandy Level, VA 24161, United States 05.10.2021 09:13:37 Accur +/-37.7 Ft ALT 909 Ft		
<b>GPS Location</b>	5	<b>GPS Location</b>	6		
<b>Field Station#</b>	15113+00	<b>Field Station#</b>	15121+00		
<b>Pic 5 Desc.</b>	RCE at Museville Rd in good condition		<b>Pic 6 Desc.</b>	Plunge pool dry and performing intended function

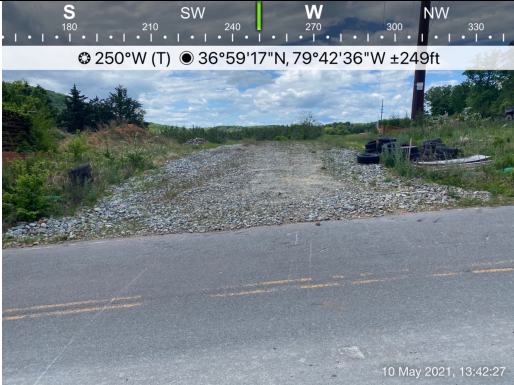
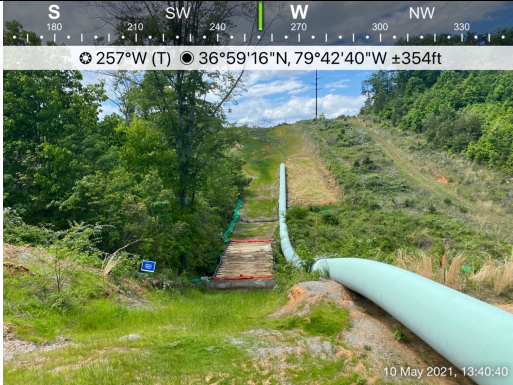
<b>GPS Location</b>	0	<b>GPS Location</b>	0		
<b>Field Station#</b>	14694+50	<b>Field Station#</b>	14689+36		
<b>Pic 1 Desc.</b>	Approximately 14694+50. Overview of road crossing and RCE.	<b>Pic 2 Desc.</b>	Approximately 14689+36. Overview of stream crossing, equipment bridge and ECDs at stream S-H34.

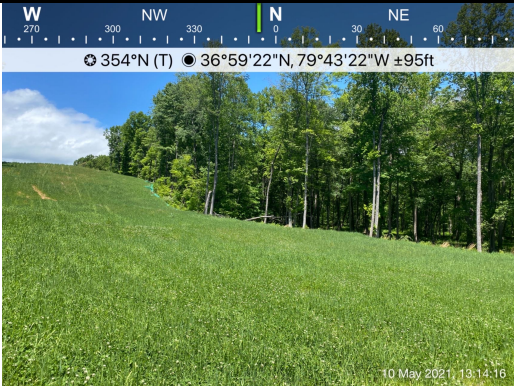
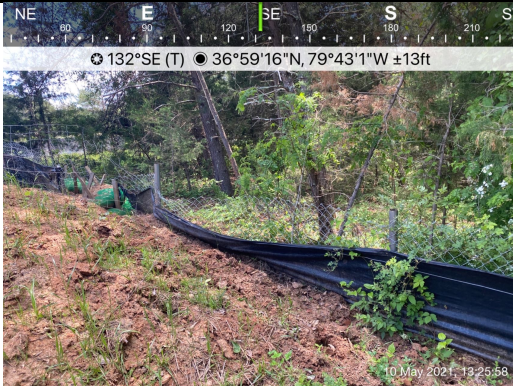
<b>GPS Location</b>	0	<b>GPS Location</b>	0		
<b>Field Station#</b>	14653+00	<b>Field Station#</b>	14673+80		
<b>Pic 5 Desc.</b>	Approximately 14653+00. Overview of ROW.	<b>Pic 6 Desc.</b>	Approximately 14673+80. SSF requires maintenance, appears to have been damaged by livestock. Reattach fabric to fence.

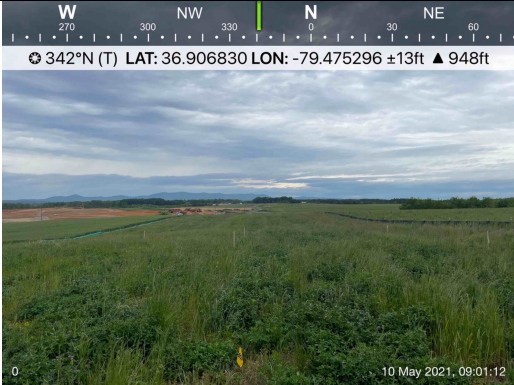
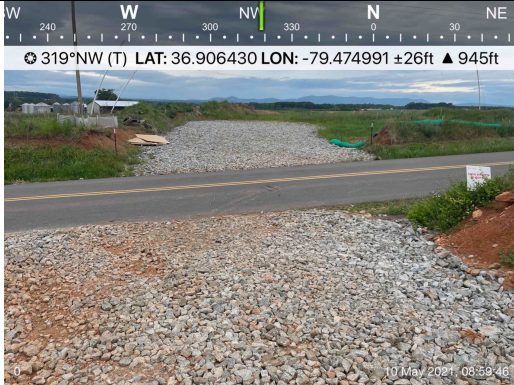
<b>GPS Location</b>	See photo		<b>GPS Location</b>	See photo	
<b>Field Station#</b>	15494+00		<b>Field Station#</b>	15496+70	
<b>Pic 1 Desc.</b>	Vegetation continues to fill in ROW.		<b>Pic 2 Desc.</b>	RCEs are in good condition at all road crossings.

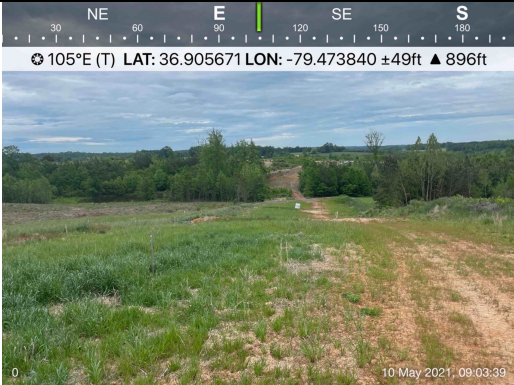
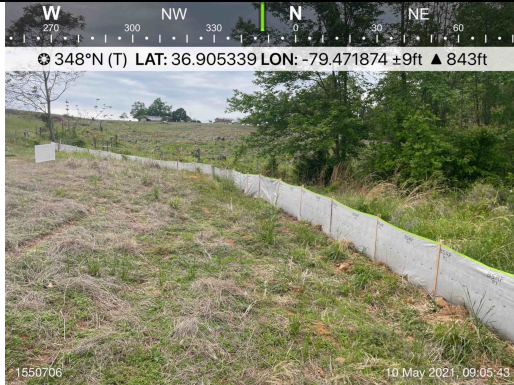
<b>GPS Location</b>	See photo		<b>GPS Location</b>	See photo	
<b>Field Station#</b>	15500+00		<b>Field Station#</b>	15507+06	
<b>Pic 3 Desc.</b>	Vegetation continues to fill in ROW.		<b>Pic 4 Desc.</b>	P1 is in good condition at all stream and wetland buffers.

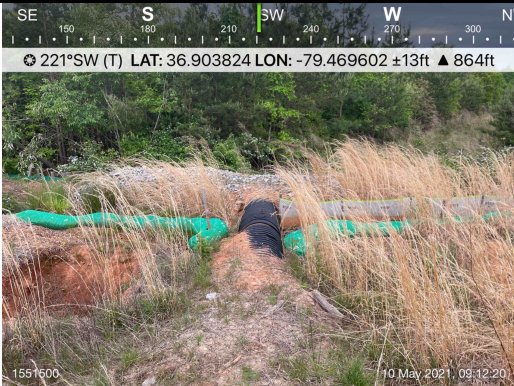
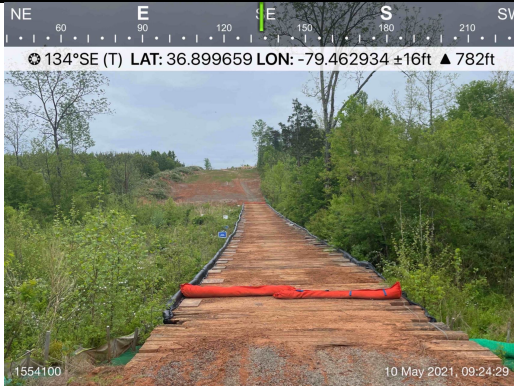
<b>GPS Location</b>	See photo		<b>GPS Location</b>	See photo	
<b>Field Station#</b>	15515+00		<b>Field Station#</b>	15541+00	
<b>Pic 5 Desc.</b>	CWDs are functioning as intended.		<b>Pic 6 Desc.</b>	Equipment bridge ECDs remain in good condition.

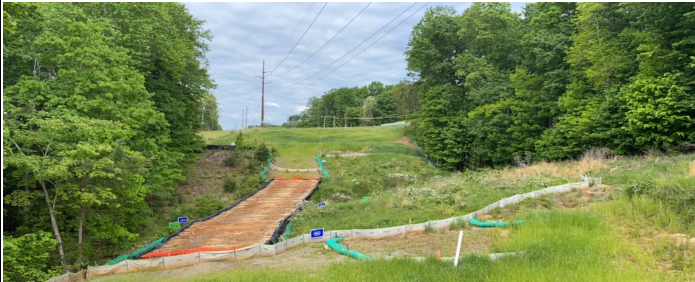
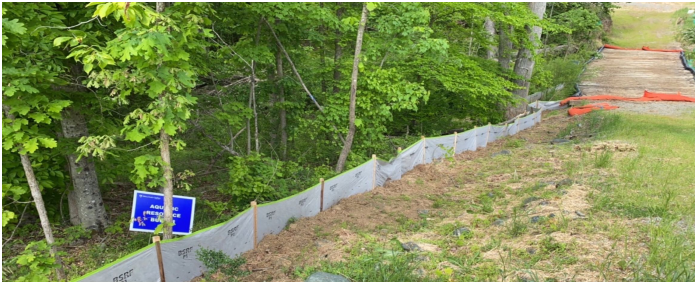
36°59'16" N 79°42'7" W 277°W COURSE 274° GPS Union Hall, VA 24176, United States 05.11.2021 10:17:00 Accur +/-104.7 Ft ALT 891 Ft			36°59'16" N 79°42'1" W 258°W COURSE 278° GPS Sorry no results found 05.11.2021 10:14:17 Accur +/-163.6 Ft ALT 941 Ft		
GPS Location	1	GPS Location	2		
Field Station#	14722+60	Field Station#	14730+00		
Pic 1 Desc.	Equipment bridge and surrounding ECDs in place and functional		Pic 2 Desc.	Contractor installed new row of P1 silt fence along perimeter of ROW

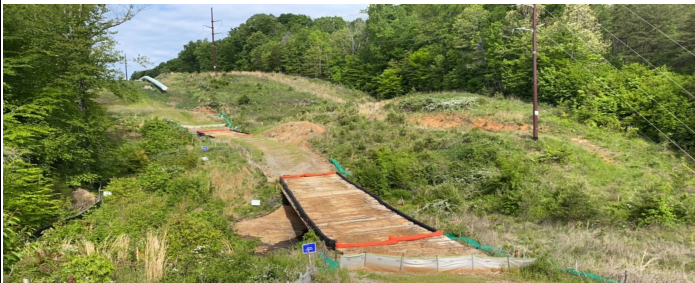
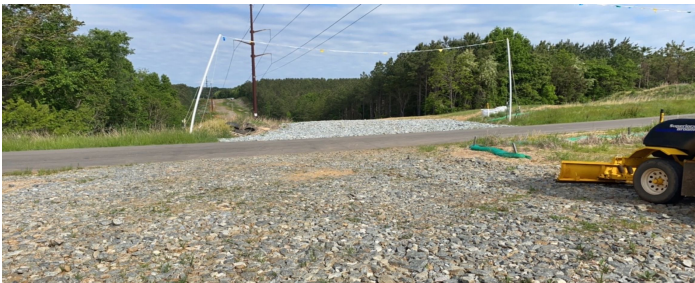
Pic 3 Desc.	Equipment bridge and surrounding ECDs in place and functional		Pic 4 Desc.	RCE at Indian Cave Rd in good condition

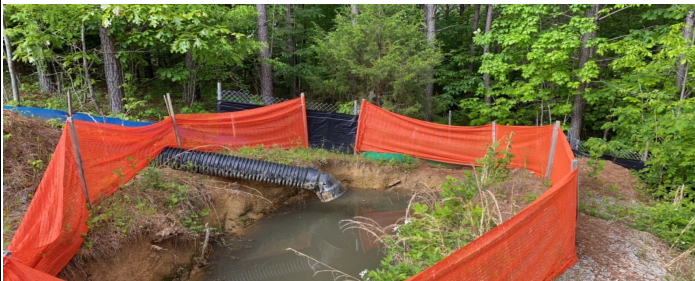
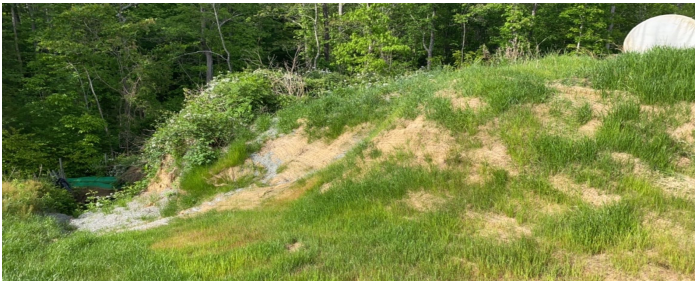
36°58'42" N 79°40'52" W 297°NW COURSE 295° GPS Penhook, VA 24137, United States 05.11.2021 09:45:31 Accur +/-16421.8 Ft ALT 934 Ft			36°58'42" N 79°40'52" W 227°SW COURSE 295° GPS Union Hall, VA 24176, United States 05.11.2021 09:35:25 Accur +/-87.4 Ft ALT 934 Ft		
GPS Location	5	GPS Location	6		
Field Station#	14783+00	Field Station#	14787+00		
Pic 5 Desc.	Slope drain tile outlet and sump performing intended functions		Pic 6 Desc.	Area where contractor installed erosion control blanket now stabilized and growing vegetation

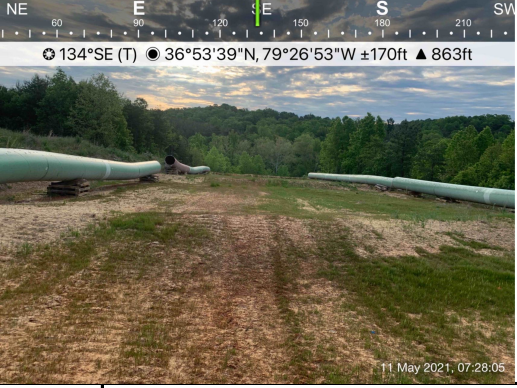
<b>GPS Location</b>	O	<b>GPS Location</b>	O		
<b>Field Station#</b>	15587+00	<b>Field Station#</b>	15589+00		
<b>Pic 1 Desc.</b>	Observing CFS that requires maintenance	<b>Pic 2 Desc.</b>	Observing temporary stabilization and water bars

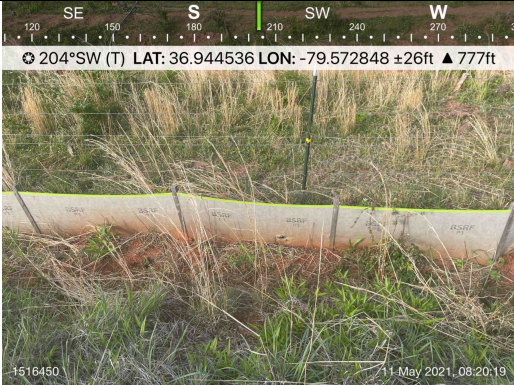
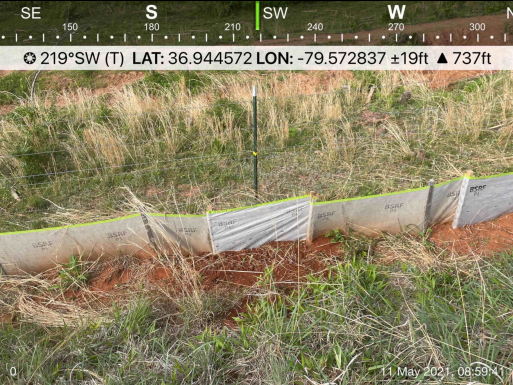
<b>GPS Location</b>	See photo		<b>GPS Location</b>	See photo	
<b>Field Station#</b>	15164+50		<b>Field Station#</b>	15164+50	
<b>Pic 1 Desc.</b>	P1 has been damaged and needs to be replaced.		<b>Pic 2 Desc.</b>	Environmental crew has corrected this issue.

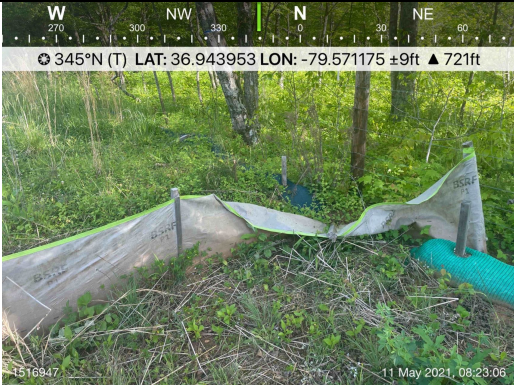
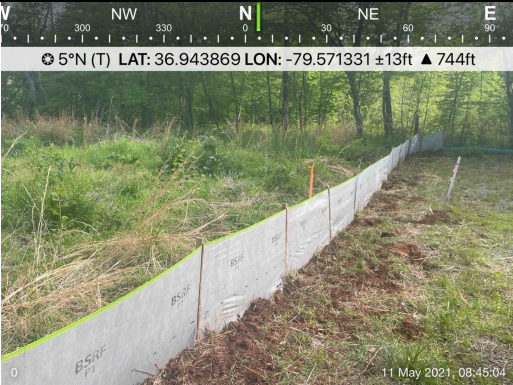
<b>GPS Location</b>	See photo		<b>GPS Location</b>	See photo	
<b>Field Station#</b>	15169+47		<b>Field Station#</b>	15169+47	
<b>Pic 3 Desc.</b>	P1 has been damaged and needs to be replaced.		<b>Pic 4 Desc.</b>	Environmental crew has corrected this issue.

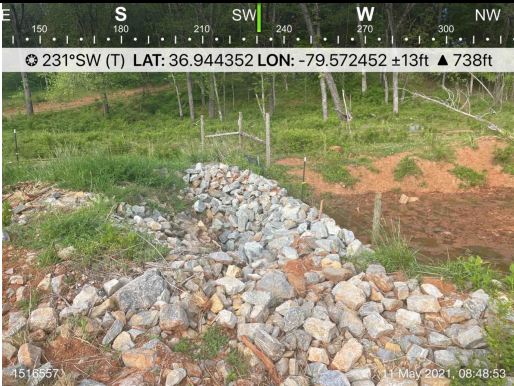
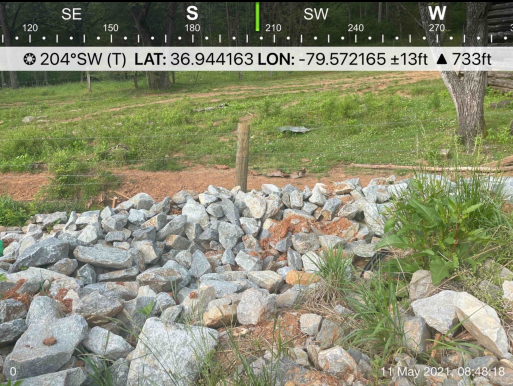
<b>GPS Location</b>	See photo		<b>GPS Location</b>	See photo	
<b>Field Station#</b>	15165+57		<b>Field Station#</b>	15166+00	
<b>Pic 5 Desc.</b>	Rock inlet remains in good condition.		<b>Pic 6 Desc.</b>	Rock outlet remains in good condition.

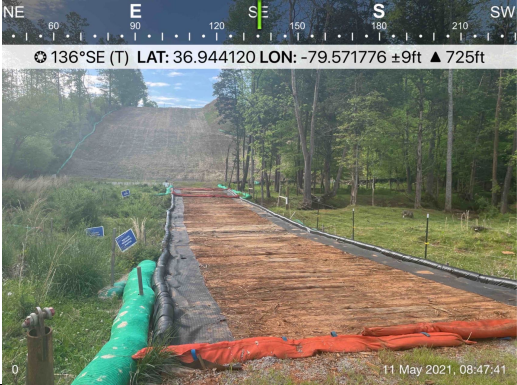
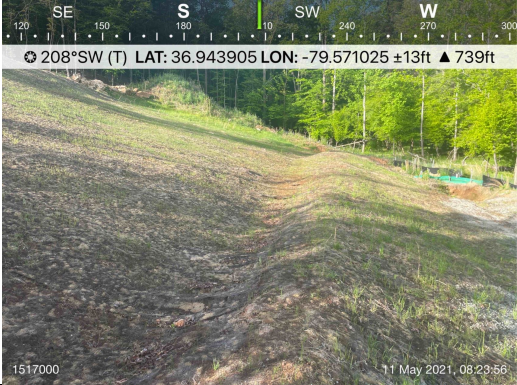
<b>GPS Location</b>	See photo		<b>GPS Location</b>	See photo	
<b>Field Station#</b>	15168+49		<b>Field Station#</b>	15170+00	
<b>Pic 7 Desc.</b>	Equipment bridge ECDs are in place and in good condition.		<b>Pic 8 Desc.</b>	Waterbars are in good condition and functioning throughout this section.

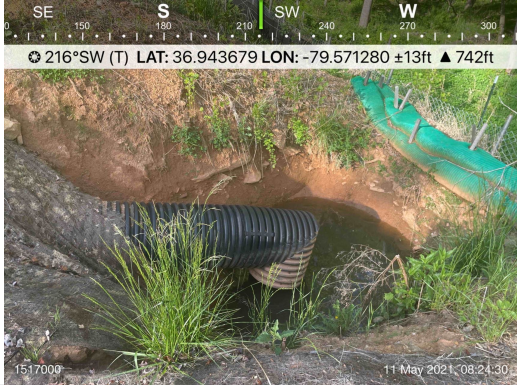
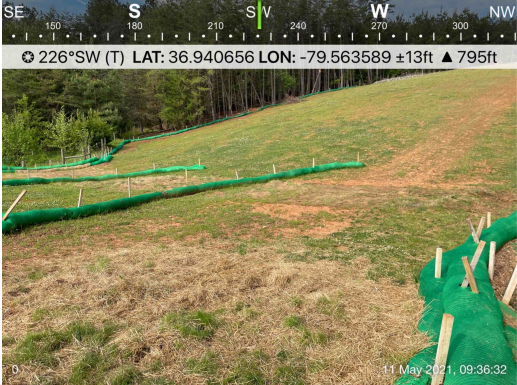
<b>GPS Location</b>	See photo		<b>GPS Location</b>	See photo	
<b>Field Station#</b>	15170+00		<b>Field Station#</b>	15195+00	
<b>Pic 9 Desc.</b>	Slope drain is functioning as intended.		<b>Pic 10 Desc.</b>	Drainage ECDs are in place and functioning.

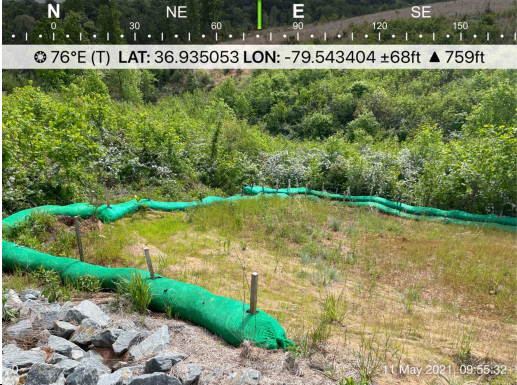
<b>GPS Location</b>	See photo	<b>GPS Location</b>			
<b>Field Station#</b>	15260+00	<b>Field Station#</b>			
<b>Pic 13 Desc.</b>	Erosion repair remains in good condition at this location.	<b>Pic 14 Desc.</b>			
Insert image here		Insert image here			
<b>GPS Location</b>		<b>GPS Location</b>			
<b>Field Station#</b>		<b>Field Station#</b>			
<b>Pic 15 Desc.</b>		<b>Pic 16 Desc.</b>			
Insert image here		Insert image here			
<b>GPS Location</b>		<b>GPS Location</b>			
<b>Field Station#</b>		<b>Field Station#</b>			
<b>Pic 17 Desc.</b>		<b>Pic 18 Desc.</b>

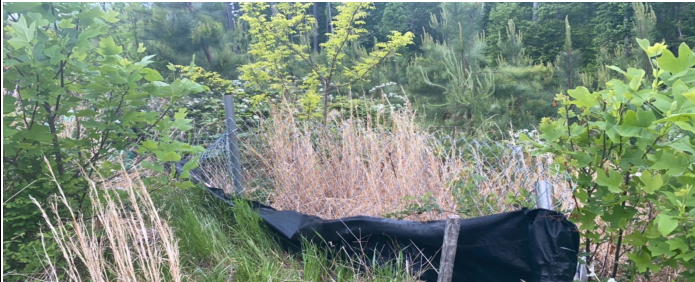
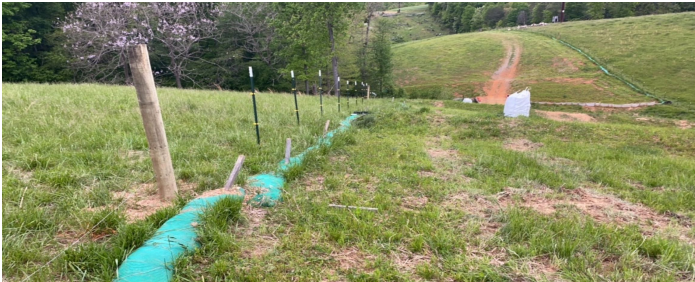
36°58'34" N 79°40'39" W 275°W COURSE 147° GPS 05.12.2021 08:11:03 Penhook, VA 24137, United States Accur +/-42.5 Ft ALT 924 Ft			36°58'4" N 79°38'21" W 340°N COURSE -1° GPS 05.12.2021 07:34:35 2019 Ramsey Memorial Rd, Penhook, VA 24137, United States Accur +/-35.0 Ft ALT 865 Ft		
GPS Location	1		GPS Location	2	
Field Station#	14805+50		Field Station#	14927+00	
Pic 1 Desc.	Routine maintenance. Reattach geotextile fabric to fencing where down.		Pic 2 Desc.	Routine maintenance. Replace perimeter CFS in section where damaged/worn.

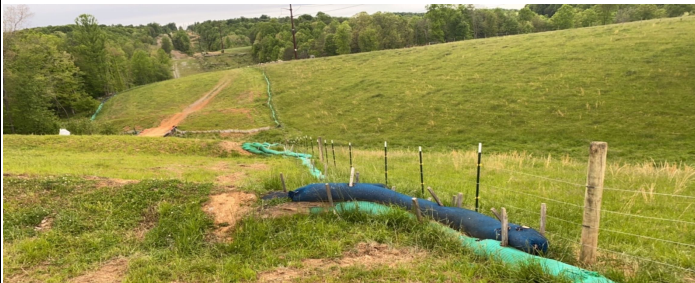
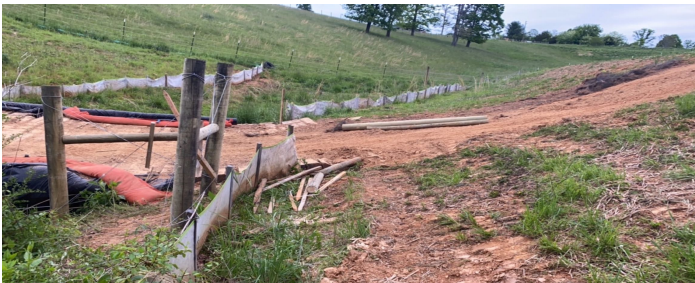
GPS Location	3		GPS Location	4	
Field Station#	14924+00		Field Station#	14923+00	
Pic 3 Desc.	Routine maintenance. Replace damaged/worn CFS end treatments where needed.		Pic 4 Desc.	Routine maintenance. Replace damaged/worn P1 silt fence where needed.

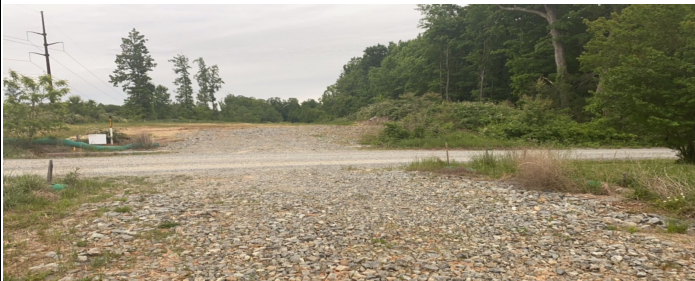
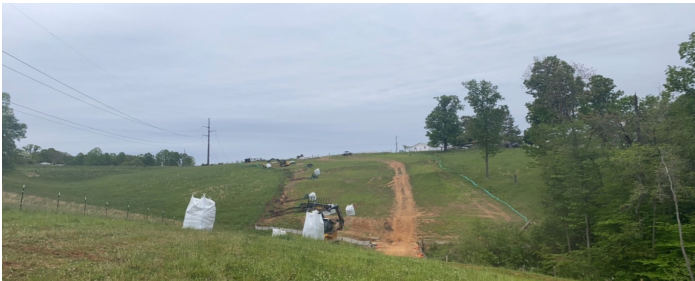
36°58'17" N 79°39'37" W 130°SE COURSE 102° GPS 05.12.2021 08:39:22 Penhook, VA 24137, United States Accur +/-36.4 Ft ALT 988 Ft			36°58'5" N 79°38'26" W 116°SE COURSE 197° GPS 05.12.2021 09:06:17 Sorry no results found Accur +/-89.7 Ft ALT 820 Ft		
GPS Location	5		GPS Location	6	
Field Station#	14861+31		Field Station#	14926+00	
Pic 5 Desc.	RCE at Bar Ridge Rd in good condition.		Pic 6 Desc.	Contractor performing environmental maintenance in section.

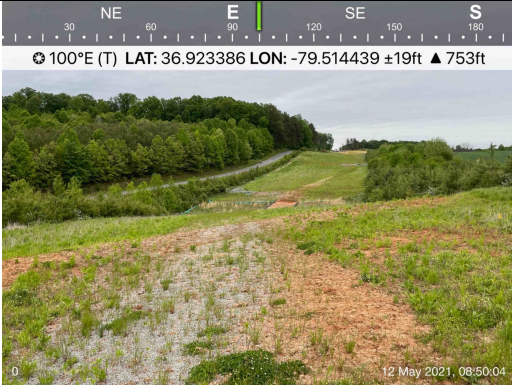
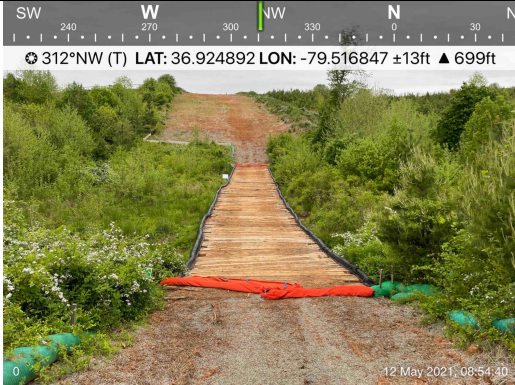
<b>GPS Location</b>	See photo		<b>GPS Location</b>	See photo	
<b>Field Station#</b>	15360+00		<b>Field Station#</b>	15346+70	
<b>Pic 1 Desc.</b>	Vegetation continues to fill in throughout this section of ROW.		<b>Pic 2 Desc.</b>	Equipment bridge ECDs are in good condition and functioning.

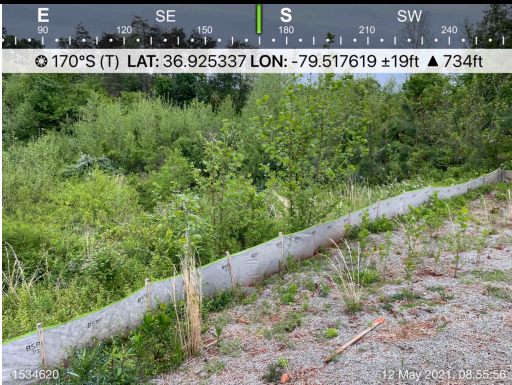
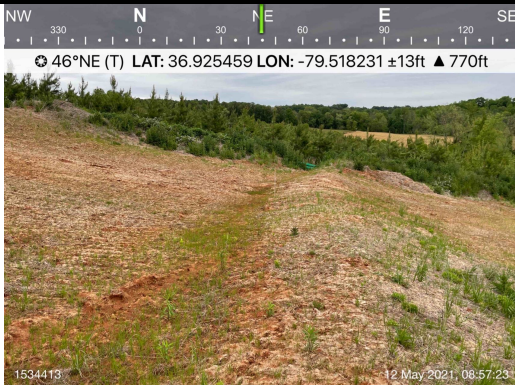
<b>GPS Location</b>	See photo		<b>GPS Location</b>	See photo	
<b>Field Station#</b>	15346+20		<b>Field Station#</b>	15344+13	
<b>Pic 3 Desc.</b>	P1 is in good condition at all stream and wetland buffers.		<b>Pic 4 Desc.</b>	Waterbars are in good condition throughout this section.

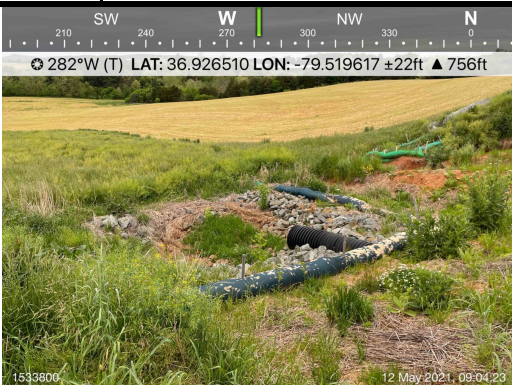
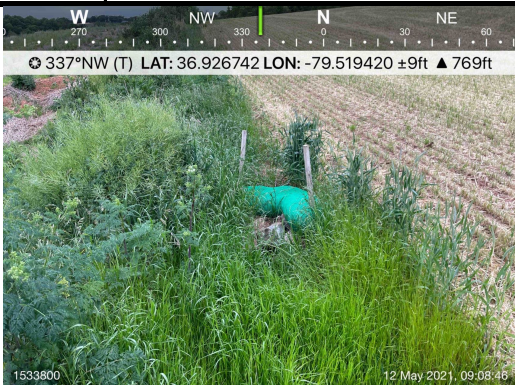
<b>GPS Location</b>	See photo		<b>GPS Location</b>	See photo	
<b>Field Station#</b>	15338+00		<b>Field Station#</b>	15338+00	
<b>Pic 5 Desc.</b>	CWD is in good condition and functioning.		<b>Pic 6 Desc.</b>	CWD inlet in good condition along wheat field.

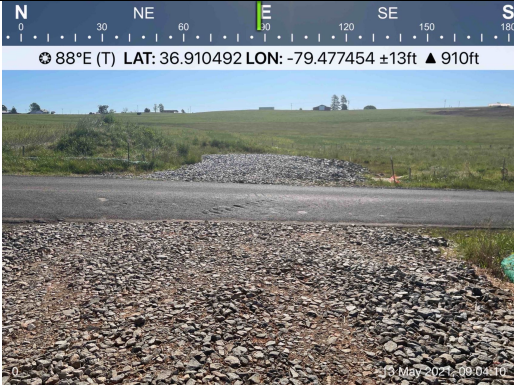
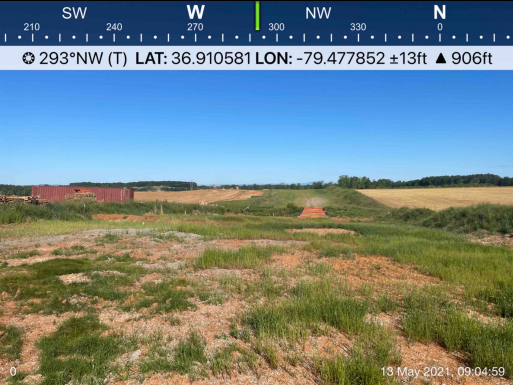
<b>GPS Location</b>	See photo		<b>GPS Location</b>	See photo	
<b>Field Station#</b>	15480+67		<b>Field Station#</b>	15478+00	
<b>Pic 1 Desc.</b>	RCEs are in good condition at road crossings.		<b>Pic 2 Desc.</b>	Vegetation continues to fill in ROW.

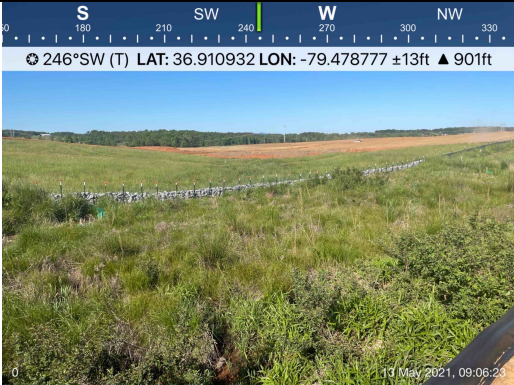
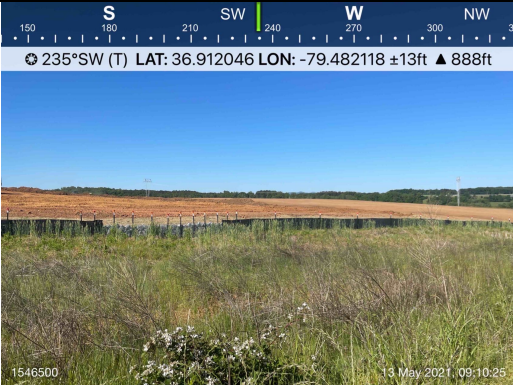
<b>GPS Location</b>	See photo		<b>GPS Location</b>	See photo	
<b>Field Station#</b>	15475+00		<b>Field Station#</b>	15465+00	
<b>Pic 3 Desc.</b>	3rd party rock outlet appears to be in good condition in this drainage.		<b>Pic 4 Desc.</b>	3rd party rock outlet appears to be in good condition with no evidence of sedimentation.

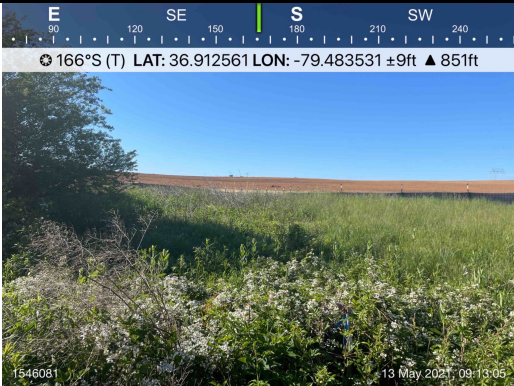
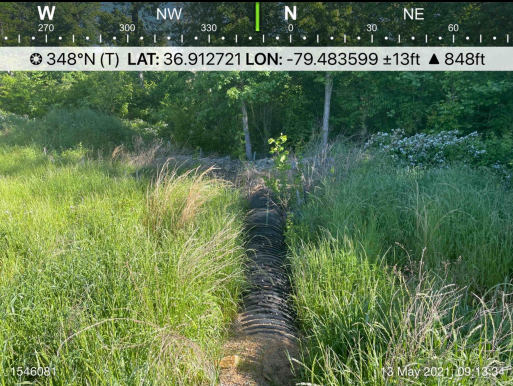
<b>GPS Location</b>	See photo		<b>GPS Location</b>	See photo	
<b>Field Station#</b>	15460+81		<b>Field Station#</b>	15460+81	
<b>Pic 5 Desc.</b>	3rd party rock outlet appears to be in good condition with no evidence of sedimentation into this CWD.		<b>Pic 6 Desc.</b>	CWDs are in good condition throughout this section.

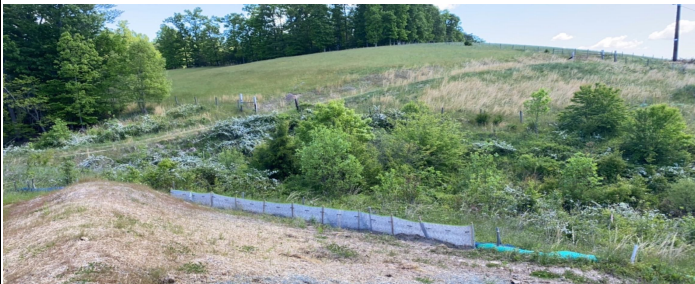
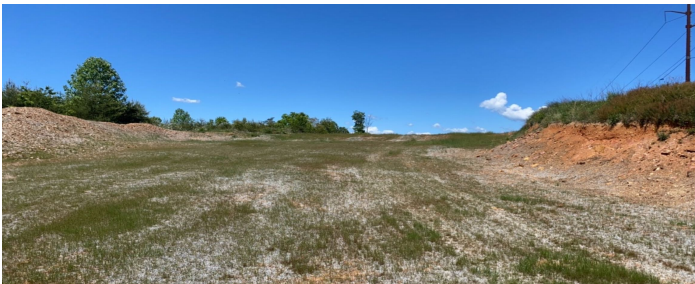
36°58'3" N 79°38'12" W 12" N COURSE 97' GPS Sorry no results found 05.13.2021 11:46:55 Accur +/-15.5 Ft ALT 845 Ft			36°58'1" N 79°37'54" W 271" W COURSE 228' GPS Sorry no results found 05.13.2021 11:40:56 Accur +/-15.4 Ft ALT 833 Ft		
GPS Location	1	GPS Location	2		
Field Station#	14932+25	Field Station#	14945+00		
Pic 1 Desc.	Contractor replaced P1 silt fence at edge of resource buffer per punch list item.		Pic 2 Desc.	Area stabilized with Edge pellets and vegetation growing in temporary seeded area.

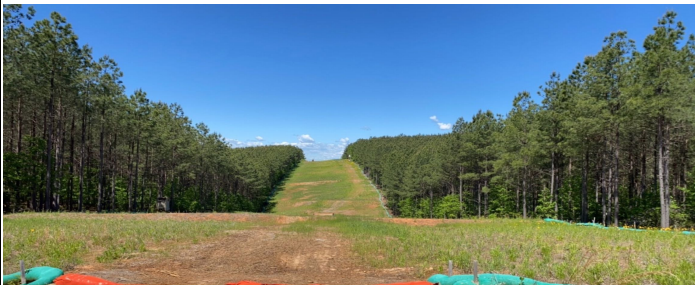
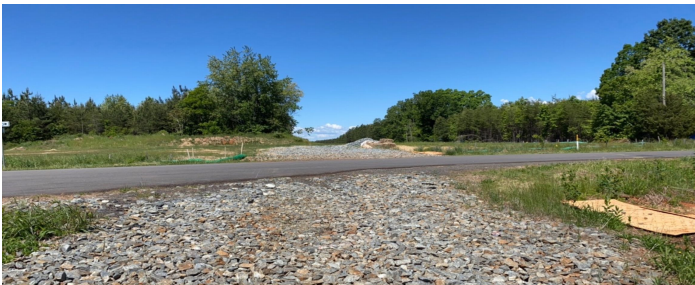
Field Station#	14967+00	Field Station#	14981+55		
Pic 3 Desc.	Vegetation growing in final cleanup area along ROW.		Pic 4 Desc.	RCE at Snow Creek Rd in good condition.

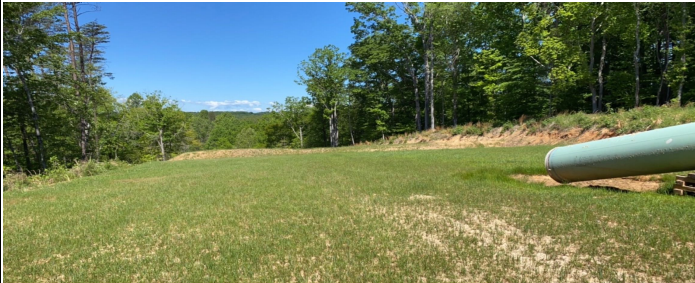
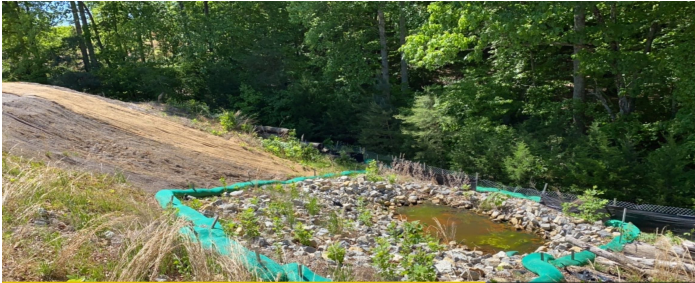
36°57'54" N 79°35'50" W 322" NW COURSE 289' GPS Penhook, VA 24137, United States 05.13.2021 10:52:33 Accur +/-15.4 Ft ALT 877 Ft			36°57'52" N 79°35'46" W 221" SW COURSE 92' GPS Penhook, VA 24137, United States 05.13.2021 10:51:00 Accur +/-59.7 Ft ALT 871 Ft		
GPS Location	5	GPS Location	6		
Field Station#	15050+00	Field Station#	15054+00		
Pic 5 Desc.	Vegetation growing in temporary seeded area of ROW.		Pic 6 Desc.	Plunge pool performing intended function. CFS, SSF, and erosion control blanket in place and functional in area.

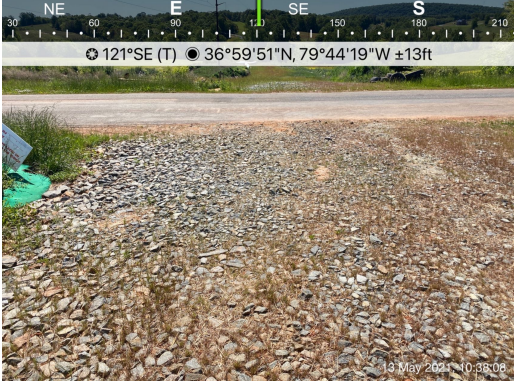
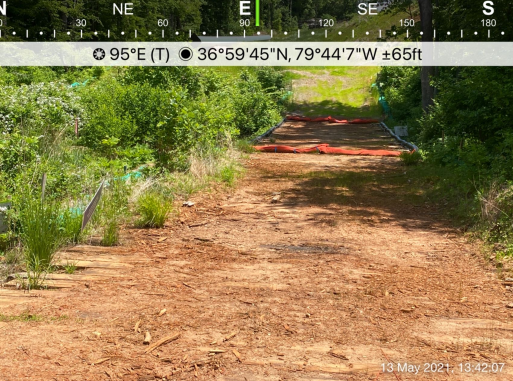
<b>GPS Location</b>	0	<b>GPS Location</b>	0		
<b>Field Station#</b>	14599+00	<b>Field Station#</b>	14611+27		
<b>Pic 1 Desc.</b>	Approximately 14599+00. Overview of road crossing and RCEs.		<b>Pic 2 Desc.</b>	Approximately 14611+27. Overview of stream crossing, equipment bridge and ECDs at stream S-E14.

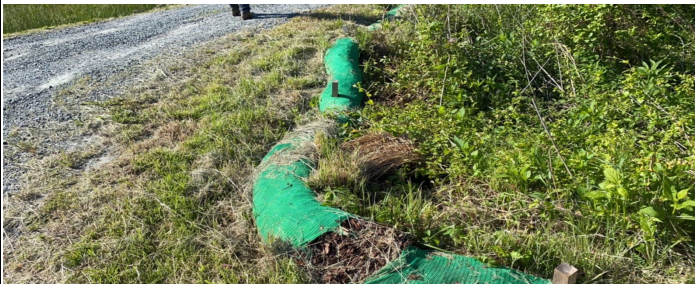
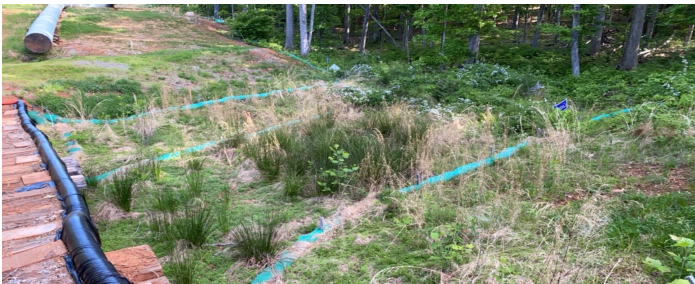
36°57'57" N 79°35'11" W 162°S COURSE 328° GPS 13685 W Gretna Rd, Sandy Level, VA 24161, United States 05.14.2021 09:34:33 Accur +/-27.2 Ft ALT 937 Ft			36°56'54" N 79°34'43" W 294°NW COURSE 237° GPS 337-521 Rockcreek Rd, Sandy Level, VA 24161, United States 05.14.2021 08:58:56 Accur +/-55.1 Ft ALT 859 Ft		
GPS Location	1	GPS Location	2		
Field Station#	15080+64	Field Station#	15141+00		
Pic 1 Desc.	Routine maintenance. Repair/replace damaged perimeter CFS along access road.	Pic 2 Desc.	Equipment bridge and surrounding ECDs in place and functional at stream crossing.

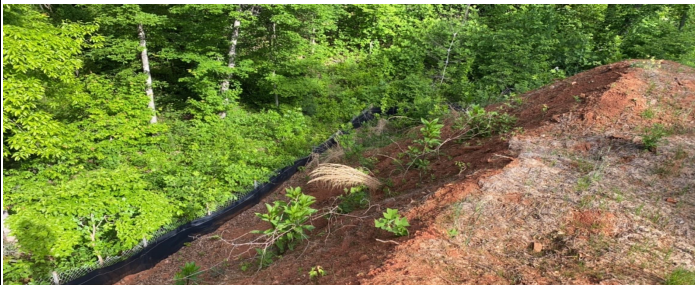
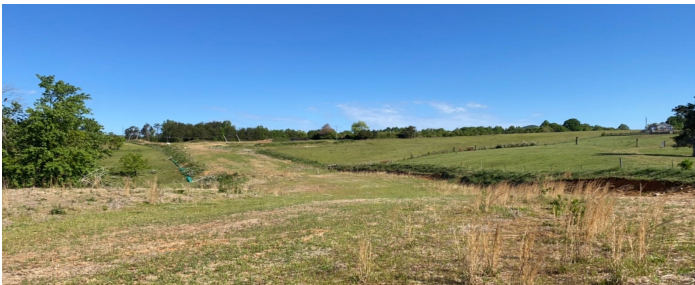
GPS Location	3	GPS Location	4		
Field Station#	15136+00	Field Station#	15087+42		
Pic 3 Desc.	SSF behind spoil pile in good condition. Spoil pile is stabilized.	Pic 4 Desc.	Picture of temporary vegetation growing along ROW.

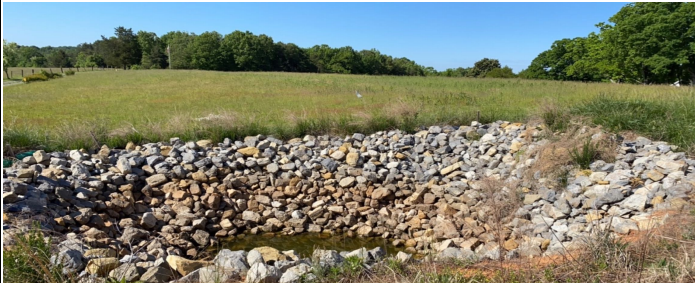
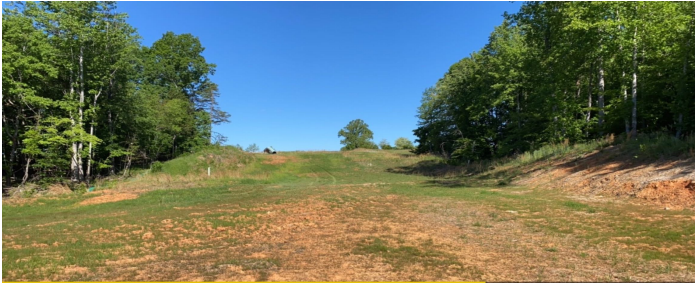
36°57'43" N 79°35'18" W 264°W COURSE 57° GPS Sandy Level, VA 24161, United States 05.14.2021 09:41:15 Accur +/-20.7 Ft ALT 912 Ft			36°57'44" N 79°35'27" W 325°NW COURSE 261° GPS Sandy Level, VA 24161, United States 05.14.2021 09:45:14 Accur +/-133.1 Ft ALT 864 Ft		
GPS Location	5	GPS Location	6		
Field Station#	15079+00	Field Station#	15070+00		
Pic 5 Desc.	Plunge pool performing intended function.	Pic 6 Desc.	Picture of temporary vegetation growing along ROW.

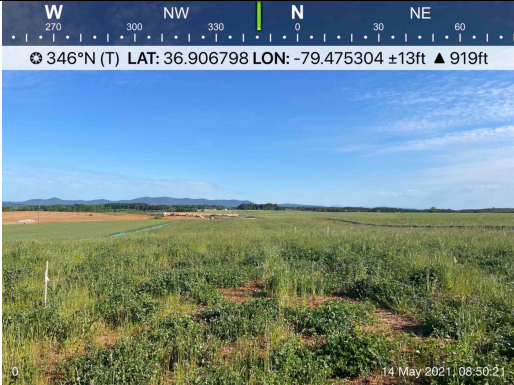
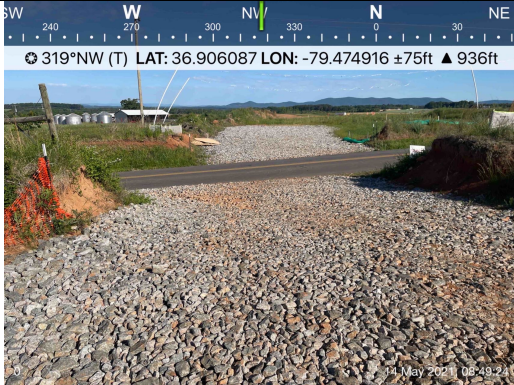
<b>GPS Location</b>	See photo		<b>GPS Location</b>	See photo	
<b>Field Station#</b>	15495+00		<b>Field Station#</b>	15496+70	
<b>Pic 1 Desc.</b>	Vegetation continues to fill in ROW.		<b>Pic 2 Desc.</b>	RCEs are in good condition at all road crossings.

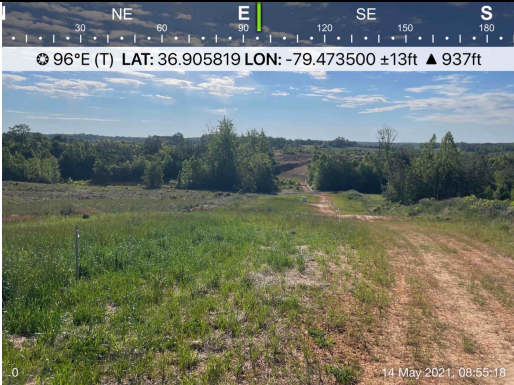
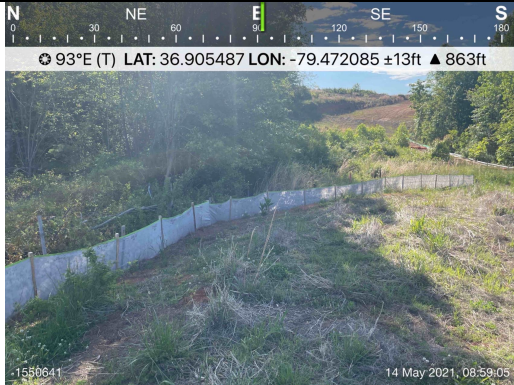
<b>GPS Location</b>	See photo		<b>GPS Location</b>	See photo	
<b>Field Station#</b>	15500+00		<b>Field Station#</b>	15506+41	
<b>Pic 3 Desc.</b>	Vegetation continues to fill in ROW.		<b>Pic 4 Desc.</b>	P1 is in good condition at all stream and wetland buffers.

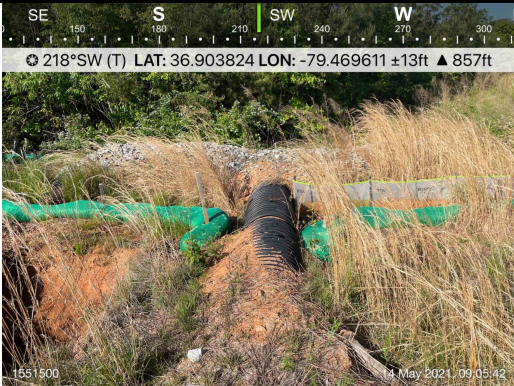
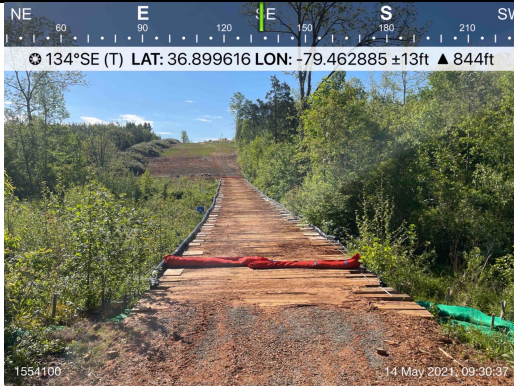
<b>GPS Location</b>	See photo		<b>GPS Location</b>	See photo	
<b>Field Station#</b>	15515+00		<b>Field Station#</b>	15541+00	
<b>Pic 5 Desc.</b>	CWDs are in good condition throughout this section.		<b>Pic 6 Desc.</b>	Equipment bridge ECDs are in good condition.
