Visual Site Inspection Report

Project Name	H-600 Pipeline Spread I		AFE	124300139	Spread	H-600 Pipeline Spread I	
Contractor	Precision				Report #	23470	
Inspector	John White				Date/Time	5/17/2021 10:10 AM	
Permit #	TBD	Inspection Type	VA SWPP		Station Begin	15584+23	
State	VA	Inspection Area	Full		Station End	15647+03	
County	Pittsylvania	Ground	Dry		Temperature (°F)	67.00	
Municipality	Chatham	Weather	Cloudy		Rain Gauge (in)	0.00	
					Rain Accumulation Time (days)	6.00

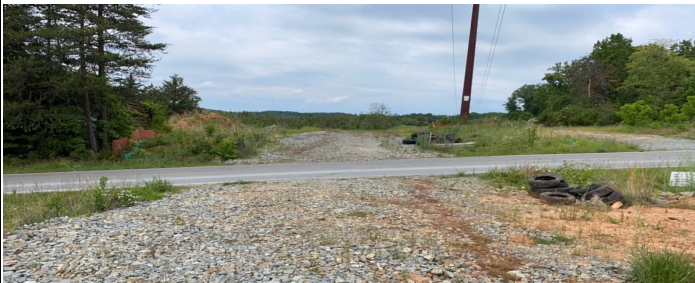
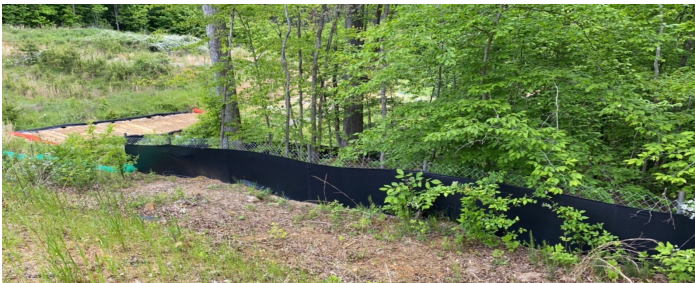
Pic 3 Desc.	RCE at Jacks Creek Rd in good condition		Pic 4 Desc.	Perimeter SSF in good condition.

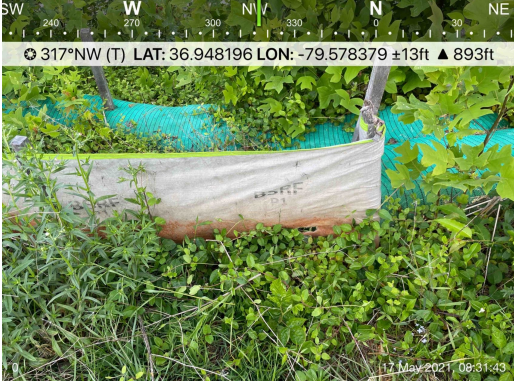
GPS Location	See photo		GPS Location	See photo	
Field Station#	15143+00		Field Station#	15143+00	
Pic 1 Desc.	P1 is damaged and needs to be replaced.		Pic 2 Desc.	Environmental crew has corrected this issue.

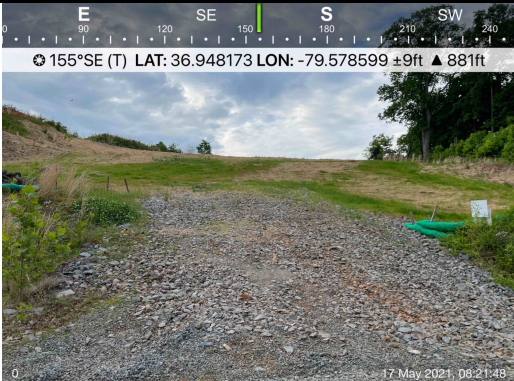
GPS Location	See photo		GPS Location	See photo	
Field Station#	15142+66		Field Station#	15165+57	
Pic 5 Desc.	RCE is in good condition at Rockcreek Rd.		Pic 6 Desc.	Rock inlet remains in good condition.

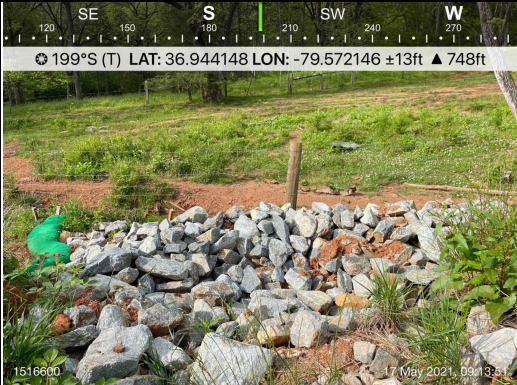
GPS Location	See photo		GPS Location	See photo	
Field Station#	15166+00		Field Station#	15167+95	
Pic 7 Desc.	Rock outlet remains in good condition.		Pic 8 Desc.	P1 is in good condition at stream buffers.

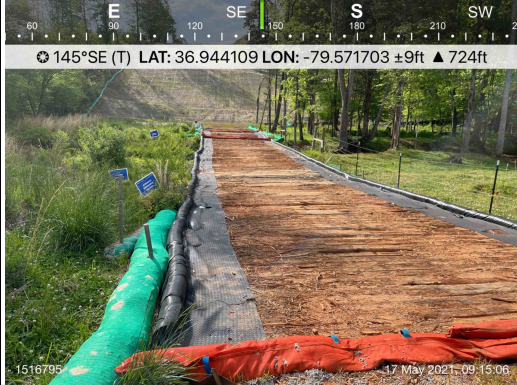
GPS Location	See photo		GPS Location	See photo	
Field Station#	15167+95		Field Station#	15170+00	
Pic 9 Desc.	Equipment bridge ECDs are in place and functioning.		Pic 10 Desc.	Waterbars are in good condition throughout this section.

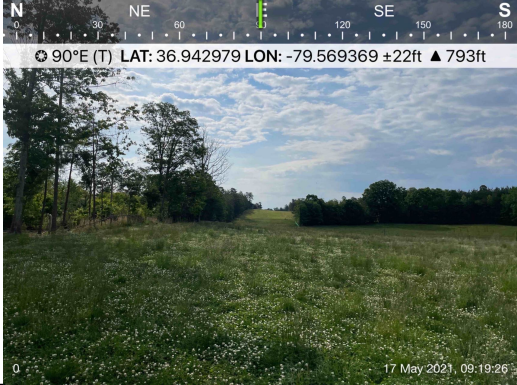
GPS Location	See photo		GPS Location	See photo	
Field Station#	15170+00		Field Station#	15175+00	
Pic 11 Desc.	Slope drain remains in good condition.		Pic 12 Desc.	Vegetation continues to fill in throughout this section of ROW.

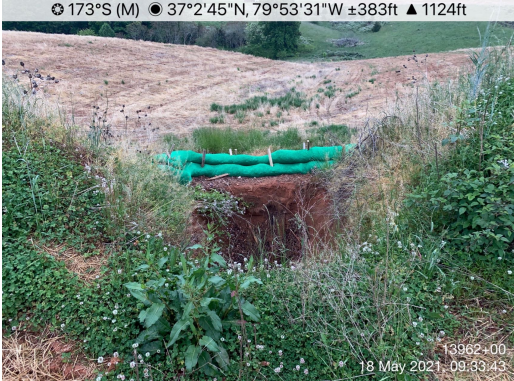
GPS Location	0	GPS Location	0		
Field Station#	13962+00	Field Station#	13967+00		
Pic 1 Desc.	Sump pit in acceptable condition	Pic 2 Desc.	Clean water diversion plunge pool in acceptable condition

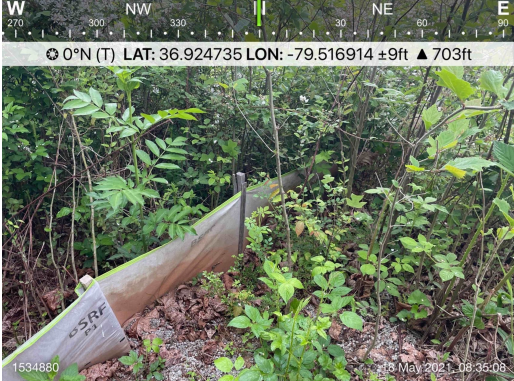
GPS Location	See photo	GPS Location	See photo		
Field Station#	15348+80	Field Station#	15323+00		
Pic 1 Desc.	P1 is degraded and needs to be replaced.	Pic 2 Desc.	P1 is degraded and needs to be replaced.

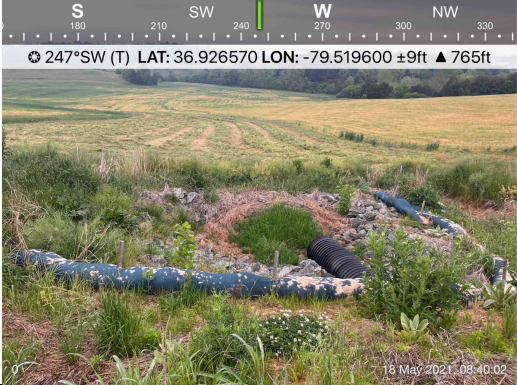
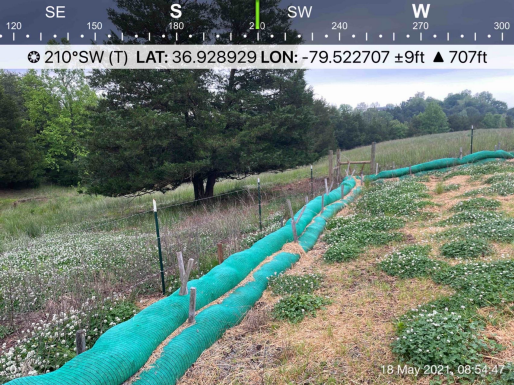
GPS Location	See photo		GPS Location	See photo	
Field Station#	15338+00		Field Station#	15325+24	
Pic 7 Desc.	CWDs are in good condition throughout this section.		Pic 8 Desc.	CFS is in good condition.

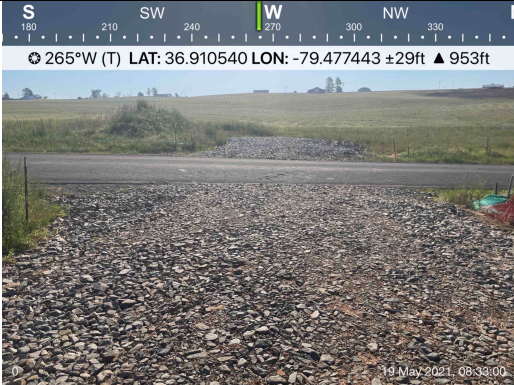
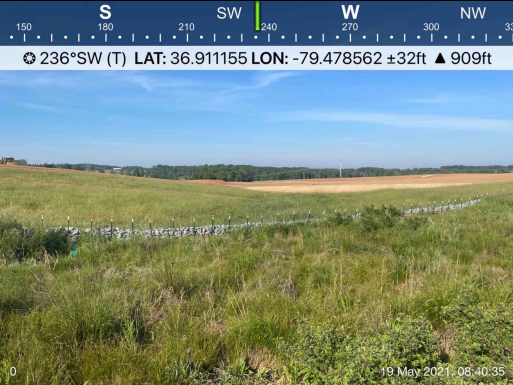
GPS Location	See photo		GPS Location	See photo	
Field Station#	15480+67		Field Station#	15475+00	
Pic 1 Desc.	RCEs are in good condition at all road crossings.		Pic 2 Desc.	3rd party rock outlet in good condition along this drainage.

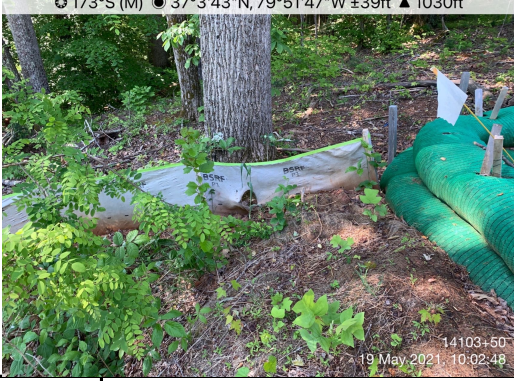
GPS Location	0	GPS Location	0		
Field Station#	14103+50	Field Station#	14080+00		
Pic 3 Desc.	P1 silt fence damaged by livestock or wildlife	Pic 4 Desc.	Clean water diversion plunge pool in acceptable condition

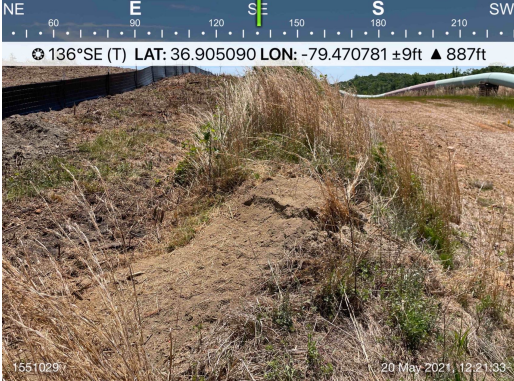
GPS Location	See photo		GPS Location	See photo	
Field Station#	15510+29		Field Station#	15495+00	
Pic 1 Desc.	3rd party has disturbed topsoil berm. This area needs to be stabilized.		Pic 2 Desc.	Vegetation continues to fill in ROW throughout this section.
