Visual Site Inspection Report

Project Name	H-600 Pipeline Spread I	AFE	124300139	Spread	H-600 Pipeline Spread I
Contractor	Precision			Report #	23723
Inspector	John White			Date/Time	5/24/2021 10:27 AM
Permit #	TBD	Inspection Type	VA SWPP	Station Begin	15647+03
State	VA	Inspection Area	Full	Station End	15772+27
County	Pittsylvania	Ground	Dry	Temperature (°F)	86.00
Municipality	Chatham	Weather	Cloudy	Rain Gauge (in)	0.00
				Rain Accumulation Time (days)	6.00

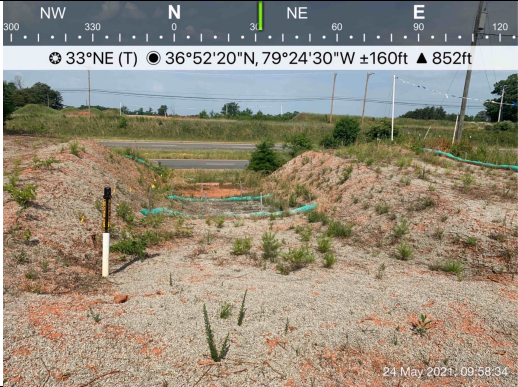
GPS Location	O	GPS Location	O		
Field Station#	15746+00	Field Station#	15745+00		
Pic 1 Desc.	Observing safety fence that requires maintenance	Pic 2 Desc.	Observing temporary stabilization and ECD's

E&S BMPs	Compliance Level	Corrective Action	Corrective Time Frame	Date Repaired
Cleanwater Diversion Pipe	Acceptable			
Compost Filter Sock	Acceptable			
Equipment Bridge	Acceptable			
Erosion Control Blanket	Acceptable			
Housekeeping	Acceptable			
Rock Filter Outlet	Acceptable			
Sensitive Resource Buffer	Acceptable			
Sensitive Resource Signage	Acceptable			
Other - Explain in Comments	Communication	Repair safety fence

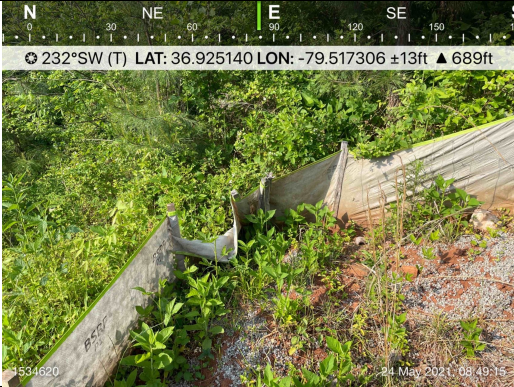
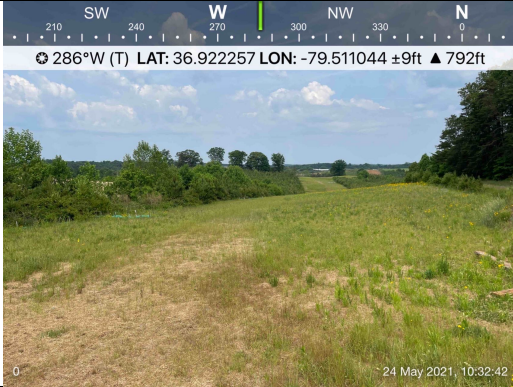
<p>286°W (T) LAT: 36.922257 LON: -79.511044 ±9ft ▲ 792ft</p> <p>0 24 May 2021, 10:32:42</p>			
GPS Location	See photo		GPS Location	See photo	
Field Station#	15346+20		Field Station#	15370+00	
Pic 1 Desc.	P1 has been damaged and needs to be replaced.		Pic 2 Desc.	Vegetation continues to fill in ROW throughout this section.

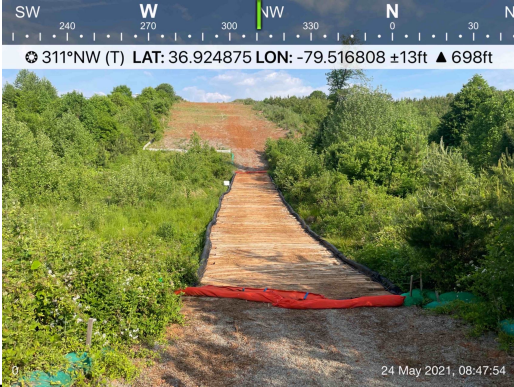
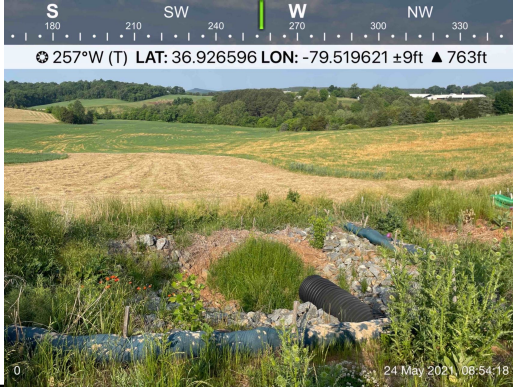
<p>257°W (T) LAT: 36.926596 LON: -79.519621 ±9ft ▲ 763ft</p> <p>0 24 May 2021, 08:54:18</p>			
GPS Location	See photo		GPS Location	See photo	
Field Station#	15346+70		Field Station#	15338+00	
Pic 3 Desc.	Equipment bridge ECDs are in good condition and functioning.		Pic 4 Desc.	CWDs are in good condition throughout this section of ROW.

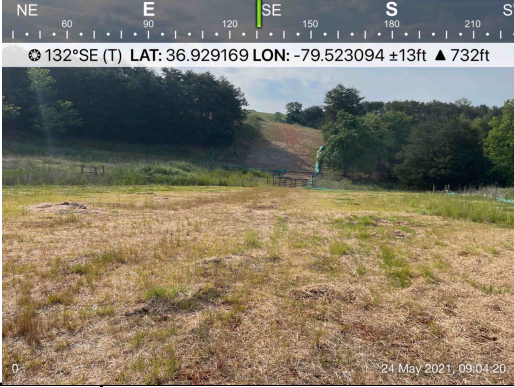
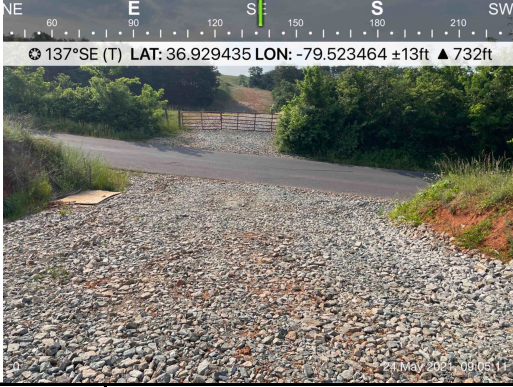
<p>137°SE (T) LAT: 36.929435 LON: -79.523464 ±13ft ▲ 732ft</p> <p>0 24 May 2021, 09:05:17</p>			
GPS Location	See photo		GPS Location	See photo	
Field Station#	15325+00		Field Station#	15323+24	
Pic 5 Desc.	Vegetation continues to fill in ROW throughout this section.		Pic 6 Desc.	RCEs are in good condition at all road crossings.

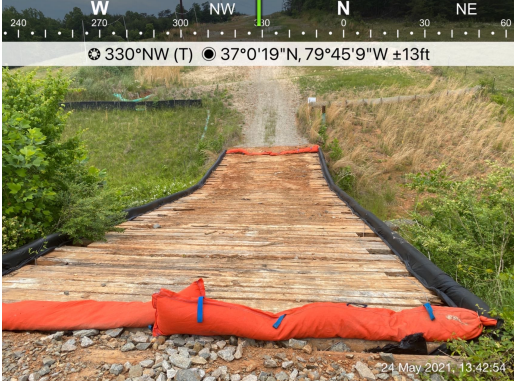
GPS Location	0	GPS Location	0		
Field Station#	14546+33	Field Station#	14524+50		
Pic 1 Desc.	Approximately 14546+33. Overview of stream crossing, equipment bridge and ECDs at stream S-G17.		Pic 2 Desc.	Approximately 14524+50. Overview of road crossing and RCEs.

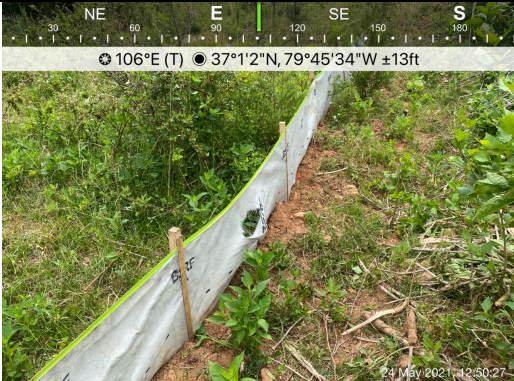
GPS Location	0	GPS Location	0		
Field Station#	14497+20	Field Station#	14496+50		
Pic 3 Desc.	Approximately 14497+20. P-1 requires maintenance. Damaged by livestock.		Pic 4 Desc.	Approximately 14496+50. Overview of ROW. Cattle graze and frequent area and were present during inspection.

4. E&S BMPs (List BMPs and note if installed and maintained as per the plan. If corrective action is needed, a picture is required.)					
E&S BMPs	Compliance Level	Corrective Action	Corrective Time Frame	Date Repaired	
3rd Party Damages	Communication	Repair P-1 damaged by livestock			
Compost Filter Sock	Acceptable				
Equipment Bridge	Acceptable				
Rock Construction Entrance	Acceptable				
Sensitive Resource Buffer	Acceptable				
Sensitive Resource Signage	Acceptable				
Silt Fence (Filter Fabric Fence)	Communication	Repair livestock damage			
Silt Fence (Reinforce Filter Fence)	Acceptable				
Waterbar	Acceptable

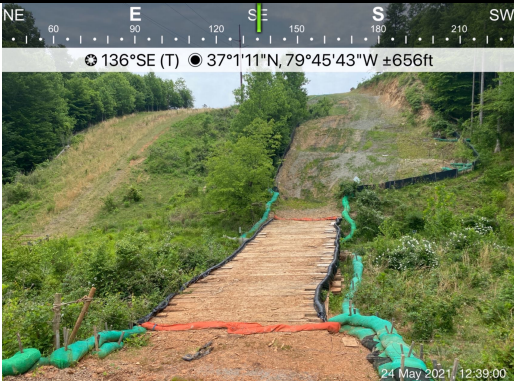
GPS Location	0	GPS Location	0		
Field Station#	14486+60	Field Station#	14471+00		
Pic 5 Desc.	Approximately 14486+60. Overview of stream crossing, equipment bridge and ECDs at stream S-G22.		Pic 6 Desc.	Approximately 14471+00. Overview of ROW.

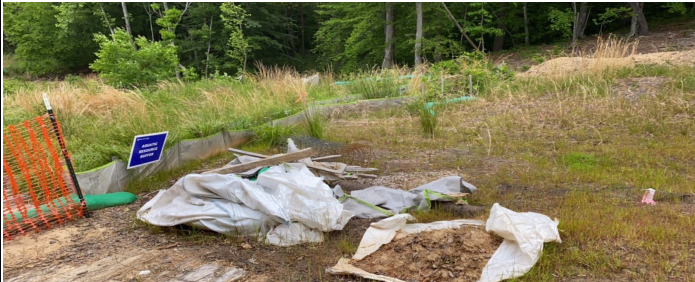
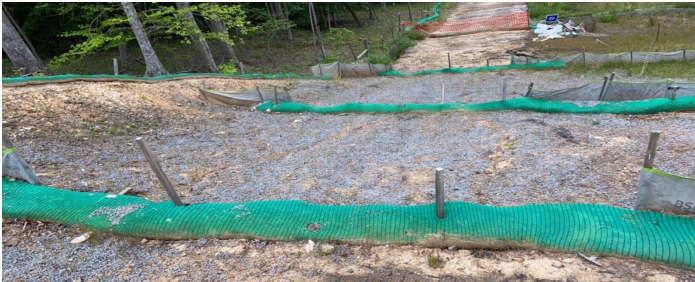
36°57'55" N 79°35'55" W 306°NW COURSE -1° GPS Penhook, VA 24137, United States 05.25.2021 08:06:57 Accur +/-15.9 Ft ALT 814 Ft			36°57'55" N 79°35'54" W 276°W COURSE -1° GPS Penhook, VA 24137, United States 05.25.2021 08:05:57 Accur +/-38.9 Ft ALT 821 Ft		
GPS Location	1		GPS Location	2	
Field Station#	15046+00		Field Station#	15046+50	
Pic 1 Desc.	Housekeeping. Remove trash pile from ROW.		Pic 2 Desc.	Routine maintenance. Replace CFS check dams that are beyond effective lifespan.

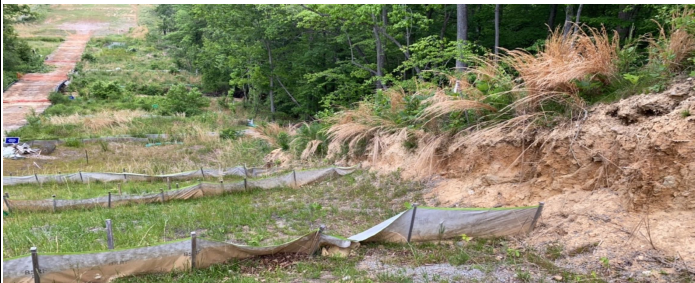
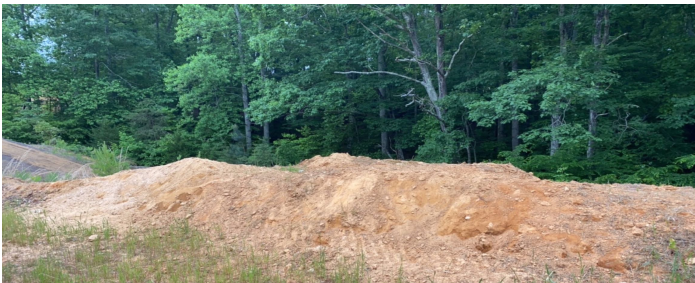
Pic 3 Desc.	Routine maintenance. Replace worn/damaged rows of P1 silt fence.		Pic 4 Desc.	Routine maintenance. Seed and stabilize denuded area of temporary diversion berm.

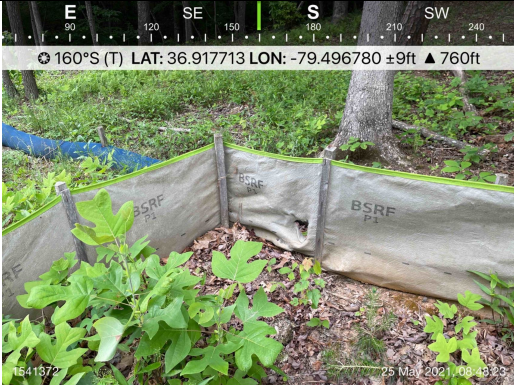
GPS Location	See photo		GPS Location	See photo	
Field Station#	15413+72		Field Station#	15413+72	
Pic 1 Desc.	P1 is damaged and needs to be replaced.		Pic 2 Desc.	Environmental crew has corrected this issue.

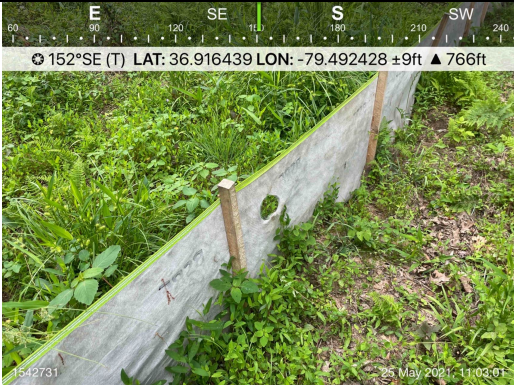
GPS Location	See photo		GPS Location	See photo	
Field Station#	15427+31		Field Station#	15427+31	
Pic 3 Desc.	P1 has been damaged and needs to be replaced.		Pic 4 Desc.	Environmental crew has corrected this issue.

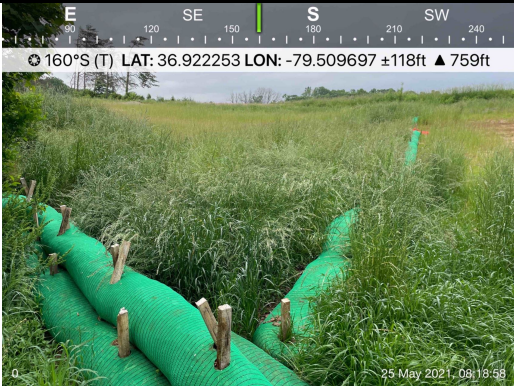
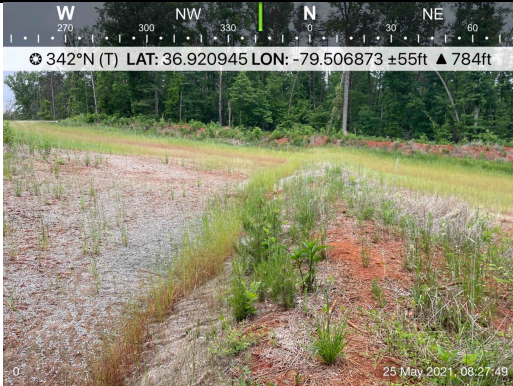
GPS Location	See photo		GPS Location	See photo	
Field Station#	15375+00		Field Station#	15383+00	
Pic 5 Desc.	Drainage ECDs are in good condition and functioning.		Pic 6 Desc.	Waterbars are functioning as intended.

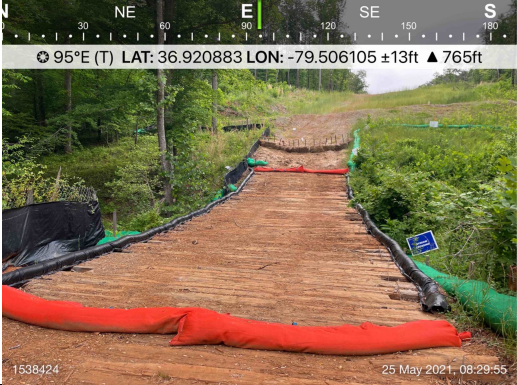
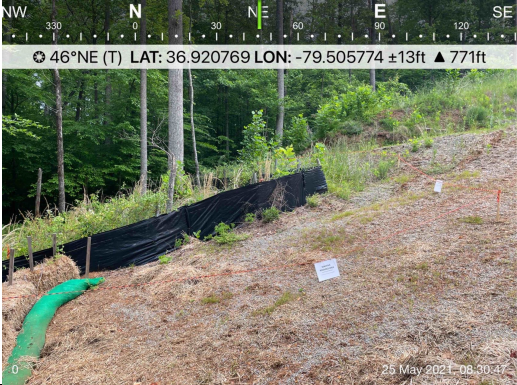
GPS Location	See photo		GPS Location	See photo	
Field Station#	15384+24		Field Station#	15385+00	
Pic 7 Desc.	Equipment bridge ECDs are in good condition.		Pic 8 Desc.	Sensitive resource buffer is in good condition at this location.

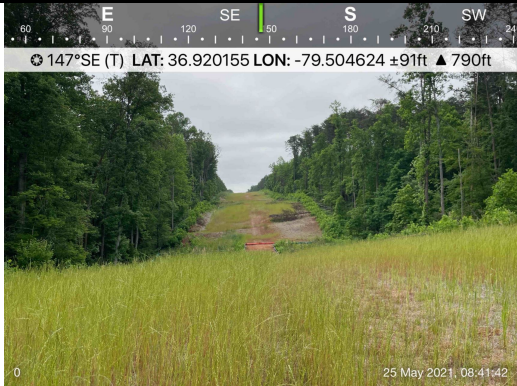
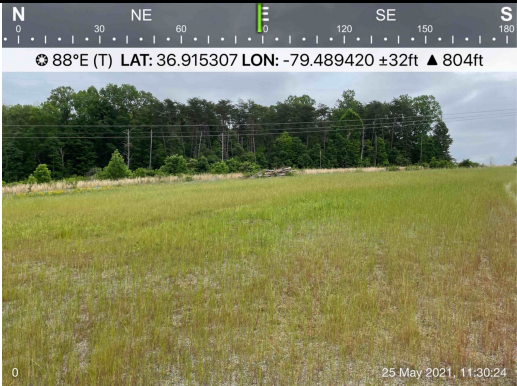
GPS Location	See photo		GPS Location	See photo	
Field Station#	15390+00		Field Station#	15440+00	
Pic 9 Desc.	Vegetation continues to fill in ROW.		Pic 10 Desc.	Vegetation continues to fill in ROW.

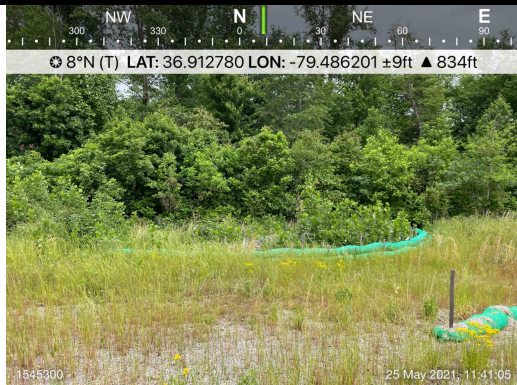
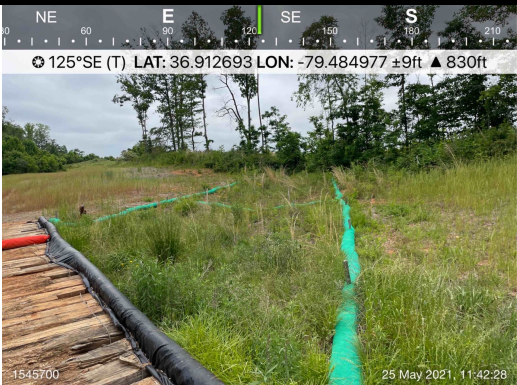
GPS Location	See photo		GPS Location	See photo	
Field Station#	15453+00		Field Station#	15457+00	
Pic 11 Desc.	CWD is in good condition.		Pic 12 Desc.	Drainage is in good condition with no evidence of sedimentation from 3rd party disturbance.

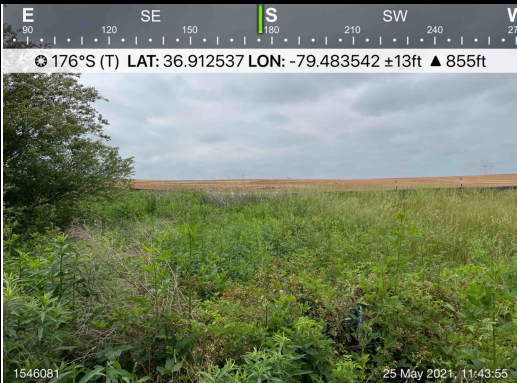
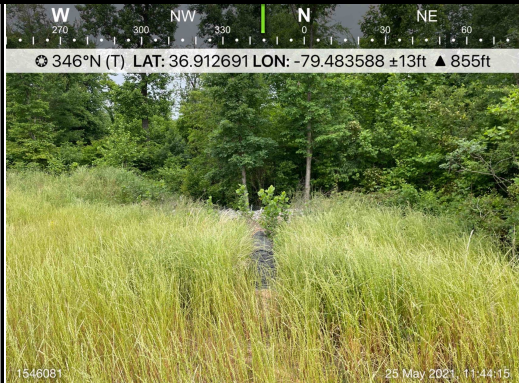
GPS Location	See photo		GPS Location	See photo	
Field Station#	15460+81		Field Station#	15460+81	
Pic 13 Desc.	3rd party rock outlet appears to be in good condition at this drainage.		Pic 14 Desc.	CWD is in good condition.

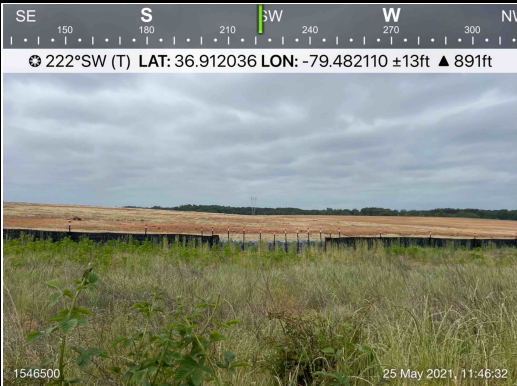
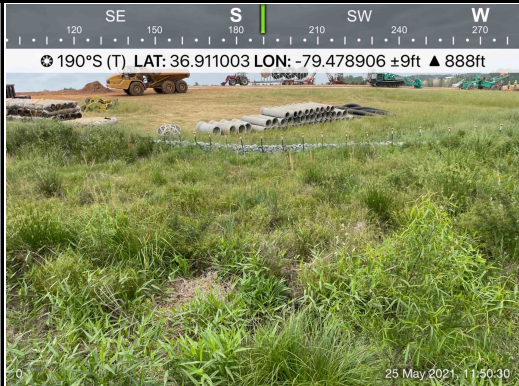
GPS Location	See photo		GPS Location	See photo	
Field Station#	15465+00		Field Station#	15475+00	
Pic 15 Desc.	3rd party rock outlet appears to be in good condition.		Pic 16 Desc.	3rd party rock outlet in good condition along this drainage.

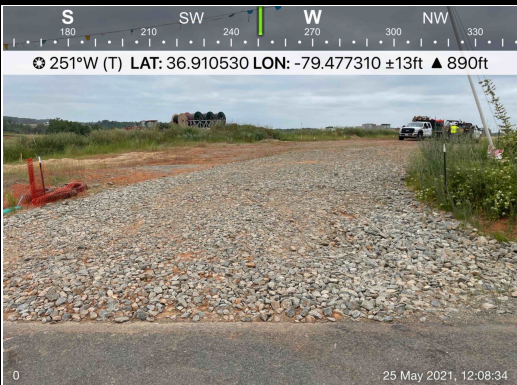
Insert image here	
GPS Location	See photo		GPS Location		
Field Station#	15480+67		Field Station#		
Pic 17 Desc.	RCEs are in good condition at all road crossings		Pic 18 Desc.

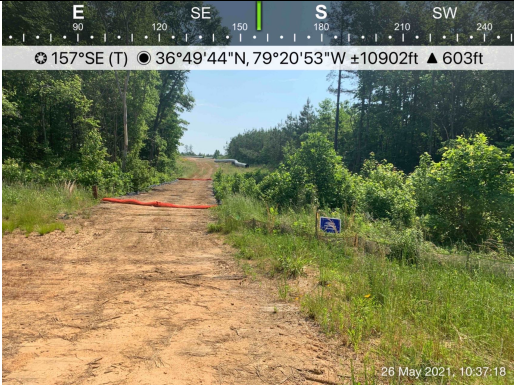
GPS Location	O	GPS Location	O		
Field Station#	16016+36	Field Station#	16006+00		
Pic 1 Desc.	Observing temporary stabilization, signage, buffer, equipment crossing and ECD's	Pic 2 Desc.	Observing temporary stabilization, water bar, sump and end treatment

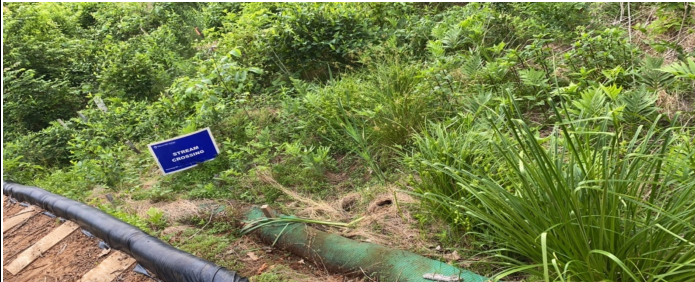
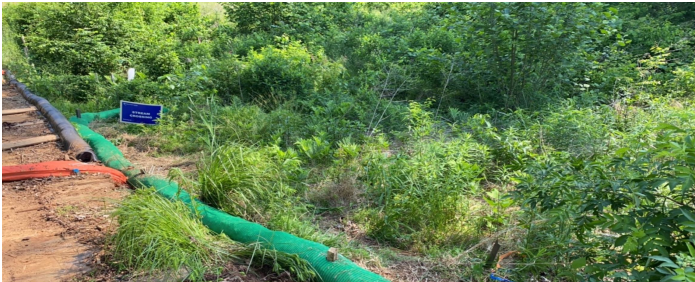
36°57'8" N 79°34'49" W 14°N COURSE 39° GPS Sandy Level, VA 24161, United States 05.26.2021 07:59:15 Accur +/-45.2 Ft ALT 880 Ft			36°57'7" N 79°34'49" W 6°N COURSE 136° GPS Sandy Level, VA 24161, United States 05.26.2021 10:07:46 Accur +/-73.2 Ft ALT 883 Ft		
GPS Location	1		GPS Location	2	
Field Station#	15126+40		Field Station#	15126+40	
Pic 1 Desc.	Routine maintenance. Replace worn perimeter CFS in resource buffer beyond effective lifespan.		Pic 2 Desc.	Contractor replaced perimeter CFS per punch list item.

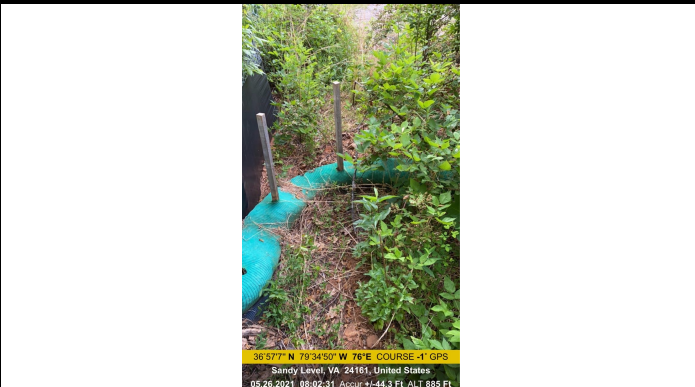
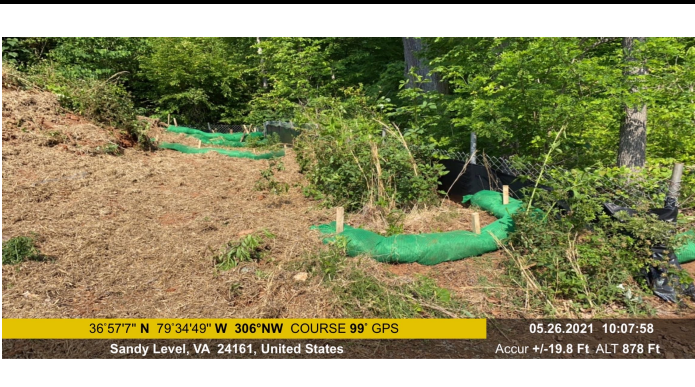
Pic 3 Desc.	Routine maintenance. Replace CFS check dams that are beyond effective lifespan.		Pic 4 Desc.	Contractor replaced CFS check dams per punch list item.

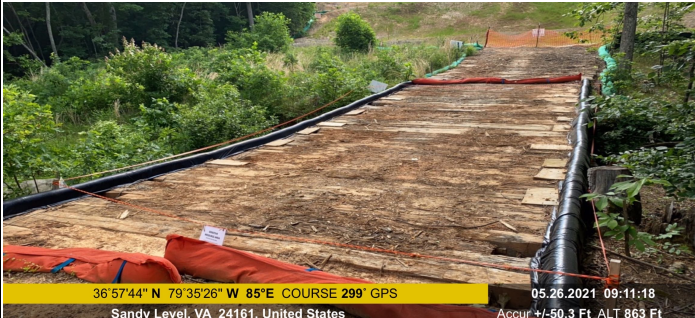
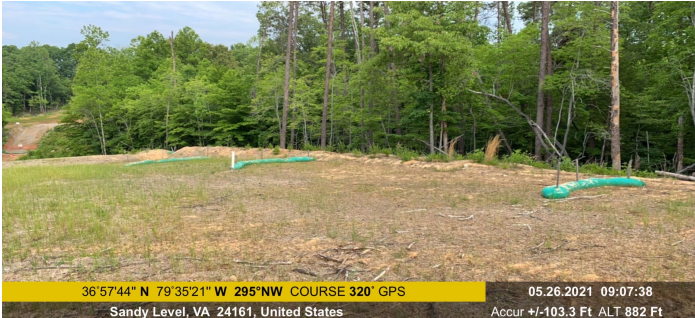
36°57'44" N 79°35'26" W 85°E COURSE 299° GPS Sandy Level, VA 24161, United States 05.26.2021 09:11:18 Accur +/-50.3 Ft ALT 863 Ft			36°57'44" N 79°35'21" W 295°NW COURSE 320° GPS Sandy Level, VA 24161, United States 05.26.2021 09:07:38 Accur +/-103.3 Ft ALT 882 Ft		
GPS Location	5		GPS Location	6	
Field Station#	15075+00		Field Station#	15076+00	
Pic 5 Desc.	Area marked off-limits for construction activities due to avian survey completed at bridge crossing.		Pic 6 Desc.	CFS check dams performing intended function.

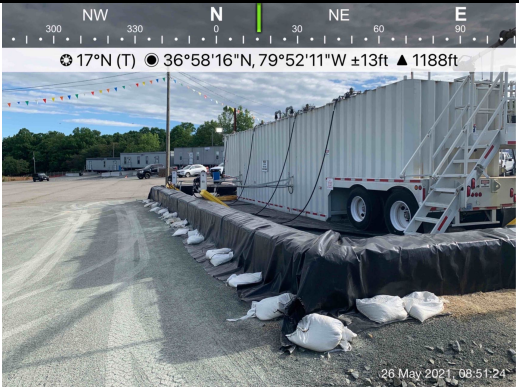
GPS Location		000000000000			
Field Station#		0000+00			
Pic 1 Desc.		Secondary containment structure for fuel cell at LY-046 in good condition.

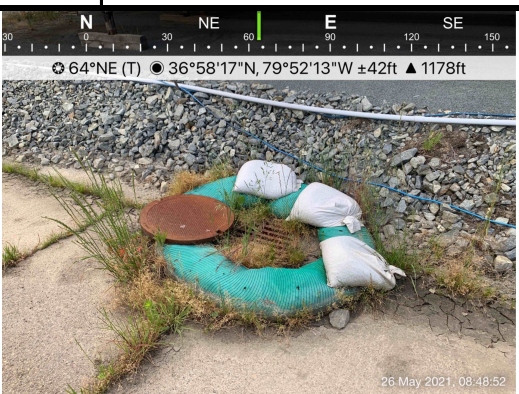
GPS Location		000000000000			
Field Station#		0000+00			
Pic 2 Desc.		Perimeter ECD's on west side of LY-046 in good condition.

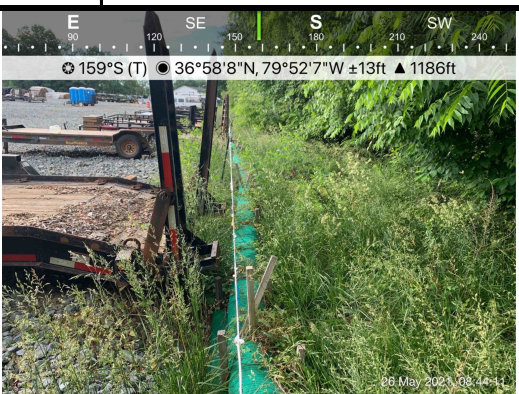
GPS Location		000000000000			
Field Station#		0000+00			
Pic 5 Desc.		Perimeter ECD's on northwest corner near employee parking area at LY-045 in good condition.

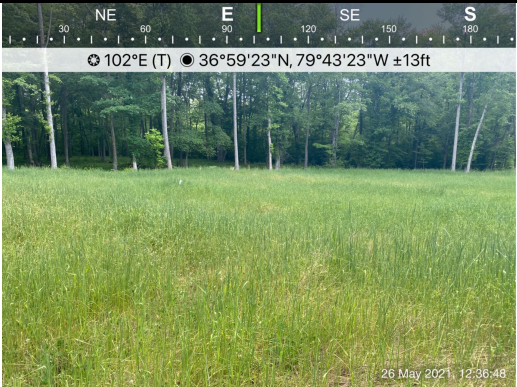
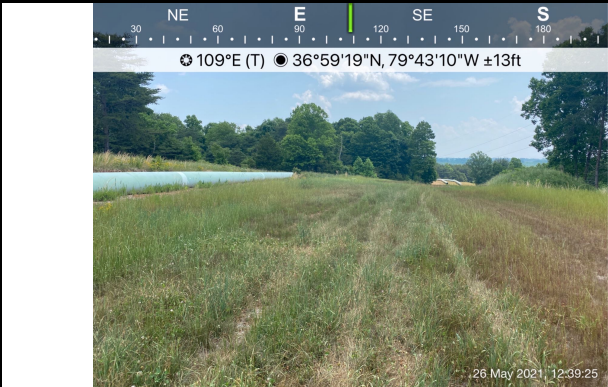
GPS Location	0		GPS Location	0	
Field Station#	14655+00		Field Station#	14665+00	
Pic 1 Desc.	Approximately 14655+00. Overview of ROW.		Pic 2 Desc.	Approximately 14665+00. Overview of ROW.

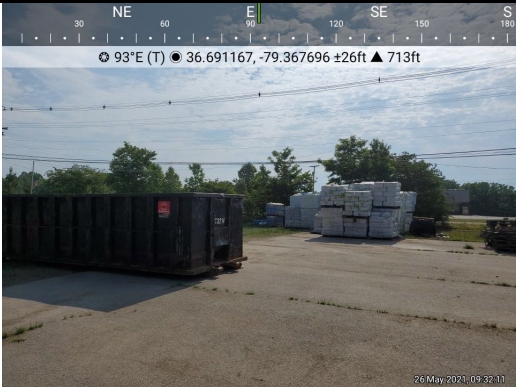
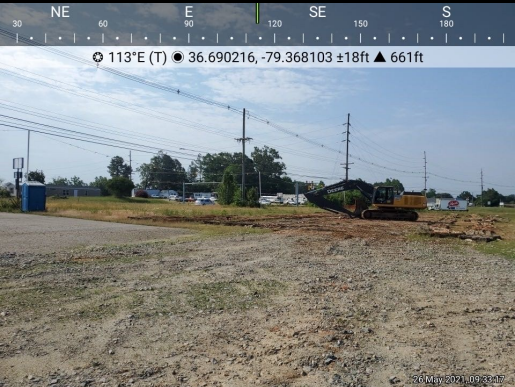
GPS Location	0		GPS Location	0	
Field Station#	0+00		Field Station#	0+00	
Pic 1 Desc.	LY-048 Housekeeping		Pic 2 Desc.	LY-048 Equipment staging & construction entrance

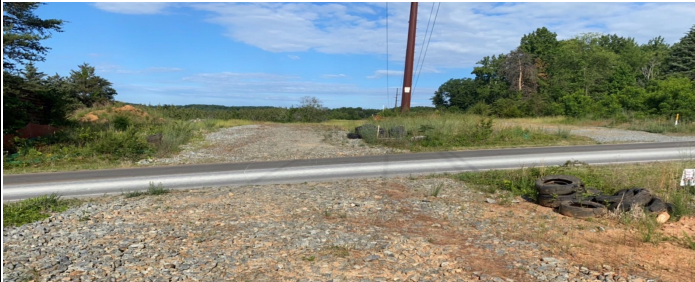
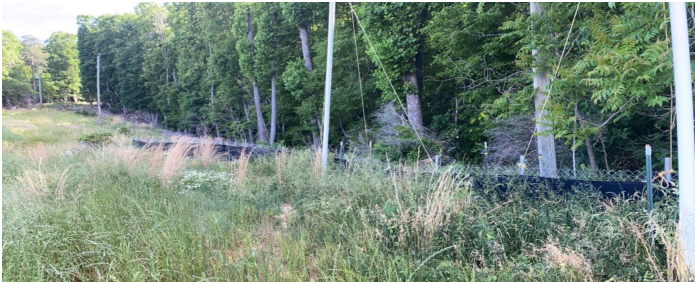
36°59'17" N 79°42'36" W 314°NW COURSE 65° GPS Union Hall, VA 24176, United States 05.27.2021 09:00:01 Accur +/-41.3 Ft ALT 950 Ft			36°59'19" N 79°42'10" W 12°N COURSE 262° GPS Union Hall, VA 24176, United States 05.27.2021 08:46:09 Accur +/-73.6 Ft ALT 902 Ft		
GPS Location	1	GPS Location	2		
Field Station#	14694+77	Field Station#	14714+99		
Pic 1 Desc.	RCE at Jacks Creek Rd in good condition		Pic 2 Desc.	Perimeter SSF in extra workspace in place and functional

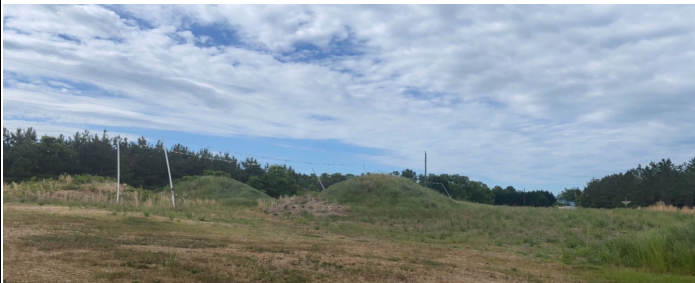
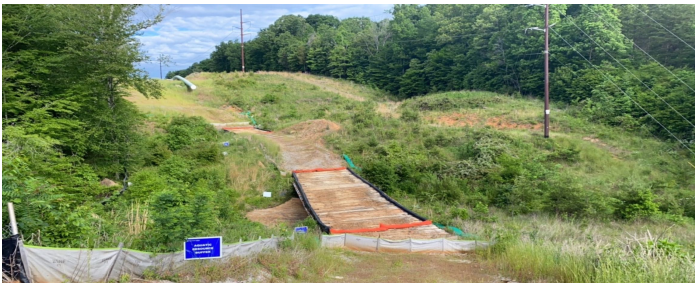
36°59'0" N 79°41'23" W 180°S COURSE 72° GPS Union Hall, VA 24176, United States 05.27.2021 09:51:49 Accur +/-45.6 Ft ALT 825 Ft			36°59'15" N 79°41'54" W 8°N COURSE 271° GPS Union Hall, VA 24176, United States 05.27.2021 08:28:29 Accur +/-138.1 Ft ALT 902 Ft		
GPS Location	3	GPS Location	4		
Field Station#	14760+00	Field Station#	14727+62		
Pic 3 Desc.	Spoil piles in extra workspace stabilized and vegetated		Pic 4 Desc.	Equipment bridge and surrounding ECDs in place and functional

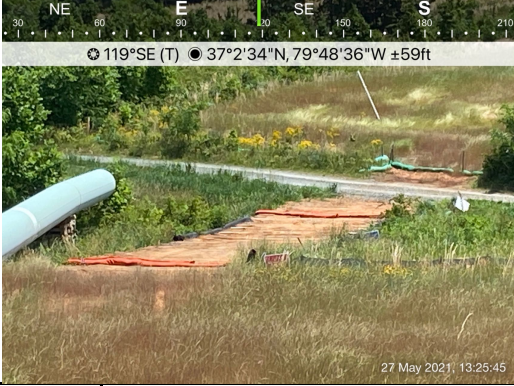
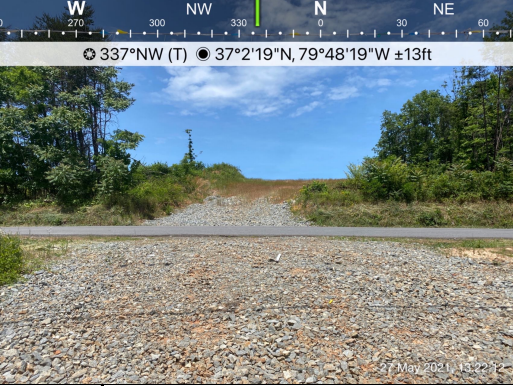
GPS Location	0	GPS Location	0		
Field Station#	14314+00	Field Station#	14333+00		
Pic 1 Desc.	Approximately 14314+00. Overview of ROW.	Pic 2 Desc.	Approximately 14333+00. Overview of road crossing and RCEs.

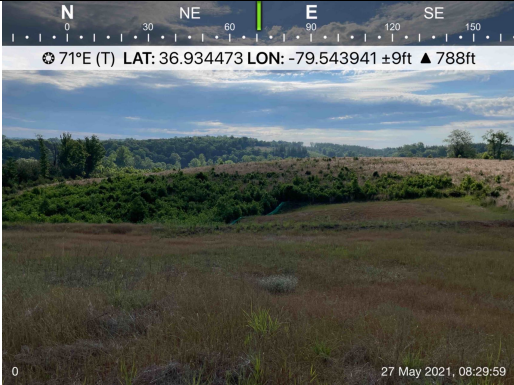
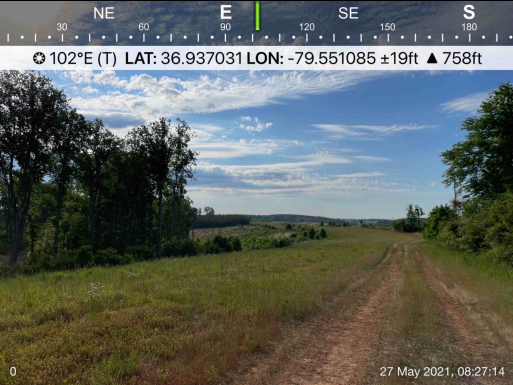
GPS Location	See photo		GPS Location	See photo	
Field Station#	15260+00		Field Station#	15235+00	
Pic 1 Desc.	Vegetation continues to fill in throughout this section of ROW.		Pic 2 Desc.	Vegetation continues to fill in throughout this section of ROW.

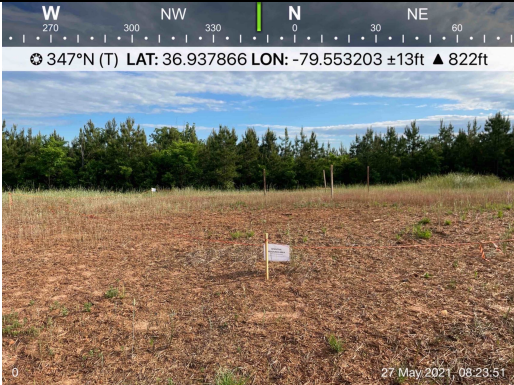
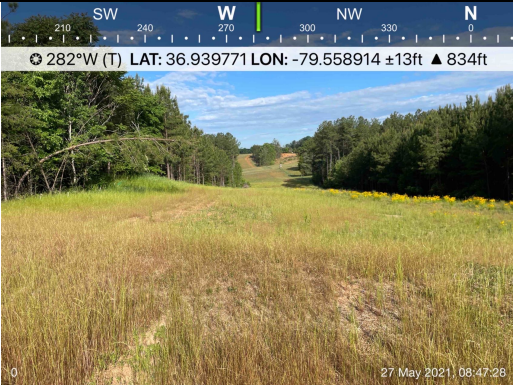
GPS Location	See photo		GPS Location	See photo	
Field Station#	15230+00		Field Station#	15209+00	
Pic 3 Desc.	Sensitive resource buffer is in good condition around ground nest.		Pic 4 Desc.	Vegetation continues to fill in throughout this section of ROW.

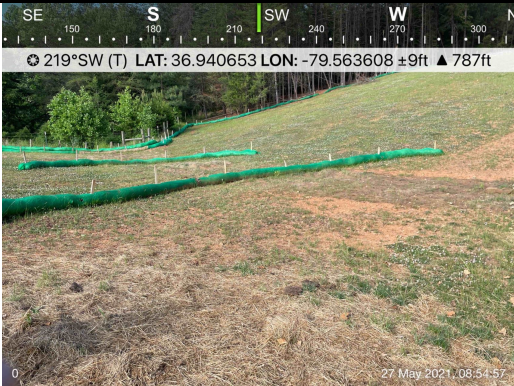
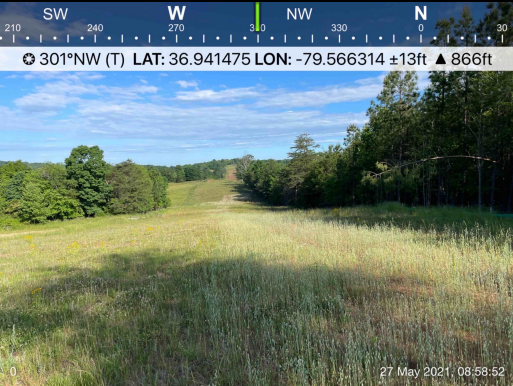
GPS Location	See photo		GPS Location	See photo	
Field Station#	15195+00		Field Station#	15190+00	
Pic 5 Desc.	Drainage ECDs are in place and in good condition.		Pic 6 Desc.	Vegetation continues to fill in throughout this section of ROW.

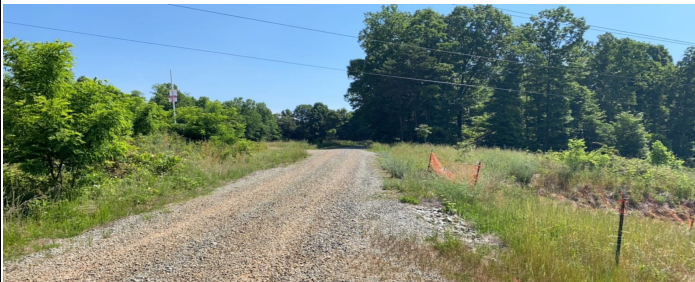
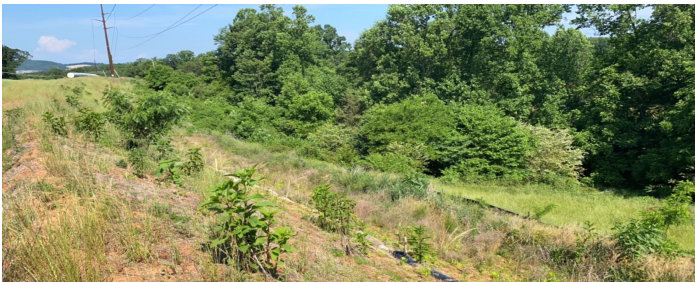
36°58'36" N 79°40'42" W 14°N COURSE -1° GPS 05.28.2021 10:56:07 Accur +/-32.5 Ft ALT 949 Ft			36°58'22" N 79°40'0" W 284°W COURSE 231° GPS 05.28.2021 10:32:10 1120 Listening Hill Rd, Penhook, VA 24137, United States Accur +/-16.2 Ft ALT 968 Ft		
GPS Location	1	GPS Location	2		
Field Station#	14802+19	Field Station#	14840+00		
Pic 1 Desc.	MVP-FR-323 in good condition at time of inspection	Pic 2 Desc.	Temporary fill slope stabilized and vegetated. ECDs in place and functional

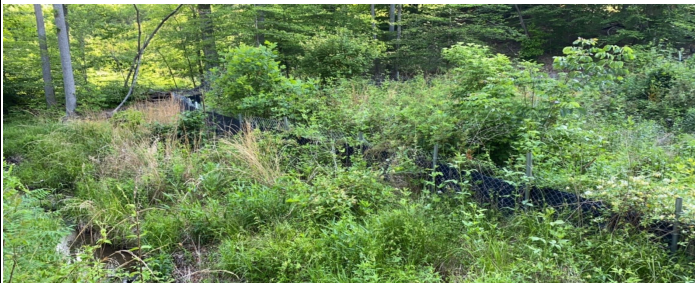
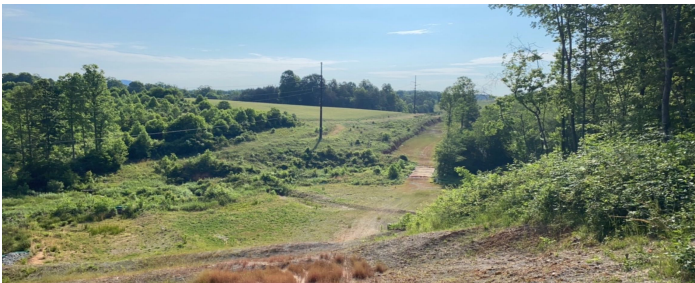
Pic 3 Desc.	Perimeter SSF in place and functional	Pic 4 Desc.	Slope in temporary stabilized and vegetated. Water bars performing intended functions.

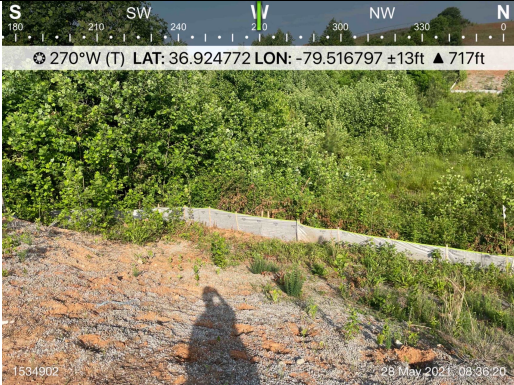
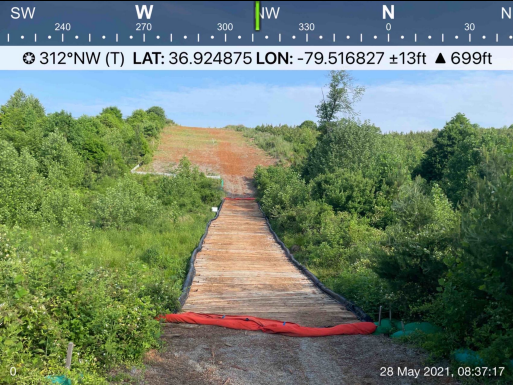
GPS Location	See photo		GPS Location	See photo	
Field Station#	15349+02		Field Station#	15346+87	
Pic 1 Desc.	P1 is in good condition at all stream and wetland buffers.		Pic 2 Desc.	Equipment bridge ECDs are in good condition and functioning.

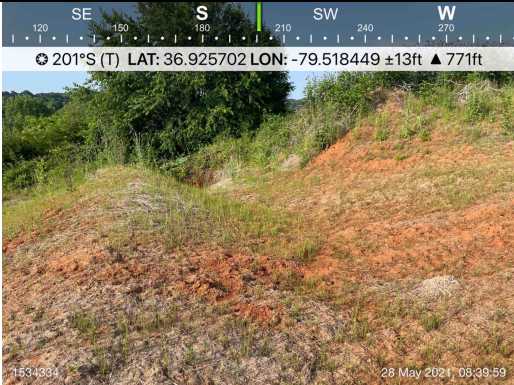
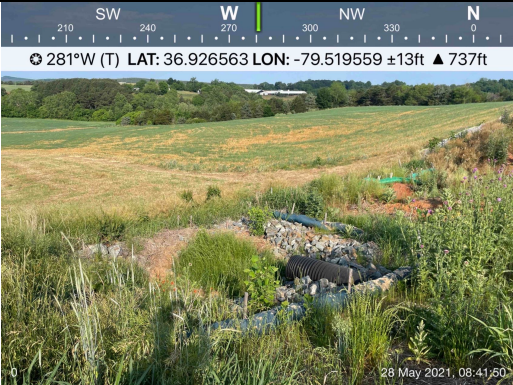
GPS Location	See photo		GPS Location	See photo	
Field Station#	15343+34		Field Station#	15338+00	
Pic 3 Desc.	Waterbars are functioning throughout this section.		Pic 4 Desc.	CWDs are in good condition and functioning.

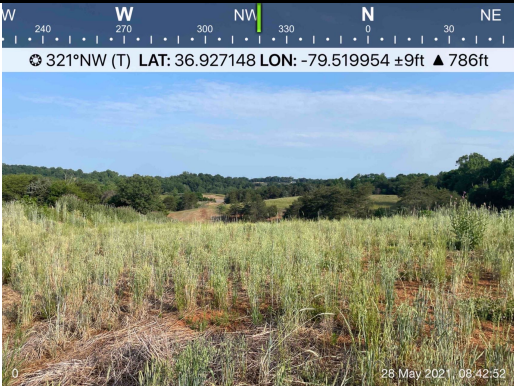
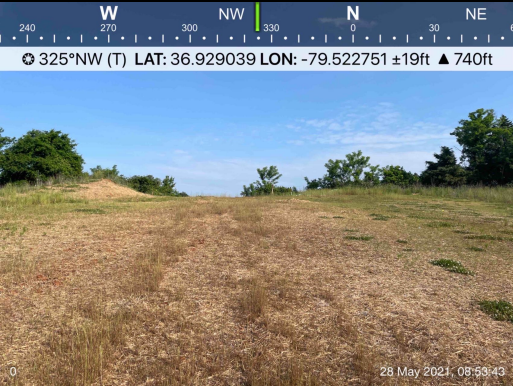
GPS Location	See photo		GPS Location	See photo	
Field Station#	15335+00		Field Station#	15325+00	
Pic 5 Desc.	Vegetation continues to fill in throughout this section of ROW.		Pic 6 Desc.	Vegetation continues to fill in throughout this section of ROW.
