# Visual Site Inspection Report

| <b>Project Name</b> | H-600 Pipeline Spread I | <b>AFE</b> | 124300139 | <b>Spread</b> | H-600 Pipeline Spread I |
| <b>Permit #</b> | TBD | <b>Inspection Type</b> | VA SWPP | <b>Station Begin</b> | 15772+27 |

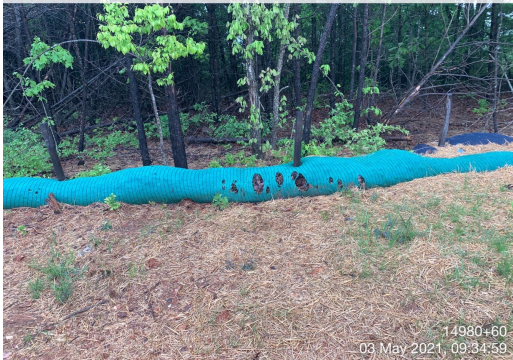
| Pic 1 Desc. | | P1 silt fence at stream buffer is deteriorated and has a hole in it | | Pic 2 Desc. | | Super silt fence fabric is detached from the wire | |

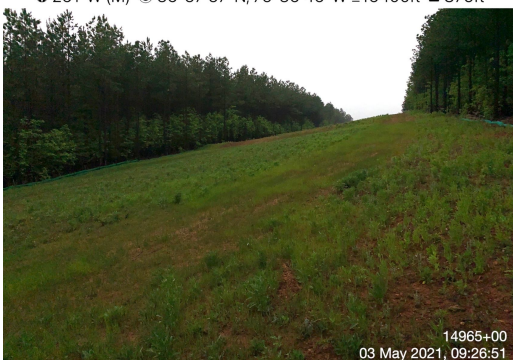
| Pic 3 Desc. | | Perimeter CFS has holes in it | | Pic 4 Desc. | | Waterbar in acceptable condition | |

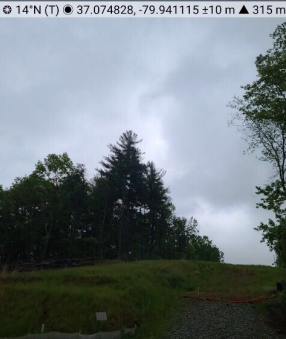
| <b>Pic 1 Desc.</b> | Row photo taken during light rain events. Monitored ECDs and vegetation growth. No environmental issues observed at the time of inspection. | | <b>Pic 2 Desc.</b> | Monitored ECDs and vegetation growth throughout. No issues observed at the time of inspection. | |

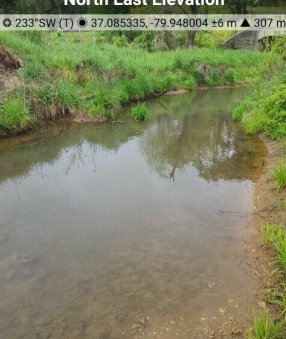
| <b>Pic 3 Desc.</b> | Monitored ECDs and vegetation growth. Observed RCE at road crossings during light rain events today. | | <b>Pic 4 Desc.</b> | Inspected ECDs while monitoring row conditions during light rain events today. No issues observed at the time of inspection | |

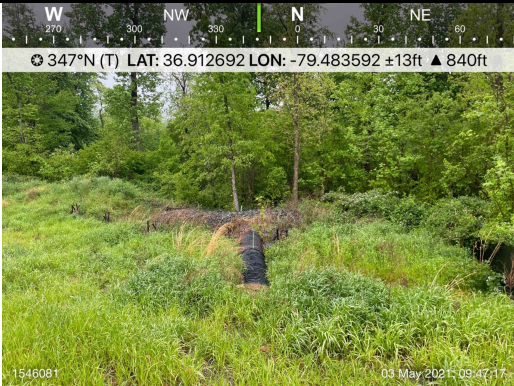
| <b>Pic 3 Desc.</b> | 3rd party rock outlet appears to be in good condition. To discharge present during inspection. | | <b>Pic 4 Desc.</b> | 3rd party rock outlet appears to be in good condition. To discharge present during inspection. | |

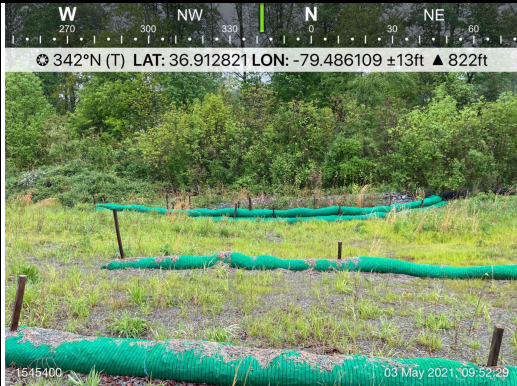
| Pic 7 Desc. | Drainage in good condition. No sedimentation present. | | Pic 8 Desc. | 3rd party rock outlet appears to be in good condition. To discharge present during inspection. | |

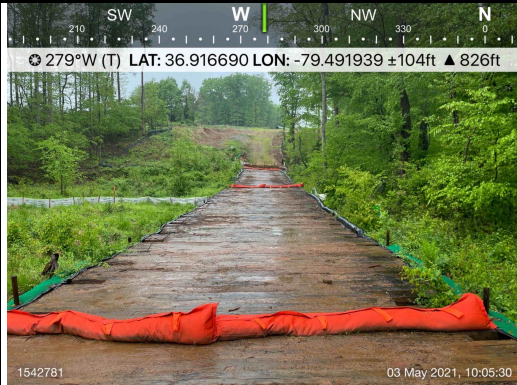
| Pic 9 Desc. | CWD in good condition. No sedimentation present. | | Pic 10 Desc. | Vegetation continues to fill in ROW. | |

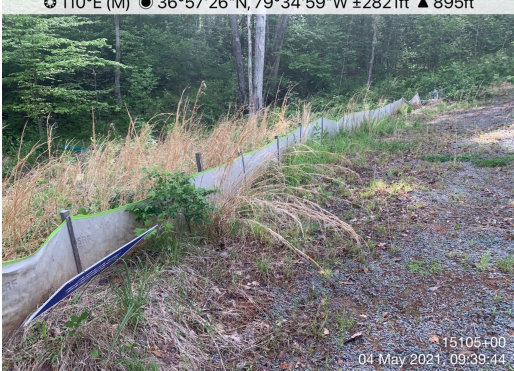
| <b>Pic 1 Desc.</b> | Waterbar in acceptable condition | <b>Pic 2 Desc.</b> | Waterbar end treatment in acceptable condition | | |

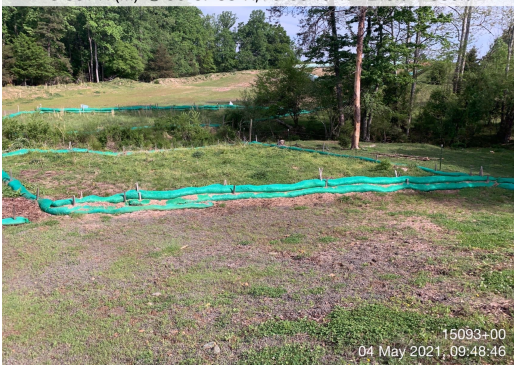
| <b>Pic 3 Desc.</b> | P1 silt fence in acceptable condition | <b>Pic 4 Desc.</b> | Permanent vegetative stabilization in acceptable condition | | |

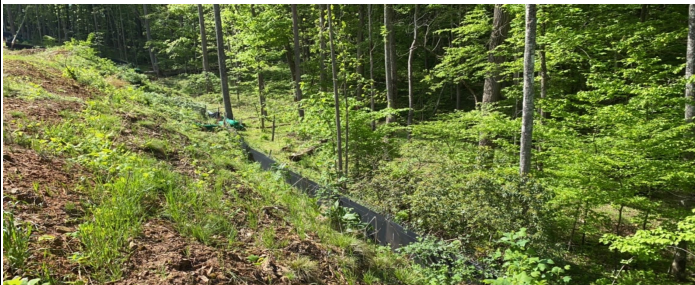
| Pic 1 Desc. | Routine maintenance. Damage to electric cattle fence from cattle damage. | | Pic 2 Desc. | Equipment bridge and surrounding ECDs in place and functional at stream crossing of S-KL54 | |

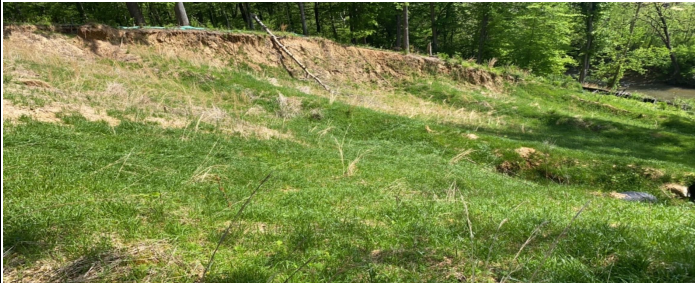
| Pic 3 Desc. | Perimeter SSF in place and functional | | Pic 4 Desc. | Area where temporary diversion berm has fallen in has been repaired and stabilized with erosion control blanket. No issues observed. | |

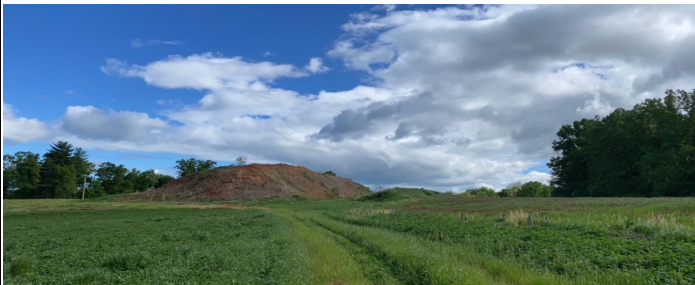
| Pic 1 Desc. | Limited vegetation observed growing in section CIS Foggy Ridge Rd. No erosion issues observed. Will monitor area. | | Pic 2 Desc. | Picture of debris pulled from off ROW surrounding S-II2 | |

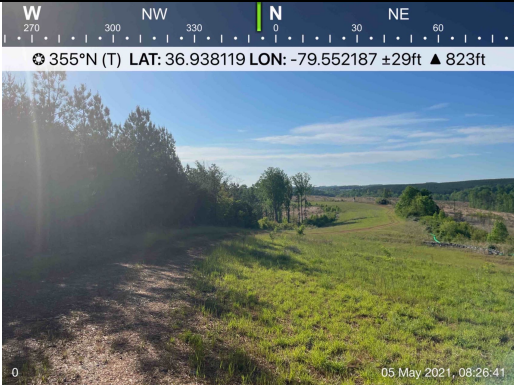
| <b>Pic 1 Desc.</b> | P1 has been damaged by livestock and needs to be replaced. | | <b>Pic 2 Desc.</b> | Erosion repair remains in good condition. | |

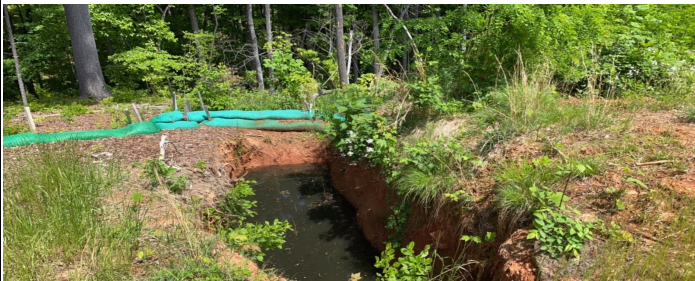
| <b>Pic 3 Desc.</b> | RCE at Bonbrook Mill RC1 in good condition | | <b>Pic 4 Desc.</b> | Perimeter CFS triple stack in place and functional | |

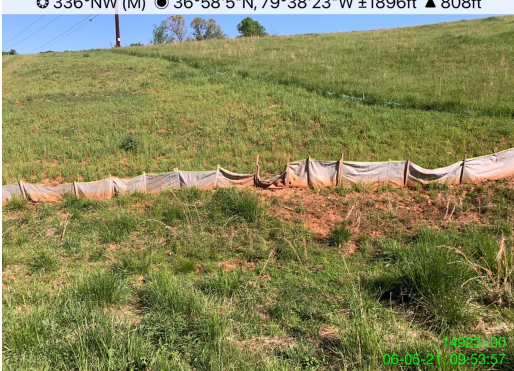
| <b>Pic 1 Desc.</b> | Permanent vegetative stabilization in acceptable condition | <b>Pic 2 Desc.</b> | Perimeter CFS damaged by livestock | | |

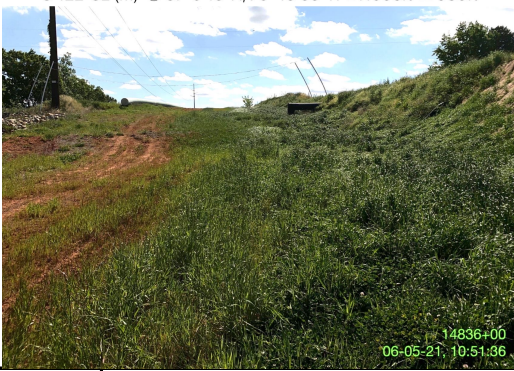
| <b>Pic 3 Desc.</b> | P1 silt fence damaged by livestock | <b>Pic 4 Desc.</b> | Waterbar in acceptable condition | | |

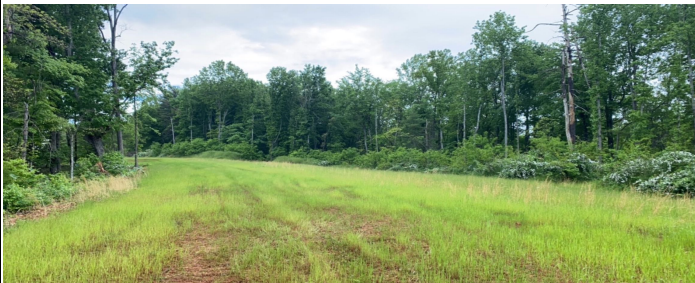
| <b>Pic 1 Desc.</b> | RCE at Bonbrook Mill RC2 in good condition | | <b>Pic 2 Desc.</b> | Temporary vegetation growing along ROW | |

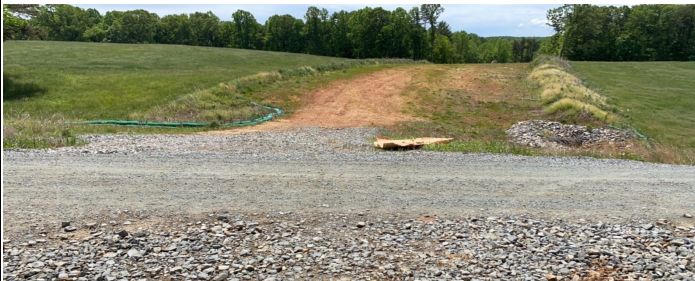
| <b>Pic 3 Desc.</b> | Temporary vegetation growing along ROW | | <b>Pic 4 Desc.</b> | Erosion control blanket performing intended function in throat of water bar. Sump pit and end treatment in good condition. | |
