# Visual Site Inspection Report

<b>Project Name</b>	H-600 Pipeline Spread I	<b>AFE</b>	124300139	<b>Spread</b>	H-600 Pipeline Spread I
<b>Contractor</b>	Precision			<b>Report #</b>	23982
<b>Inspector</b>	Logan Box			<b>Date/Time</b>	6/1/2021 3:38 PM
<b>Permit #</b>	TBD	<b>Inspection Type</b>	VA SWPP	<b>Station Begin</b>	13670+00
<b>State</b>	VA	<b>Inspection Area</b>	Partial	<b>Station End</b>	13784+35
<b>County</b>	Franklin	<b>Ground</b>	Damp	<b>Temperature (°F)</b>	81.00
<b>Municipality</b>	N/A	<b>Weather</b>	Sunny	<b>Rain Gauge (in)</b>	0.00
				<b>Rain Accumulation Time (days)</b>	0.00

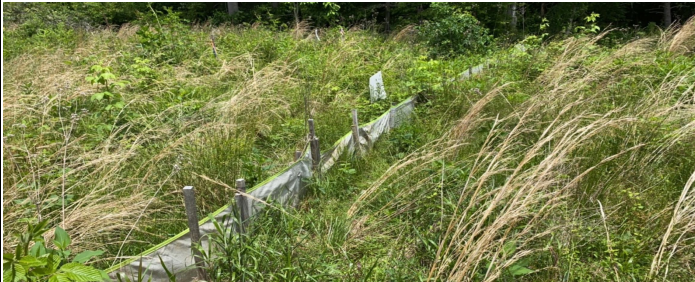
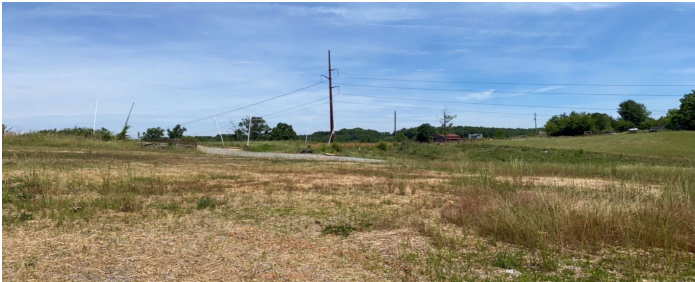
36°57'55" N 79°35'57" W 37°NE COURSE 36' GPS 06.01.2021 12:45:09 Sorry no results found Accur +/-86.4 Ft ALT 914 Ft			36°58'2" N 79°38'15" W 14°N COURSE 326' GPS 06.01.2021 11:18:15 2082 Ramsey Memorial Rd, Penhook, VA 24137, United States Accur +/-19.6 Ft ALT 863 Ft		
GPS Location	1		GPS Location	2	
Field Station#	15044+50		Field Station#	14929+00	
Pic 1 Desc.	Routine maintenance. Replace damaged panel of P1 silt fence from third party damage.		Pic 2 Desc.	Temporary vegetation growing in extra workspace. RCE in good condition.

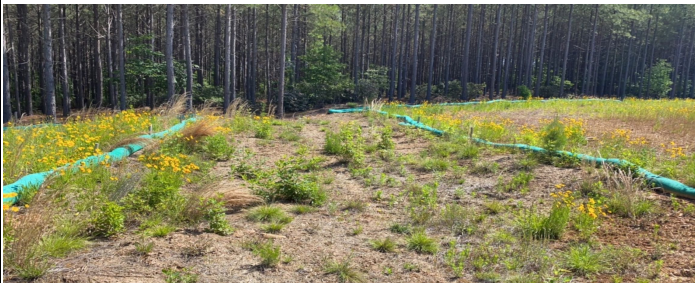
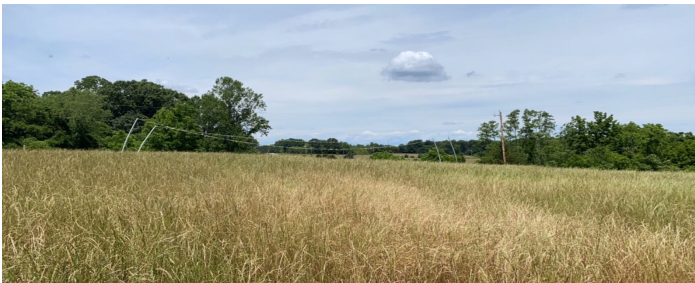
Field Station#	14967+00		Field Station#	14995+00	
Pic 3 Desc.	Natural drainage area performing intended function. Perimeter controls in place and functional.		Pic 4 Desc.	Permanent vegetation growing along ROW in final cleanup area.

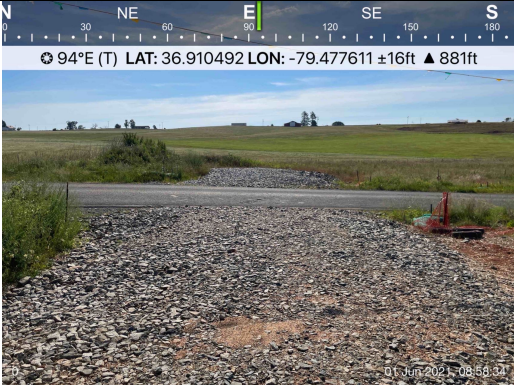
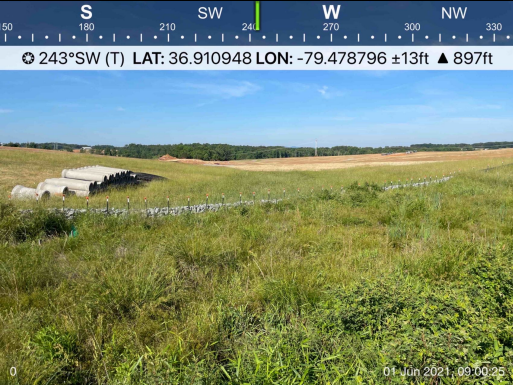
<b>GPS Location</b>	See photo		<b>GPS Location</b>	See photo	
<b>Field Station#</b>	15480+67		<b>Field Station#</b>	15475+00	
<b>Pic 1 Desc.</b>	RCEs are in good condition at all road crossings.		<b>Pic 2 Desc.</b>	3rd party rock outlet remains in good condition along this drainage.

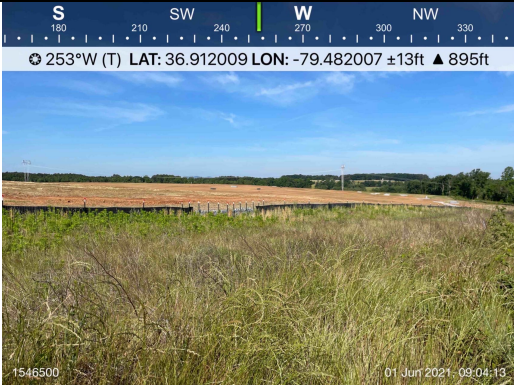
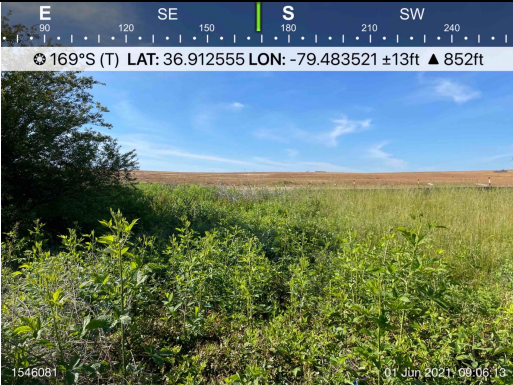
<b>GPS Location</b>	See photo		<b>GPS Location</b>	See photo	
<b>Field Station#</b>	15465+00		<b>Field Station#</b>	15460+81	
<b>Pic 3 Desc.</b>	3rd party rock outlet appears to be in good condition with no evidence of sedimentation onto MVP ROW.		<b>Pic 4 Desc.</b>	3rd party rock outlet appears to be in good condition with no evidence of sedimentation onto MVP ROW.

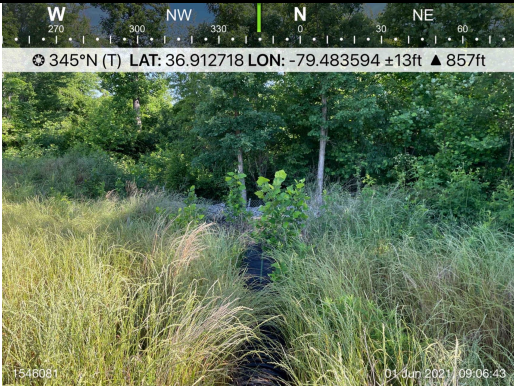
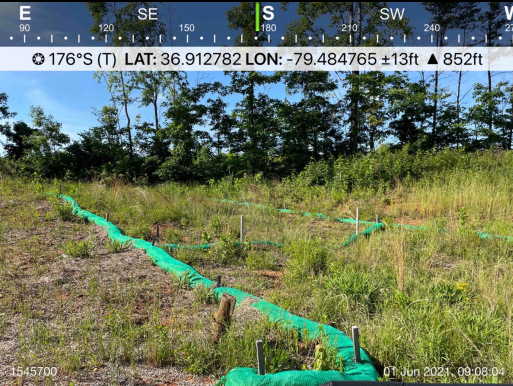
<b>Pic 5 Desc.</b>	CWD is in good condition.		<b>Pic 6 Desc.</b>	Drainage ECDs are in good condition with no evidence of sedimentation onto MVP ROW.

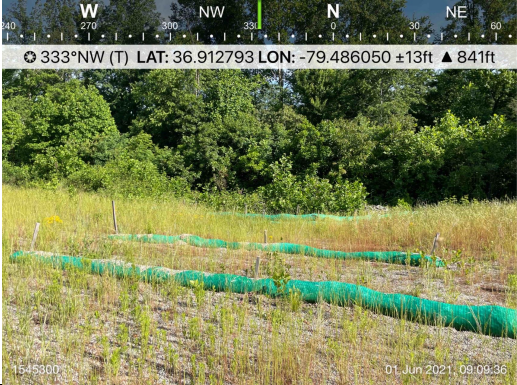
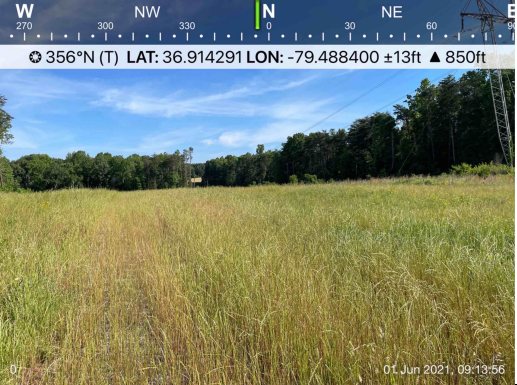
<b>GPS Location</b>	See photo		<b>GPS Location</b>	See photo	
<b>Field Station#</b>	15453+00		<b>Field Station#</b>	15442+00	
<b>Pic 7 Desc.</b>	CWD is in good condition with no evidence of sedimentation from 3rd party disturbance.		<b>Pic 8 Desc.</b>	Vegetation continues to fill in ROW.

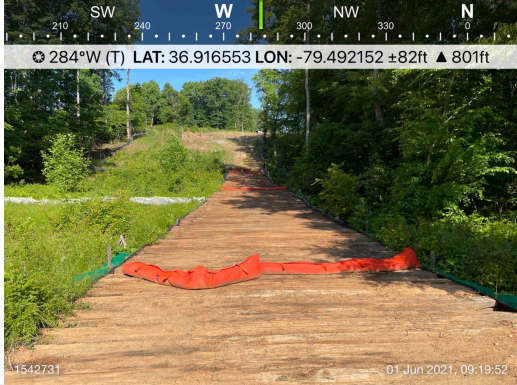
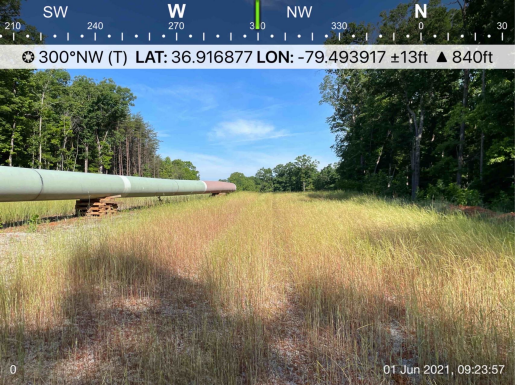
<b>GPS Location</b>	See photo		<b>GPS Location</b>	See photo	
<b>Field Station#</b>	15427+31		<b>Field Station#</b>	15422+00	
<b>Pic 9 Desc.</b>	Equipment bridge ECDs are in good condition and functioning.		<b>Pic 10 Desc.</b>	Vegetation continues to fill in ROW.

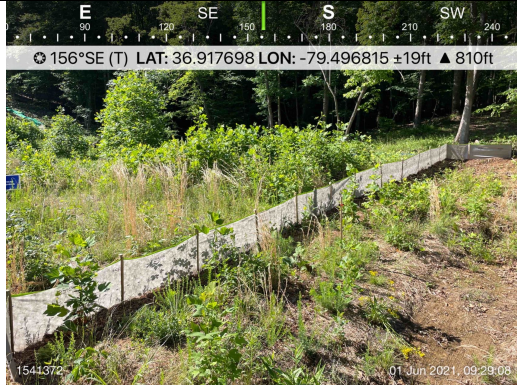
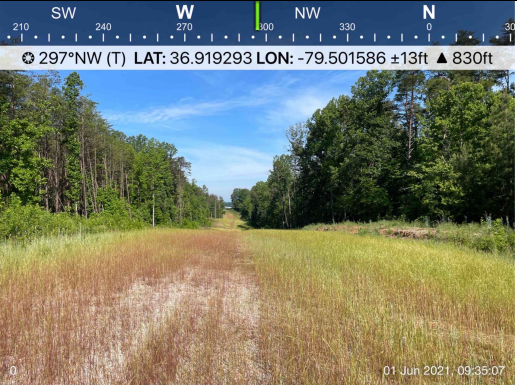
<b>GPS Location</b>	See photo		<b>GPS Location</b>	See photo	
<b>Field Station#</b>	15413+72		<b>Field Station#</b>	15400+00	
<b>Pic 11 Desc.</b>	P1 is in good condition at all stream and wetland crossings.		<b>Pic 12 Desc.</b>	Vegetation continues to fill in ROW.

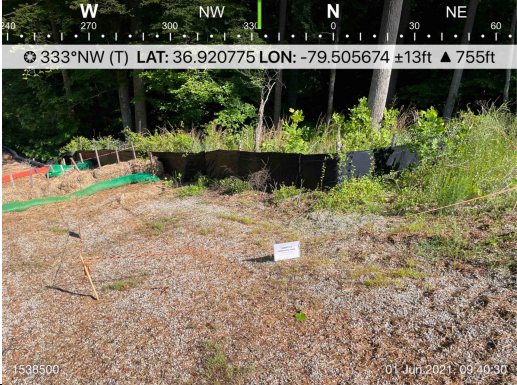
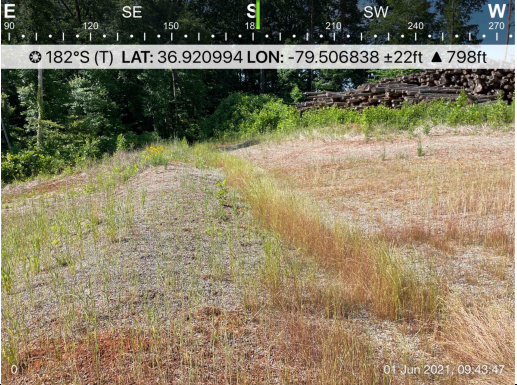
<b>GPS Location</b>	See photo		<b>GPS Location</b>	See photo	
<b>Field Station#</b>	15385+00		<b>Field Station#</b>	15383+00	
<b>Pic 13 Desc.</b>	Sensitive resource buffer is in good condition.		<b>Pic 14 Desc.</b>	Waterbars are functioning as intended throughout this section.

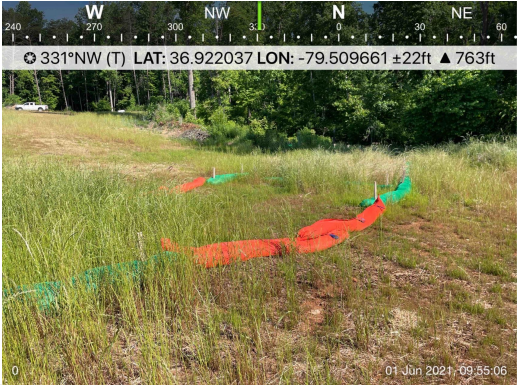
Insert image here	
<b>GPS Location</b>	See photo		<b>GPS Location</b>		
<b>Field Station#</b>	15375+00		<b>Field Station#</b>		
<b>Pic 15 Desc.</b>	Drainage ECDs are in good condition and functioning.		<b>Pic 16 Desc.</b>		
Insert image here			Insert image here		
<b>GPS Location</b>			<b>GPS Location</b>		
<b>Field Station#</b>			<b>Field Station#</b>		
<b>Pic 17 Desc.</b>			<b>Pic 18 Desc.</b>

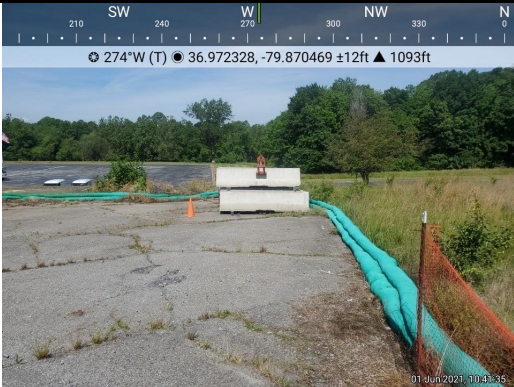
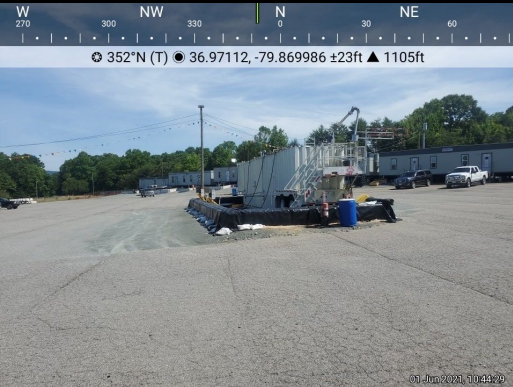
GPS Location	00000000000		GPS Location	00000000000	
Field Station#	0000+00		Field Station#	0000+00	
Pic 1 Desc.	Perimeter ECD's on north end of LY046 in good condition.		Pic 2 Desc.	Secondary containment structure for fuel cell in good condition.

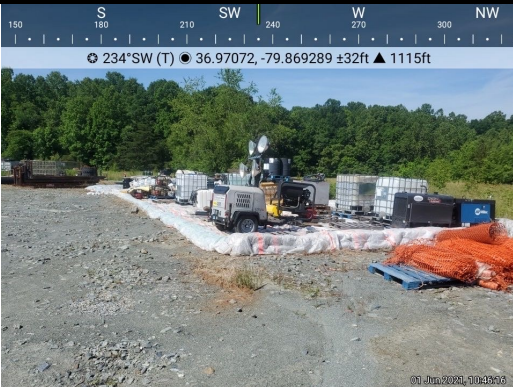
GPS Location	00000000000		GPS Location	00000000000	
Field Station#	0000+00		Field Station#	0000+00	
Pic 3 Desc.	Secondary containment structure for and perimeter ECD's on south end of LY-046 in good condition.		Pic 4 Desc.	Secondary containment structure for on north end of LY-045 in good condition.

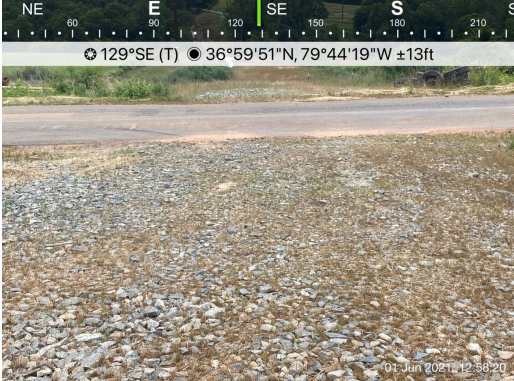
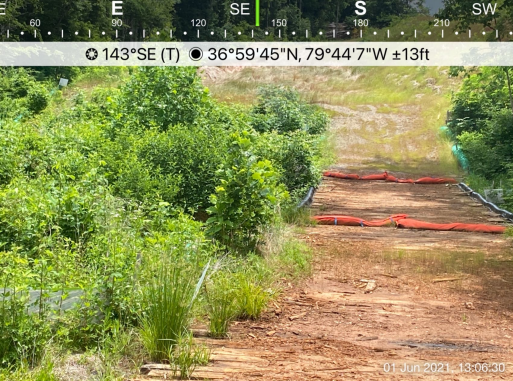
<b>GPS Location</b>	0	<b>GPS Location</b>	0		
<b>Field Station#</b>	14599+00	<b>Field Station#</b>	14611+27		
<b>Pic 1 Desc.</b>	Approximately 14599+00. Overview of road crossing and RCEs.		<b>Pic 2 Desc.</b>	Approximately 14611+27. Overview of stream crossing, equipment bridge and ECDs at stream S-E14.

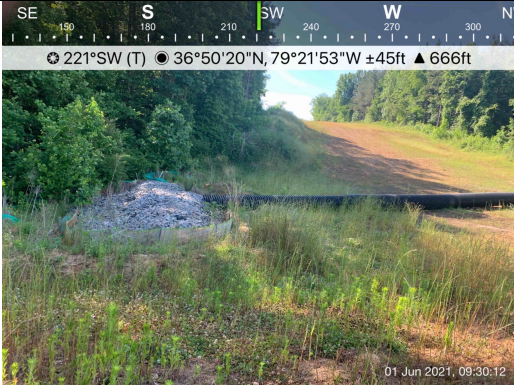
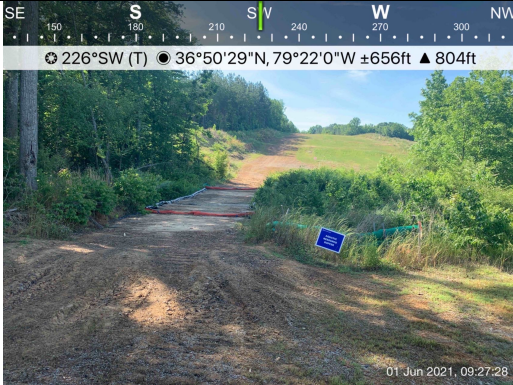
<b>GPS Location</b>	O	<b>GPS Location</b>	O		
<b>Field Station#</b>	15934+00	<b>Field Station#</b>	15923+49		
<b>Pic 1 Desc.</b>	Observing temporary stabilization,CWD outlet and ECD's	<b>Pic 2 Desc.</b>	Observing temporary stabilization, signage, buffer, equipment crossing and ECD's

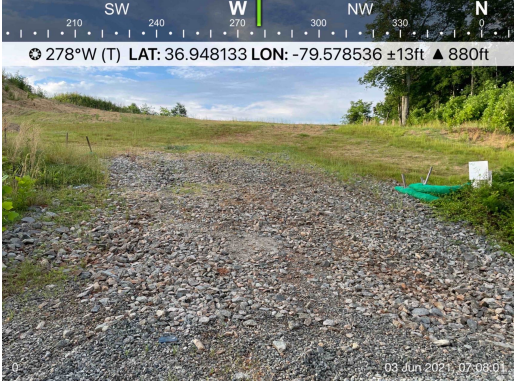
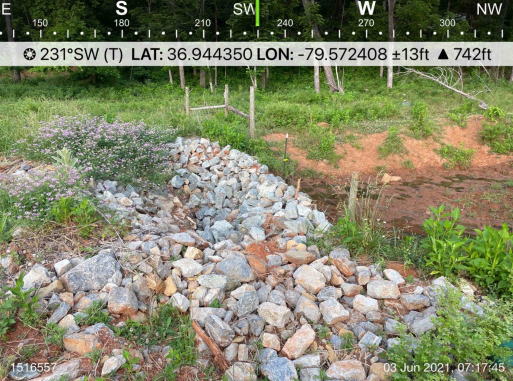
<b>GPS Location</b>	See photo		<b>GPS Location</b>	See photo	
<b>Field Station#</b>	15142+66		<b>Field Station#</b>	15165+57	
<b>Pic 1 Desc.</b>	RCE is in good condition at Rockcreek Rd.		<b>Pic 2 Desc.</b>	Rock inlet is in good condition along this drainage.

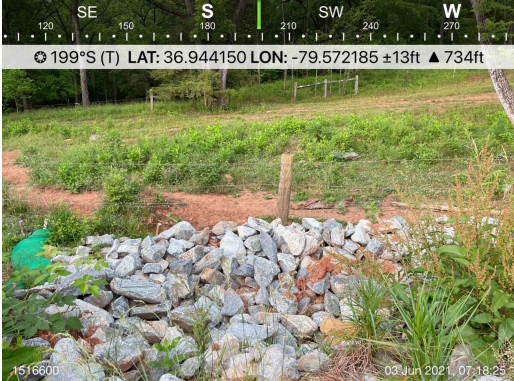
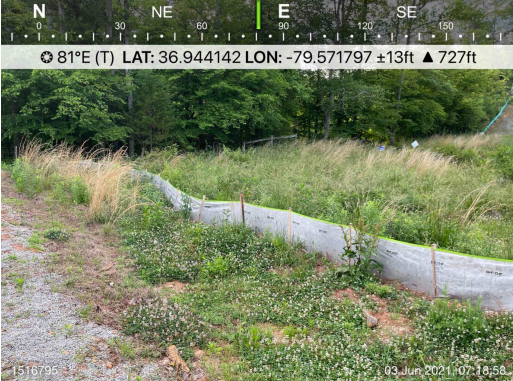
<b>GPS Location</b>	See photo		<b>GPS Location</b>	See photo	
<b>Field Station#</b>	15166+00		<b>Field Station#</b>	15167+95	
<b>Pic 3 Desc.</b>	Rock outlet remains in good condition.		<b>Pic 4 Desc.</b>	P1 is in good condition at this stream buffer.

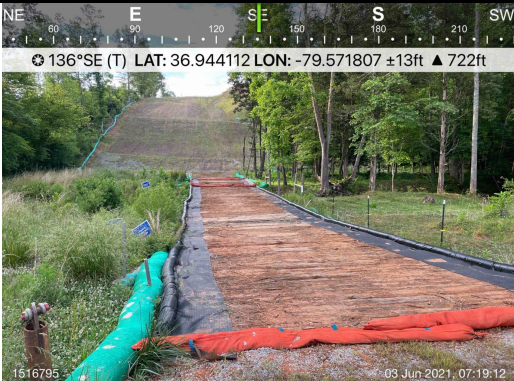
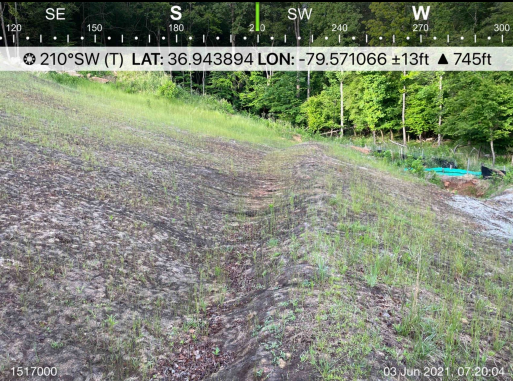
<b>GPS Location</b>	See photo		<b>GPS Location</b>	See photo	
<b>Field Station#</b>	15167+95		<b>Field Station#</b>	15170+00	
<b>Pic 5 Desc.</b>	Equipment bridge ECDs are in place and functioning.		<b>Pic 6 Desc.</b>	Waterbars are functioning as intended throughout this section.

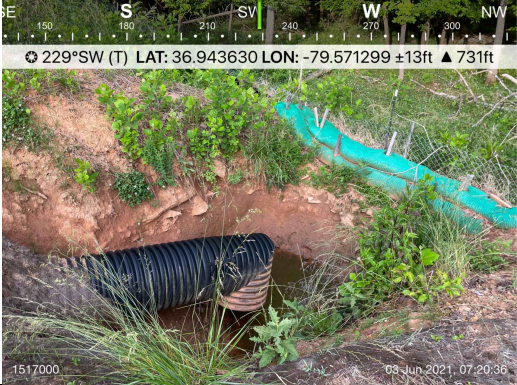
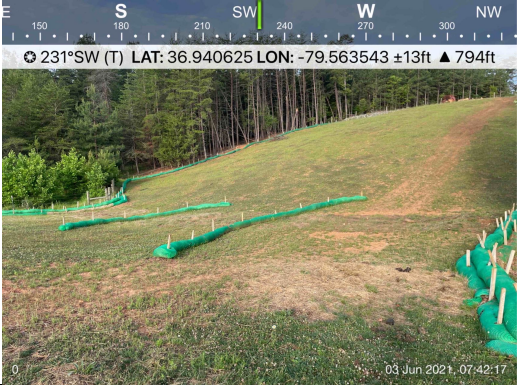
<b>GPS Location</b>	See photo		<b>GPS Location</b>	See photo	
<b>Field Station#</b>	15170+00		<b>Field Station#</b>	15195+00	
<b>Pic 7 Desc.</b>	Slope drain is functioning as intended.		<b>Pic 8 Desc.</b>	Drainage ECDs are in good condition at this location.

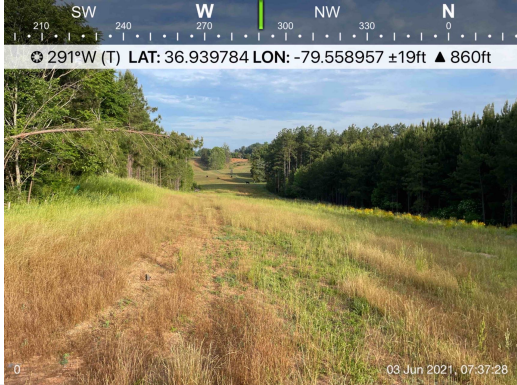
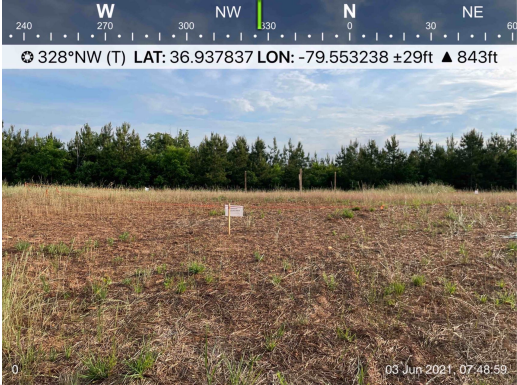
<b>GPS Location</b>	See photo		<b>GPS Location</b>	See photo	
<b>Field Station#</b>	15209+00		<b>Field Station#</b>	15230+00	
<b>Pic 9 Desc.</b>	Vegetation continues to fill in throughout this section of ROW		<b>Pic 10 Desc.</b>	Sensitive resource buffer is in good condition around ground nest at this location.

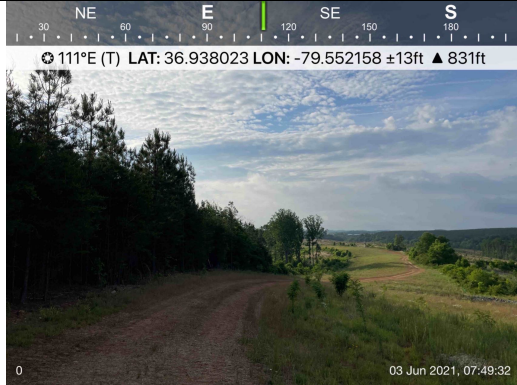
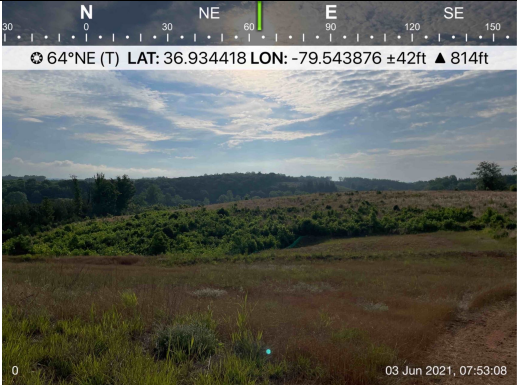
<b>GPS Location</b>	See photo		<b>GPS Location</b>	See photo	
<b>Field Station#</b>	15235+00		<b>Field Station#</b>	15260+00	
<b>Pic 11 Desc.</b>	Vegetation continues to fill in throughout this section of ROW		<b>Pic 12 Desc.</b>	Vegetation continues to fill in throughout this section of ROW

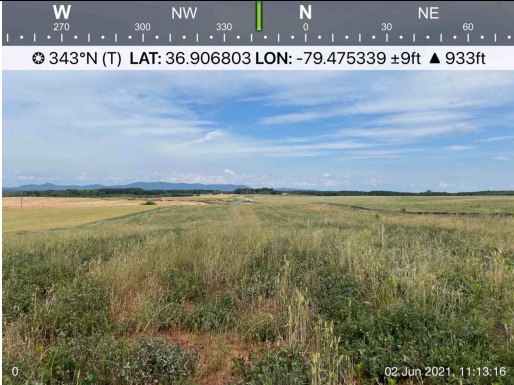
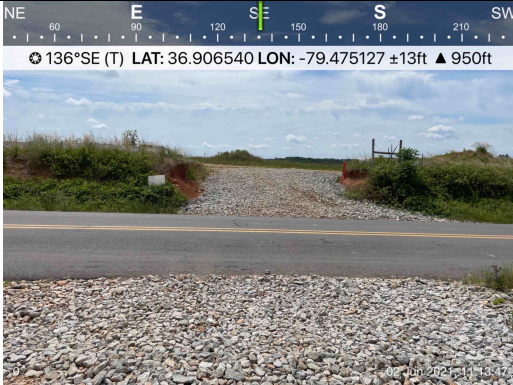
<b>GPS Location</b>	See photo		<b>GPS Location</b>	See photo	
<b>Field Station#</b>	15495+00		<b>Field Station#</b>	15496+70	
<b>Pic 1 Desc.</b>	Vegetation continues to fill in throughout this section of ROW.		<b>Pic 2 Desc.</b>	RCEs are in good condition at all road crossings.

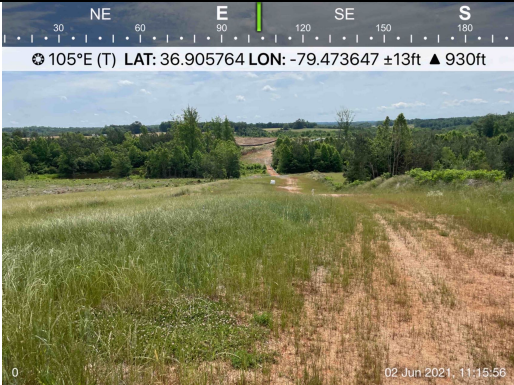
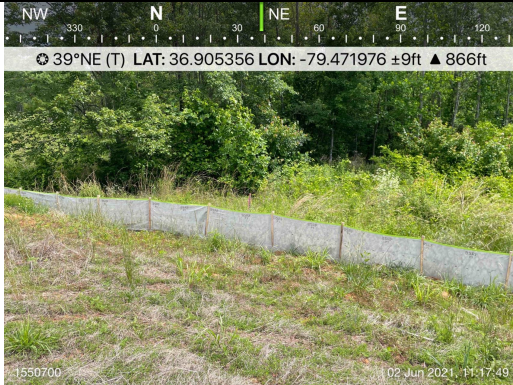
<b>GPS Location</b>	See photo		<b>GPS Location</b>	See photo	
<b>Field Station#</b>	15503+00		<b>Field Station#</b>	15507+00	
<b>Pic 3 Desc.</b>	Vegetation continues to fill in throughout this section of ROW.		<b>Pic 4 Desc.</b>	P1 is in good condition at all stream and wetland buffers.

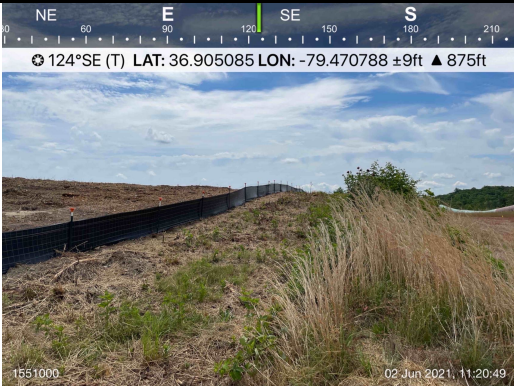
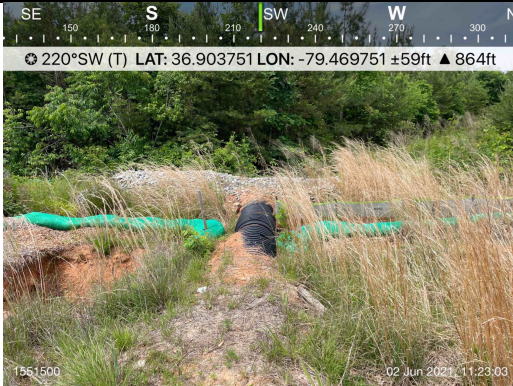
<b>GPS Location</b>	See photo		<b>GPS Location</b>	See photo	
<b>Field Station#</b>	15510+00		<b>Field Station#</b>	15515+00	
<b>Pic 5 Desc.</b>	3rd party ECDs appear to be in good condition with no evidence of sedimentation onto MVP ROW.		<b>Pic 6 Desc.</b>	CWDs are in good condition and functioning.

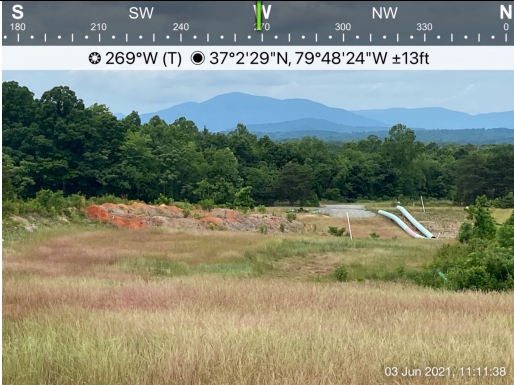
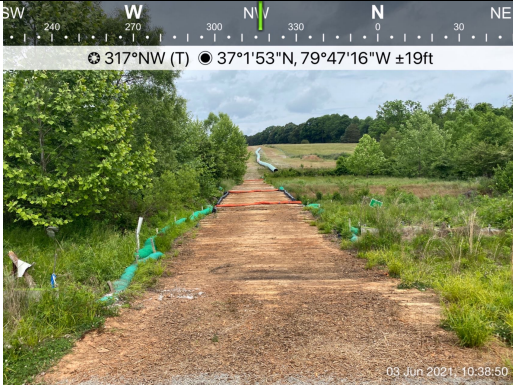
<b>GPS Location</b>	0	<b>GPS Location</b>	0		
<b>Field Station#</b>	14319+00	<b>Field Station#</b>	14391+50		
<b>Pic 1 Desc.</b>	Approximately 14319+00. Overview of ROW.	<b>Pic 2 Desc.</b>	Approximately 14391+50. Overview of stream crossing, equipment bridge and ECDs at stream S-A41.

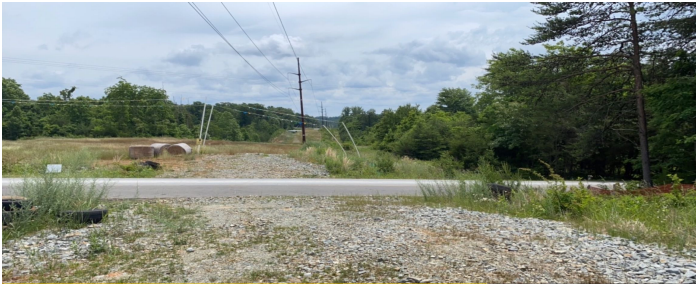
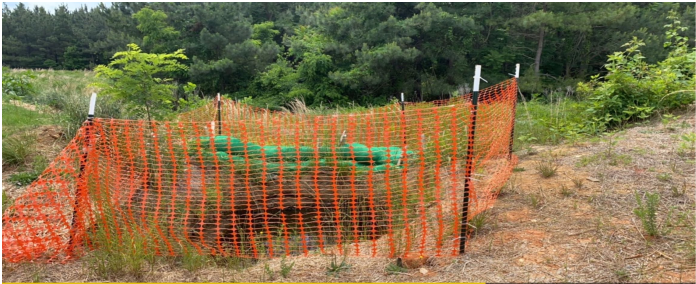
<small>36°59'16" N 79°42'37" W 110°E COURSE 187' GPS 1559-2499 Jacks Creek Rd, Union Hall, VA 24176, United States 06.03.2021 12:13:17 Accur +/-38.9 Ft ALT 949 Ft</small>			<small>36°58'59" N 79°41'22" W 147°SE COURSE 292' GPS 06.03.2021 12:22:46 Accur +/-18.7 Ft ALT 958 Ft</small>		
<b>GPS Location</b>	1	<b>GPS Location</b>	2		
<b>Field Station#</b>	14694+77	<b>Field Station#</b>	14761+00		
<b>Pic 1 Desc.</b>	RCE at Jacks Creek Rd in good condition.		<b>Pic 2 Desc.</b>	Sump pit and end treatment performing intended functions. Safety fence installed around sump pit.

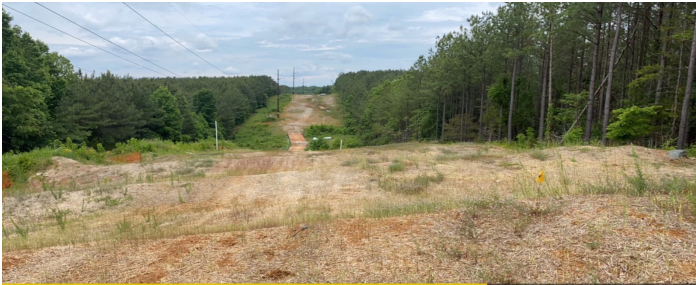
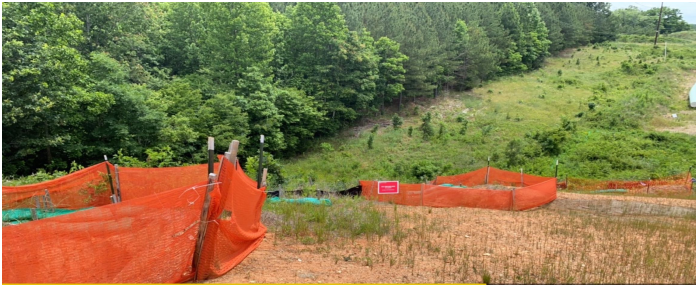
<b>GPS Location</b>	3	<b>GPS Location</b>	4		
<b>Field Station#</b>	14755+00	<b>Field Station#</b>	14765+00		
<b>Pic 3 Desc.</b>	ROW stabilized in temporary area. Water bars performing intended functions. Limited vegetation observed.		<b>Pic 4 Desc.</b>	Sumps, end treatments, and perimeter SSF performing intended functions. Limited vegetation observed.

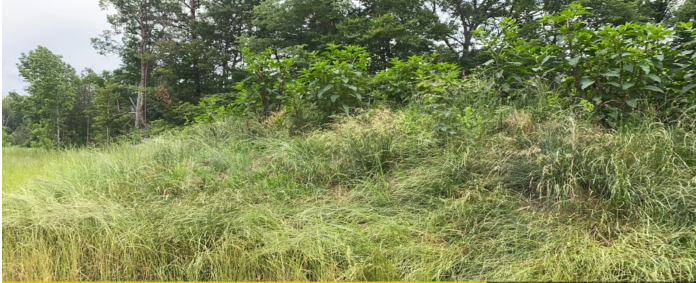
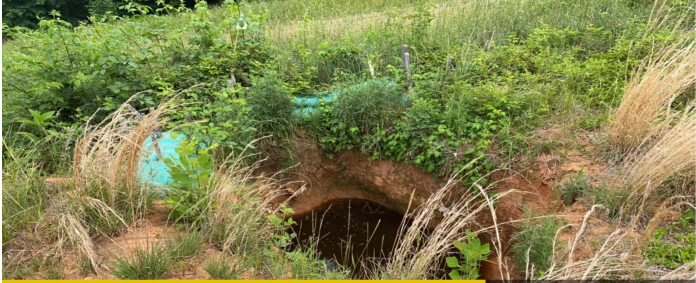
<small>36°58'37" N 79°40'44" W 224°SW COURSE 244' GPS 700-1080 Indian Cave Rd, Union Hall, VA 24176, United States 06.03.2021 12:53:59 Accur +/-44.7 Ft ALT 939 Ft</small>			<small>36°58'38" N 79°40'45" W 98°E COURSE 24' GPS 700-1080 Indian Cave Rd, Union Hall, VA 24176, United States 06.03.2021 12:54:45 Accur +/-15.5 Ft ALT 937 Ft</small>		
<b>GPS Location</b>	5	<b>GPS Location</b>	6		
<b>Field Station#</b>	14801+00	<b>Field Station#</b>	14798+00		
<b>Pic 5 Desc.</b>	Temporary diversion berm stabilized and vegetated.		<b>Pic 6 Desc.</b>	Sump pit and end treatment in good condition and functional.

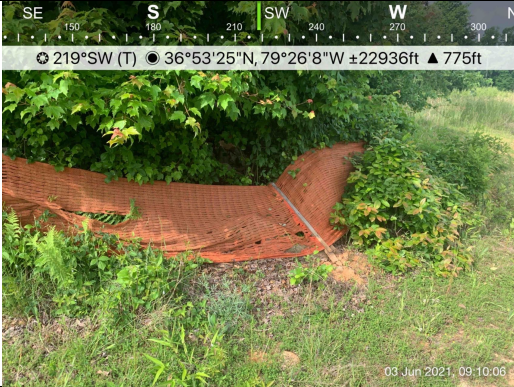
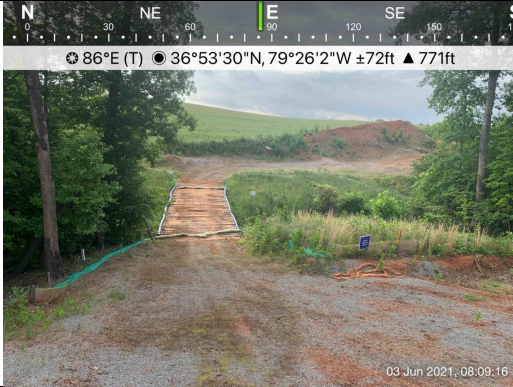
<b>GPS Location</b>	O	<b>GPS Location</b>	O		
<b>Field Station#</b>	15608+00	<b>Field Station#</b>	15636+45		
<b>Pic 1 Desc.</b>	Observing safety fence that requires maintenance.	<b>Pic 2 Desc.</b>	Observing temporary stabilization, signage, buffer, equipment crossing and ECD's

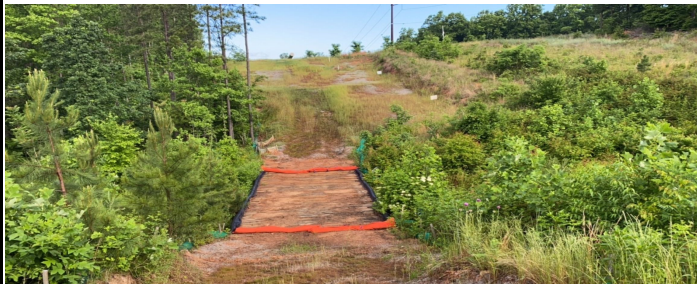
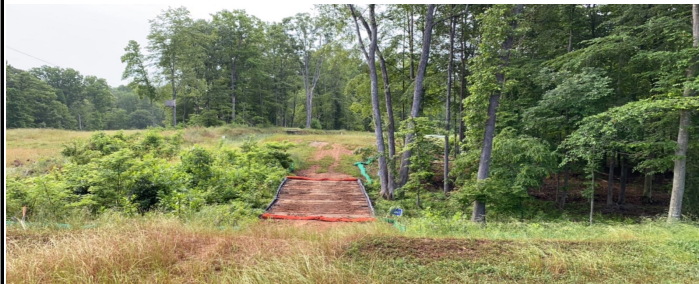
36°58'34" N 79°40'38" W 332°NW COURSE 348° GPS 179-367 Listening Hill Rd, Penhook, VA 24137, United States 06.04.2021 09:04:34 Accur +/-49.8 Ft ALT 983 Ft			36°58'20" N 79°39'56" W 160°S COURSE 293° GPS 179-367 Listening Hill Rd, Penhook, VA 24137, United States 06.04.2021 09:00:07 Accur +/-22384.3 Ft ALT 983 Ft		
GPS Location	1	GPS Location	2		
Field Station#	14804+99	Field Station#	14816+07		
Pic 1 Desc.	Equipment bridge and surrounding ECDs in place and functional at stream crossing		Pic 2 Desc.	Equipment bridge and surrounding ECDs in place and functional at stream crossing

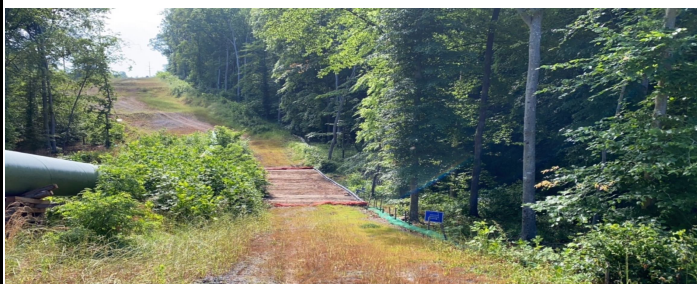
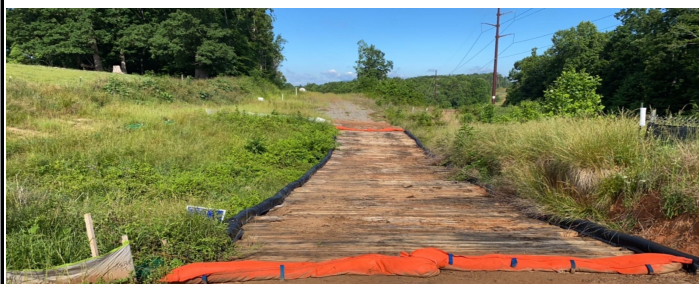
GPS Location	3	GPS Location	4		
Field Station#	14823+54	Field Station#	14832+61		
Pic 3 Desc.	Equipment bridge and surrounding ECDs in place and functional at stream crossing		Pic 4 Desc.	Equipment bridge and surrounding ECDs in place and functional at stream crossing

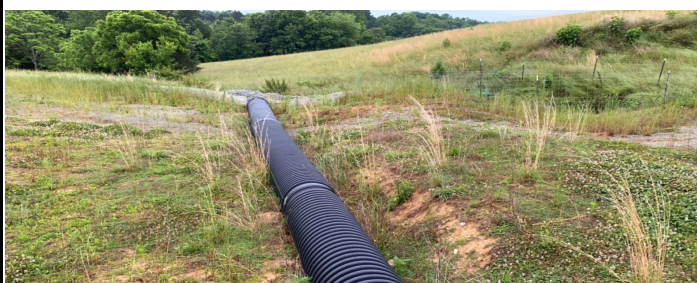
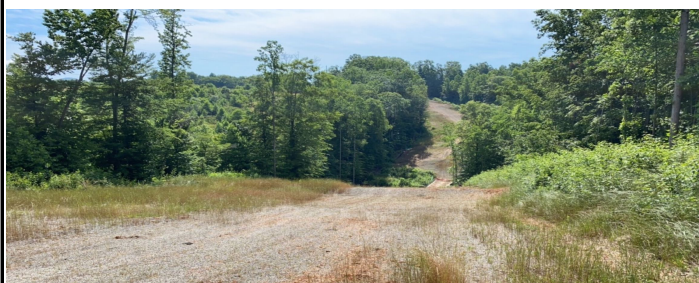
36°58'18" N 79°39'41" W 154°SE COURSE 293° GPS 2201 Bar Ridge Rd, Penhook, VA 24137, United States 06.04.2021 08:37:24 Accur +/-131.6 Ft ALT 983 Ft			36°58'16" N 79°39'31" W 95°E COURSE -1° GPS 355 Listening Hill Rd, Penhook, VA 24137, United States 06.04.2021 10:14:16 Accur +/-20.3 Ft ALT 956 Ft		
GPS Location	5	GPS Location	6		
Field Station#	14850+00	Field Station#	14864+00		
Pic 5 Desc.	CWD drain performing intended function		Pic 6 Desc.	ROW stabilized in temporary area. No vegetation along travel lane.

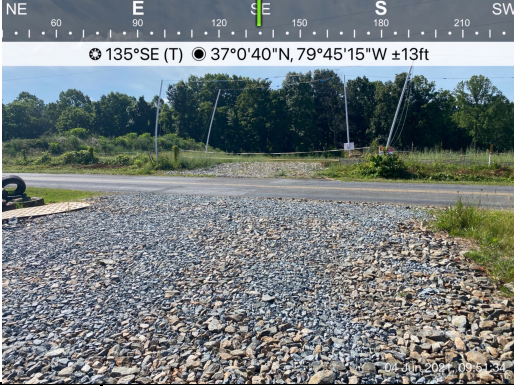
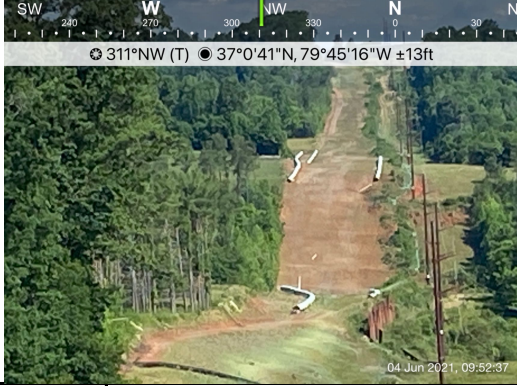
<b>GPS Location</b>	0	<b>GPS Location</b>	0		
<b>Field Station#</b>	14524+50	<b>Field Station#</b>	14510+00		
<b>Pic 1 Desc.</b>	Approximately 14524+50. Overview of road crossing and RCEs.	<b>Pic 2 Desc.</b>	Approximately 14510+00. Overview of ROW.

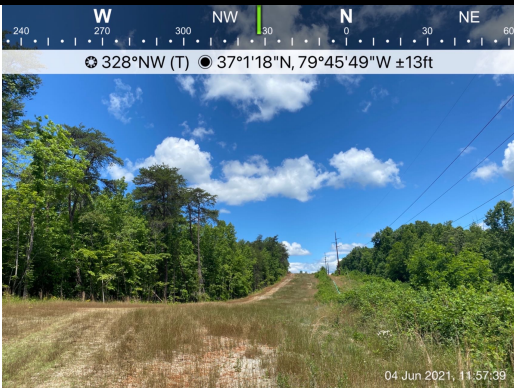
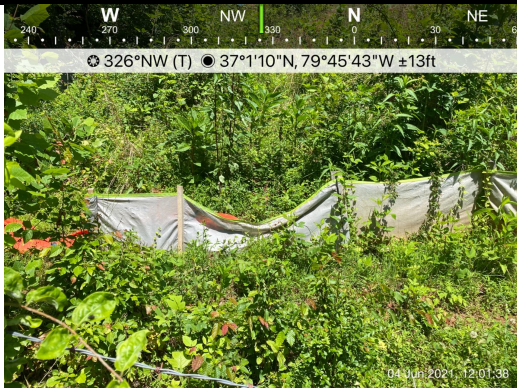
<b>GPS Location</b>	0	<b>GPS Location</b>	0		
<b>Field Station#</b>	14470+00	<b>Field Station#</b>	14486+00		
<b>Pic 5 Desc.</b>	Approximately 14470+00. Overview of ROW.	<b>Pic 6 Desc.</b>	Approximately 14486+00. P-1 requires maintenance. Damaged by livestock.

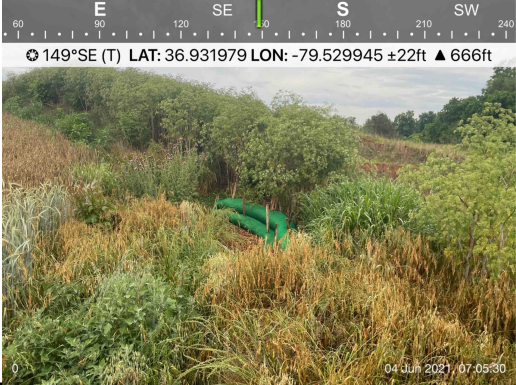
<b>GPS Location</b>	See photo		<b>GPS Location</b>	See photo	
<b>Field Station#</b>	15299+00		<b>Field Station#</b>	15311+78	
<b>Pic 5 Desc.</b>	CWD inlets are in good condition.		<b>Pic 6 Desc.</b>	P1 is in good condition around wetland buffer.
