# Visual Site Inspection Report

<b>Project Name</b>	H-600 Pipeline Spread I	<b>AFE</b>	124300139	<b>Spread</b>	H-600 Pipeline Spread I
<b>Contractor</b>	Precision			<b>Report #</b>	24249
<b>Inspector</b>	Logan Box			<b>Date/Time</b>	6/7/2021 4:38 PM
<b>Permit #</b>	TBD	<b>Inspection Type</b>	VA SWPP	<b>Station Begin</b>	13670+00
<b>State</b>	VA	<b>Inspection Area</b>	Partial	<b>Station End</b>	13748+30
<b>County</b>	Franklin	<b>Ground</b>	Dry	<b>Temperature (°F)</b>	80.00
<b>Municipality</b>	N/A	<b>Weather</b>	Cloudy	<b>Rain Gauge (in)</b>	0.00
				<b>Rain Accumulation Time (days)</b>	0.00

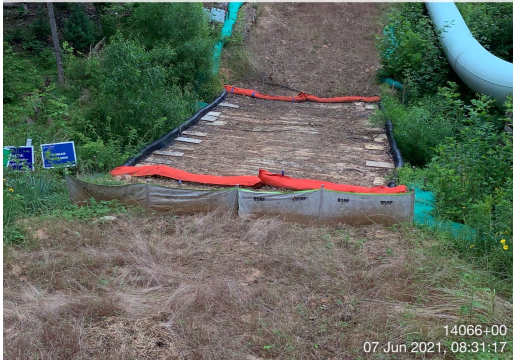
<div>14104+00 07 Jun 2021, 08:55:02</div>		
GPS Location	0		GPS Location	0	
Field Station#	14066+00		Field Station#	14104+00	
Pic 1 Desc.	Equipment bridge in acceptable condition		Pic 2 Desc.	P1 silt fence with holes and broken stakes from 14104+00 to 14104+50, damaged by livestock, contractor addressed immediately	
<div>168°S (M) 37°3'43"N, 79°51'47"W ±55ft ▲1023ft</div>

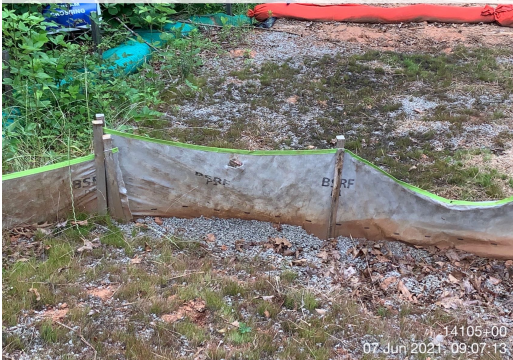
<div>14105+00 07 Jun 2021, 09:07:13</div>		
GPS Location	0		GPS Location	0	
Field Station#	14104+00		Field Station#	14105+00	
Pic 3 Desc.	P1 silt fence after repair by contractor from 14104+00 to 14104+50		Pic 4 Desc.	P1 silt fence with a hole in it, damaged by livestock, contractor repaired immediately

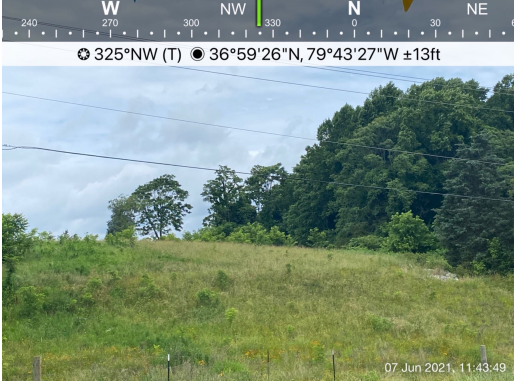
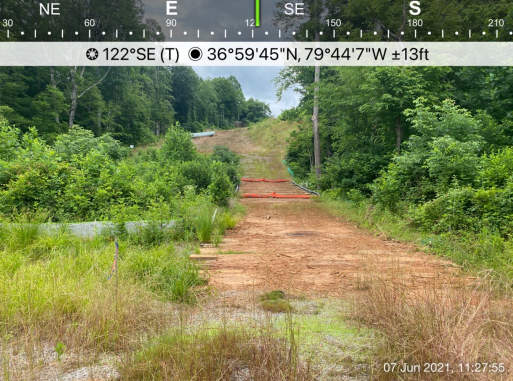
<b>GPS Location</b>	0	<b>GPS Location</b>	0		
<b>Field Station#</b>	14647+00	<b>Field Station#</b>	14611+27		
<b>Pic 1 Desc.</b>	Approximately 14647+00. Overview of ROW.	<b>Pic 2 Desc.</b>	Approximately 14611+27. Overview of stream crossing, equipment bridge and ECDs at stream S-E14.

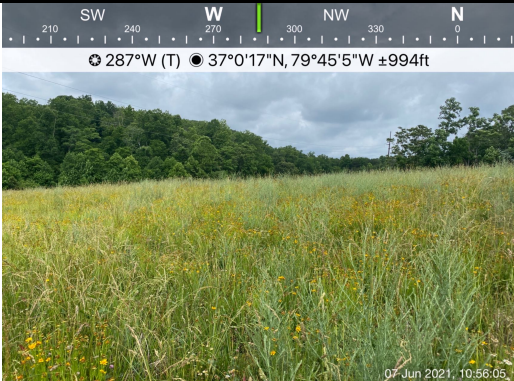
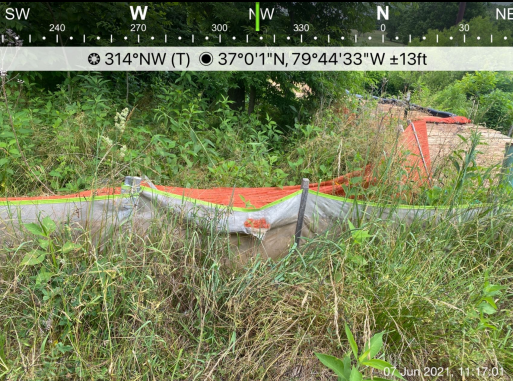
<b>GPS Location</b>	0	<b>GPS Location</b>	0		
<b>Field Station#</b>	14549+50	<b>Field Station#</b>	14583+25		
<b>Pic 5 Desc.</b>	Approximately 14549+50. Overview of ROW.	<b>Pic 6 Desc.</b>	Approximately 14583+25. P-1 and safety fence damaged by livestock and requires maintenance.

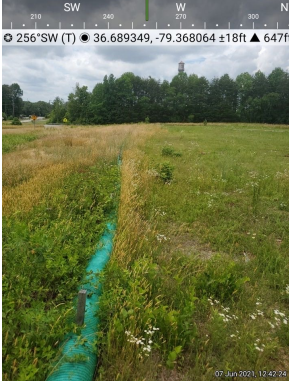
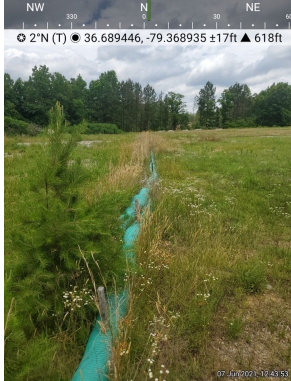
<b>GPS Location</b>	0	<b>GPS Location</b>	0		
<b>Field Station#</b>	0+00	<b>Field Station#</b>	0+00		
<b>Pic 1 Desc.</b>	LY-048 South perimeter CFS		<b>Pic 2 Desc.</b>	LY-048 West perimeter CFS

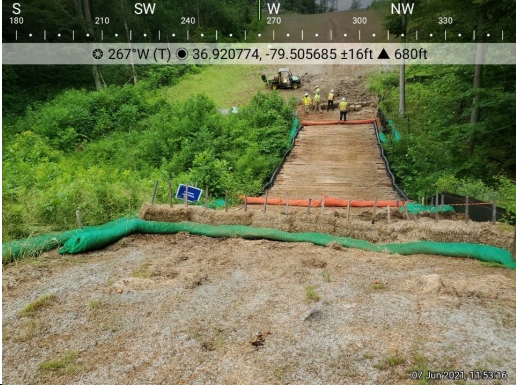
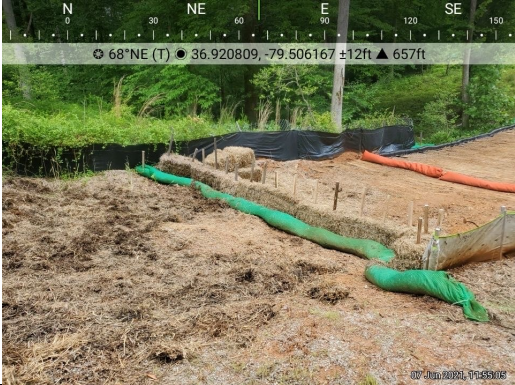
<b>GPS Location</b>	0	<b>GPS Location</b>	0		
<b>Field Station#</b>	15389+74	<b>Field Station#</b>	15389+74		
<b>Pic 13 Desc.</b>	GAS S-G6 Straw bale reinforcement replaced	<b>Pic 14 Desc.</b>	CIS S-G6 Straw bale reinforcement replaced		
Insert image here		Insert image here			
<b>GPS Location</b>		<b>GPS Location</b>			
<b>Field Station#</b>		<b>Field Station#</b>			
<b>Pic 15 Desc.</b>		<b>Pic 16 Desc.</b>			
Insert image here		Insert image here			
<b>GPS Location</b>		<b>GPS Location</b>			
<b>Field Station#</b>		<b>Field Station#</b>			
<b>Pic 17 Desc.</b>		<b>Pic 18 Desc.</b>

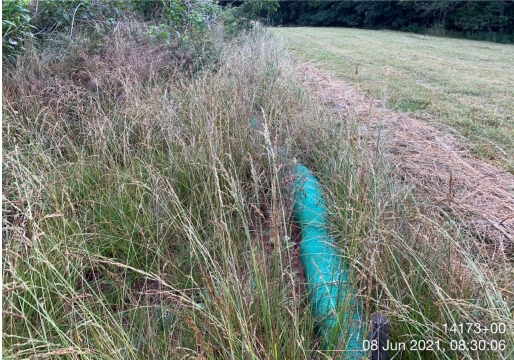
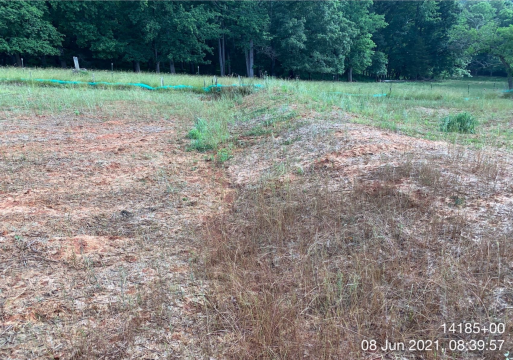
<b>GPS Location</b>	0	<b>GPS Location</b>	0		
<b>Field Station#</b>	14173+00	<b>Field Station#</b>	14185+00		
<b>Pic 1 Desc.</b>	Perimeter CFS in acceptable condition	<b>Pic 2 Desc.</b>	Waterbar in acceptable condition

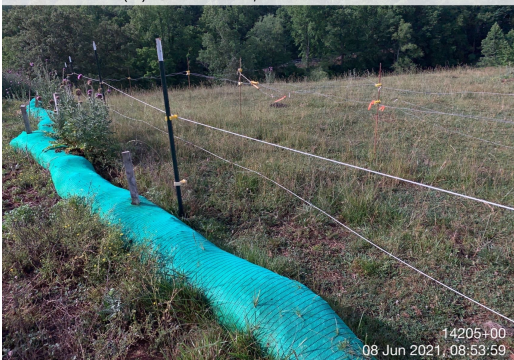
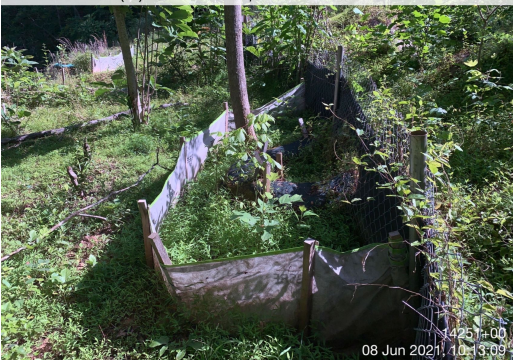
<b>GPS Location</b>	0	<b>GPS Location</b>	0		
<b>Field Station#</b>	14205+00	<b>Field Station#</b>	14251+00		
<b>Pic 3 Desc.</b>	Electric fence damaged by livestock	<b>Pic 4 Desc.</b>	P1 silt fence in acceptable condition

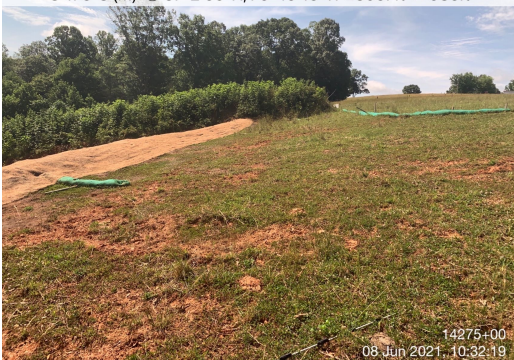
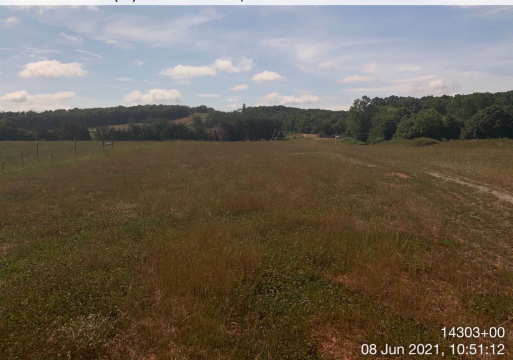
<b>GPS Location</b>	0	<b>GPS Location</b>	0		
<b>Field Station#</b>	14277+00	<b>Field Station#</b>	14303+00		
<b>Pic 5 Desc.</b>	Electric fence damaged by livestock from 14275+00 to 14277+00	<b>Pic 6 Desc.</b>	Temporary vegetative stabilization in acceptable condition

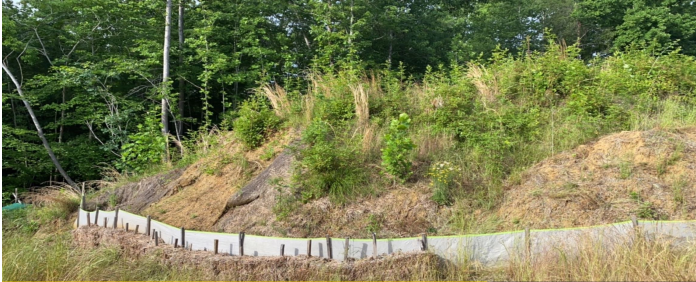
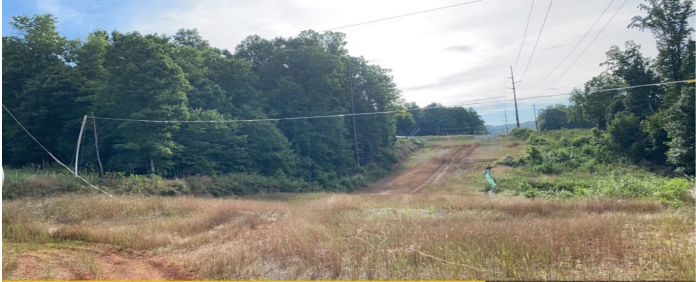
<small>36°59'16" N 79°42'5" W 258°W COURSE 290° GPS Union Hall, VA 24176, United States</small>			<small>36°59'17" N 79°42'22" W 86°E COURSE 290° GPS Union Hall, VA 24176, United States</small>		
<small>06.09.2021 08:17:29 Accur +/-221.3 Ft ALT 900 Ft</small>			<small>06.09.2021 08:35:45 Accur +/-189.7 Ft ALT 900 Ft</small>		
<b>GPS Location</b>	1		<b>GPS Location</b>	2	
<b>Field Station#</b>	14726+00		<b>Field Station#</b>	14716+00	
<b>Pic 1 Desc.</b>	P1 silt fence surrounding stabilized spoil pile. No issues observed.		<b>Pic 2 Desc.</b>	Goalpost down across ROW.

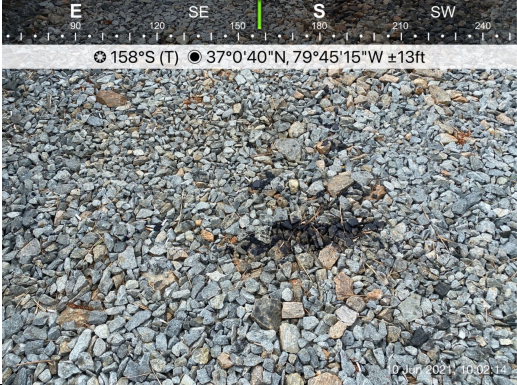
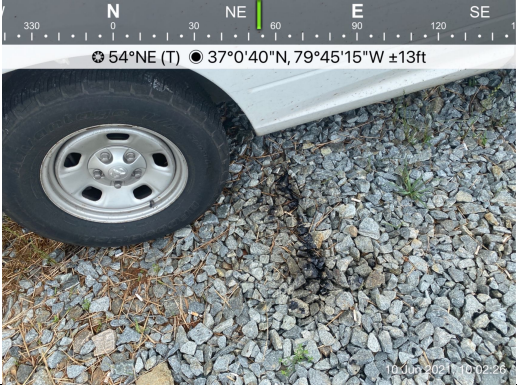
<b>GPS Location</b>	0	<b>GPS Location</b>	0		
<b>Field Station#</b>	14524+70	<b>Field Station#</b>	14524+70		
<b>Pic 13 Desc.</b>	Approximately 14524+70. Observed what appears to be oil and tar from paving company on CIS RCE of Timber Ridge Road.		<b>Pic 14 Desc.</b>	Approximately 14524+70. Observed what appears to be oil and tar from paving company on CIS RCE of Timber Ridge Road.

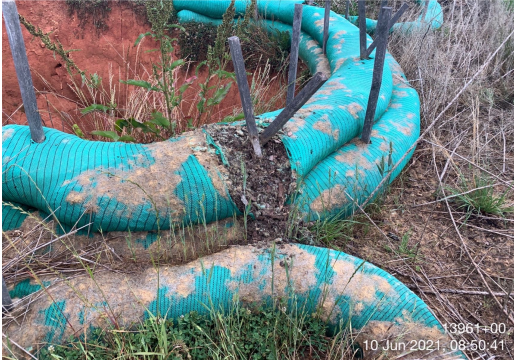
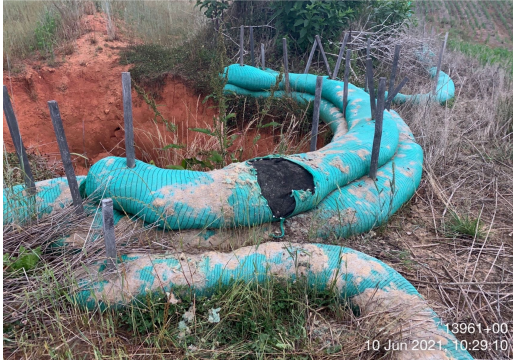
<b>GPS Location</b>	0	<b>GPS Location</b>	0		
<b>Field Station#</b>	13961+00	<b>Field Station#</b>	13961+00		
<b>Pic 1 Desc.</b>	CFS on waterbar end treatment damaged by wildlife. Contractor addressed immediately		<b>Pic 2 Desc.</b>	CFS on waterbar end treatment after maintenance

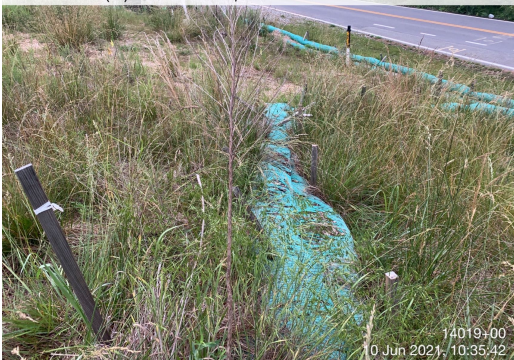
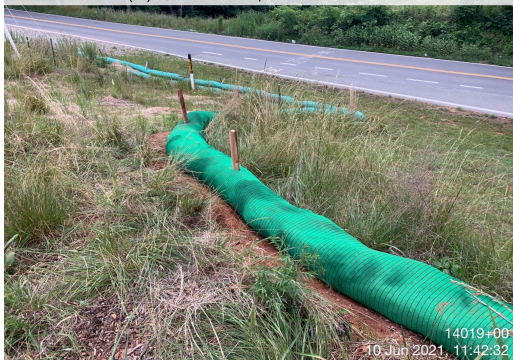
<b>GPS Location</b>	0	<b>GPS Location</b>	0		
<b>Field Station#</b>	14019+00	<b>Field Station#</b>	14019+00		
<b>Pic 3 Desc.</b>	Perimeter CFS is deteriorated, contractor addressed immediately		<b>Pic 4 Desc.</b>	Perimeter CFS after maintenance

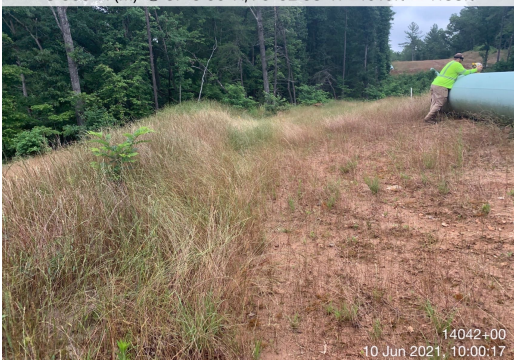
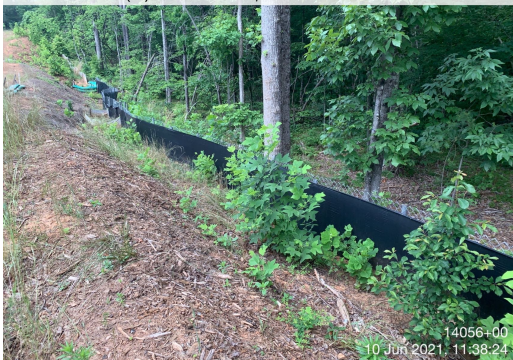
<b>GPS Location</b>	0	<b>GPS Location</b>	0		
<b>Field Station#</b>	14042+00	<b>Field Station#</b>	14056+00		
<b>Pic 5 Desc.</b>	Waterbar in acceptable condition		<b>Pic 6 Desc.</b>	Super silt fence in acceptable condition

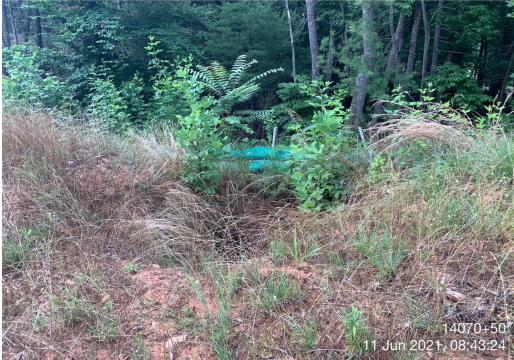
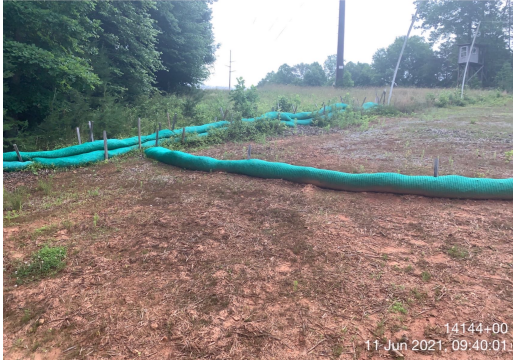
<b>GPS Location</b>	0	<b>GPS Location</b>	0		
<b>Field Station#</b>	14070+50	<b>Field Station#</b>	14144+00		
<b>Pic 1 Desc.</b>	Waterbar end treatment in acceptable condition	<b>Pic 2 Desc.</b>	CFS in acceptable condition

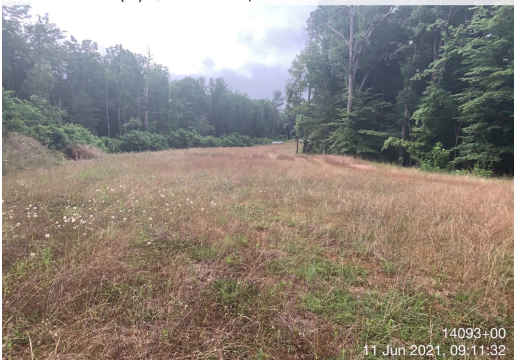
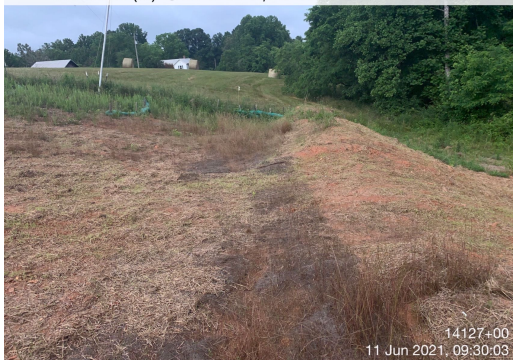
<b>GPS Location</b>	0	<b>GPS Location</b>	0		
<b>Field Station#</b>	14093+00	<b>Field Station#</b>	14127+00		
<b>Pic 3 Desc.</b>	Temporary vegetative stabilization in acceptable condition	<b>Pic 4 Desc.</b>	Waterbar in acceptable condition

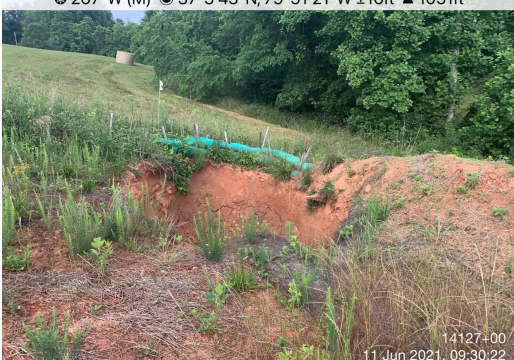
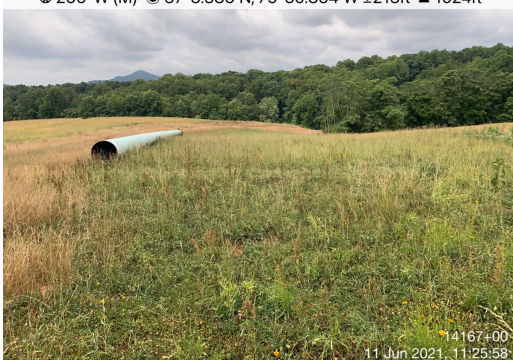
<b>GPS Location</b>	0	<b>GPS Location</b>	0		
<b>Field Station#</b>	14127+00	<b>Field Station#</b>	14167+00		
<b>Pic 5 Desc.</b>	Waterbar end treatment in acceptable condition	<b>Pic 6 Desc.</b>	Permanent vegetative stabilization in acceptable condition
