Mountain Valley Pipeline Project – Spread G

Environmental Auditor Quarterly Report for Q2 2021

July 15, 2021

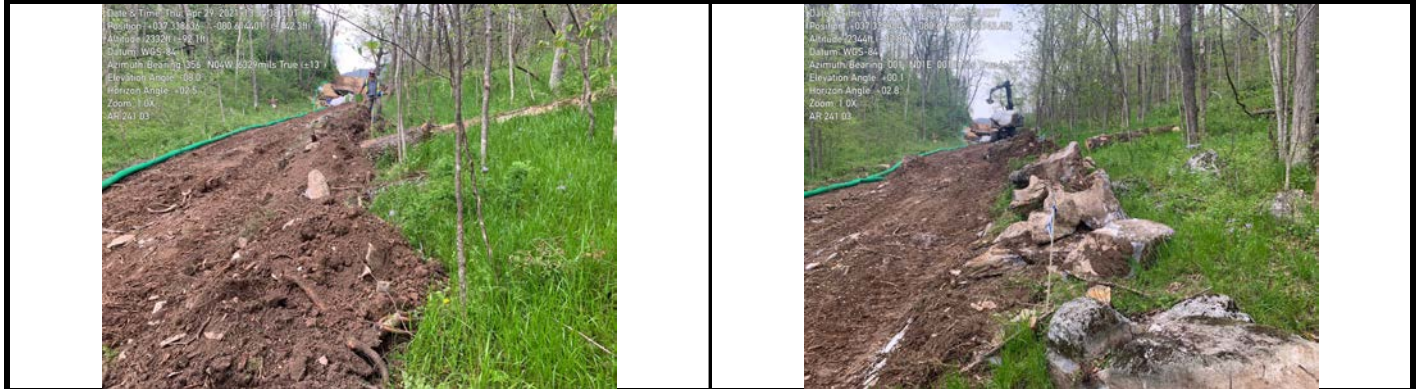
GPS Location	See photo for GPS location.	GPS Location	See photo for GPS location.
Field Station#	10819+08	Field Station#	10819+08
Pic 1 Desc.	Topsoil outside LOD.	Pic 2 Desc.	Rocks piled outside LOD.

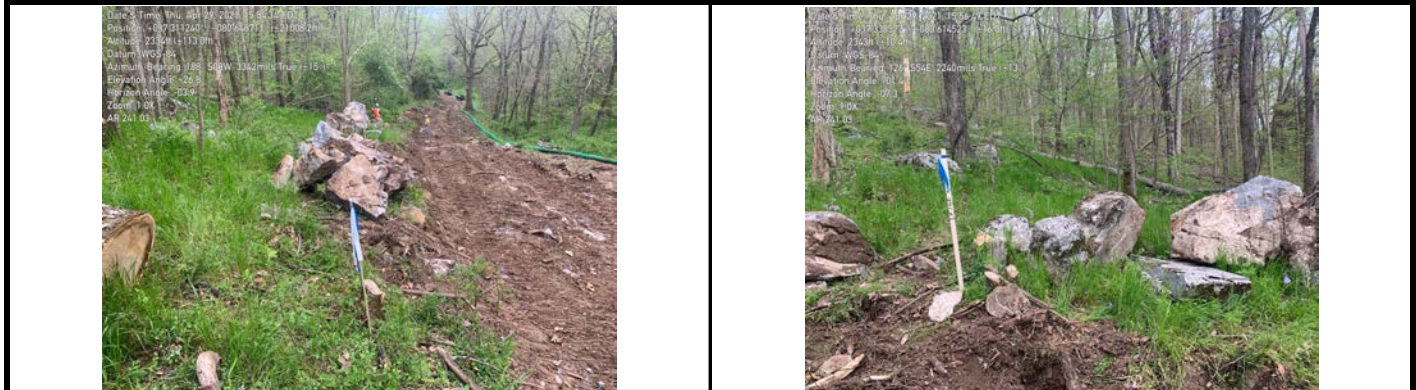
GPS Location	See photo for GPS location.	GPS Location	See photo for GPS location.
Field Station#	10819+08	Field Station#	10819+08
Pic 3 Desc.	Rocks outside LOD.	Pic 4 Desc.	Rocks outside LOD.

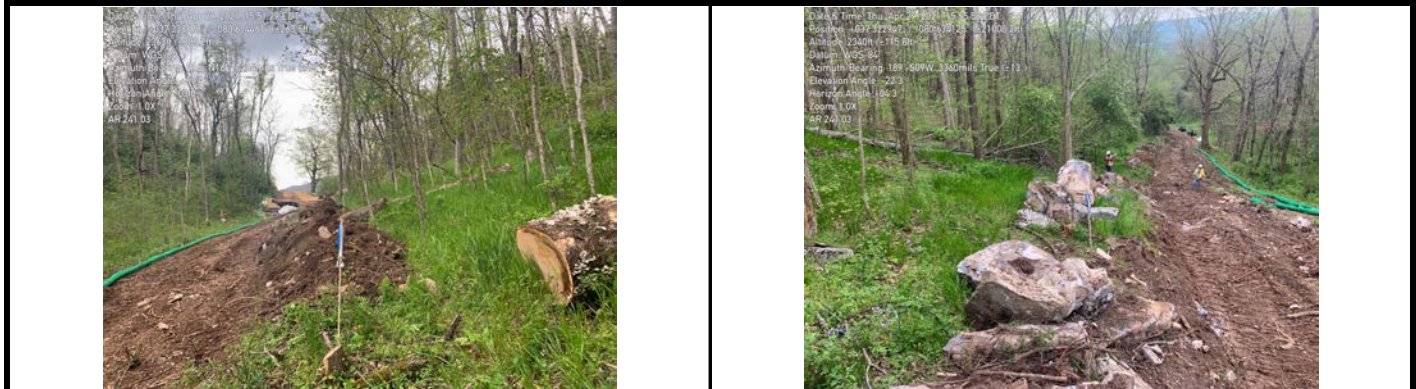
GPS Location	See photo for GPS location.	GPS Location	See photo for GPS location.
Field Station#	10819+08	Field Station#	10819+08
Pic 5 Desc.	Topsoil outside LOD.	Pic 6 Desc.	Rocks outside LOD.

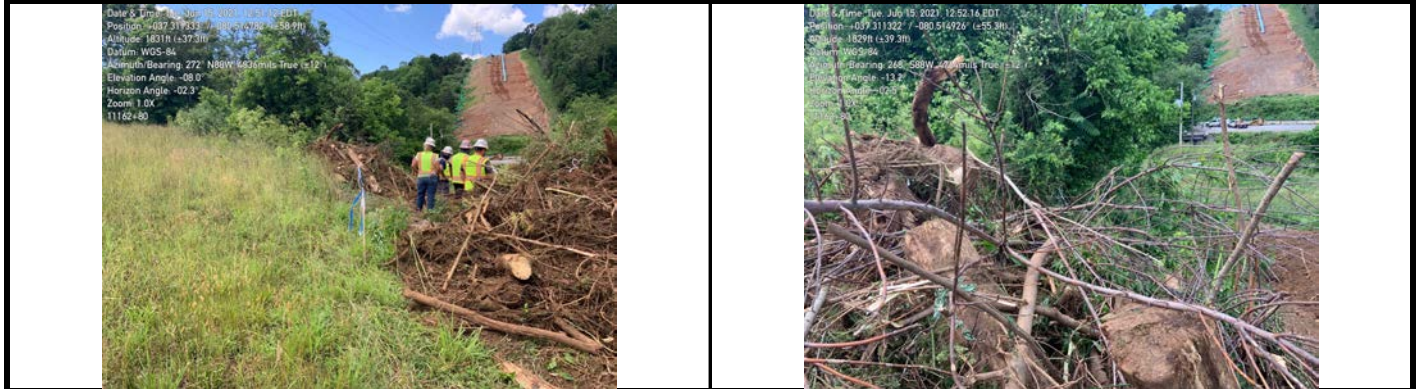
GPS Location	See photo	GPS Location	See photo
Field Station#	11162+80	Field Station#	11162+80
Pic 1 Desc.	Grubbed material shoved beyond the LOD	Pic 2 Desc.	Grubbed material shoved beyond the LOD

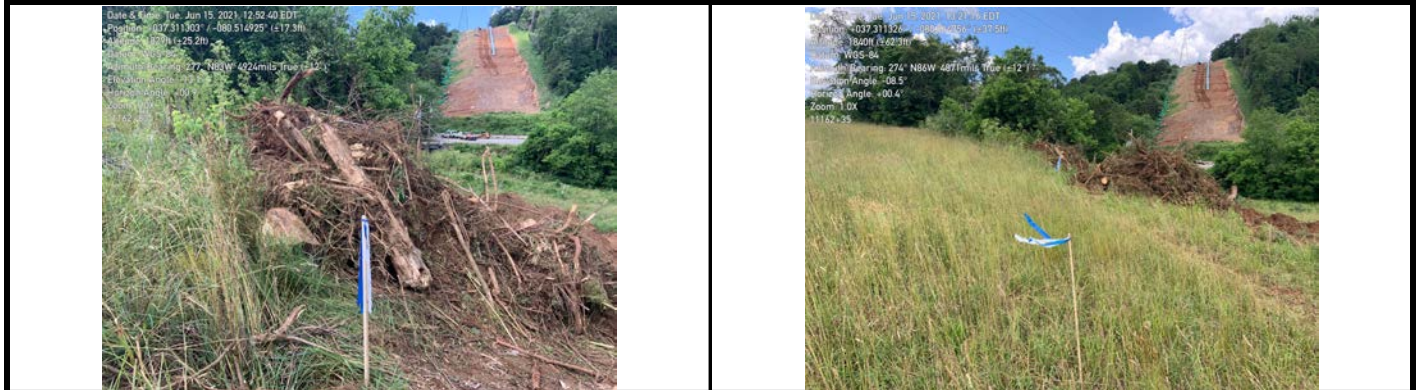
GPS Location	See photo	GPS Location	See photo
Field Station#	11162+80	Field Station#	11162+80
Pic 3 Desc.	Grubbed material shoved beyond the LOD	Pic 4 Desc.	Grubbed material shoved beyond the LOD

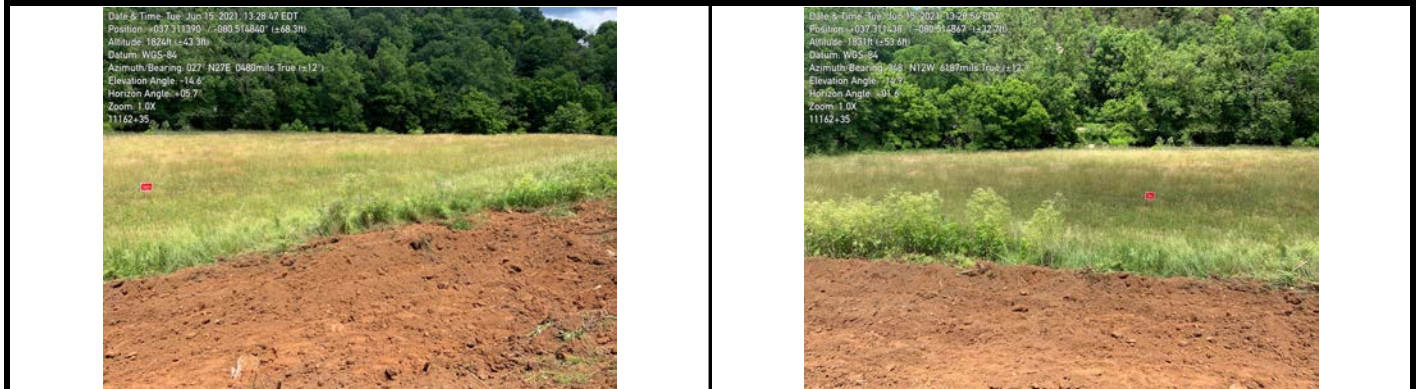
GPS Location	See photo	GPS Location	See photo
Field Station#	11162+80	Field Station#	11162+80
Pic 5 Desc.	Ground disturbance before ECD's were installed	Pic 6 Desc.	Ground disturbance before ECD's were installed
