Mountain Valley Pipeline Project – Spread H

Environmental Auditor Quarterly Report for Q2 2021

July 15, 2021

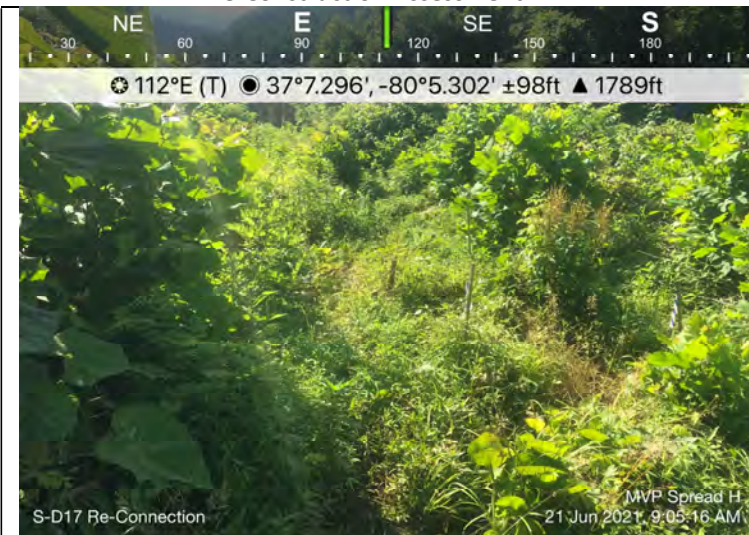
Pre-Construction Assessment

Overview of work area during pre-construction conditions. Wetland habitat log is to be installed across stream channel and re-connect the channel through the berm, depicted near the blue and white striped flagging. No aquatic macroinvertebrates or fish were observed in the channel prior to the work activity.

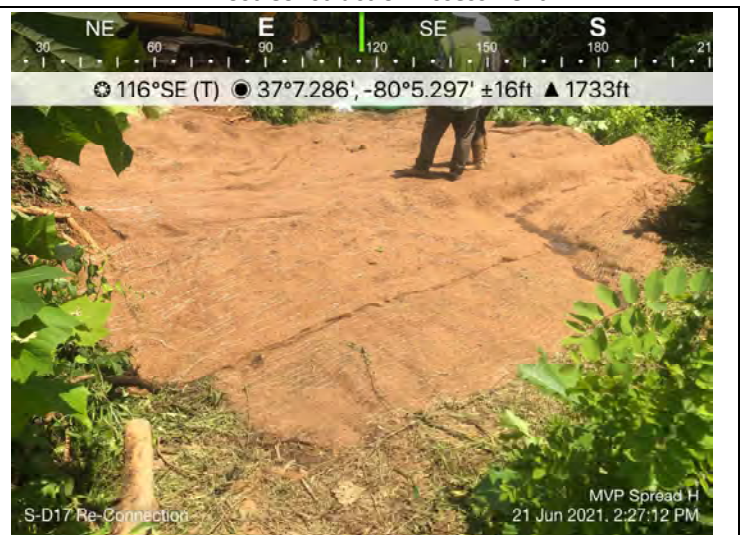
Post-Construction Assessment

Post-construction stream flow at the re-connection point of S-D17 to S-D14. The WHL was installed across the stream and the re-connection has prevented the continued erosion of the hillside. The disturbed area was seeded and stabilized with matting, and the stream flow was clear after flowing through the work area.

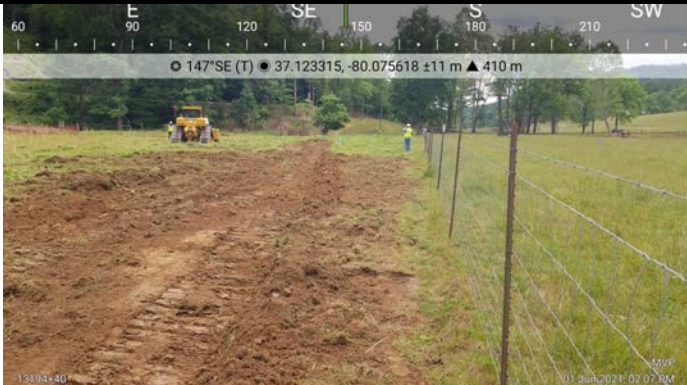
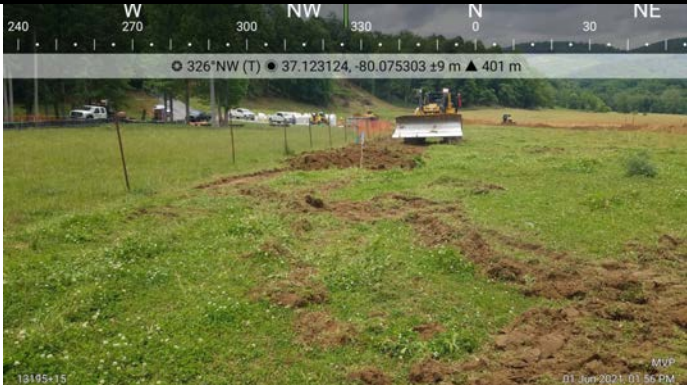
GPS Location	37 07' 24.01" N, 80 04' 31.76" W		GPS Location	37 07' 24.01" N, 80 04' 31.76" W	
Field Station#	13194+40		Field Station#	13195+14	
Pic 1 Desc.	Start of grading activity beyond LOD.		Pic 2 Desc.	Dozer tracks extend beyond the area graded outside of LOD.

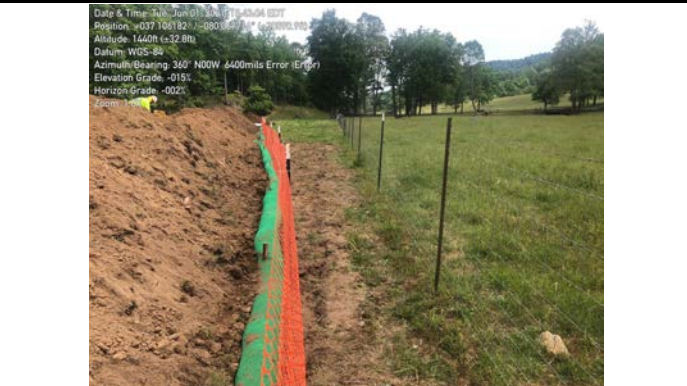
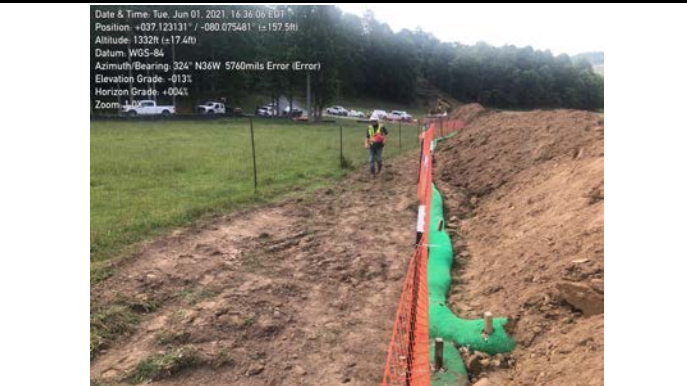
GPS Location	37 07' 24.01" N, 80 04' 31.76" W		GPS Location	37 07' 24.01" N, 80 04' 31.76" W	
Field Station#	13194+50		Field Station#	13194+75	
Pic 3 Desc.	Perimeter controls installed.		Pic 4 Desc.	The disturbed area was seeded.

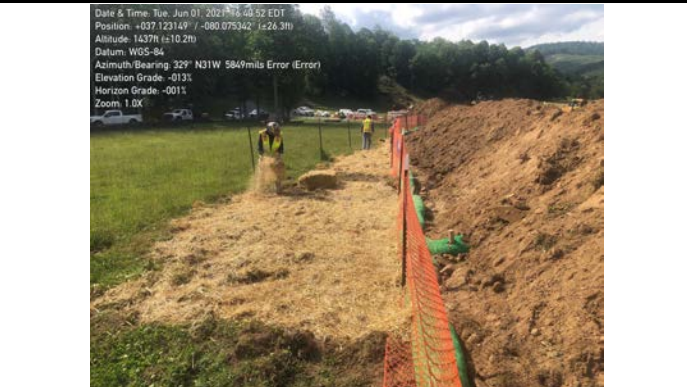
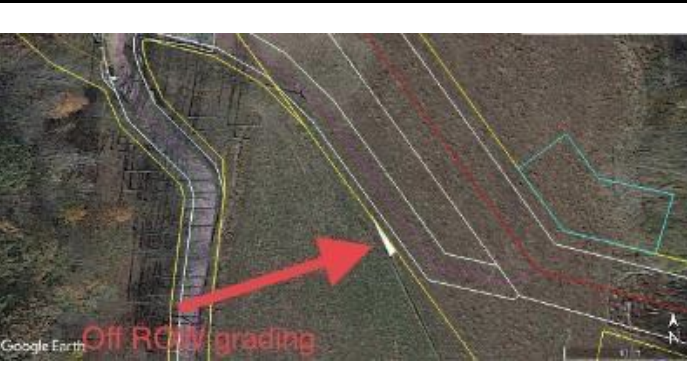
GPS Location	37 07' 24.01" N, 80 04' 31.76" W		GPS Location	37 07' 24.01" N, 80 04' 31.76" W	
Field Station#	13194+75		Field Station#	13194+40	
Pic 5 Desc.	The area was stabilized with mulch.		Pic 6 Desc.	Google Earth image of affected area.

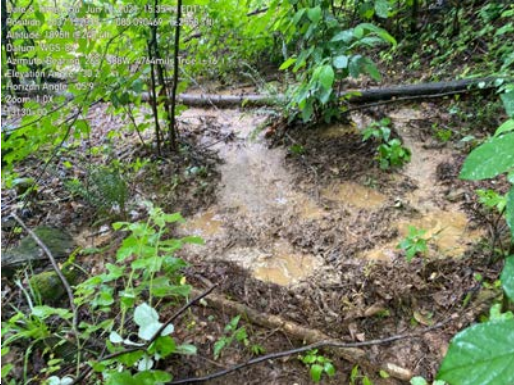
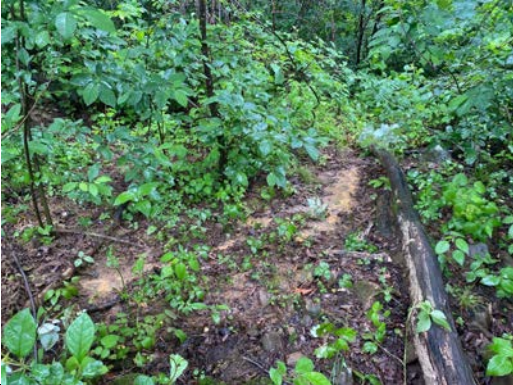
GPS Location	See photo	GPS Location	See photo		
Field Station#	13130+00	Field Station#	13130+00		
Pic 1 Desc.	Sediment outside of LOD on north side of ROW.	Pic 2 Desc.	Trail of off ROW sedimentation on north side of ROW.

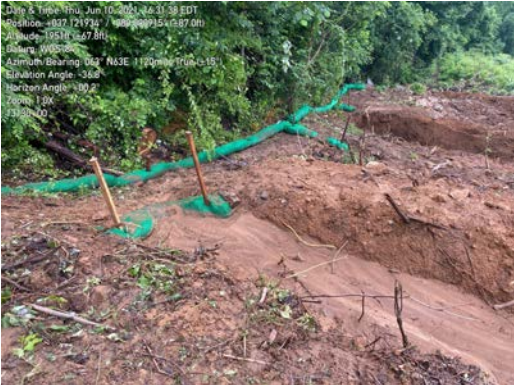
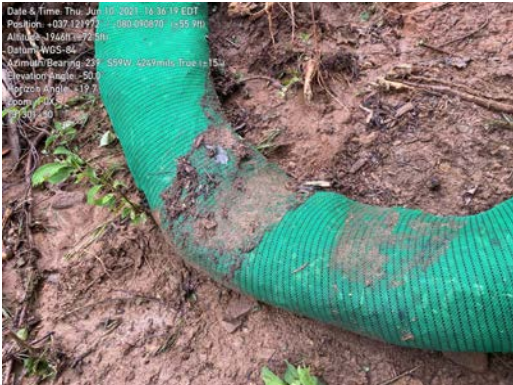
GPS Location	See photo	GPS Location	See photo		
Field Station#	13130+00	Field Station#	13130+50		
Pic 3 Desc.	Interim waterbar end treatment overwhelmed.	Pic 4 Desc.	12" CFS overwhelmed by runoff.

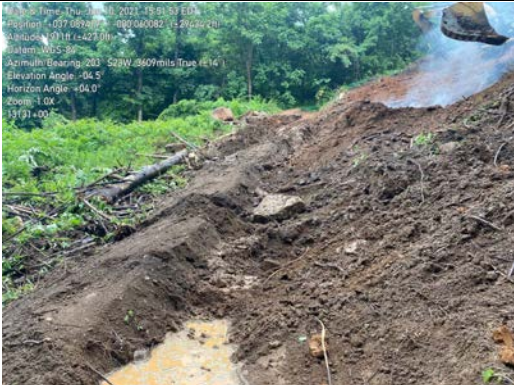
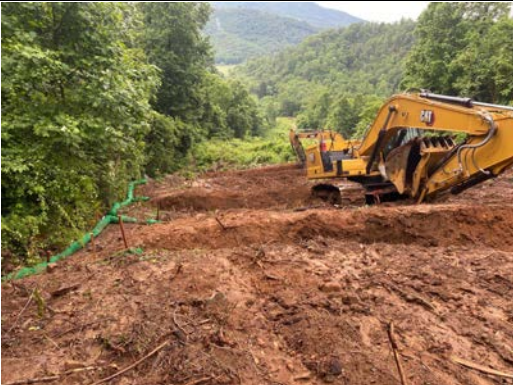
GPS Location	See photo	GPS Location	See photo		
Field Station#	13131+00	Field Station#	13131+00		
Pic 5 Desc.	Interim waterbar at end of grubbing operations.	Pic 6 Desc.	Interim waterbars enhanced in size.

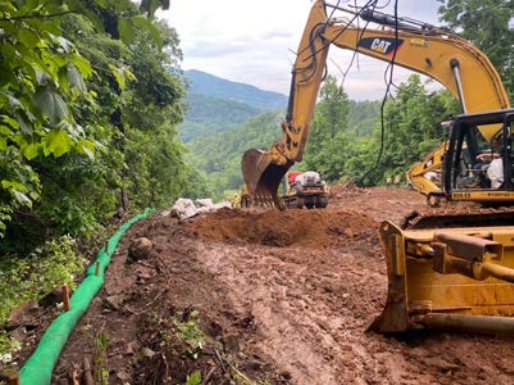
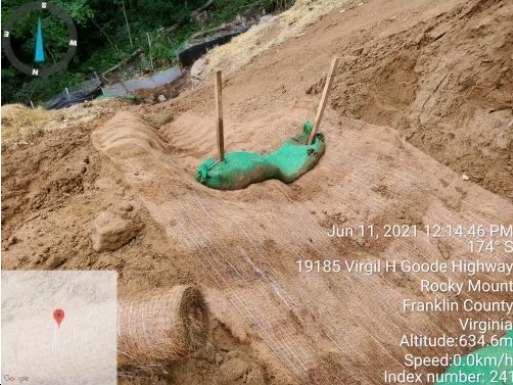
<p>Jun 11, 2021 12:14:46 PM -174° S 19185 Virgil H Goode Highway Rocky Mount Franklin County Virginia Altitude: 634.6m Speed: 0.0km/h Index number: 241</p>	
GPS Location	See photo	GPS Location	37.121753, 80.091970		
Field Station#	13131+00	Field Station#	13126+00		
Pic 13 Desc.	Sump pits added at ends of interim waterbars.	Pic 14 Desc.	Waterbar running straight down fill slope with no sump installed.

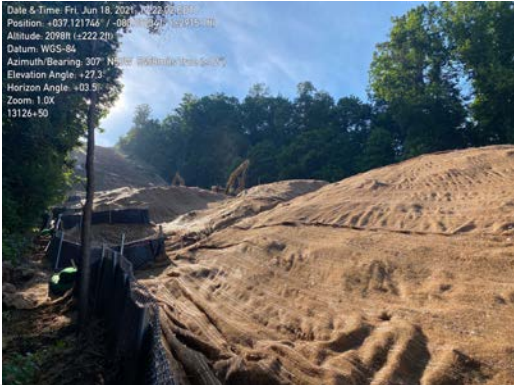
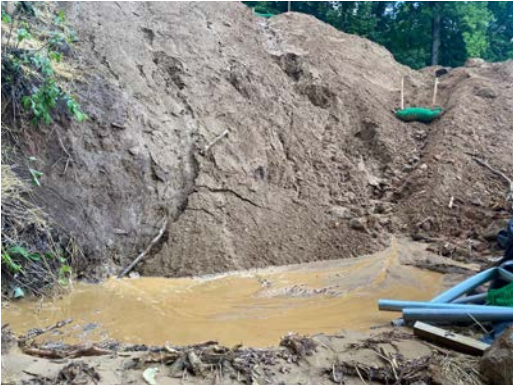
<p>Date & Time: Fri, Jun 18, 2021 12:22:05 EDT Position: +037.121745° / -080.092654° (-8410.1m) Altitude: 2099ft (+222.2m) Datum: WGS-84 Azimuth/Bearing: 307° NAD83 (Magnetic True) Elevation Angle: +27.3° Horizon Angle: +03.5° Zoom: 1.0x 13126+00</p>	
GPS Location	37.121753, 80.091970	GPS Location	37.121753, 80.091970		
Field Station#	13126+50	Field Station#	13126+50		
Pic 15 Desc.	Fill slope has been stabilized with erosion control blanket.	Pic 16 Desc.	Waterbar outlet down fill slope with no sump, drain pipe.

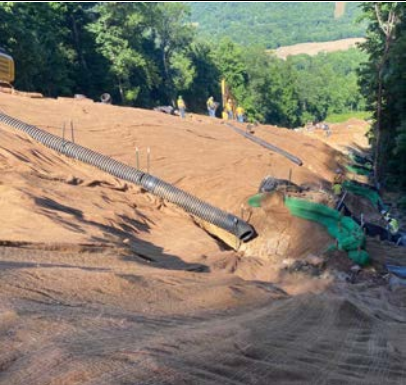
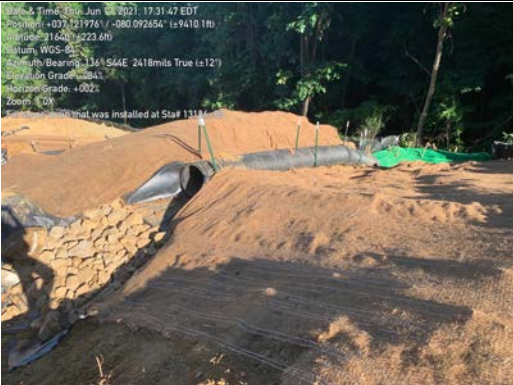
<p>Date & Time: Sat, Jun 19, 2021 17:31:47 EDT Position: +037.121976° / -080.092654° (-8410.1m) Altitude: 2164ft (+223.6m) Datum: WGS-84 Azimuth/Bearing: 136° S44E 2418mils True (+12°) Elevation Angle: +04.7° Horizon Angle: +02.1° Zoom: 1.0x Sump pit that was installed at Sta# 13131</p>	
GPS Location	37.121753, 80.091970	GPS Location	See photo		
Field Station#	13125+00	Field Station#	13126+00		
Pic 17 Desc.	Sump pits, end treatments and slope drains installed on fill slope stabilized with blanket.	Pic 18 Desc.	Fill slope drain, sump and end treatments installed.
