# Visual Site Inspection Report

<b>Project Name</b>	H-600 Pipeline Spread G	<b>AFE</b>	124300137	<b>Spread</b>	H-600 Pipeline Spread G
<b>Contractor</b>	Precision			<b>Report #</b>	24519
<b>Inspector</b>	Len Kruizenga			<b>Date/Time</b>	6/14/2021 11:42 AM
<b>Permit #</b>	TBD	<b>Inspection Type</b>	VA SWPP	<b>Station Begin</b>	12005+00
<b>State</b>	VA	<b>Inspection Area</b>	Full	<b>Station End</b>	12005+00
<b>County</b>	Giles	<b>Ground</b>	Wet	<b>Temperature (°F)</b>	77.00
<b>Municipality</b>	N/A	<b>Weather</b>	Sunny	<b>Rain Gauge (in)</b>	0.40
				<b>Rain Accumulation Time (days)</b>	1.00

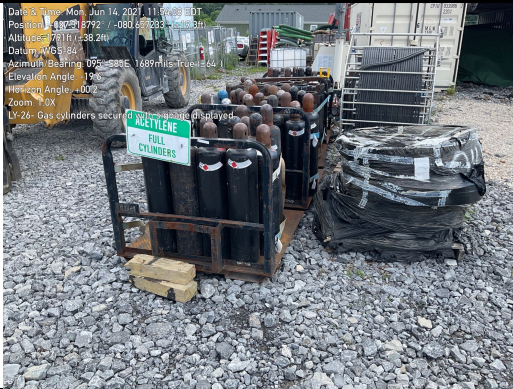
<p>Date &amp; Time: Mon, Jun 14, 2021, 11:56:53 EDT Position: -809.315527° / -080.657351° (15.7ft) Altitude: 1727ft (+26.2ft) Datum: WGS 84 Azimuth/Heading: 052°/504E 3129mils True (+65°) Elevation Angle: -19° Horizon Angle: +00.8° Zoom: 1.0X LY-26- Gas cylinders secured and signage displayed.</p>

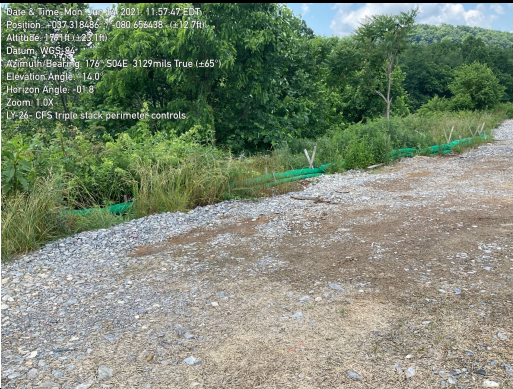
<p>Date &amp; Time: Mon, Jun 14, 2021, 11:57:47 EDT Position: -809.315527° / -080.657351° (15.7ft) Altitude: 1727ft (+26.2ft) Datum: WGS 84 Azimuth/Heading: 170°/504E 3129mils True (+65°) Elevation Angle: -14.0° Horizon Angle: +01.8° Zoom: 1.0X LY-26- CFS triple stack perimeter controls.</p>			
GPS Location	See photo GPS		GPS Location	See photo GPS	
Field Station#	12005+00		Field Station#	12005+00	
Pic 1 Desc.	LY-26- Gas cylinders secured and signage visible.		Pic 2 Desc.	LY-26- CFS triple stack perimeter controls.

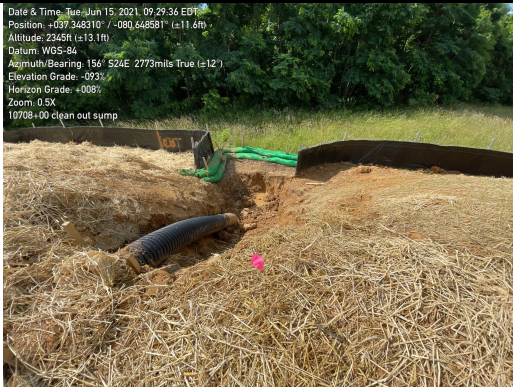
<p>Date &amp; Time: Tue Jun 15, 2021, 09:29:36 EDT Position: +037.248310° / -080.648581° (±11.6m) Altitude: 2345ft (±13.1m) Datum: WGS-84 Azimuth/Bearing: 156° S24E 2773mils True (±12°) Elevation Grade: -093% Horizon Grade: +008% Zoom: 0.5X 10708+00 clean out sump</p>

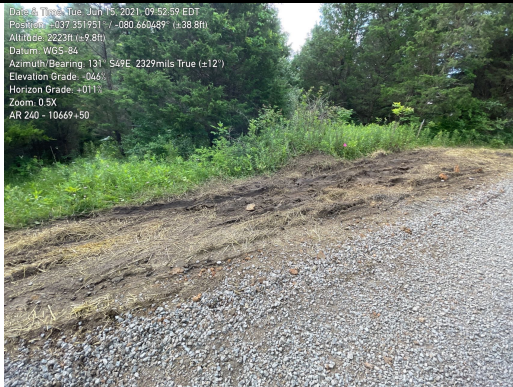
<p>Date &amp; Time: Tue Jun 15, 2021, 09:52:59 EDT Position: +037.257135191° / -080.660469° (±13.6m) Altitude: 2223ft (±9.3m) Datum: WGS-84 Azimuth/Bearing: 131° S49E 2329mils True (±12°) Elevation Grade: -046% Horizon Grade: +011% Zoom: 0.5X AR 240 - 10669+50</p>			
GPS Location	1	GPS Location	2		
Field Station#	10708+00	Field Station#	10669+50		
Pic 1 Desc.	Clean out sump.	Pic 2 Desc.	Repair/stabilize or add rock.

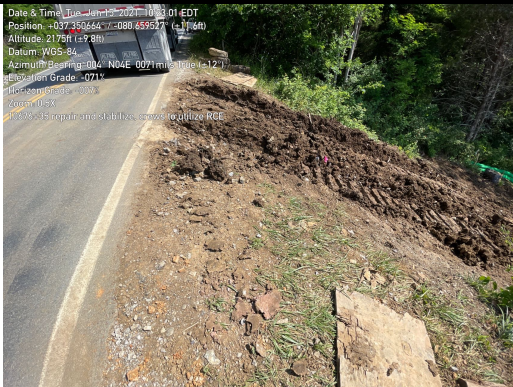
<p>Date &amp; Time: Tue Jun 15, 2021, 10:01:01 EDT Position: +037.350664° / -080.659571° (±11.6m) Altitude: 2175ft (±7.8m) Datum: WGS-84 Azimuth/Bearing: 104° N04E 0021mils True (±12°) Elevation Grade: -071% Horizon Grade: +033% Zoom: 0.5X 10676+35 repair and stabilize or create RCE</p>

GPS Location	3	GPS Location	4		
Field Station#	10676+35	Field Station#	10677+61		
Pic 3 Desc.	Repair and stabilize or create RCE.	Pic 4 Desc.	EI recommend instal 18" CFS perimeter control not called for on E&S sheets.

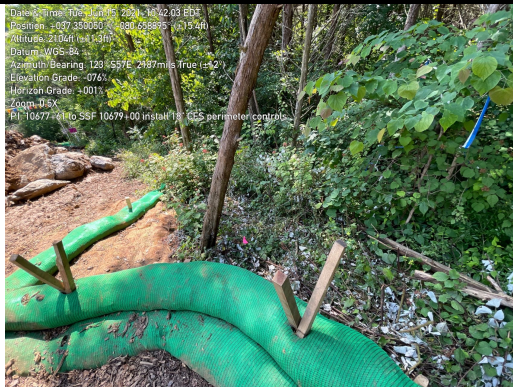
<p>Date &amp; Time: Tue Jun 15, 2021, 10:02:03 EDT Position: +037.350060° / -080.658895° (±15.4m) Altitude: 2104ft (±4.1m) Datum: WGS-84 Azimuth/Bearing: 122° S59E 2487mils True (±12°) Elevation Grade: -076% Horizon Grade: +001% Zoom: 0.5X PI-10677+61 to S&amp;F 10679+00 instal 18" CFS perimeter control</p>

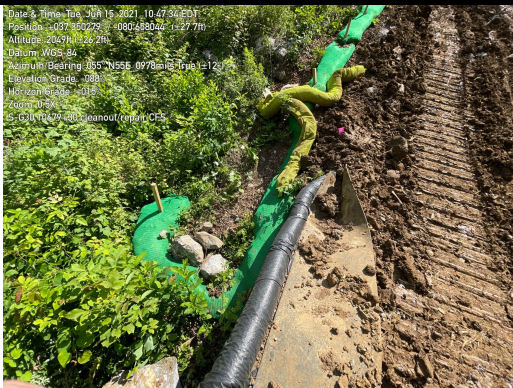
<p>Date &amp; Time: Tue Jun 15, 2021, 10:47:32 EDT Position: +037.350775° / -080.668342° (±27.7m) Altitude: 2045ft (±12.2m) Datum: WGS-84 Azimuth/Bearing: 105° N55E 0078mils True (±12°) Elevation Grade: -088% Horizon Grade: +018% Zoom: 0.5X S 10679+00 cleanout (repair) CFS</p>

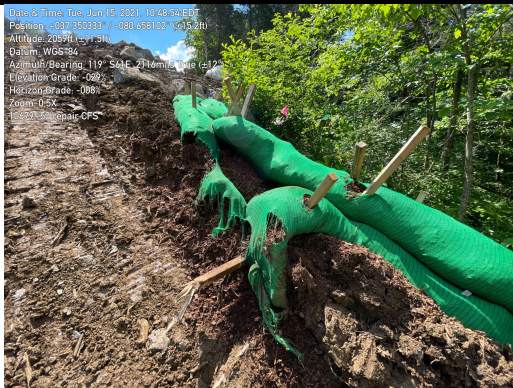
<p>Date &amp; Time: Tue Jun 15, 2021, 10:48:54 EDT Position: +037.350289° / -080.668122° (±15.4m) Altitude: 2039ft (±11.3m) Datum: WGS-84 Azimuth/Bearing: 119° S41E 2146mils True (±12°) Elevation Grade: -089% Horizon Grade: -066% Zoom: 0.5X 10679+50 repair CFS</p>			
GPS Location	5	GPS Location	6		
Field Station#	10679+30	Field Station#	10679+50		
Pic 5 Desc.	Repair/clean out CFS.	Pic 6 Desc.	Repair/replace CFS.

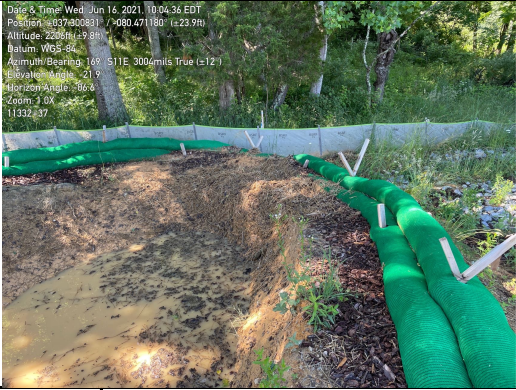
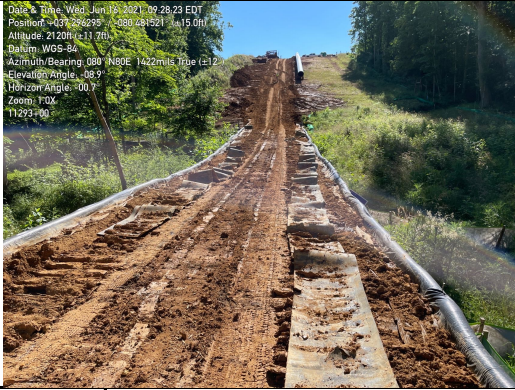
<b>GPS Location</b>	See photo	<b>GPS Location</b>	See photo		
<b>Field Station#</b>	11332+37	<b>Field Station#</b>	11293+00		
<b>Pic 1 Desc.</b>	Clean off CFS end treatment	<b>Pic 2 Desc.</b>	Repair mining belt and clean off bridge

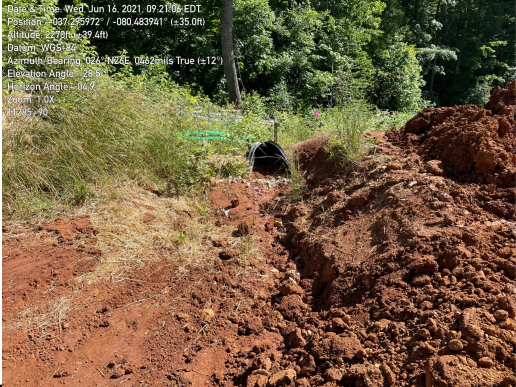
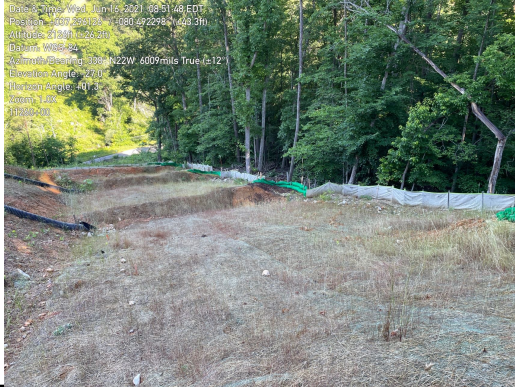
<b>GPS Location</b>	See photo	<b>GPS Location</b>	See photo		
<b>Field Station#</b>	11285+90	<b>Field Station#</b>	11260+00		
<b>Pic 3 Desc.</b>	Clean sediment out of rock inlet	<b>Pic 4 Desc.</b>	End treatments in place

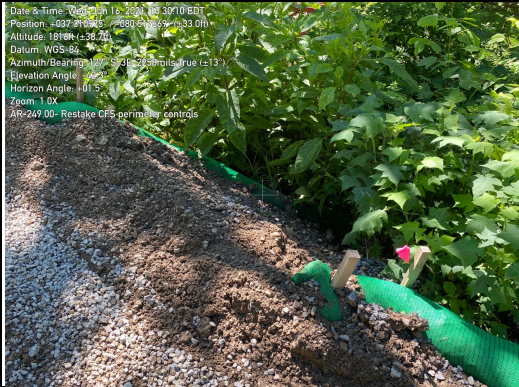
<p>Date &amp; Time: Wed Jun 16 2021 10:30:10 EDT Position: +037 314710 / -080 523846 (+139.3m) Altitude: 1810ft (+55.7m) Datum: WGS-84 Azimuth/Bearing: 109° S31E 1938mils True (+13°) Elevation Angle: +35.3° Horizon Angle: +06.1° Zoom: 1.0X AR-249.00- Restake CFS perimeter controls</p>	
GPS Location	See photo GPS		GPS Location	See photo GPS	
Field Station#	11132+00		Field Station#	11150+00	
Pic 7 Desc.	Karst ECD's & signage.		Pic 8 Desc.	AR-249.00- CFS perimeter controls on access road need to be reinstated and staked.

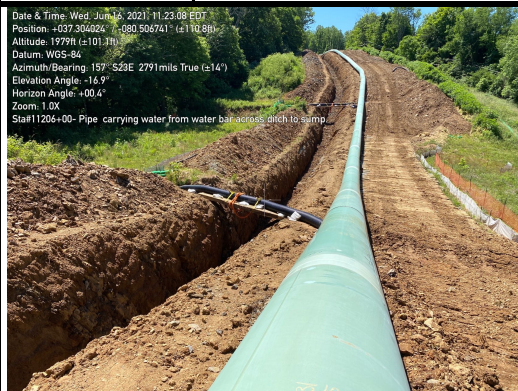
<p>Date &amp; Time: Wed Jun 16 2021 11:23:08 EDT Position: +037 304932 / -080 506741 (+110.8m) Altitude: 1979ft (+60.3m) Datum: WGS-84 Azimuth/Bearing: 159° S23E 2791mils True (+14°) Elevation Angle: +16.9° Horizon Angle: +00.4° Zoom: 1.0X Staff: 11206+00- Pipe carrying water from water bar across ditch to sump pit</p>

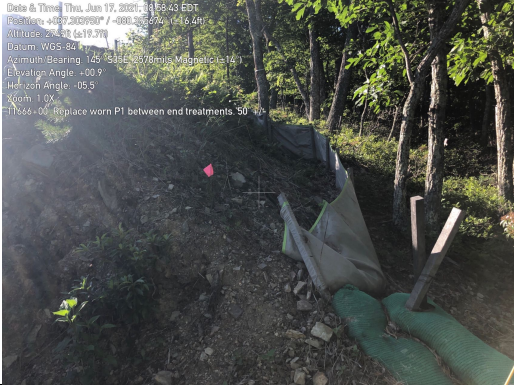
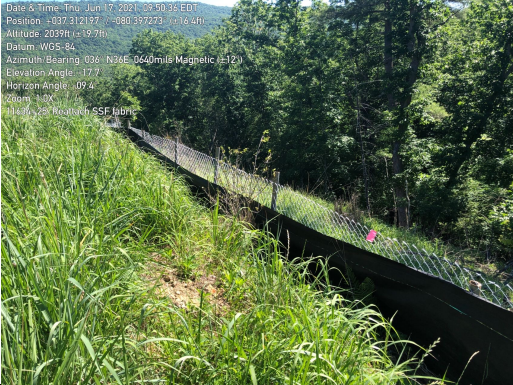
<b>GPS Location</b>	On photo	<b>GPS Location</b>	On photo		
<b>Field Station#</b>	11666+00	<b>Field Station#</b>	11634+25		
<b>Pic 1 Desc.</b>	Communication. Example of worn P1 to be replaced.	<b>Pic 2 Desc.</b>	Communication. Example of fabric to be re-attached to chain link SSF.
