Visual Site Inspection Report

Project Name	H-600 Pipeline Spread G	AFE	124300137	Spread	H-600 Pipeline Spread G
Contractor	Precision			Report #	24806
Inspector	Patrick Shields			Date/Time	6/21/2021 3:53 PM
Permit #	TBD	Inspection Type	VA SWPP	Station Begin	10655+00
State	VA	Inspection Area	Partial	Station End	10859+34
County	Giles	Ground	Dry	Temperature (°F)	85.00
Municipality	N/A	Weather	Sunny	Rain Gauge (in)	0.00
				Rain Accumulation Time (days)	1.00

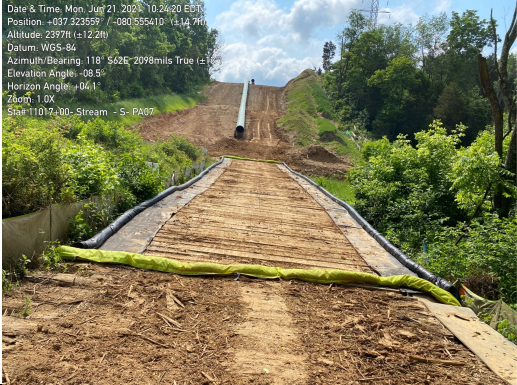
GPS Location	See photo GPS		GPS Location	See photo GPS	
Field Station#	11016+00		Field Station#	11017+00	
Pic 7 Desc.	Stream S-RR5		Pic 8 Desc.	Stream S-PA07	
<p>Date & Time: Mon, Jun 21, 2021, 10:30:09 EDT Position: +037.322763° / -080.555116° (+27.25ft) Altitude: 2409ft (+13.5ft) Datum: WGS-84 Azimuth/Bearing: 170° S10E, 3022mils True (+13°) Elevation Angle: -14.9° Horizon Angle: +03.4° Zoom: 1.0X Stream S- IJ19 Stat: 11023+68</p>

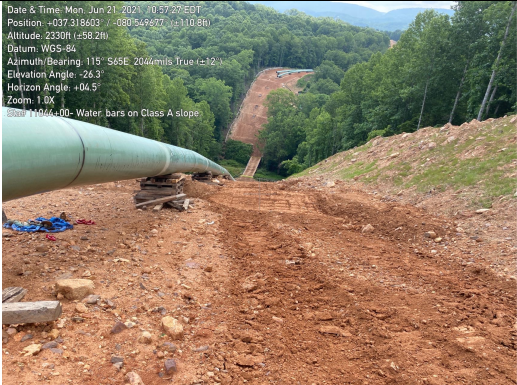
<p>Date & Time: Mon, Jun 21, 2021, 10:57:27 EDT Position: +037.318603° / -080.549677° (+110.8ft) Altitude: 2330ft (+41.5ft) Datum: WGS-84 Azimuth/Bearing: 115° S45E, 2044mils True (+12°) Elevation Angle: -24.3° Horizon Angle: +04.5° Zoom: 1.0X Stat: 11044+00- Water bars on Class A slope</p>

GPS Location	See photo GPS		GPS Location	See photo GPS	
Field Station#	11034+00		Field Station#	11044+00	
Pic 11 Desc.	Row dry and maintained in very good condition.		Pic 12 Desc.	Water bars on Class A slope.

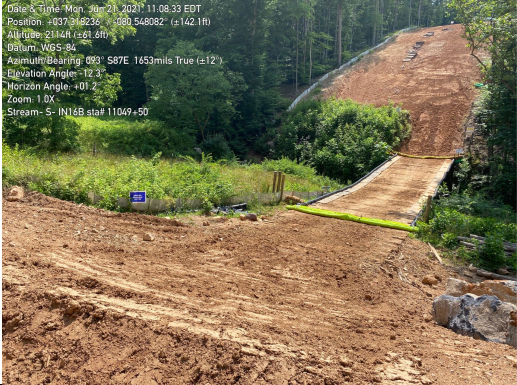
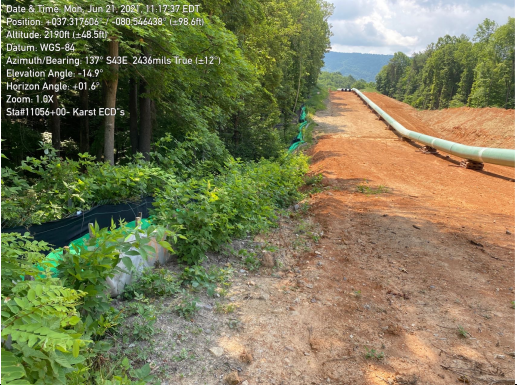
GPS Location	See photo GPS	GPS Location	See photo GPS		
Field Station#	11049+50	Field Station#	11086+00		
Pic 13 Desc.	Stream S- IJ16B	Pic 14 Desc.	Karst ECD's.

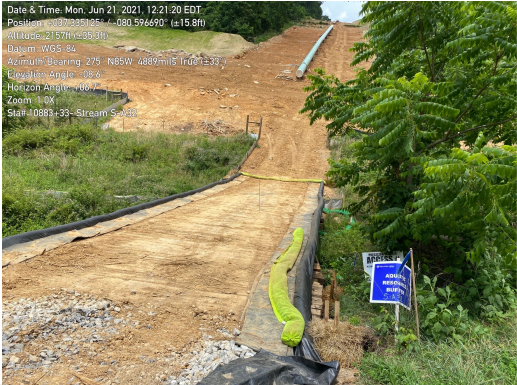
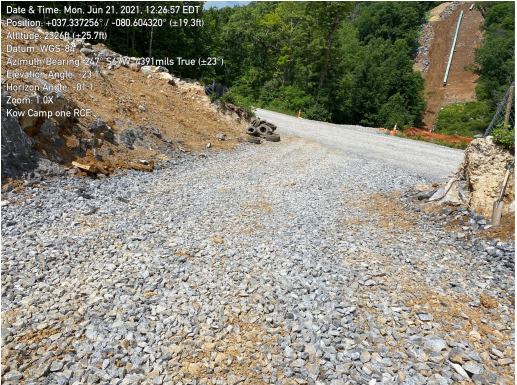
GPS Location	See photo GPS	GPS Location	See photo GPS		
Field Station#	10883+33	Field Station#	10859+34		
Pic 15 Desc.	Stream S-A32	Pic 16 Desc.	Kow Camp one RCE.		
<div>Insert image here</div>		<div>Insert image here</div>			
GPS Location		GPS Location			
Field Station#		Field Station#			
Pic 17 Desc.		Pic 18 Desc.

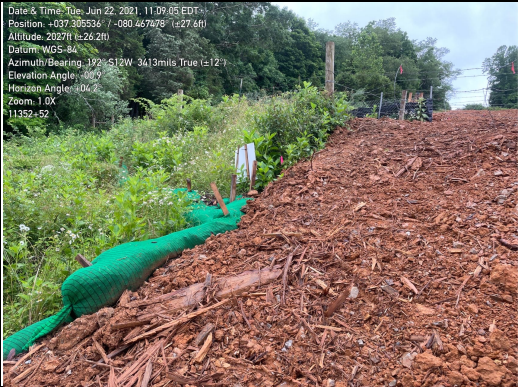
GPS Location	See photo	GPS Location	See photo		
Field Station#	11352+52	Field Station#	11338+00		
Pic 7 Desc.	CFS needs cleaned off	Pic 8 Desc.	P1 silt fence perimeter control in place		
<p>Date & Time: Tue, Jun 22, 2021, 10:23:12 EDT Position: +037.303112° / -080.47142° (+29.8ft) Altitude: 2130ft (+23.4ft) Datum: WGS-84 Azimuth/Bearing: 043° N43E 07.6mils True (+12°) Elevation Angle: +08.9° Horizon Angle: +02.7° Zoom: 1.0X 11328+00</p>

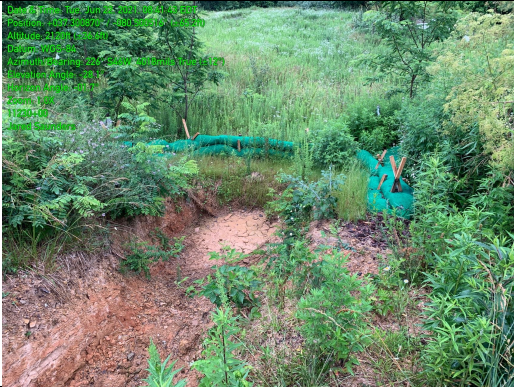
GPS Location	See photo for GPS location.		GPS Location	See photo for GPS location.	
Field Station#	11230+00		Field Station#	11232+00	
Pic 1 Desc.	Sump pit that requires sediment removal. Item added to the punchlist.		Pic 2 Desc.	Ditch dug through area.

7. Identify all remedial measures that have been taken since the previous inspection was conducted.					
Comments (Reference above questions as appropriate.)					
Conducted VA SWPPP inspection from station number 11227+00 to station number 11254+99 (MP 212.64 to MP 213.16). Due to on going rain event all crew working in the area were off due to a rain day. Crew working in the area are trenching, lowering in, and backfill/rough grade. Construction in the area stopped at station number 11246+00 and couldn't work any further than 11252+00 due to floodplain. Deficiency located at station number 11230+00 - sump pit requires sediment removal. Item communicated with the contractor via punchlist. Rain gauges will be checked on 6/23/21 due to on going showers.					
Note: It is a condition of National Pollutant Discharge Elimination System and Erosion and Sediment permits that a maintenance program be conducted to provide for the operation and maintenance of all BMPs to be inspected on a weekly basis and after each stormwater event. Please list in the space provided comments to note if repairs or replacement are needed or have been made for BMPs as a result of the inspection. Failure to conduct the required inspection may result in permit suspension or the imposition of civil penalties. If supplemental monitoring is required as part of a permit condition this form may be used to meet those monitoring requirements.

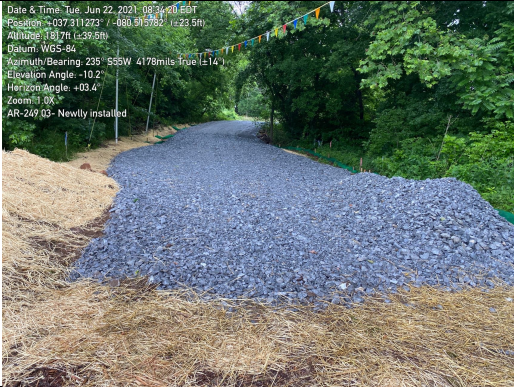
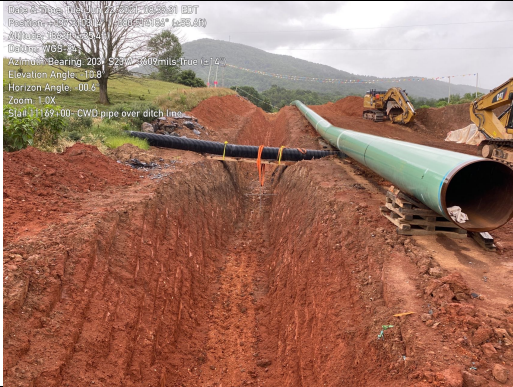
GPS Location	See photo GPS	GPS Location	See photo GPS		
Field Station#	11158+59	Field Station#	11169+00		
Pic 1 Desc.	AR-249.03- Newly installed rock and controls.	Pic 2 Desc.	CWD pipe spanning ditch.

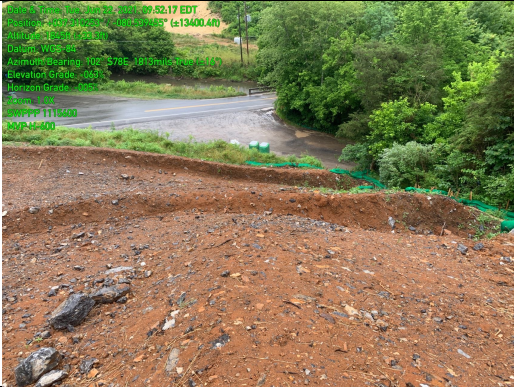
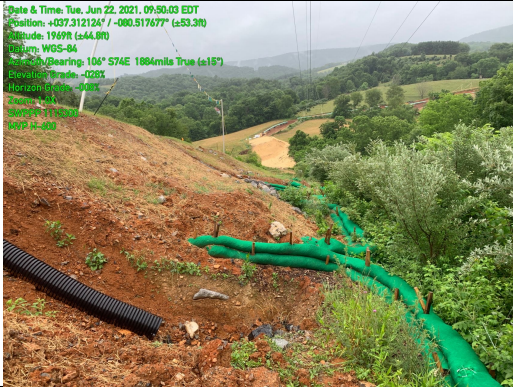
GPS Location	See photo		GPS Location	See photo	
Field Station#	11156+00		Field Station#	11153+00	
Pic 1 Desc.	Earthen water bar is acceptable and functional.		Pic 2 Desc.	Inspection of end treatment, sump pit, and slope drain acceptable

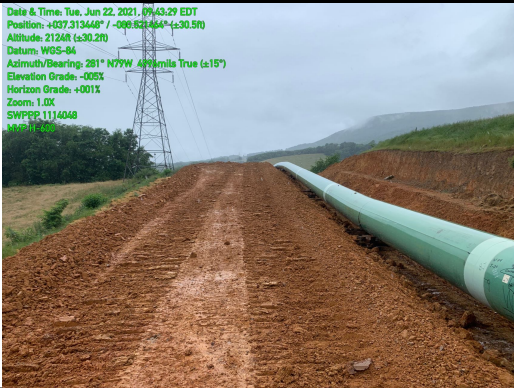
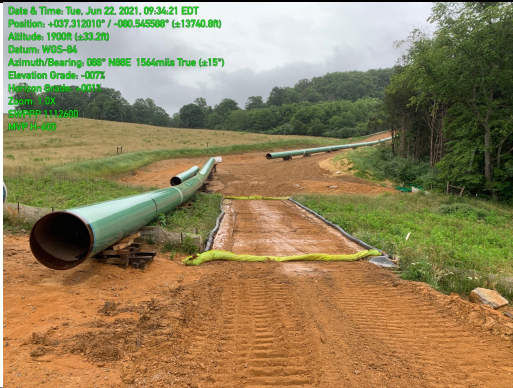
GPS Location	see photo		GPS Location	see photo	
Field Station#	11140+48		Field Station#	11126+00	
Pic 5 Desc.	Inspection of two toned travel lane acceptable Fill slope berm functional		Pic 6 Desc.	Drainage feature equipment bridge was clean of sediment and waddles in place.

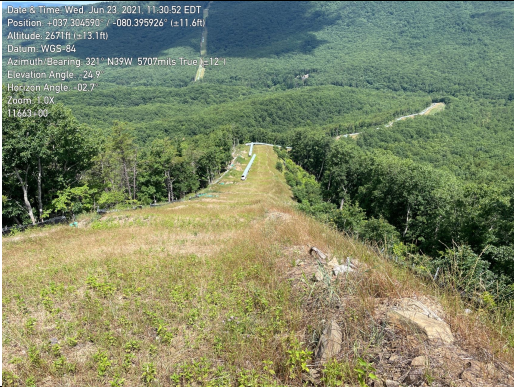
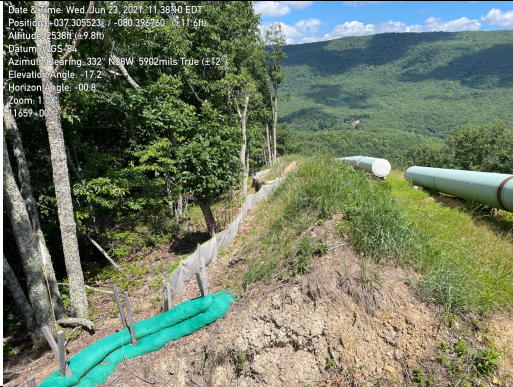
GPS Location	See photo	GPS Location	See photo		
Field Station#	11663+00	Field Station#	11659+00		
Pic 1 Desc.	Waterbars in place	Pic 2 Desc.	P1 silt fence perimeter control in place

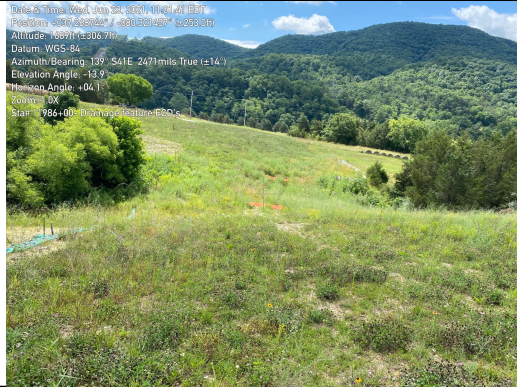
<p>Date & Time: Wed Jun 23 2021 11:04:49 EDT Position: +037 268247 / -080 320497 (±85.9ft) Altitude: 1632ft (±36.7ft) Datum: WGS-84 Azimuth/Bearing: 032° N12E 6270mils True (±14°) Elevation Angle: -04.8° Horizon Angle: +01.7° Zoom: 1.0X AR- /66.00- Access rd& rock check dams</p>

GPS Location	See photo GPS		GPS Location	See photo GPS	
Field Station#	11986+00		Field Station#	11988+00	
Pic 11 Desc.	Drainage feature & ECD's.		Pic 12 Desc.	AR-266.00- Access road and rock check dams.

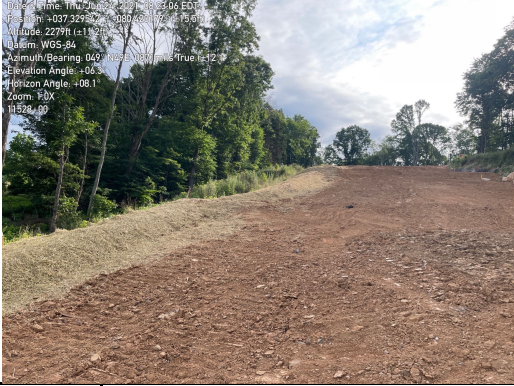
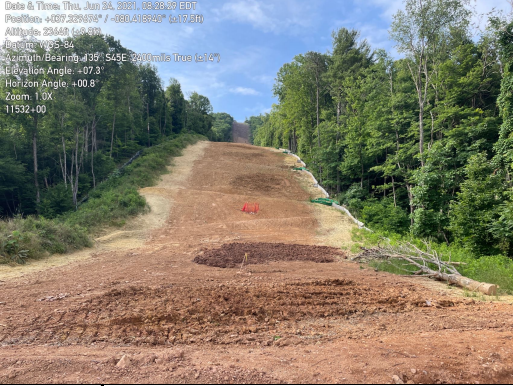
GPS Location	See photo	GPS Location	See photo		
Field Station#	11528+00	Field Station#	11532+00		
Pic 1 Desc.	Temporary ROW diversion berm in place and stabilized	Pic 2 Desc.	Waterbars in place
