Visual Site Inspection Report

Project Name	H-600 Pipeline Spread H	AFE	124300138	Spread	H-600 Pipeline Spread H
Contractor	Precision			Report #	23469
Inspector	Logan Box			Date/Time	5/17/2021 3:02 PM
Permit #	TBD	Inspection Type	VA SWPP	Station Begin	13415+51
State	VA	Inspection Area	Partial	Station End	13525+99
County	Franklin	Ground	Dry	Temperature (°F)	71.00
Municipality	N/A	Weather	Cloudy	Rain Gauge (in)	0.00
				Rain Accumulation Time (days)	0.00

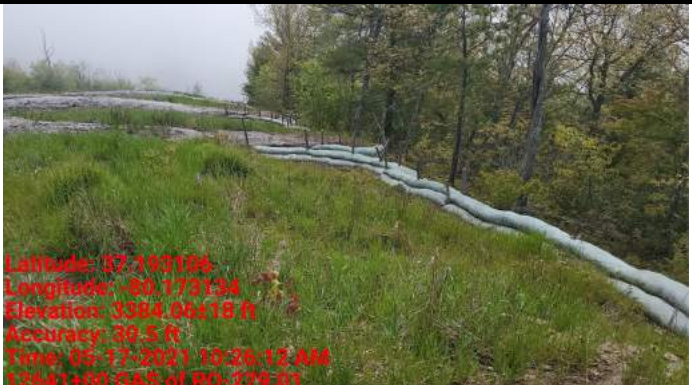
<p>Latitude: 37.193106 Longitude: -80.173134 Elevation: 3384.86±10 ft Accuracy: 39.5 ft Time: 05-17-2021 10:26:12 AM 12641+00 GAS of RO-279.01</p>

GPS Location	See pic for GPS location		GPS Location	See pic for GPS location	
Field Station#	12641+00		Field Station#	12641+00	
Pic 3 Desc.	Current ROW conditions on the GAS of RO-279.01.		Pic 4 Desc.	Perimeter CFS remains in acceptable condition throughout the area.

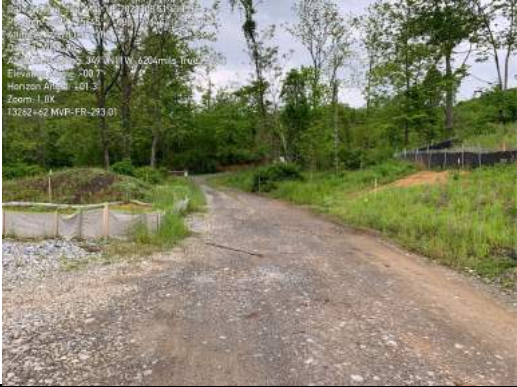
GPS Location	0	GPS Location	0		
Field Station#	13262+62	Field Station#	13260+75		
Pic 7 Desc.	Flanders Road/MVP-FR-293.01, wear from logging company using road to access their property (3rd party)		Pic 8 Desc.	MVP-S-II4, in good condition

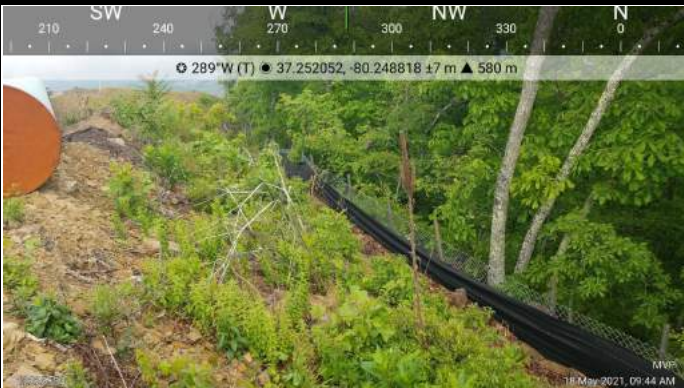
GPS Location	See Above		GPS Location	See Above	
Field Station#	12225+50		Field Station#	12225+50	
Pic 15 Desc.	Punchlist Item: Repair super silt fence.		Pic 16 Desc.	Punchlist Item: Super silt fence repaired.

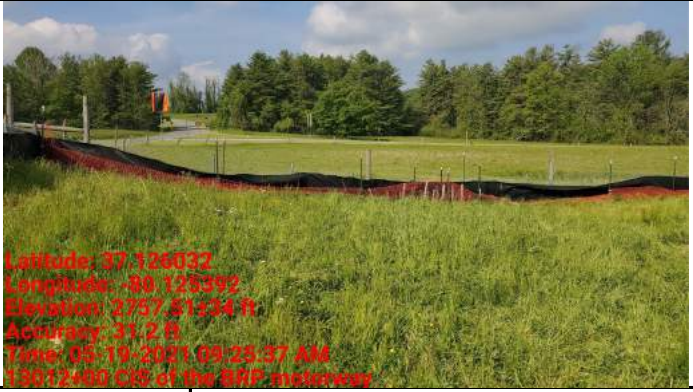
<p>Latitude: 37.126032 Longitude: -88.125392 Elevation: 2757.51±34 ft Accuracy: 31.2 ft Time: 05-19-2021 09:23:37 AM 13012+00 CIS of the BRP motorway</p>			
GPS Location	See pic for GPS location		GPS Location	See pic for GPS location	
Field Station#	13033+59		Field Station#	13012+00	
Pic 1 Desc.	0.0" of precipitation accumulation at Callaway Road.		Pic 2 Desc.	SSF and orange safety fence damaged by cattle on the CIS of the BRP motorway. Added to punch list.

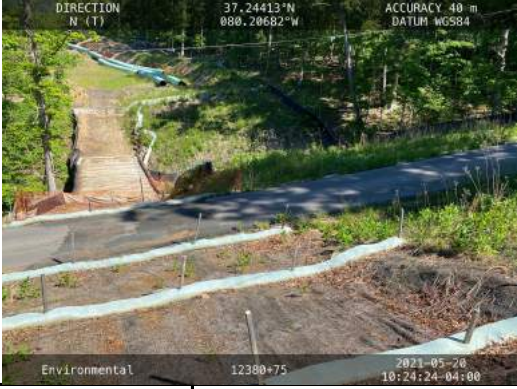
GPS Location	See photo		GPS Location	See photo	
Field Station#	12380+75		Field Station#	12380+04	
Pic 15 Desc.	Cannery road crossing conditions		Pic 16 Desc.	Stream crossing S-NN19 in acceptable condition

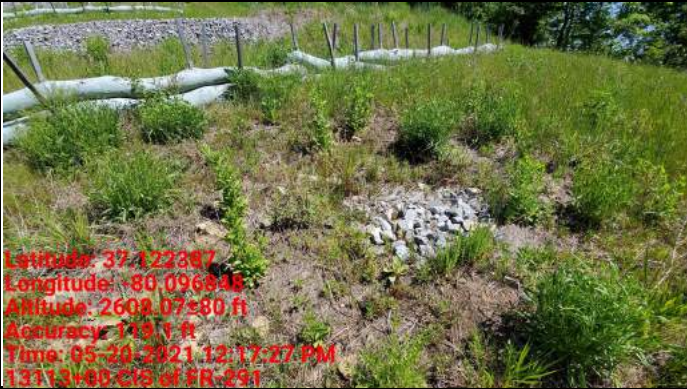
GPS Location	See pic for GPS location		GPS Location	See pic for GPS location	
Field Station#	13113+00		Field Station#	13113+00	
Pic 13 Desc.	Trench drain pipe with rock apron on CIS of FR-291.		Pic 14 Desc.	Permanent Slope Breaker and Rock Level Spreader on the CIS of FR-291.

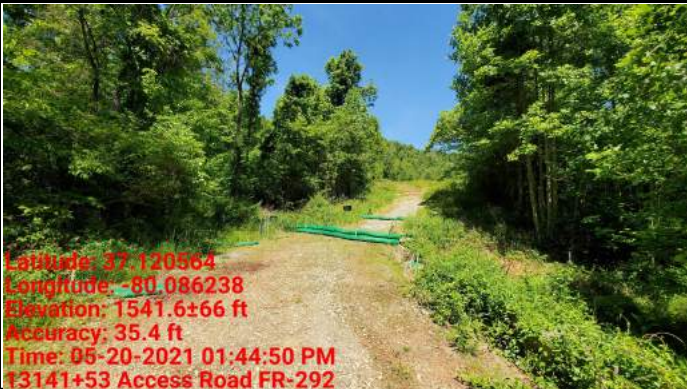
GPS Location	See pic for GPS location		GPS Location	See pic for GPS location	
Field Station#	13141+53		Field Station#	13141+53	
Pic 17 Desc.	ECD's installed along FR-292.		Pic 18 Desc.	Entrance of FR-292 off of Adney Gap Road.
