# Visual Site Inspection Report

<b>Project Name</b>	H-600 Pipeline Spread H	<b>AFE</b>	124300138	<b>Spread</b>	H-600 Pipeline Spread H
<b>Contractor</b>	Precision			<b>Report #</b>	24807
<b>Inspector</b>	Logan Box			<b>Date/Time</b>	6/21/2021 3:12 PM
<b>Permit #</b>	TBD	<b>Inspection Type</b>	VA SWPP	<b>Station Begin</b>	13415+51
<b>State</b>	VA	<b>Inspection Area</b>	Partial	<b>Station End</b>	13525+99
<b>County</b>	Franklin	<b>Ground</b>	Dry	<b>Temperature (°F)</b>	93.00
<b>Municipality</b>	N/A	<b>Weather</b>	Sunny	<b>Rain Gauge (in)</b>	0.00
				<b>Rain Accumulation Time (days)</b>	0.00

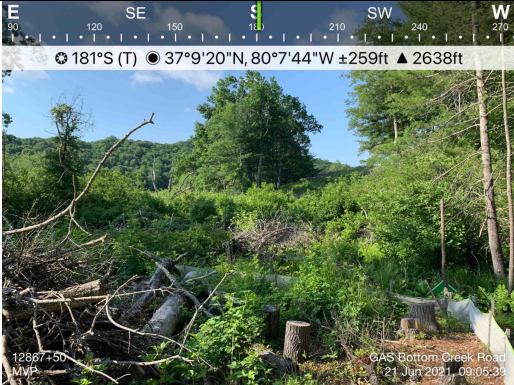
<b>GPS Location</b>	See photo		<b>GPS Location</b>	See photo	
<b>Field Station#</b>	12867+50		<b>Field Station#</b>	12866+00	
<b>Pic 1 Desc.</b>	ROW Conditions on the GAS of Bottom Creek Road		<b>Pic 2 Desc.</b>	Stockpile well stabilized on CIS of Bottom Creek Road

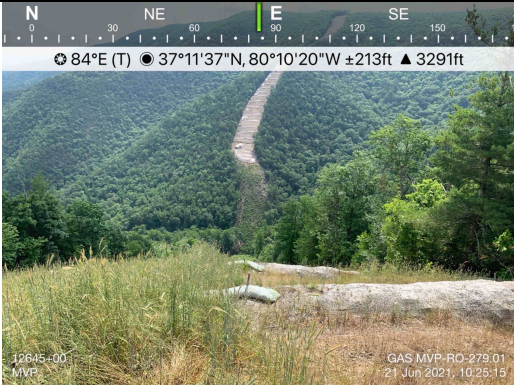
<b>GPS Location</b>	See photo		<b>GPS Location</b>	See photo	
<b>Field Station#</b>	12645+00		<b>Field Station#</b>	12676+00	
<b>Pic 3 Desc.</b>	ROW conditions on GAS of RO-279.01 looking towards S-IJ50		<b>Pic 4 Desc.</b>	ROW conditions on CIS of Honeysuckle Road

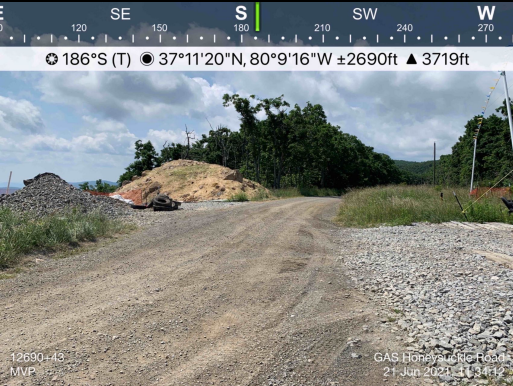
<b>GPS Location</b>	See photo		<b>GPS Location</b>	See photo	
<b>Field Station#</b>	12677+00		<b>Field Station#</b>	12690+43	
<b>Pic 5 Desc.</b>	Perimeter controls in place and functional		<b>Pic 6 Desc.</b>	Honeysuckle Road Crossing

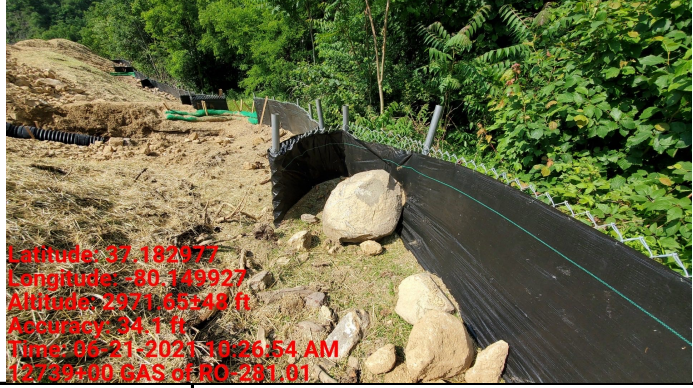
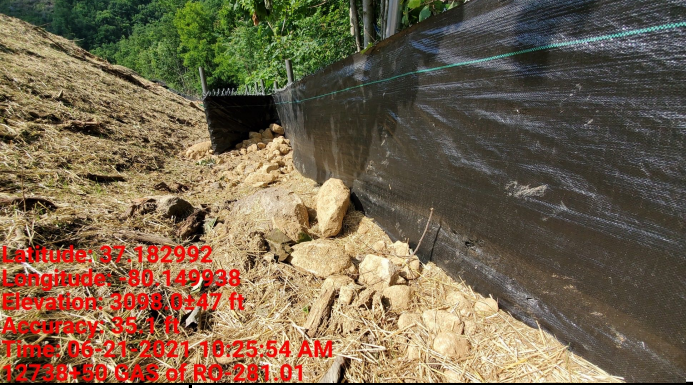
<b>GPS Location</b>	See photo	<b>GPS Location</b>	See photo		
<b>Field Station#</b>	12739+00	<b>Field Station#</b>	12738+50		
<b>Pic 11 Desc.</b>	Rocks on SSF need to be removed and repairs made if needed	<b>Pic 12 Desc.</b>	Rocks on SSF need to be removed and repairs made if needed

GPS Location	See photo		GPS Location	See photo	
Field Station#	12738+50		Field Station#	12739+50	
Pic 15 Desc.	Rocks have been removed from SSF		Pic 16 Desc.	Holes in SSF fabric have been repaired	
  <p>DIRECTION N (T) +37.19077° -080.15390° ACCURACY 58 ft DATUM WGS84 12702+00 Sump needs to be cleaned out 2021-06-21 09:36:32-04:00</p>			 		
GPS Location	See photo		GPS Location	37.19077 N, -080.15390 W	
Field Station#	12702+00		Field Station#	12702+00	
Pic 17 Desc.	Sump needs to be cleaned out		Pic 18 Desc.	Sump being cleaned out and material placed and compacted on backside of waterbar

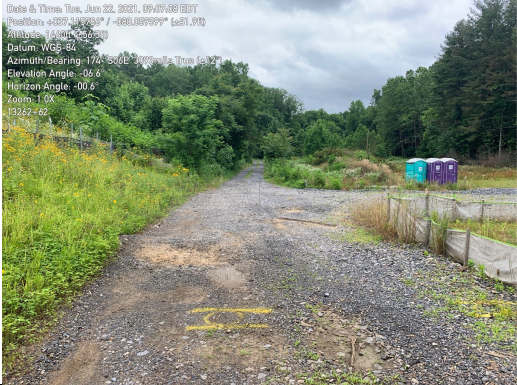
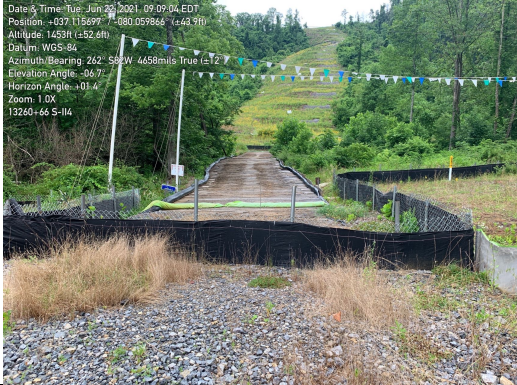
<b>GPS Location</b>	0	<b>GPS Location</b>	0		
<b>Field Station#</b>	13262+62	<b>Field Station#</b>	13260+66		
<b>Pic 7 Desc.</b>	Flanders Road Crossing, in good condition. RCE in good condition and functioning properly.		<b>Pic 8 Desc.</b>	MVP- S-II4, in good condition

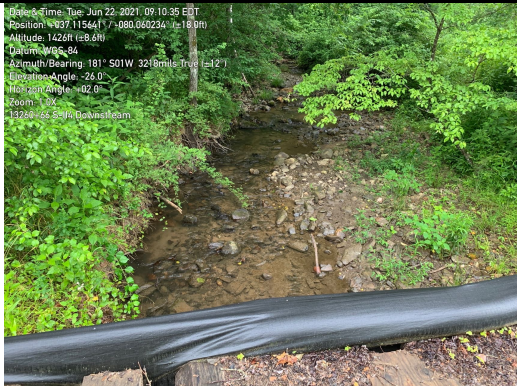
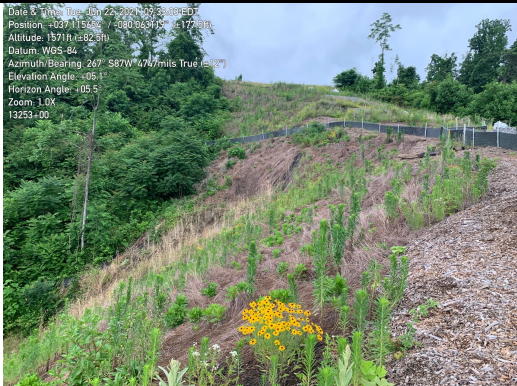
<b>GPS Location</b>	0	<b>GPS Location</b>	0		
<b>Field Station#</b>	13260+66	<b>Field Station#</b>	13253+00		
<b>Pic 9 Desc.</b>	MVP-S-II4 Downstream, in good condition, no impacts to stream or corresponding buffer zone observed.		<b>Pic 10 Desc.</b>	Slip observed to be stable, no notable changes, vegetation establishing

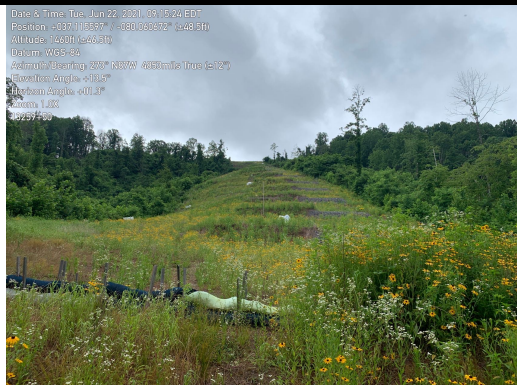
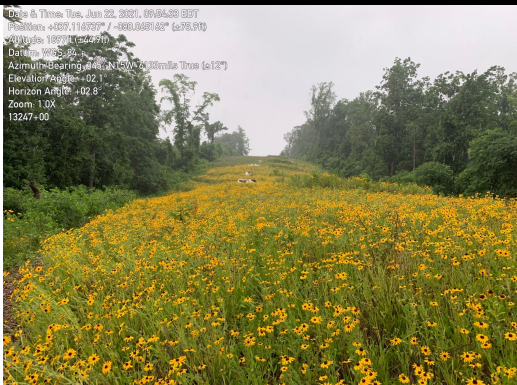
<b>GPS Location</b>	0	<b>GPS Location</b>	0		
<b>Field Station#</b>	13259+50	<b>Field Station#</b>	13247+00		
<b>Pic 11 Desc.</b>	ROW and ECDs in good condition, with good vegetation establishing across LOD.		<b>Pic 12 Desc.</b>	ROW and ECDs in good condition, with good vegetation establishing across LOD.

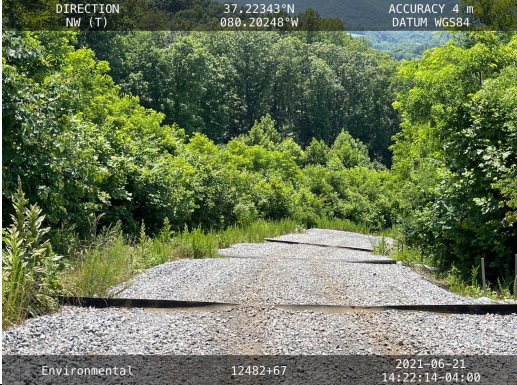
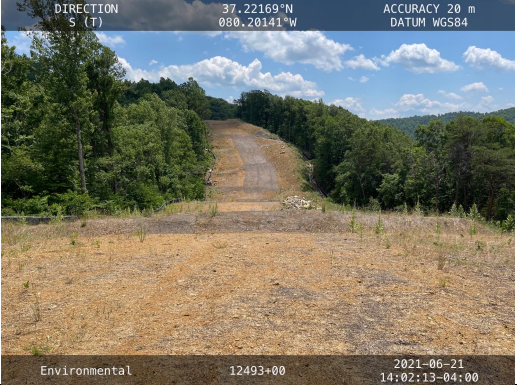
<b>GPS Location</b>	See photo		<b>GPS Location</b>	See photo	
<b>Field Station#</b>	12482+67		<b>Field Station#</b>	12493+00	
<b>Pic 13 Desc.</b>	Water deflectors and broad base dip on access road MVP-MLV-AR-28 in acceptable condition		<b>Pic 14 Desc.</b>	Stabilized ROW in acceptable condition

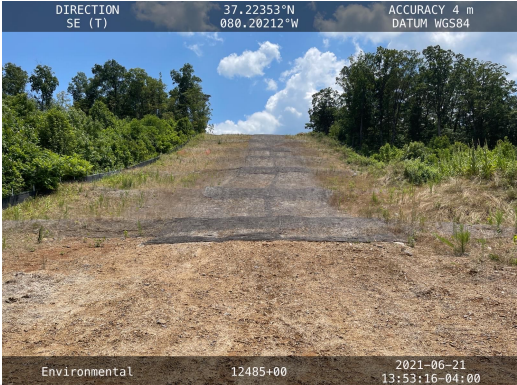
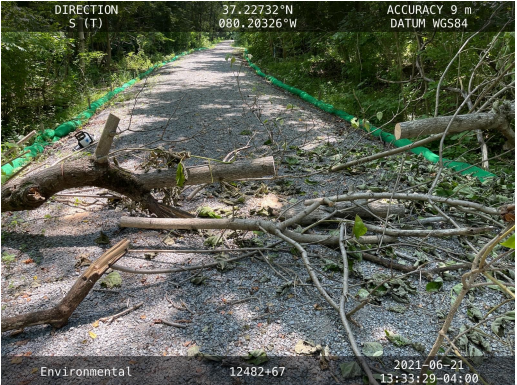
<b>GPS Location</b>	See photo		<b>GPS Location</b>	See photo	
<b>Field Station#</b>	12485+00		<b>Field Station#</b>	12482+67	
<b>Pic 15 Desc.</b>	Stabilized slope in acceptable condition		<b>Pic 16 Desc.</b>	Second set of trees that had fallen being cut up and prepared for removal.

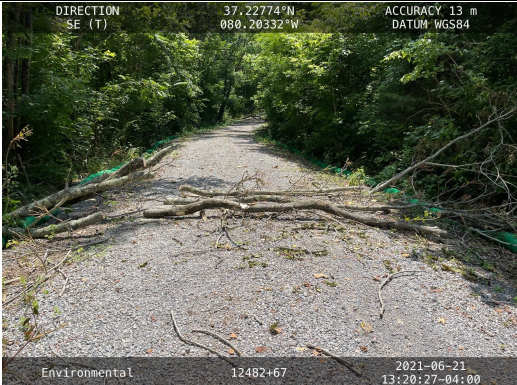
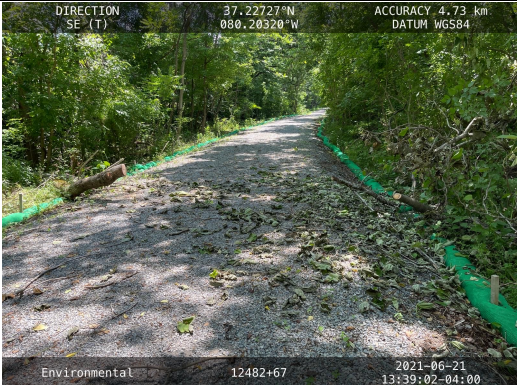
<b>GPS Location</b>	See photo		<b>GPS Location</b>	See photo	
<b>Field Station#</b>	12482+67		<b>Field Station#</b>	12482+67	
<b>Pic 17 Desc.</b>	First two trees blocking the access road.		<b>Pic 18 Desc.</b>	Access road MVP-MLV-AR-28 in acceptable condition after the removal of the fallen trees.

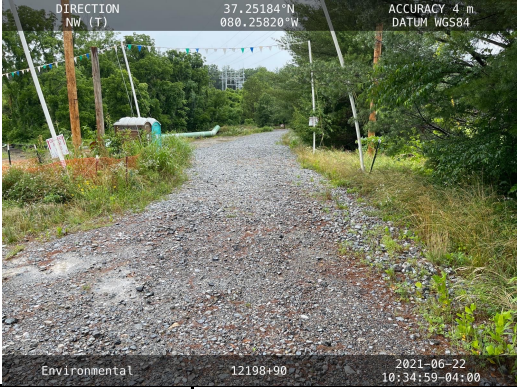
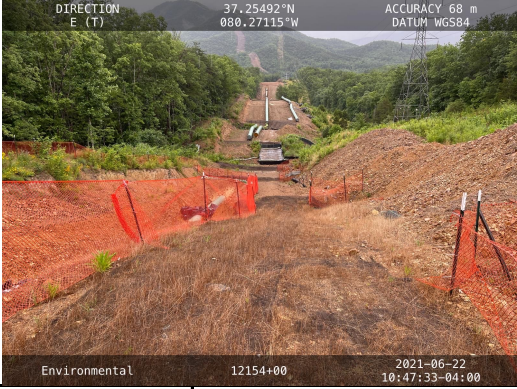
<b>GPS Location</b>	See photo		<b>GPS Location</b>	See photo	
<b>Field Station#</b>	12198+90		<b>Field Station#</b>	12254+00	
<b>Pic 7 Desc.</b>	Access Road MVP-MN-275 in acceptable condition		<b>Pic 8 Desc.</b>	Stabilized ROW in acceptable condition

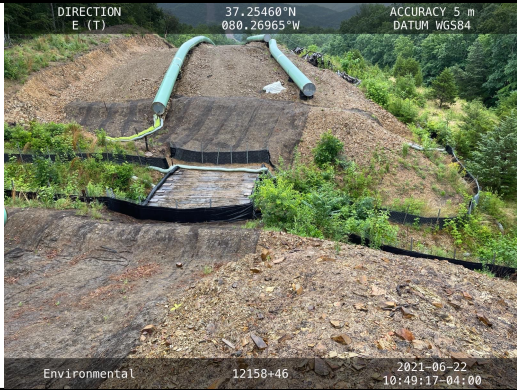
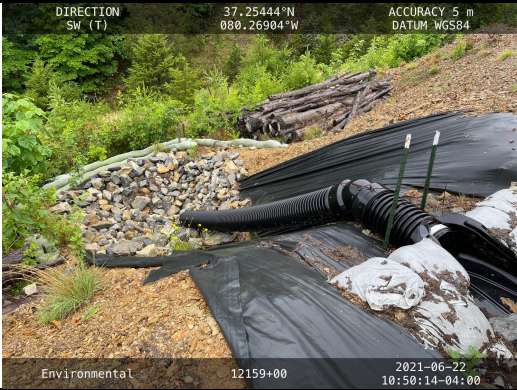
<b>GPS Location</b>	See photo		<b>GPS Location</b>	See photo	
<b>Field Station#</b>	12158+46		<b>Field Station#</b>	12159+00	
<b>Pic 9 Desc.</b>	Clean water crossing in acceptable condition		<b>Pic 10 Desc.</b>	Fill slope drain in acceptable condition

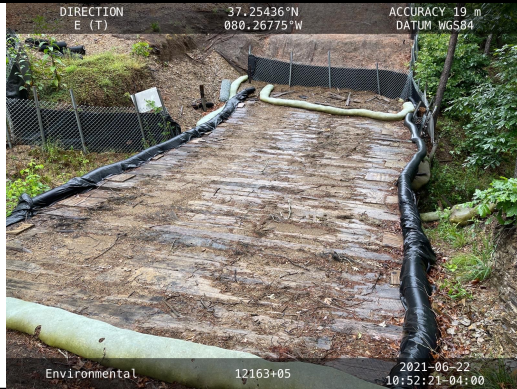
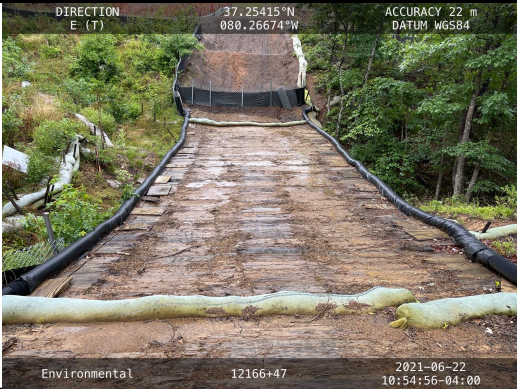
<b>GPS Location</b>	See photo		<b>GPS Location</b>	See photo	
<b>Field Station#</b>	12163+05		<b>Field Station#</b>	12166+47	
<b>Pic 11 Desc.</b>	Bridge and ECDs crossing S-C25 In Acceptable condition		<b>Pic 12 Desc.</b>	Bridge and ECDs at stream crossing S-C24 in acceptable condition

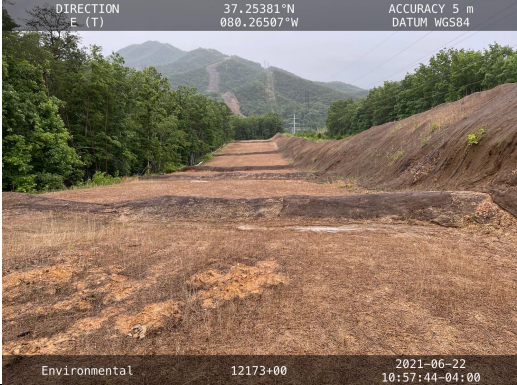
<b>GPS Location</b>	See photo		<b>GPS Location</b>	See photo	
<b>Field Station#</b>	12173+00		<b>Field Station#</b>	12185+00	
<b>Pic 13 Desc.</b>	Stabilized ROW in acceptable condition		<b>Pic 14 Desc.</b>	Stabilized ROW in acceptable condition

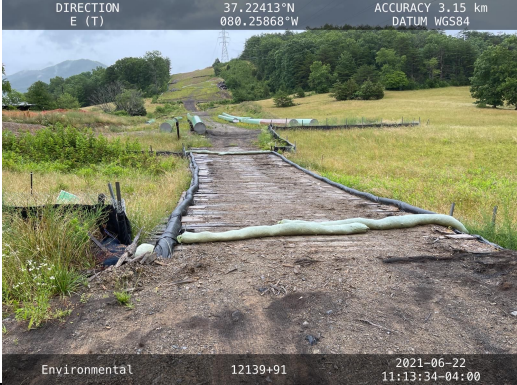
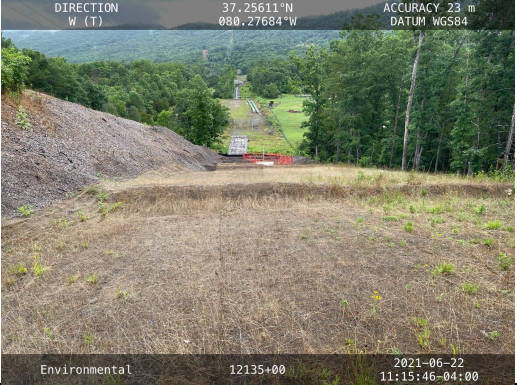
<b>GPS Location</b>	See photo		<b>GPS Location</b>	See photo	
<b>Field Station#</b>	12139+91		<b>Field Station#</b>	12135+00	
<b>Pic 15 Desc.</b>	Wetland W-C6 in acceptable condition		<b>Pic 16 Desc.</b>	Stabilized ROW in acceptable condition

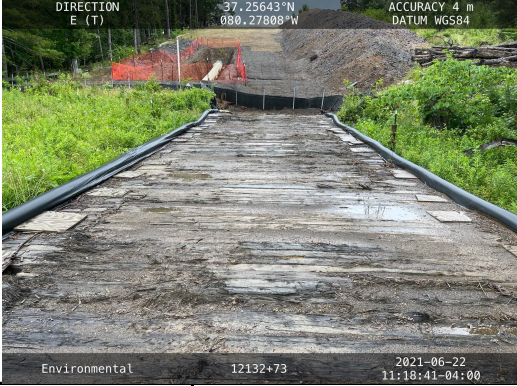
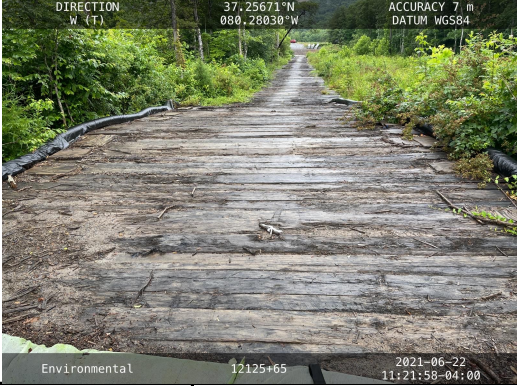
<b>GPS Location</b>	See photo		<b>GPS Location</b>	See photo	
<b>Field Station#</b>	12132+73		<b>Field Station#</b>	12125+65	
<b>Pic 17 Desc.</b>	Bridge and ECDs crossing stream S-C29 in acceptable condition		<b>Pic 18 Desc.</b>	Bridge and ECDs crossing stream S-MM31 in acceptable condition

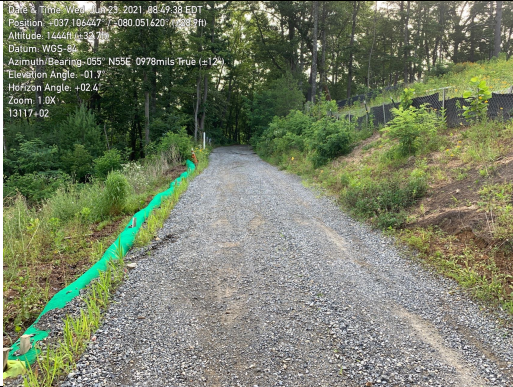
<p>Date &amp; Time: Wed, Jun 23, 2021 08:59:38 EDT Position: +037.104412 / -080.051620 / 13317.0 Altitude: 1444ft (+44.4ft) Datum: WGS-84 Azimuth/Bearing: 055.1N55E 0978mils True (+12) Elevation Angle: -01.7 Horizon Angle: +02.4 Zoom: 1.0x 13317+02</p>			
<b>GPS Location</b>	0	<b>GPS Location</b>	0		
<b>Field Station#</b>	13316+21	<b>Field Station#</b>	13317+02		
<b>Pic 1 Desc.</b>	Wades Gap Road Crossing, in good condition. RCE in good condition as well		<b>Pic 2 Desc.</b>	Private road in good condition

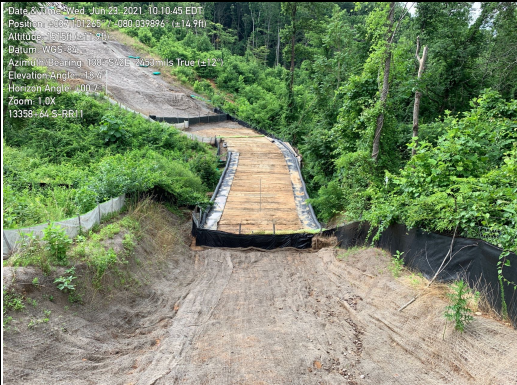
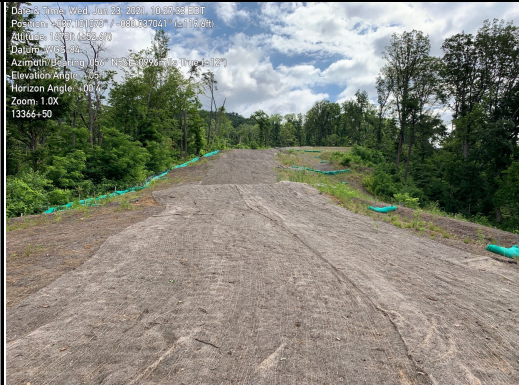
GPS Location		0		GPS Location		0					
Field Station#		13358+64		Field Station#		13366+50					
Pic 13 Desc.		MVP-S-RR11 and associated buffer zone, in good condition		Pic 14 Desc.		ROW and ECDs in good condition					
<p>Date &amp; Time: Wed Jun 23, 2021 10:33:58 EDT Position: +037.092861° / +080.027904° (±15.6ft) Altitude: 13374ft (±11.6ft) Datum: WGS-84 Azimuth/Bearing: 090° S90°E 1956mils True (±12°) Elevation Angle: +01.0° Horizon Angle: -00.0° Zoom: 1.0X 13374+50</p>

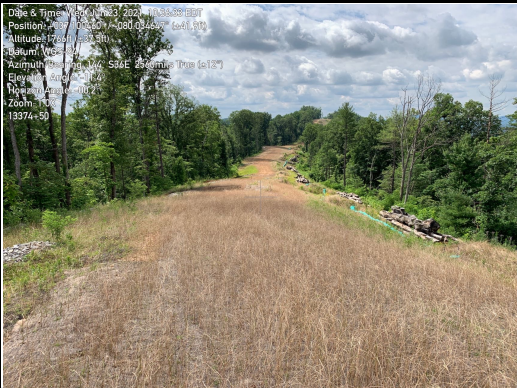
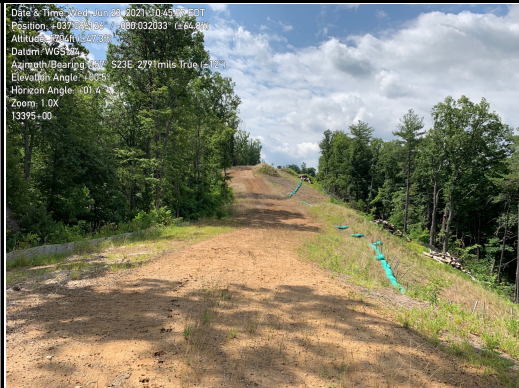
GPS Location		0		GPS Location		0					
Field Station#		13374+50		Field Station#		13395+00					
Pic 15 Desc.		ROW and ECDs in good condition, with good vegetation establishing across LOD		Pic 16 Desc.		ROW and ECDs in good condition, with good vegetation establishing across LOD					
<p>Date &amp; Time: Wed Jun 23, 2021 11:00:29 EDT Position: +037.092861° / +080.027904° (±15.6ft) Altitude: 13413ft (±11.6ft) Datum: WGS-84 Azimuth/Bearing: 110° S70°E 1956mils True (±12°) Elevation Angle: +01.0° Horizon Angle: -00.0° Zoom: 1.0X 13413+05 SRR11</p>

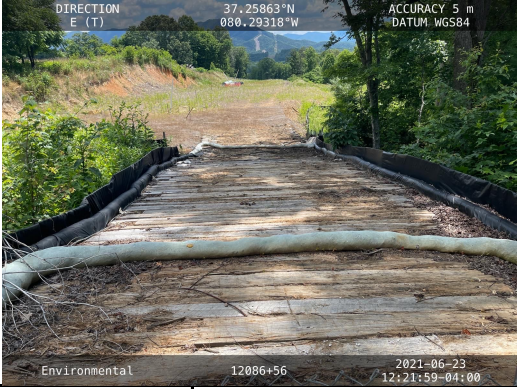
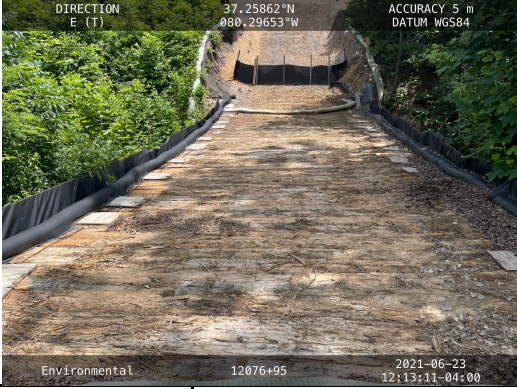
<b>GPS Location</b>	See photo		<b>GPS Location</b>	See photo	
<b>Field Station#</b>	12086+56		<b>Field Station#</b>	12076+95	
<b>Pic 7 Desc.</b>	Bridge and ECDs at stream crossing S-MM14 in acceptable condition		<b>Pic 8 Desc.</b>	Bridge and ECDs crossing stream S-MM15 in acceptable condition

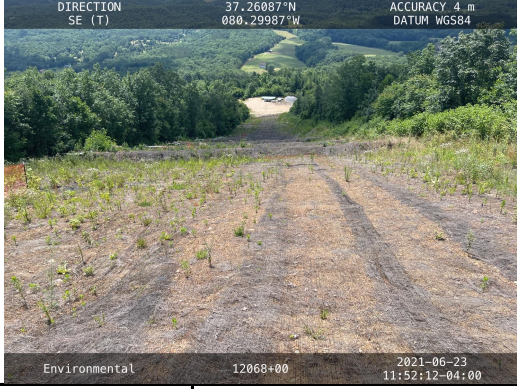
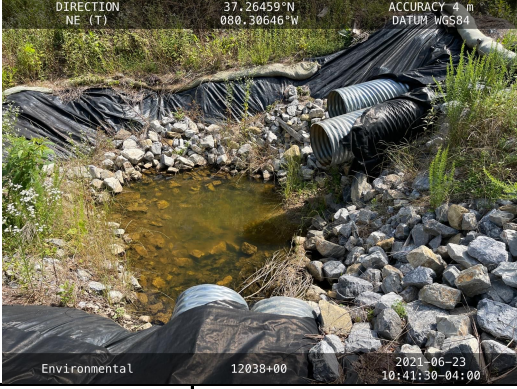
<b>GPS Location</b>	See photo		<b>GPS Location</b>	See photo	
<b>Field Station#</b>	12068+00		<b>Field Station#</b>	12038+00	
<b>Pic 9 Desc.</b>	Stabilized ROW in acceptable condition		<b>Pic 10 Desc.</b>	Clean water crossing pipe inlet in acceptable condition

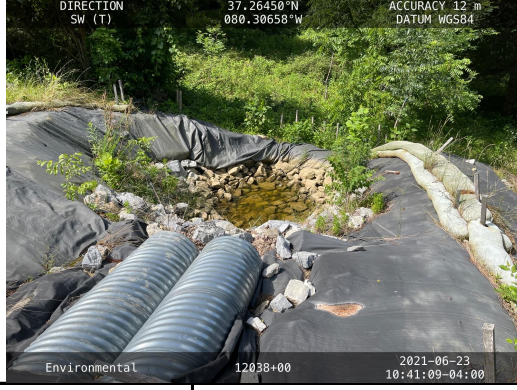
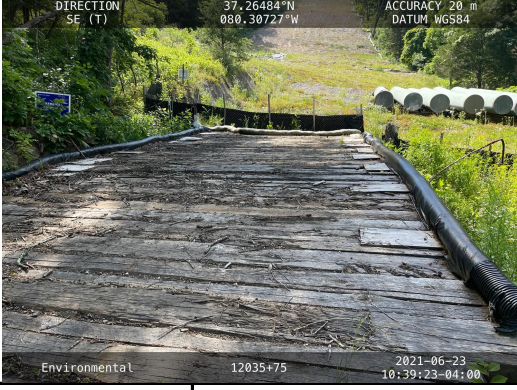
<b>GPS Location</b>	See photo		<b>GPS Location</b>	See photo	
<b>Field Station#</b>	12038+00		<b>Field Station#</b>	12035+75	
<b>Pic 11 Desc.</b>	Clean water crossing pipe outlet in acceptable condition		<b>Pic 12 Desc.</b>	Bridge and ECDs crossing stream S-PP23 in acceptable condition

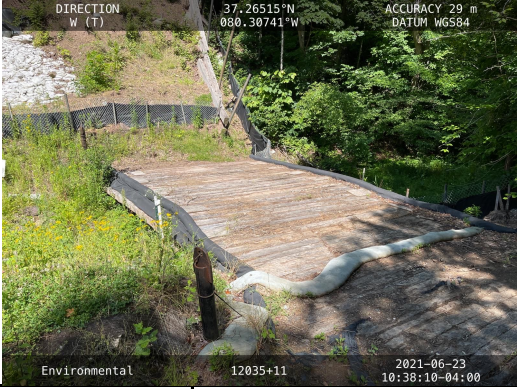
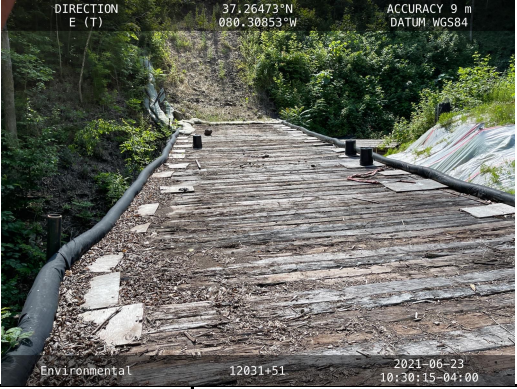
<b>GPS Location</b>	see photo		<b>GPS Location</b>	See photo	
<b>Field Station#</b>	12035+11		<b>Field Station#</b>	12031+51	
<b>Pic 13 Desc.</b>	Bridge and ECDs crossing stream S-G40 in acceptable condition		<b>Pic 14 Desc.</b>	Bridge and ECDs crossing stream S-G39 in acceptable condition

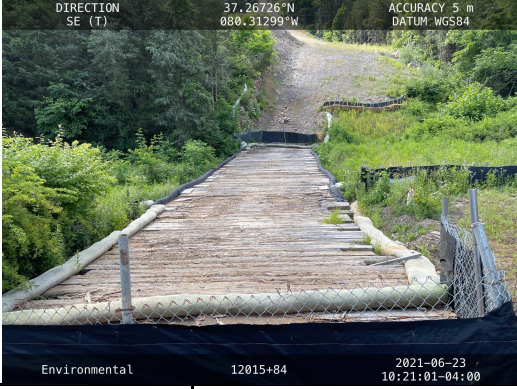
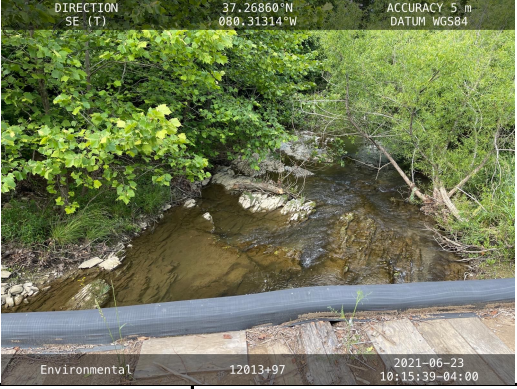
<b>GPS Location</b>	See photo		<b>GPS Location</b>	See photo	
<b>Field Station#</b>	12015+84		<b>Field Station#</b>	12013+97	
<b>Pic 15 Desc.</b>	Bridge and ECDs crossing stream S-G38 in acceptable condition		<b>Pic 16 Desc.</b>	Down stream of S-G36 in acceptable condition

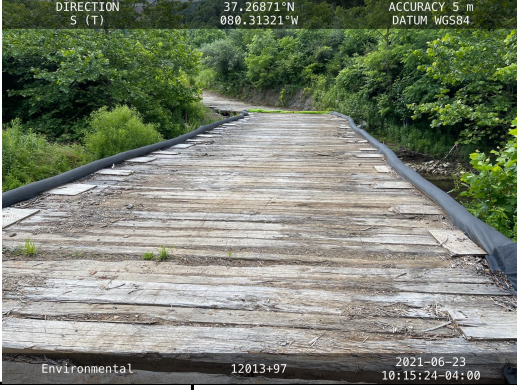
<b>GPS Location</b>	See photo		<b>GPS Location</b>	See photo	
<b>Field Station#</b>	12013+97		<b>Field Station#</b>	12013+97	
<b>Pic 17 Desc.</b>	Bridge and ECDs crossing stream S-G36 in acceptable condition		<b>Pic 18 Desc.</b>	Access Road MVP-MN-268.01 in acceptable condition

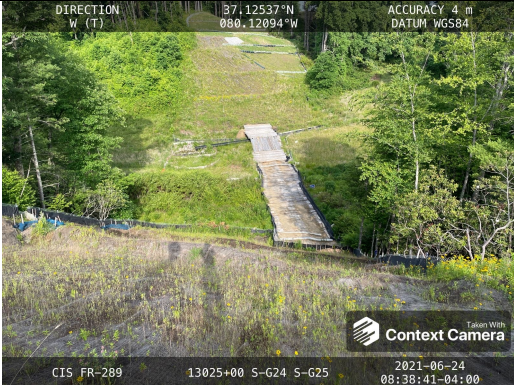
<b>GPS Location</b>	See photo		<b>GPS Location</b>	See photo	
<b>Field Station#</b>	13025+00		<b>Field Station#</b>	13041+00	
<b>Pic 1 Desc.</b>	Streams S-G24 and S-G25 on CIS of FR-289		<b>Pic 2 Desc.</b>	Current ROW conditions on GAS of FR-289

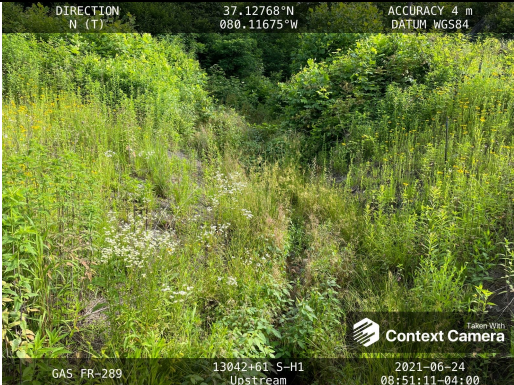
<b>GPS Location</b>	See photo		<b>GPS Location</b>	See photo	
<b>Field Station#</b>	13042+61		<b>Field Station#</b>	13053+00	
<b>Pic 3 Desc.</b>	Stream S-H1 on GAS of FR-289		<b>Pic 4 Desc.</b>	Level Spreader and Permanent slope breaker

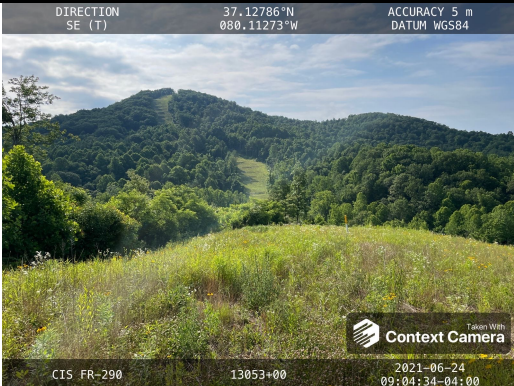
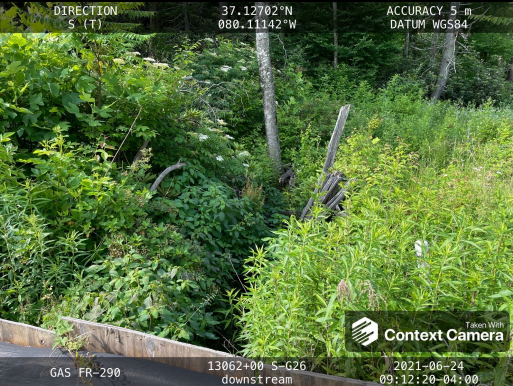
<b>GPS Location</b>	See photo		<b>GPS Location</b>	See photo	
<b>Field Station#</b>	13053+00		<b>Field Station#</b>	13062+00	
<b>Pic 5 Desc.</b>	Current ROW conditions on CIS of FR-290. Well vegetated.		<b>Pic 6 Desc.</b>	Stream S-G26 on GAS of FR-290

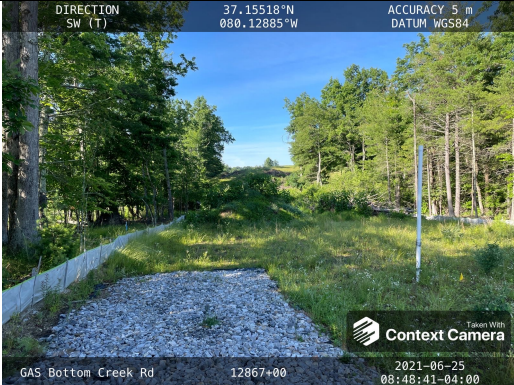
<b>GPS Location</b>	See photo		<b>GPS Location</b>	See photo	
<b>Field Station#</b>	12867+00		<b>Field Station#</b>	12866+00	
<b>Pic 1 Desc.</b>	Current ROW conditions on GAS of Bottom Creek Road		<b>Pic 2 Desc.</b>	Current ROW conditions on CIS of Bottom Creek Road

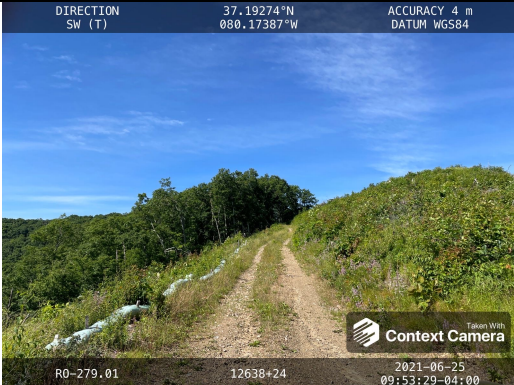
<b>GPS Location</b>	See photo		<b>GPS Location</b>	See photo	
<b>Field Station#</b>	12638+24		<b>Field Station#</b>	12643+00	
<b>Pic 3 Desc.</b>	Access Road RO-279.01		<b>Pic 4 Desc.</b>	Waterbar/sump on GAS of RO-279.01

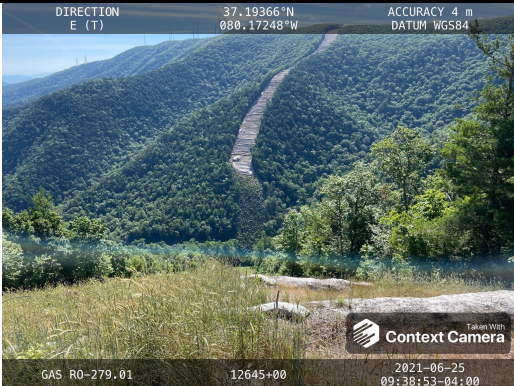
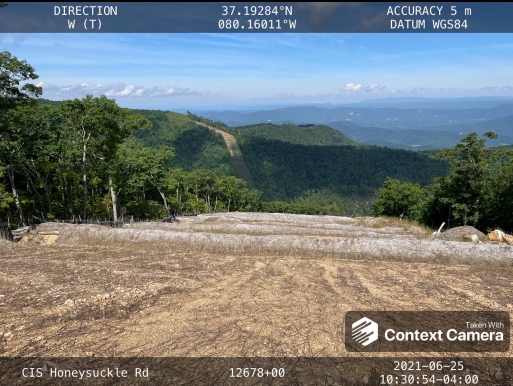
<b>GPS Location</b>	See photo		<b>GPS Location</b>	See photo	
<b>Field Station#</b>	12645+00		<b>Field Station#</b>	12678+00	
<b>Pic 5 Desc.</b>	Current ROW conditions on GAS of RO-279.01		<b>Pic 6 Desc.</b>	Current ROW conditions on CIS of Honeysuckle Road. Waterbars/sumps in compliance

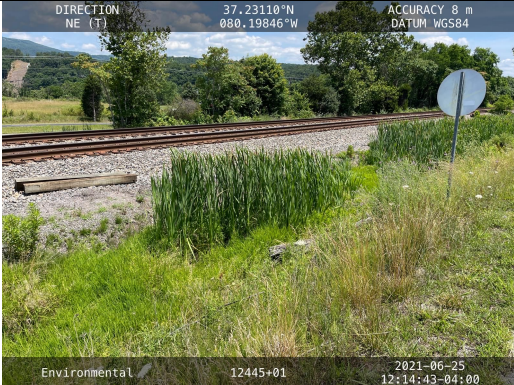
<b>GPS Location</b>	See photo		<b>GPS Location</b>	See photo	
<b>Field Station#</b>	12445+01		<b>Field Station#</b>	12455+21	
<b>Pic 1 Desc.</b>	Stream crossing S-I1 in acceptable condition		<b>Pic 2 Desc.</b>	Bridge and ECDs at stream crossing S-CD12b in acceptable condition

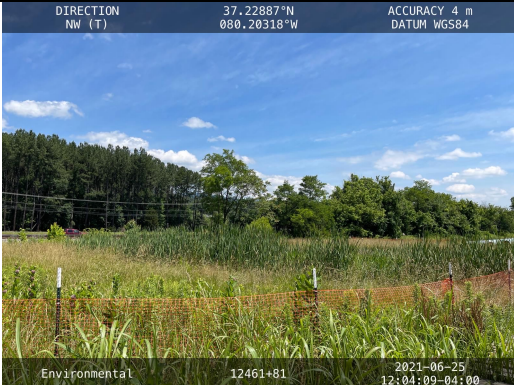
<b>GPS Location</b>	See photo		<b>GPS Location</b>	See photo	
<b>Field Station#</b>	12461+81		<b>Field Station#</b>	12468+00	
<b>Pic 3 Desc.</b>	Wetland W-KL58 in acceptable condition		<b>Pic 4 Desc.</b>	Stabilized ROW in acceptable condition

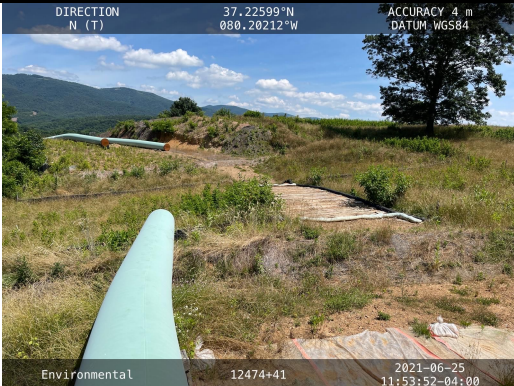
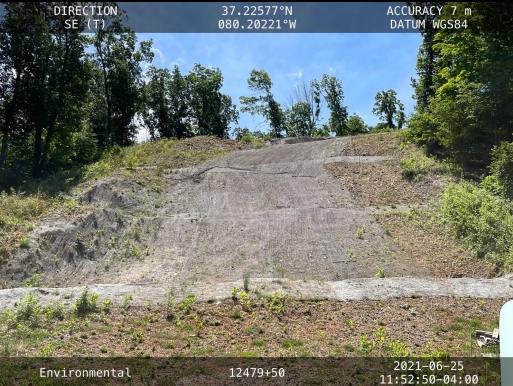
<b>GPS Location</b>	See photo		<b>GPS Location</b>	See photo	
<b>Field Station#</b>	12474+41		<b>Field Station#</b>	12479+50	
<b>Pic 5 Desc.</b>	Clean water crossing in acceptable condition		<b>Pic 6 Desc.</b>	Stabilized slope in acceptable condition

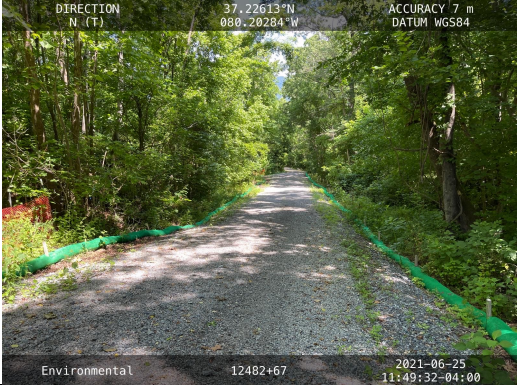
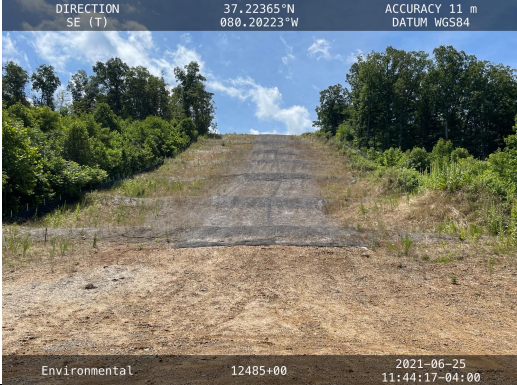
<b>GPS Location</b>	See photo		<b>GPS Location</b>	See photo	
<b>Field Station#</b>	12482+67		<b>Field Station#</b>	12485+00	
<b>Pic 7 Desc.</b>	Access Road MVP-MLV-AR-28 in acceptable condition		<b>Pic 8 Desc.</b>	Stabilized slope in acceptable condition

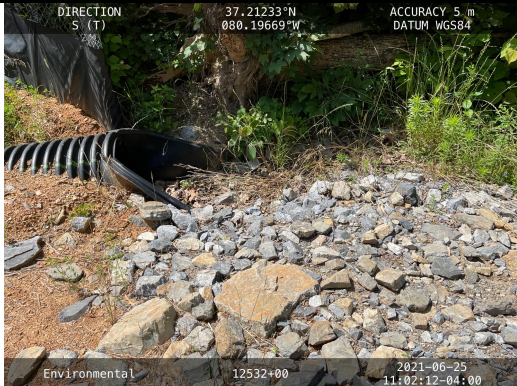
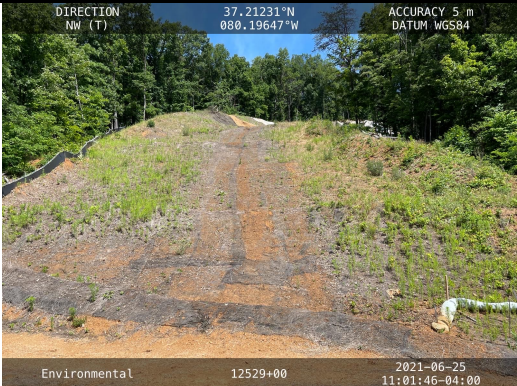
<b>GPS Location</b>	See photo		<b>GPS Location</b>	See photo	
<b>Field Station#</b>	12532+00		<b>Field Station#</b>	12529+00	
<b>Pic 9 Desc.</b>	Clean water crossing pipe inlet in acceptable condition		<b>Pic 10 Desc.</b>	Stabilized slope in acceptable condition

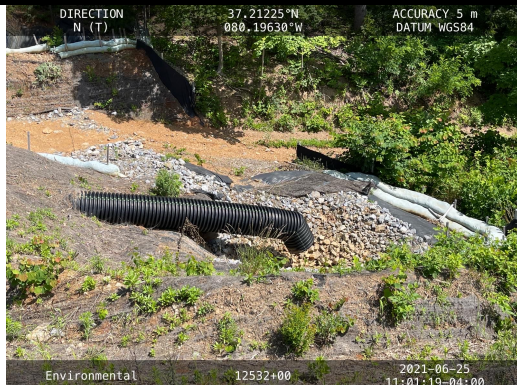
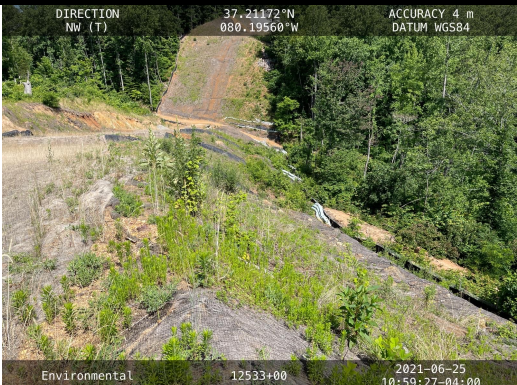
<b>GPS Location</b>	see photo		<b>GPS Location</b>	See photo	
<b>Field Station#</b>	12532+00		<b>Field Station#</b>	12533+00	
<b>Pic 11 Desc.</b>	Clean water crossing pipe outlet in acceptable condition		<b>Pic 12 Desc.</b>	Stabilized ROW in acceptable condition
