# Visual Site Inspection Report

| <b>Project Name</b> | H-603 Pipeline Spread I | <b>AFE</b> | 124300139 | <b>Spread</b> | H-603 Pipeline Spread I | |
| <b>Permit #</b> | TBD | <b>Inspection Type</b> | VA SWPP | <b>Station Begin</b> | 00+00 | |

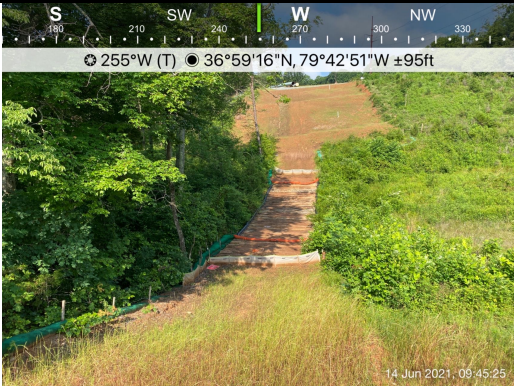
| <b>Pic 3 Desc.</b> | Approximately 14673+75. SSF damaged by livestock. | | <b>Pic 4 Desc.</b> | Approximately 14674+50. SSF requires maintenance. | |

| 3rd Party Damages | Communication | Repair livestock damage to SSF | | | |

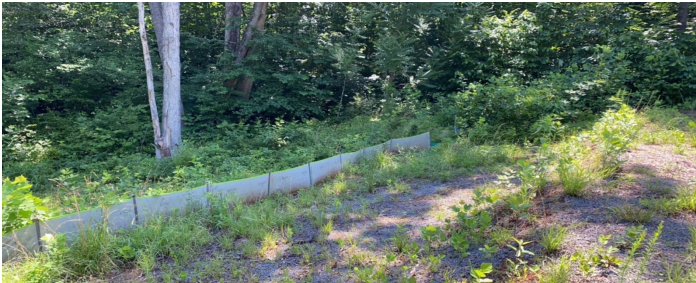
| <b>Pic 1 Desc.</b> | Vegetation growing in temporary area. Limited vegetation observed in travel lane. Will monitor area. | | <b>Pic 2 Desc.</b> | Plunge pool performing intended function. | |

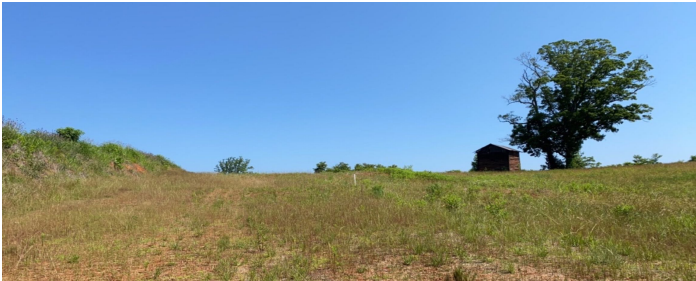
| <b>Pic 3 Desc.</b> | Contractor repaired damaged P1 silt fence per punch list item. | | <b>Pic 4 Desc.</b> | Recently installed CFS check dams performing intended function. | |

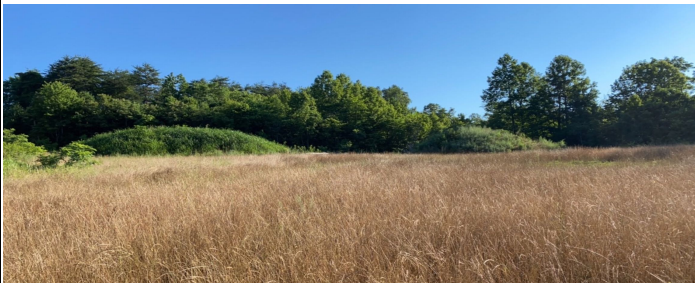
| Pic 1 Desc. | Routine maintenance. Re-pin Curlex to berm around plunge pool. | Pic 2 Desc. | Minor erosion rills forming along ROW. Will monitor area for signs of worsening. | | |

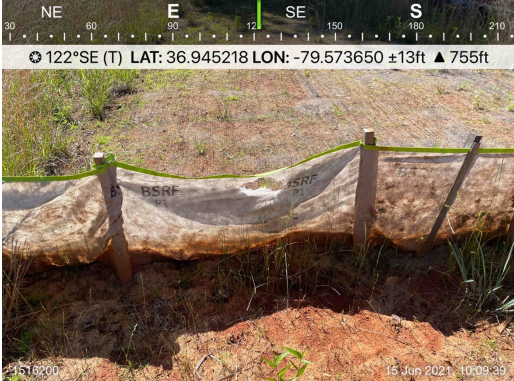
| <b>Pic 1 Desc.</b> | CFS has been damaged and needs to be repaired. | | <b>Pic 2 Desc.</b> | CFS has been displaced and needs to be restaked. | |

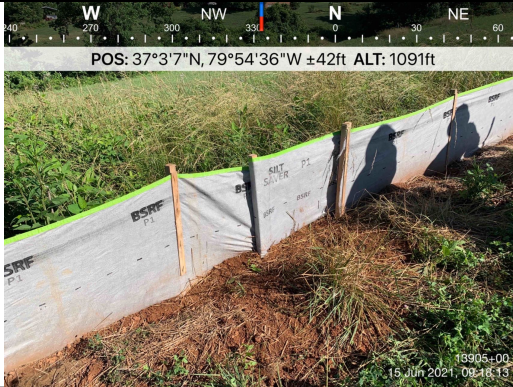
| <b>Pic 1 Desc.</b> | P1 silt fence in acceptable condition | <b>Pic 2 Desc.</b> | P1 silt fence with holes from wildlife damage in multiple panels from 13918+00 to 13921+00 | | |

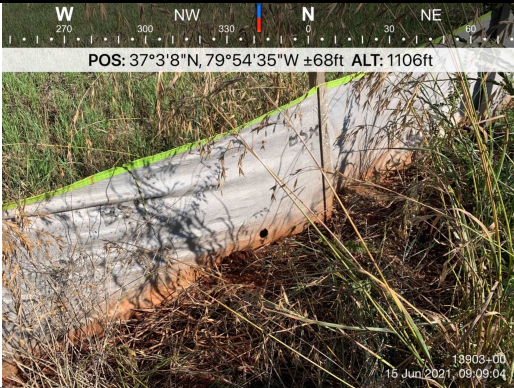
| <b>Pic 3 Desc.</b> | P1 silt fence with hole at ground line, damaged by wildlife, contractor repaired immediately | <b>Pic 4 Desc.</b> | P1 silt fence after repair | | |

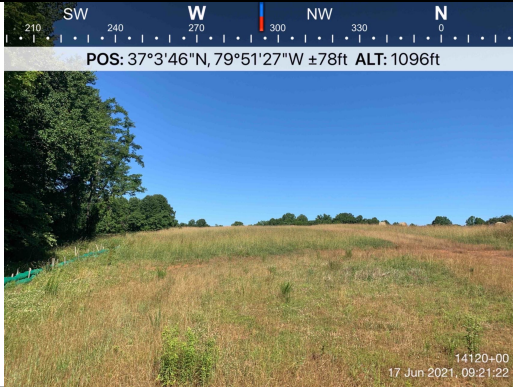
| <b>Pic 1 Desc.</b> | Waterbar end treatment in acceptable condition | <b>Pic 2 Desc.</b> | P1 silt fence with broken stakes | | |

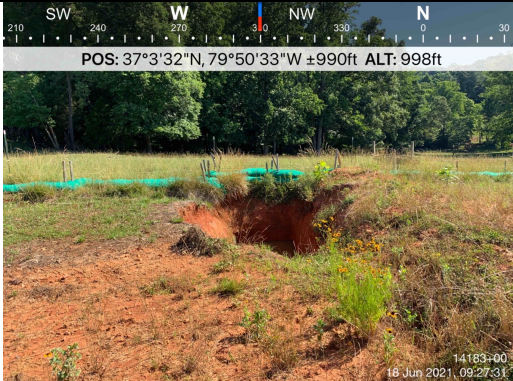
| <b>Pic 1 Desc.</b> | Perimeter CFS is deteriorated and damaged by livestock from 14295+00 to 14303+00 | | <b>Pic 2 Desc.</b> | Waterbar in acceptable condition | |

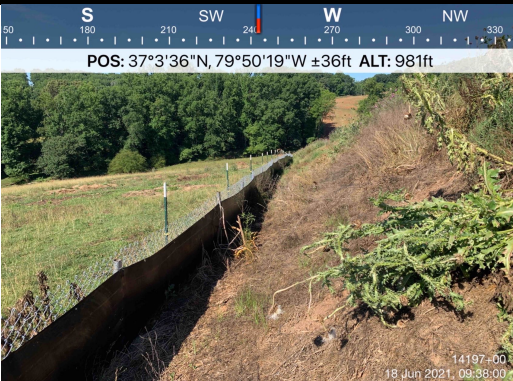
| <b>Pic 3 Desc.</b> | Waterbar end treatment in acceptable condition | | <b>Pic 4 Desc.</b> | Electric fence damaged by livestock, contractor repaired immediately | |

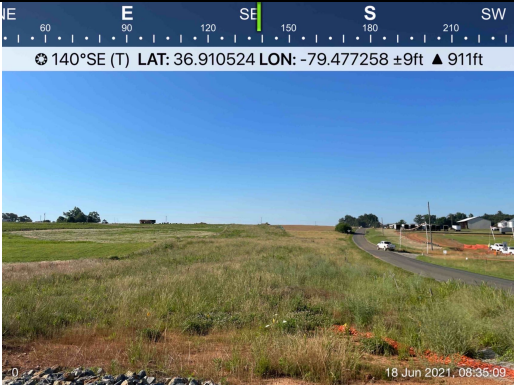
| <b>Pic 1 Desc.</b> | P1 is degraded and needs to be replaced. | | <b>Pic 2 Desc.</b> | Environmental crew has corrected this issue. | |
