Visual Site Inspection Report

Project Name	H-600 Pipeline Spread I	AFE	124300139	Spread	H-600 Pipeline Spread I
Contractor	Precision			Report #	24794
Inspector	John White			Date/Time	6/21/2021 10:17 AM
Permit #	TBD	Inspection Type	VA SWPP	Station Begin	15584+23
State	VA	Inspection Area	Full	Station End	15647+03
County	Pittsylvania	Ground	Dry	Temperature (°F)	82.00
Municipality	Chatham	Weather	Sunny	Rain Gauge (in)	0.00
				Rain Accumulation Time (days)	6.00

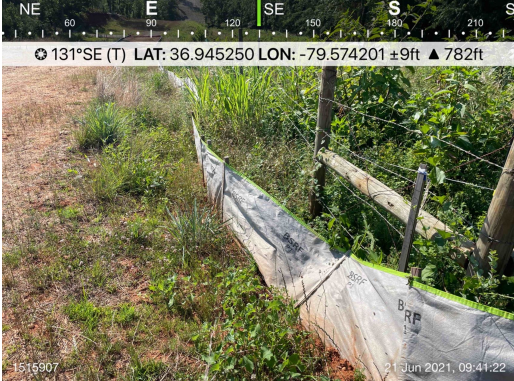
GPS Location	See photo		GPS Location	See photo	
Field Station#	15159+07		Field Station#	15159+07	
Pic 1 Desc.	P1 has been damaged and needs to be restaked.		Pic 2 Desc.	Environmental crew has corrected this issue.

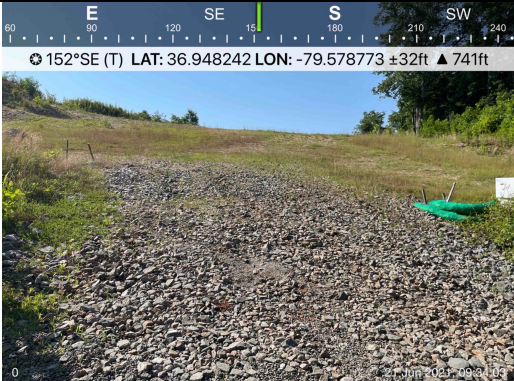
GPS Location	See photo		GPS Location	See photo	
Field Station#	15142+66		Field Station#	15165+57	
Pic 3 Desc.	RCEs are in good condition at all road crossings.		Pic 4 Desc.	Rock inlet remains in good condition.

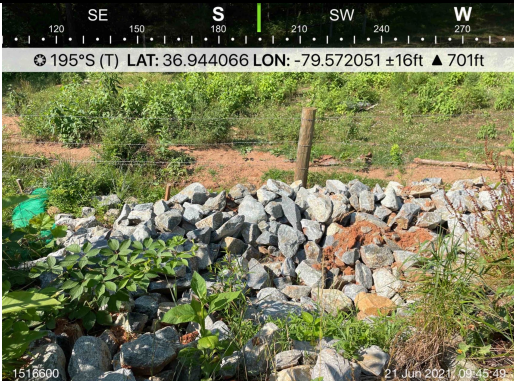
GPS Location	See photo		GPS Location	See photo	
Field Station#	15166+00		Field Station#	15167+95	
Pic 5 Desc.	Rock outlet remains in good condition.		Pic 6 Desc.	P1 is in good condition at all stream and wetland buffers.

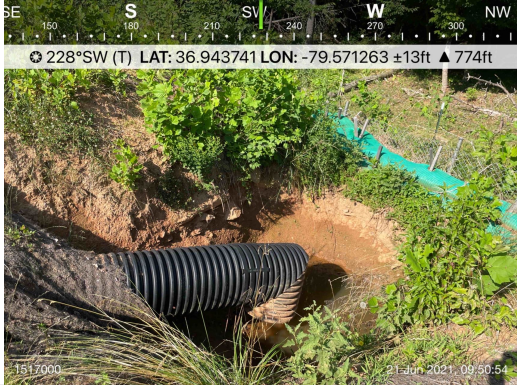
GPS Location	See photo		GPS Location	See photo	
Field Station#	15170+00		Field Station#	15195+00	
Pic 9 Desc.	Slope drain is functioning as intended.		Pic 10 Desc.	Drainage ECDs are in good condition and functioning.

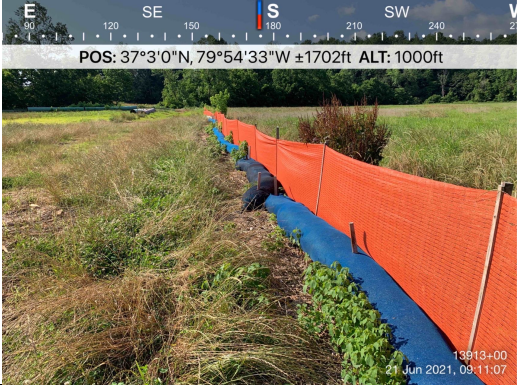
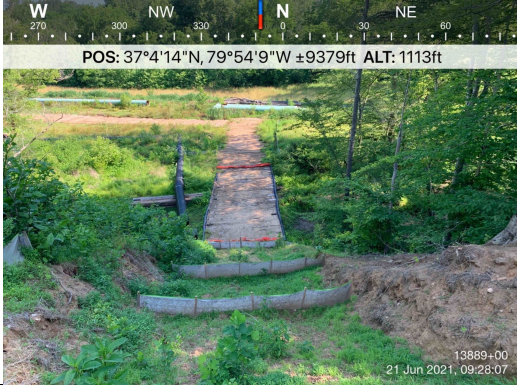
GPS Location	0	GPS Location	0		
Field Station#	13913+00	Field Station#	13889+00		
Pic 7 Desc.	Perimeter CFS in acceptable condition	Pic 8 Desc.	P1 silt fence in acceptable condition

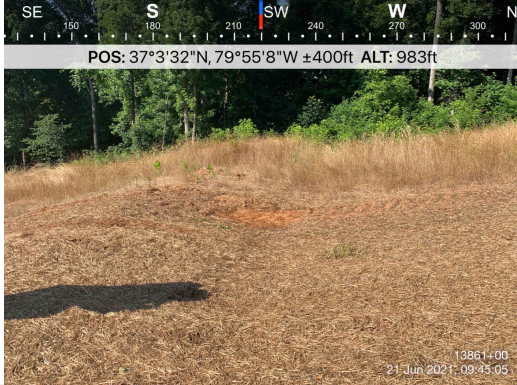
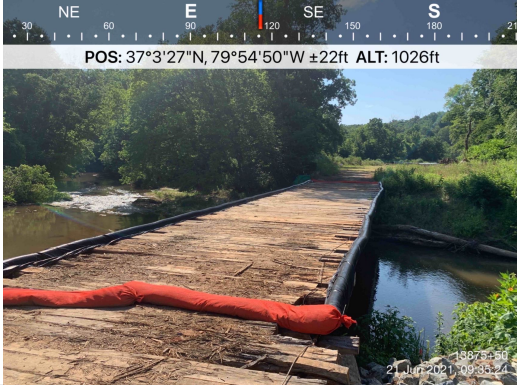
GPS Location	0	GPS Location	0		
Field Station#	13861+00	Field Station#	13875+50		
Pic 9 Desc.	Waterbar in acceptable condition	Pic 10 Desc.	Equipment bridge in acceptable condition

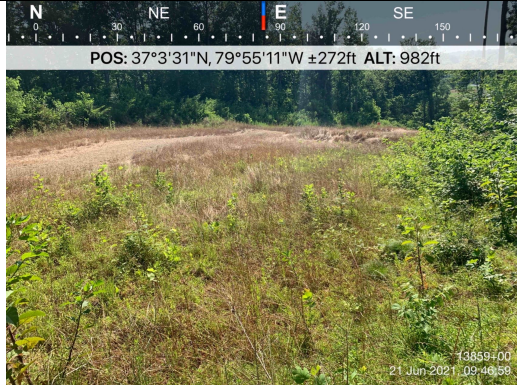
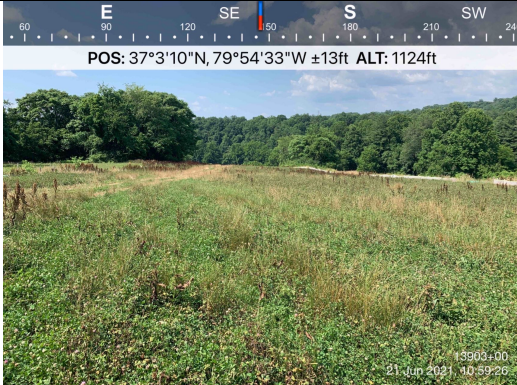
GPS Location	0	GPS Location	0		
Field Station#	13859+00	Field Station#	13903+00		
Pic 11 Desc.	Temporary vegetative stabilization in acceptable condition	Pic 12 Desc.	Permanent vegetative stabilization in acceptable condition

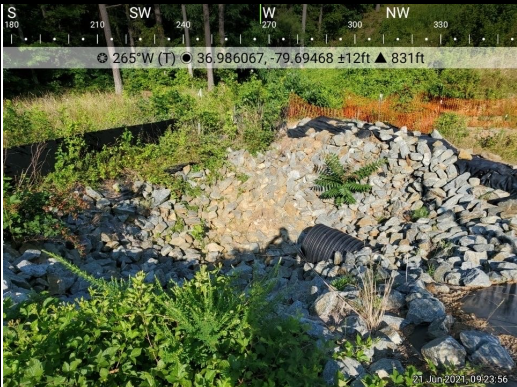
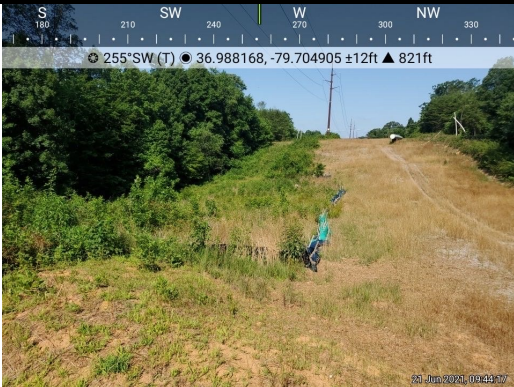
GPS Location	0	GPS Location	0		
Field Station#	14742+00	Field Station#	14712+00		
Pic 7 Desc.	Plunge pool	Pic 8 Desc.	SSF and stabilization

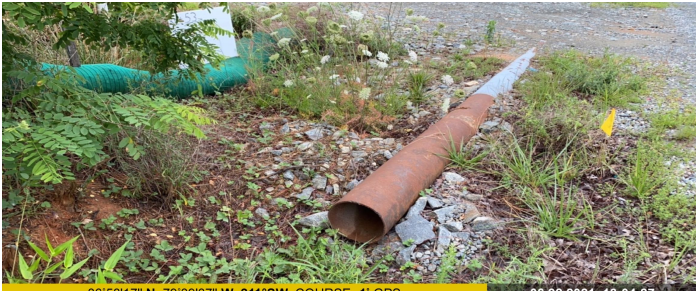
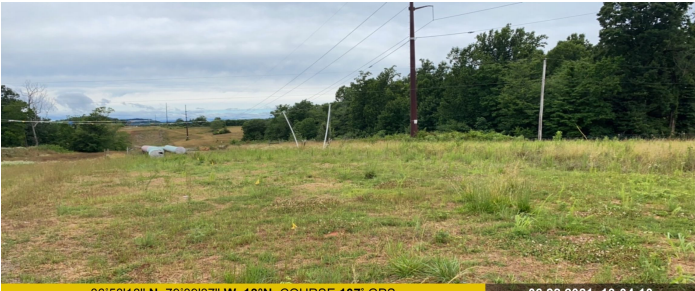
Field Station#	14861+31		Field Station#	14858+00	
Pic 3 Desc.	Culvert at road crossing in good condition.		Pic 4 Desc.	ROW stabilized in temporary area. Goalposts visible and I'm good condition at line crossings of ROW.

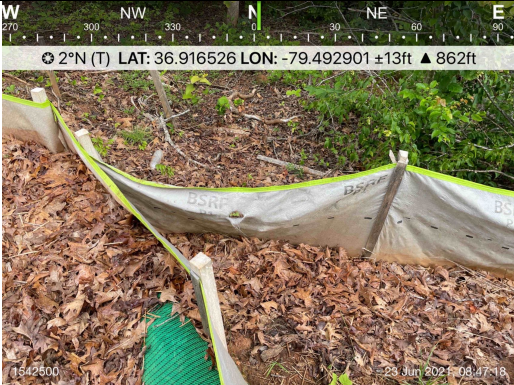
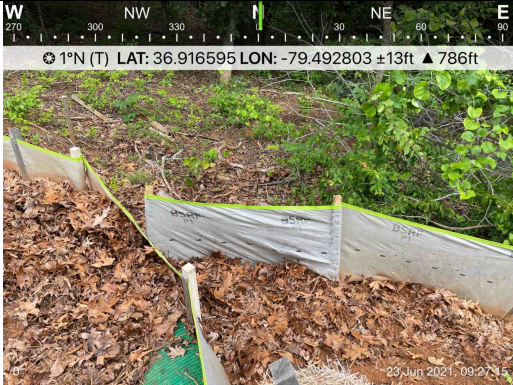
GPS Location	See photo		GPS Location	See photo	
Field Station#	15425+00		Field Station#	15425+00	
Pic 1 Desc.	P1 has been damaged and needs to be replaced.		Pic 2 Desc.	Environmental crew has corrected this issue.

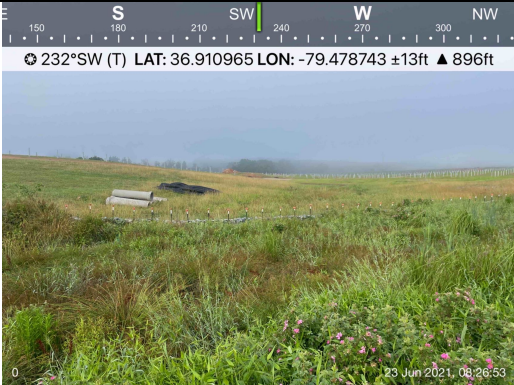
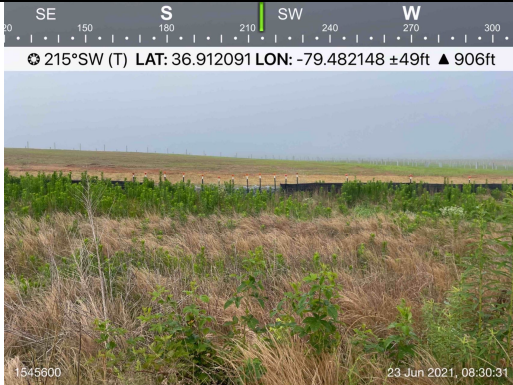
GPS Location	See photo		GPS Location	See photo	
Field Station#	15475+00		Field Station#	15456+00	
Pic 3 Desc.	Rock outlet is in good condition within this drainage.		Pic 4 Desc.	No evidence of sedimentation from 3rd party rock outlet.

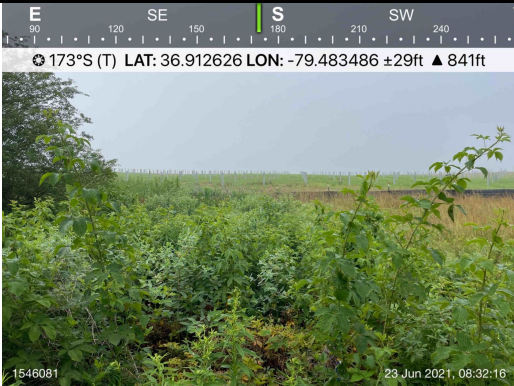
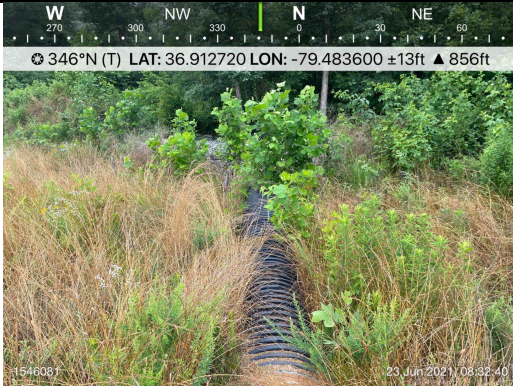
GPS Location	See photo		GPS Location	See photo	
Field Station#	15460+81		Field Station#	15460+81	
Pic 5 Desc.	CWD inlet in good condition. No evidence of sedimentation from 3rd party disturbance.		Pic 6 Desc.	CWD in good condition.

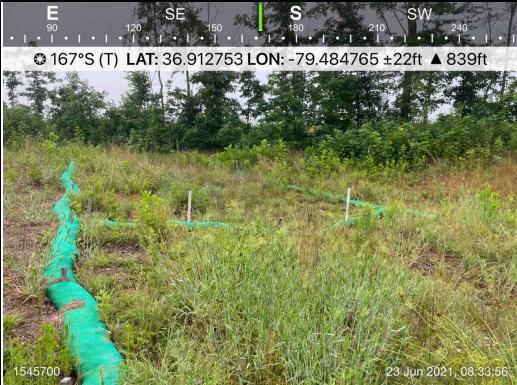
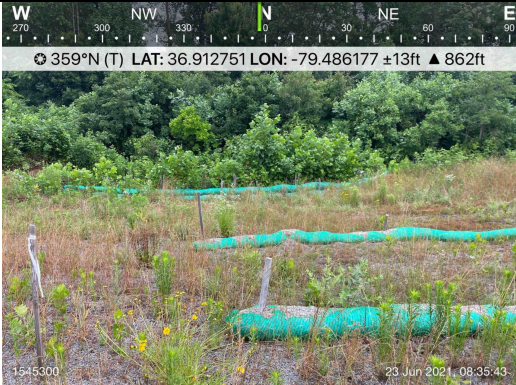
GPS Location	See photo		GPS Location	See photo	
Field Station#	15457+00		Field Station#	15453+00	
Pic 7 Desc.	Drainage in good condition. No evidence of sedimentation from 3rd party disturbance.		Pic 8 Desc.	CWD in good condition condition. No evidence of sedimentation from 3rd party disturbance.

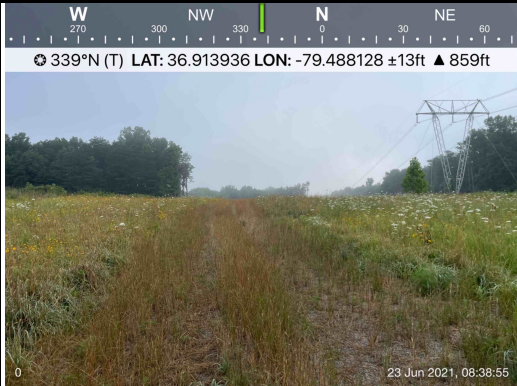
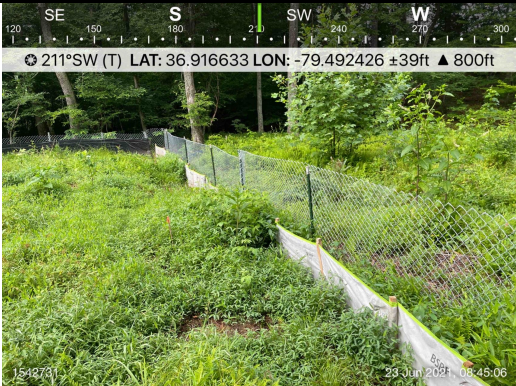
GPS Location	See photo		GPS Location	See photo	
Field Station#	15445+00		Field Station#	15427+31	
Pic 9 Desc.	Vegetation continues to fill in throughout this section of ROW.		Pic 10 Desc.	Reinforced P1 remains in good condition.

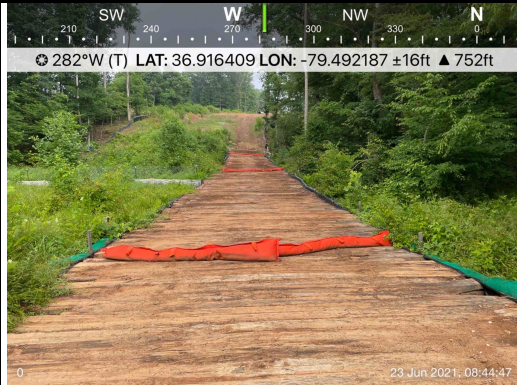
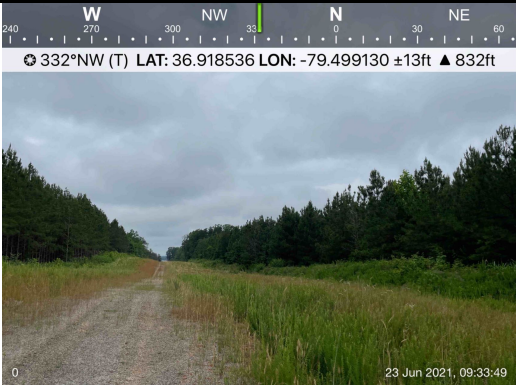
GPS Location	See photo		GPS Location	See photo	
Field Station#	15427+30		Field Station#	15400+00	
Pic 11 Desc.	Equipment bridge ECDs are in place and functioning.		Pic 12 Desc.	Vegetation continues to fill in throughout this section of ROW.

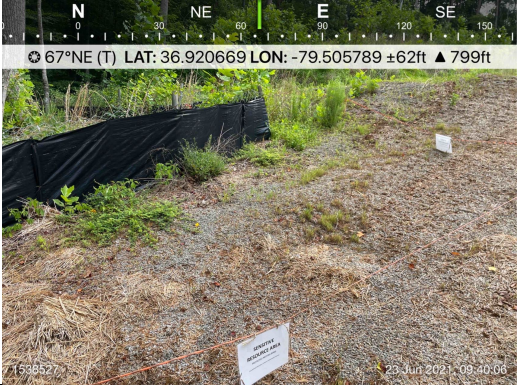
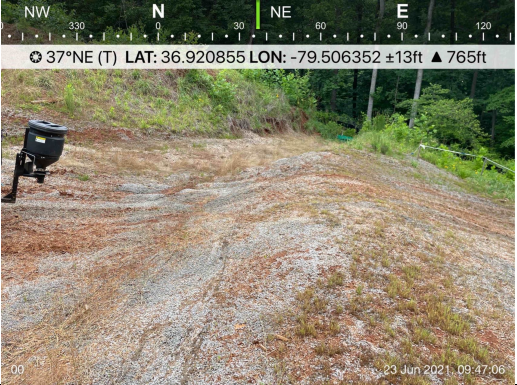
GPS Location	See photo	GPS Location	See photo		
Field Station#	15385+00	Field Station#	15383+00		
Pic 13 Desc.	Sensitive resource buffer is in good condition.	Pic 14 Desc.	Waterbars are functioning as intended.

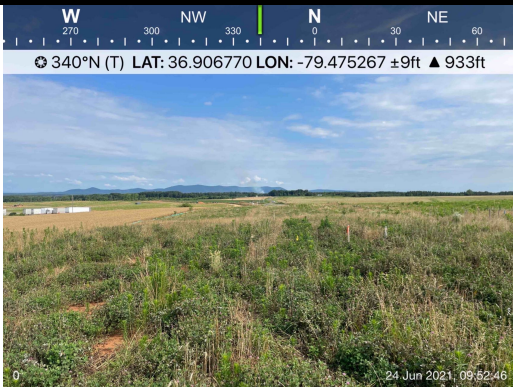
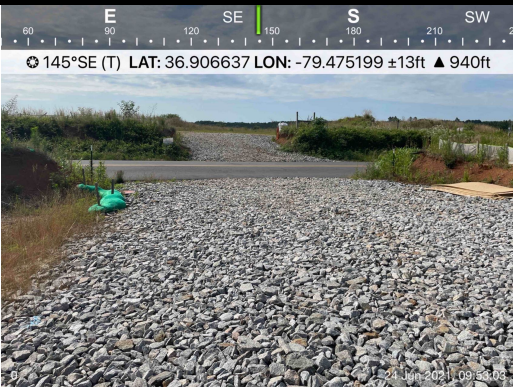
GPS Location	See photo		GPS Location	See photo	
Field Station#	15495+00		Field Station#	15496+70	
Pic 1 Desc.	Vegetation continues to fill in throughout this section.		Pic 2 Desc.	RCEs are in good condition at all road crossings.

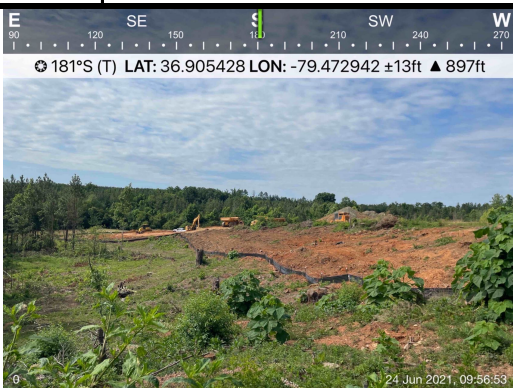
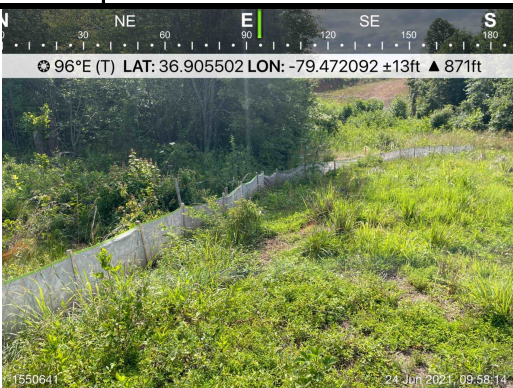
GPS Location	See photo		GPS Location	See photo	
Field Station#	15505+00		Field Station#	15506+41	
Pic 3 Desc.	3rd party disturbance occurring next to MVP ROW. EI will continue to monitor this area.		Pic 4 Desc.	P1 is in good condition at all stream and wetland buffers.

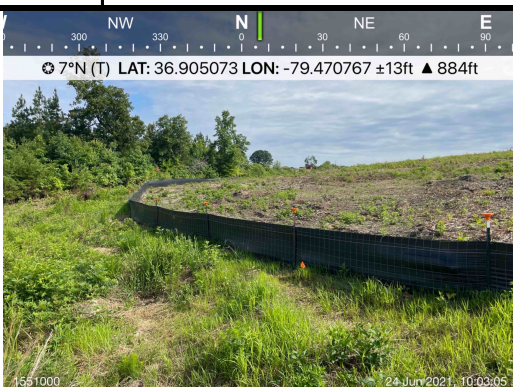
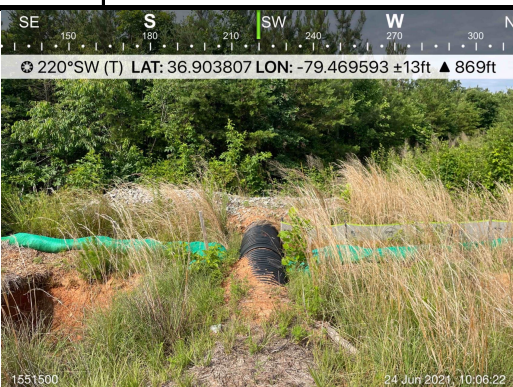
GPS Location	See photo		GPS Location	See photo	
Field Station#	15510+00		Field Station#	15515+00	
Pic 5 Desc.	3rd party ECDs appear to be in good condition with no evidence of sedimentation onto MVP ROW.		Pic 6 Desc.	CWDs are functioning as intended.

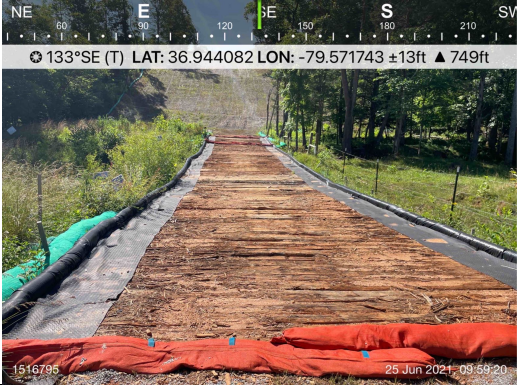
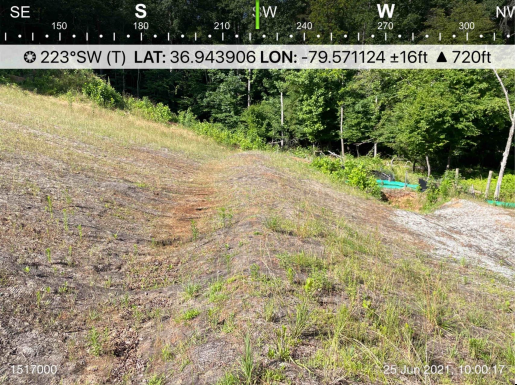
GPS Location	See photo		GPS Location	See photo	
Field Station#	15167+95		Field Station#	15170+00	
Pic 7 Desc.	Equipment bridge ECDs are in place and functioning.		Pic 8 Desc.	Waterbars are functioning as intended.

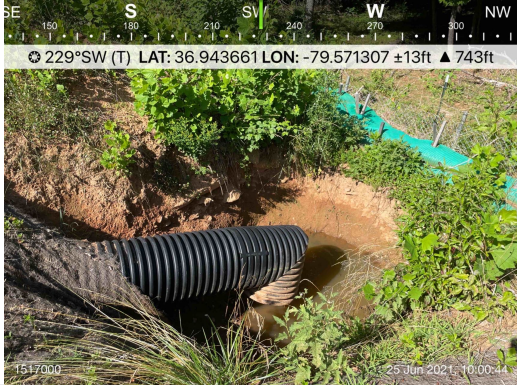
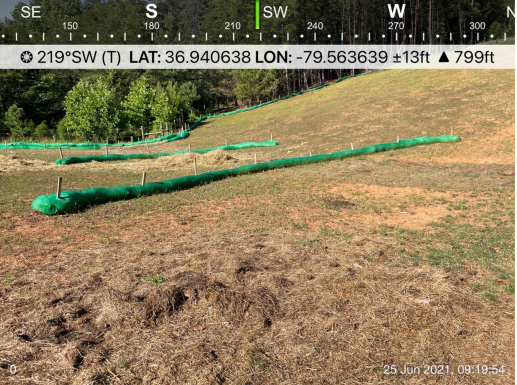
GPS Location	See photo		GPS Location	See photo	
Field Station#	15170+00		Field Station#	15195+00	
Pic 9 Desc.	Slope drain is in good condition at this location.		Pic 10 Desc.	Drainage feature ECDs are in place and functioning.

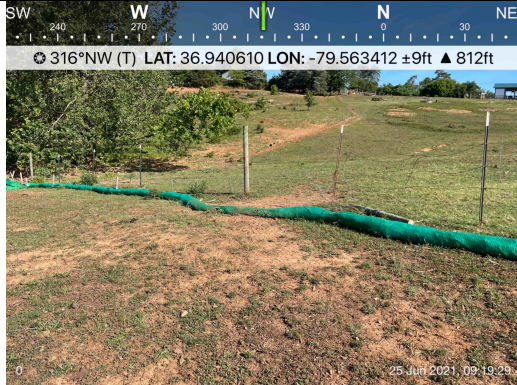
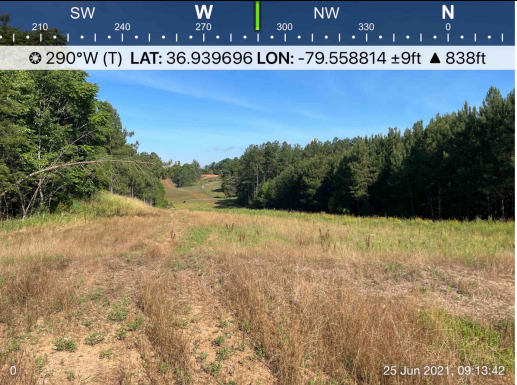
GPS Location	See photo		GPS Location	See photo	
Field Station#	15195+50		Field Station#	15209+00	
Pic 11 Desc.	Fence gap remains open by 3rd party allowing livestock onto ROW.		Pic 12 Desc.	Vegetation continues to fill in throughout this section.
