Mountain Valley Pipeline Project – Spread G

Environmental Auditor Quarterly Report for Q3 2021

October 15, 2021

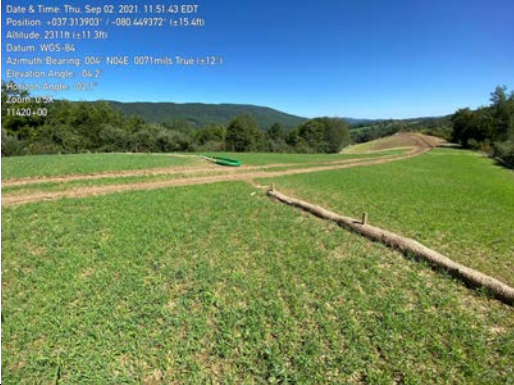
GPS Location	See photo	GPS Location	See photo		
Field Station#	11420+00	Field Station#	11421+00		
Pic 1 Desc.	CFS water bar was not put back in place	Pic 2 Desc.	CFS water bar was not put back in place		
<p>Date & Time: Thu, Sep 02, 2021, 11:45:00 EDT Position: +037 314270 / -080 448654 (+21.7ft) Altitude: 2301ft (+23.0ft) Datum: WGS-84 Azimuth/Bearing: 297 N63W 5380mils True (+12°) Elevation Angle: +02.8° Horizon Angle: +03.3° Zoom: 0.5X 11422+75</p>

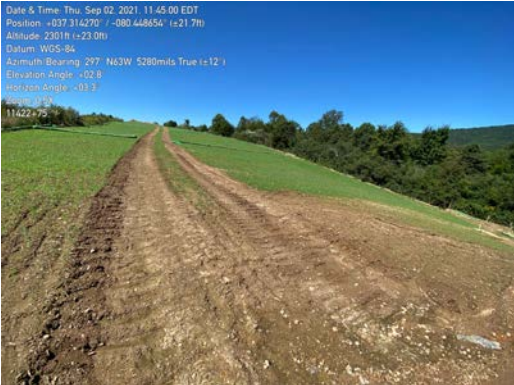
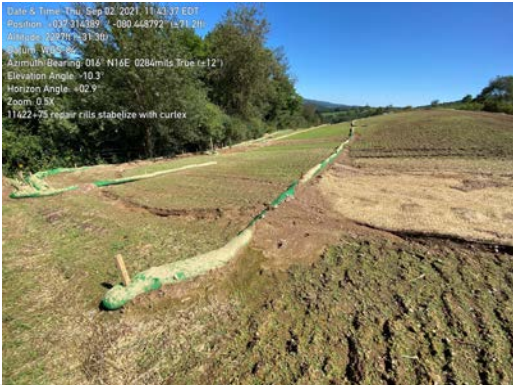
GPS Location	See photo	GPS Location	See photo		
Field Station#	11422+75	Field Station#	11422+75		
Pic 3 Desc.	CFS water bars not in place	Pic 4 Desc.	Rilling and erosion		
<p>Date & Time: Thu, Sep 02, 2021, 11:40:55 EDT Position: +037 314635 / -080 448610 (+15.8ft) Altitude: 2273ft (+10.7ft) Datum: WGS-84 Azimuth/Bearing: 305 N15W 8133mils True (+12°) Elevation Angle: +24.2° Horizon Angle: +03.6° Zoom: 0.5X 11422+752ft</p>  		<p>Date & Time: Thu, Sep 02, 2021, 11:41:37 EDT Position: +037 314526 / -080 448330 (+29.4ft) Altitude: 2260ft (+18.6ft) Datum: WGS-84 Azimuth/Bearing: 311 N31W 5529mils True (+12°) Elevation Angle: +25.5° Horizon Angle: +03.6° Zoom: 0.5X 11422+752ft</p>  			
GPS Location	See photo	GPS Location	See photo		
Field Station#	11422+75	Field Station#	11422+75		
Pic 5 Desc.	Sediment off row	Pic 6 Desc.	Over run CFS

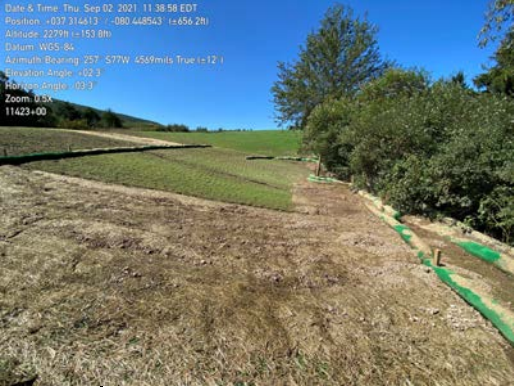
<p>Insert image here</p>			
GPS Location	See photo	GPS Location			
Field Station#	11423+00	Field Station#			
Pic 7 Desc.	Over view of impacted area	Pic 8 Desc.			
<p>Insert image here</p>		<p>Insert image here</p>			
GPS Location		GPS Location			
Field Station#		Field Station#			
Pic 9 Desc.		Pic 10 Desc.			
<p>Insert image here</p>		<p>Insert image here</p>			
GPS Location		GPS Location			
Field Station#		Field Station#			
Pic 11 Desc.		Pic 12 Desc.

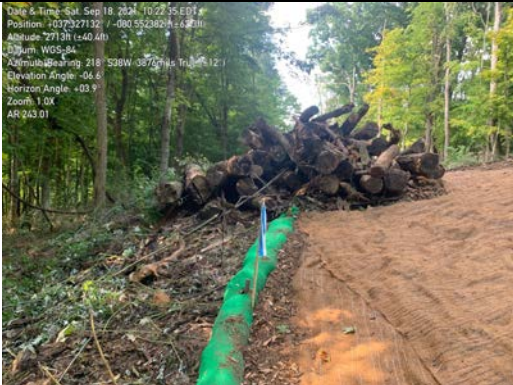
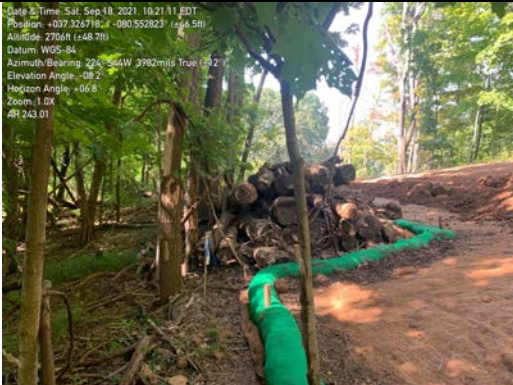
<p>Date & Time: Sat, Sep 18, 2021, 10:21:11 EDT Position: +0373247182 / -080552823 / +64.5m Altitude: 2706ft (+48.7m) Datum: WGS-84 Azimuth Bearing: 224° S44W 3792mils True (+12°) Elevation Angle: +08.2° Horizon Angle: +06.8° Zoom: 1.0X AR 243.01</p>			
GPS Location	See photo for GPS location.		GPS Location	See photo for GPS location.	
Field Station#	11011+68		Field Station#	11011+68	
Pic 1 Desc.	Logs stacked outside the LOD.		Pic 2 Desc.	Logs stacked outside the LOD.

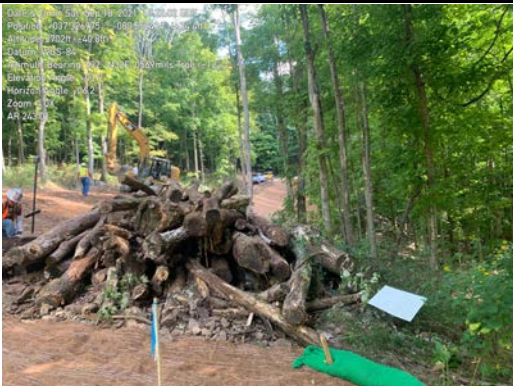
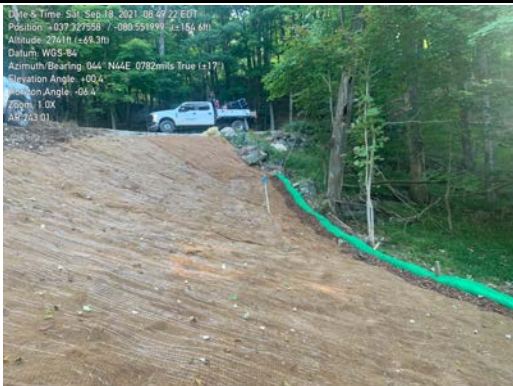
GPS Location	See photo for GPS location.		GPS Location	See photo for GPS location.	
Field Station#	11011+68		Field Station#	11011+68	
Pic 3 Desc.	Logs stacked outside the LOD.		Pic 4 Desc.	Equipment operated outside the LOD and controls installed outside the LOD.

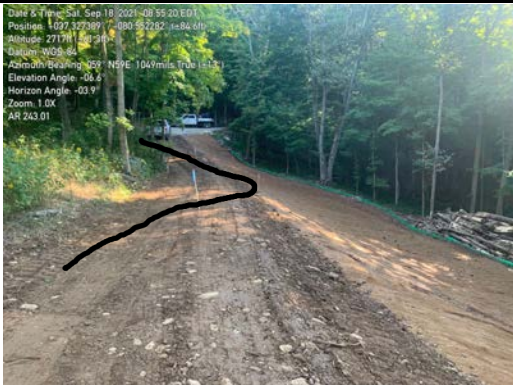
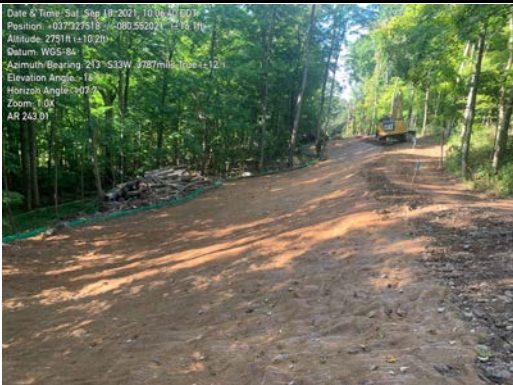
Pic 5 Desc.	Equipment operated outside the LOD. Black line represents LOD.		Pic 6 Desc.	Equipment operated outside the LOD.
