# Visual Site Inspection Report

<b>Project Name</b>	H-600 Pipeline Spread G	<b>AFE</b>	124300137	<b>Spread</b>	H-600 Pipeline Spread G
<b>Contractor</b>	Precision			<b>Report #</b>	25095
<b>Inspector</b>	Patrick Shields			<b>Date/Time</b>	6/28/2021 4:17 PM
<b>Permit #</b>	TBD	<b>Inspection Type</b>	VA SWPP	<b>Station Begin</b>	11254+99
<b>State</b>	VA	<b>Inspection Area</b>	Partial	<b>Station End</b>	11524+16
<b>County</b>	Giles	<b>Ground</b>	Dry	<b>Temperature (°F)</b>	87.00
<b>Municipality</b>	N/A	<b>Weather</b>	Sunny	<b>Rain Gauge (in)</b>	0.00
				<b>Rain Accumulation Time (days)</b>	1.00

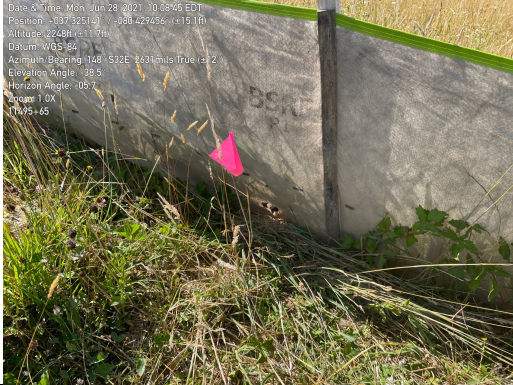
<p>Date &amp; Time: Mon Jun 28 2021 10:09:06 EDT Position: +037.319310 / -080.429456 (-15.1m) Altitude: 2245ft (+11.5m) Datum: WGS-84 Azimuth/Bearing: 168 S32E 2631mils True (+12°) Elevation Angle: -38.5 Horizon Angle: -05.7 Zoom: 1.0x 11495+65</p>			
<b>GPS Location</b>	See photo	<b>GPS Location</b>	See photo		
<b>Field Station#</b>	11501+11	<b>Field Station#</b>	11495+65		
<b>Pic 1 Desc.</b>	Install triangular foam dike to specifications	<b>Pic 2 Desc.</b>	Replace hole in P1 silt fence perimeter control

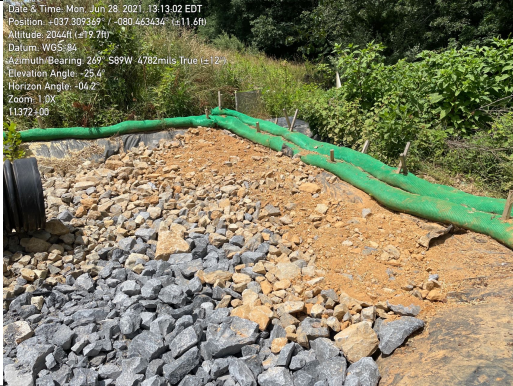
<p>Date &amp; Time: Mon Jun 28 2021 13:13:02 EDT Position: +037.309249 / -080.463404 (-11.6m) Altitude: 2044ft (+9.7ft) Datum: WGS-84 Azimuth/Bearing: 267 S89W 4782mils True (+12°) Elevation Angle: -25.4 Horizon Angle: -04.2 Zoom: 1.0x 11372+00</p>			
<b>GPS Location</b>	See photo	<b>GPS Location</b>	See photo		
<b>Field Station#</b>	11440+80	<b>Field Station#</b>	11372+00		
<b>Pic 5 Desc.</b>	Repair side rail and geotextile fabric on equipment bridge	<b>Pic 6 Desc.</b>	Remove dirt from plunge pool

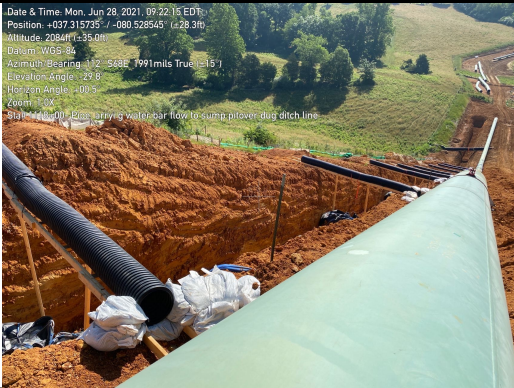
<p>Date &amp; Time: Mon, Jun 28, 2021, 09:26:02 EDT  Position: +037.3153235 / -080.528545 (+22830ft)  Altitude: 2084ft (+35.0m)  Datum: WGS 84  Azimuth/Bearing: 125.555E 2222mils True (+14.1)  Elevation Angle: +03.6  Horizon Angle: +06.7  Zoom: 1.0X  Sta# 11132+00- Pipe carrying water bar flow across dug ditch to sump.</p>

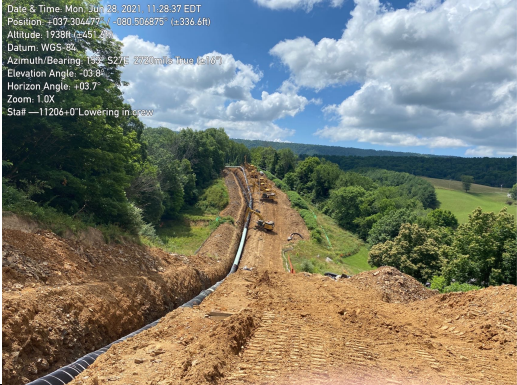
<p><small>Date &amp; Time: Mon Jun 28 2021 11:28:37 EDT Position: -037.304479°N, -080.506875°W (-336.6ft) Altitude: 1938ft (-591.2m) Datum: WGS-84 Azimuth/Bearing: 186.521W 6027mils (true)=15.1 Elevation Angle: -30.0° Horizon Angle: -03.7° Zoom: 1.0X Staff: 11206+00 Lowering in crew</small></p>

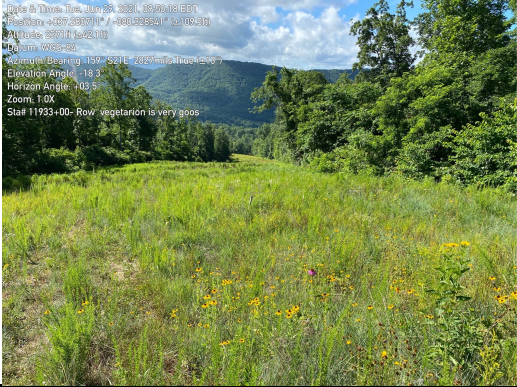
<p>Date &amp; Time: Tue, Jun 29, 2021, 09:59:58 EDT Position: -037.289711° / -880.328991° (-200.9ft) Altitude: 2324ft (-272.5ft) Datum: WGS-84 Azimuth/Bearing: 301° N31W 3031mils True (±13°) Elevation Angle: -02.5° Horizon Angle: -03.5° Zoom: 1.0X Staff 11933+00- Row vegetation is very good.</p>

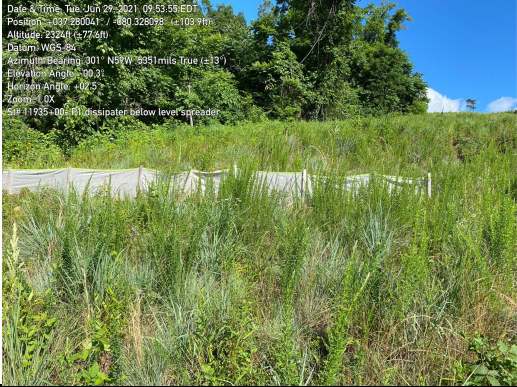
<p>Date &amp; Time: Tue, Jun 29, 2021, 09:59:58 EDT Position: -037.290041° / -880.328998° (-200.9ft) Altitude: 2324ft (-272.5ft) Datum: WGS-84 Azimuth/Bearing: 301° N31W 3031mils True (±13°) Elevation Angle: -02.5° Horizon Angle: -03.5° Zoom: 1.0X Staff 11935+00- P1 disapper below level spreader.</p>			
<b>GPS Location</b>	See photo GPS		<b>GPS Location</b>	See photo GPS	
<b>Field Station#</b>	11933+00		<b>Field Station#</b>	11935+00	
<b>Pic 7 Desc.</b>	Row vegetation in inspection area is very good.		<b>Pic 8 Desc.</b>	P1 disapper below level spreader.

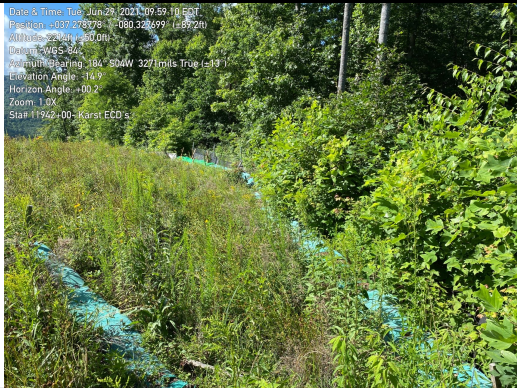
<p>Date &amp; Time: Tue, Jun 29, 2021, 09:59:58 EDT Position: -037.289711° / -880.328991° (-200.9ft) Altitude: 2324ft (-272.5ft) Datum: WGS-84 Azimuth/Bearing: 301° N31W 3031mils True (±13°) Elevation Angle: -02.5° Horizon Angle: -03.5° Zoom: 1.0X Staff 11942+00- Karst ECD's.</p>

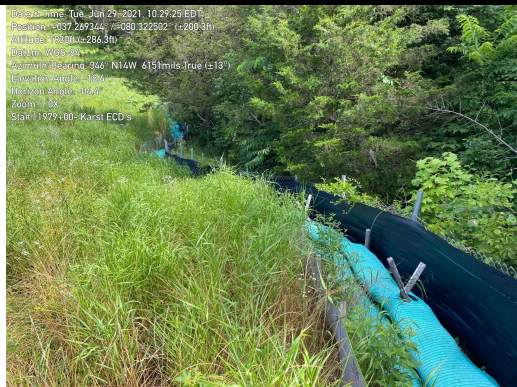
<p>Date &amp; Time: Tue, Jun 29, 2021, 10:29:25 EDT Position: -037.289744° / -880.322802° (-200.9ft) Altitude: 1638ft (-150.4ft) Datum: WGS-84 Azimuth/Bearing: 346° N14W 6151mils True (±13°) Elevation Angle: -12.4° Horizon Angle: -02.0° Zoom: 1.0X Staff 11979+00- Karst ECD's.</p>

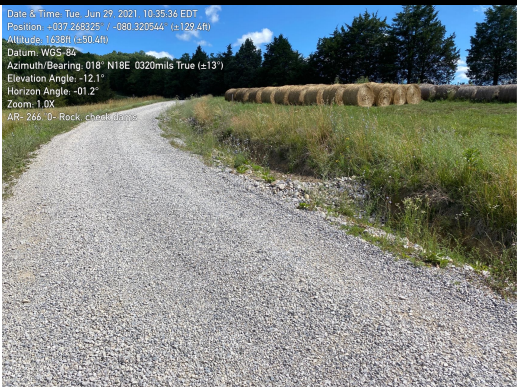
<p>Date &amp; Time: Tue, Jun 29, 2021, 10:35:36 EDT Position: -037.288335° / -880.320544° (-129.4ft) Altitude: 1638ft (-150.4ft) Datum: WGS-84 Azimuth/Bearing: 018° N18E 0320mils True (±13°) Elevation Angle: -12.1° Horizon Angle: -01.2° Zoom: 1.0X AR-266.00- Rock check dams.</p>

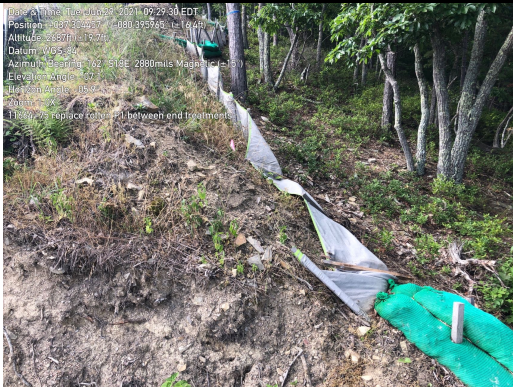
GPS Location		On photo		GPS Location	
Field Station#		11664+75		Field Station#	
Pic 1 Desc.		Communication; Example of P1 silt fence in need of replacement.		Pic 2 Desc.	
				Communication; Example of need for re-attachment of SSF fabric.

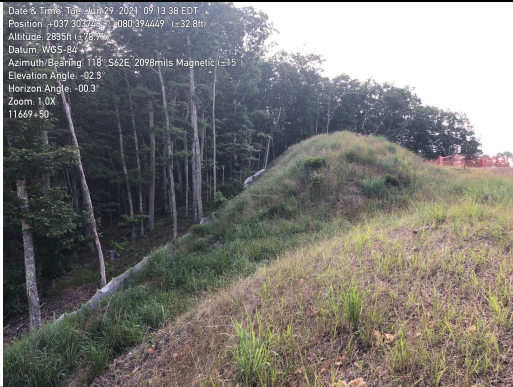
GPS Location		On photo		GPS Location	
Field Station#		11669+50		Field Station#	
Pic 3 Desc.		ROW stable. Perimeter controls are in place.		Pic 4 Desc.	
				Perimeter ECDs in place and functional.

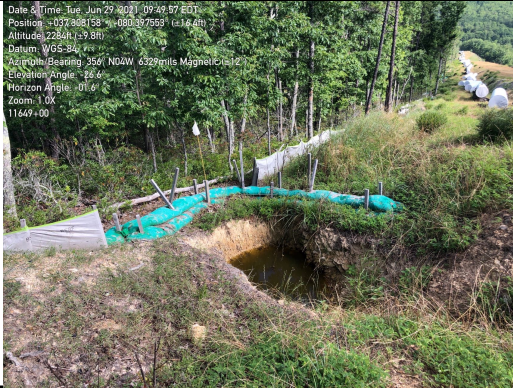
GPS Location		On photo		GPS Location	
Field Station#		11649+00		Field Station#	
Pic 5 Desc.		ECDs in place, effective.		Pic 6 Desc.	
				ROW stable. Deer laying in shade of pipe.

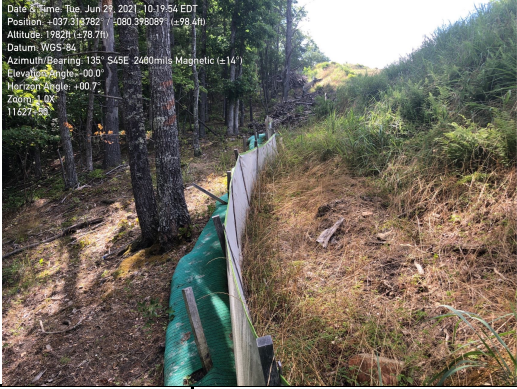
<b>GPS Location</b>	On photo	<b>GPS Location</b>	On photo		
<b>Field Station#</b>	11627+50	<b>Field Station#</b>	11626+04		
<b>Pic 7 Desc.</b>	Perimeter ECDs in place, functional.	<b>Pic 8 Desc.</b>	The S-HH18 crossing is stable. No impact.

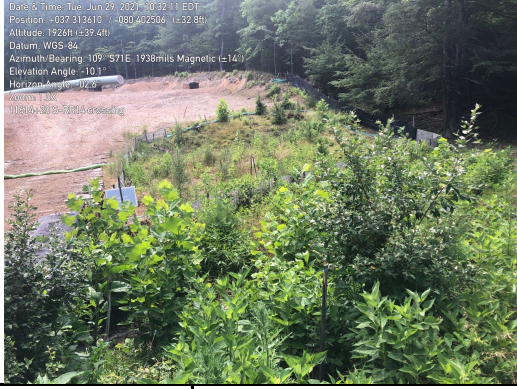
<b>GPS Location</b>	On photo	<b>GPS Location</b>	On photo		
<b>Field Station#</b>	11614+20	<b>Field Station#</b>	11608+17		
<b>Pic 9 Desc.</b>	The S-RR14 crossing is stable. No impact.	<b>Pic 10 Desc.</b>	The S-006 crossing is stable. No impact.		
Insert image here		Insert image here			
<b>GPS Location</b>		<b>GPS Location</b>			
<b>Field Station#</b>		<b>Field Station#</b>			
<b>Pic 11 Desc.</b>		<b>Pic 12 Desc.</b>

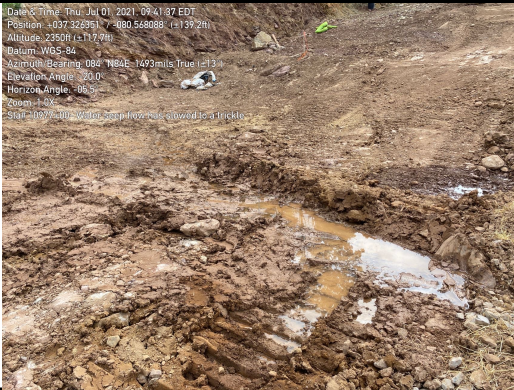
<p>Date &amp; Time: Thu Jul 01, 2021, 09:41:37 EDT Position: +037.322917° / -080.568088° (-119.21) Altitude: 2350ft (-717m) Datum: WGS-84 Azimuth/Bearing: 084° N84E 1493mils True (-13°) Elevation Angle: -20.0° Horizon Angle: +05.5° Zoom: 1.0X Sta# 10977+00- Water seep has slowed to a trickle</p>		  <p>Date &amp; Time: Thu Jul 01, 2021, 09:49:55 EDT Position: +037.325922° / -080.565288° (-119.611) Altitude: 2339ft (-713m) Datum: WGS-84 Azimuth/Bearing: 127° S53E 2258mils True (-13°) Elevation Angle: -22.8° Horizon Angle: +00.0° Zoom: 1.0X Sta# 10985+00- Stream S- E24- Stream has dried up</p>

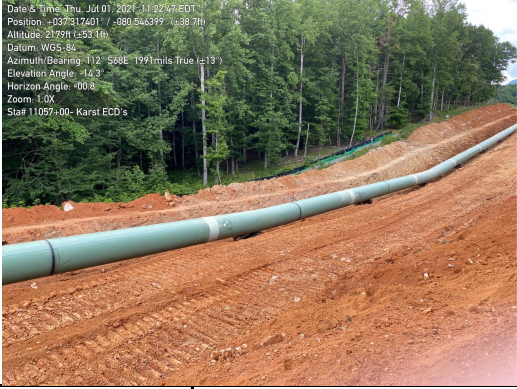
<p><small>Date &amp; Time: Thu Jul 01, 2021, 11:22:57 EDT Position: -037°31'24.01" / -980.546399 / 539.7m Altitude: 2179ft (664.1m) Datum: WGS-84 Azimuth/Bearing: 112° S68E 1991mils True (±13°) Elevation Angle: +16.2° Horizon Angle: +00.3° Zoom: 1.0X Sta# 11057+00- Karst ECD's</small></p>

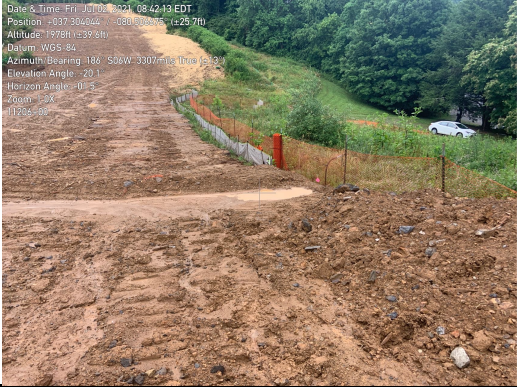
<p>Date &amp; Time: Fri, Jul 02, 2021, 08:42:19 EDT Position: +037.204342, -080.507700 (+397.5ft) Altitude: 1576ft (+479.9ft) Datum: WGS-84 Azimuth Bearing: 186.580W 3307mils True (+63.0) Elevation Angle: +20.1 Horizon Angle: +00.2 Zoom: 1.0X 11206+00</p>			
<b>GPS Location</b>	See photo	<b>GPS Location</b>	See photo		
<b>Field Station#</b>	11191+00	<b>Field Station#</b>	11206+00		
<b>Pic 7 Desc.</b>	Environmental bridge needs maintenance	<b>Pic 8 Desc.</b>	Temporary construction berm needs redone

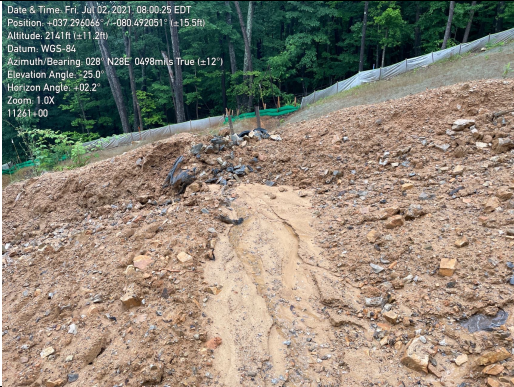
<b>GPS Location</b>	See photo	<b>GPS Location</b>	See photo		
<b>Field Station#</b>	11261+00	<b>Field Station#</b>	11293+00		
<b>Pic 1 Desc.</b>	Rock inlet needs maintenance	<b>Pic 2 Desc.</b>	Equipment bridge needs cleaned off
