Visual Site Inspection Report

Project Name	H-600 Pipeline Spread G	AFE	124300137	Spread	H-600 Pipeline Spread G
Contractor	Precision			Report #	25747
Inspector	Len Kruizenga			Date/Time	7/12/2021 10:12 AM
Permit #	TBD	Inspection Type	VA SWPP	Station Begin	12005+00
State	VA	Inspection Area	Full	Station End	12005+00
County	Giles	Ground	Dry	Temperature (°F)	71.00
Municipality	N/A	Weather	Sunny	Rain Gauge (in)	0.30
				Rain Accumulation Time (days)	1.00

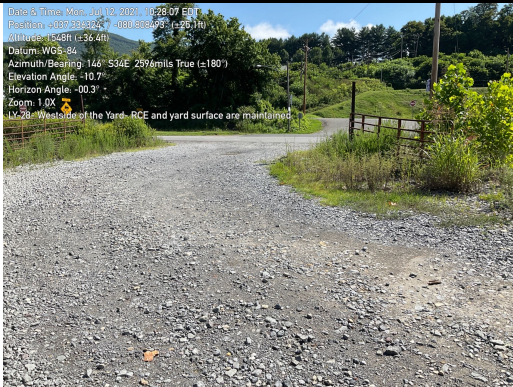
<p>Date & Time: Mon, Jul 12, 2021, 10:28:07 EDT Position: +037.335804 / -080.808014 (±13.3ft) Altitude: 1550ft (±22.9ft) Datum: WGS-84 Azimuth/Bearing: 144.534E 259°mils True (±180°) Elevation Angle: -10.7° Horizon Angle: -00.3° Zoom: 1.0X LY-28: Westside of the yard- RCE and yard surface are maintained.</p>

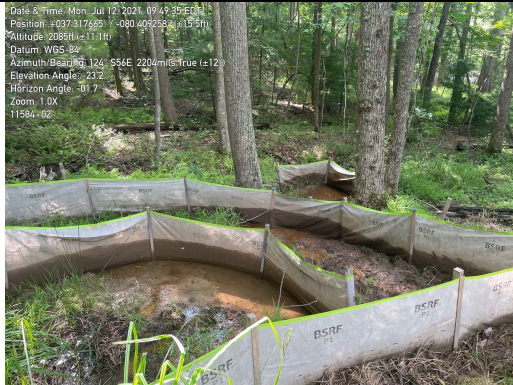
GPS Location				See photo				GPS Location				See photo			
Field Station#				11555+00				Field Station#				11584+02			
Pic 3 Desc.				Waterbars in place				Pic 4 Desc.				P1 silt fence no longer filtering needs replaced

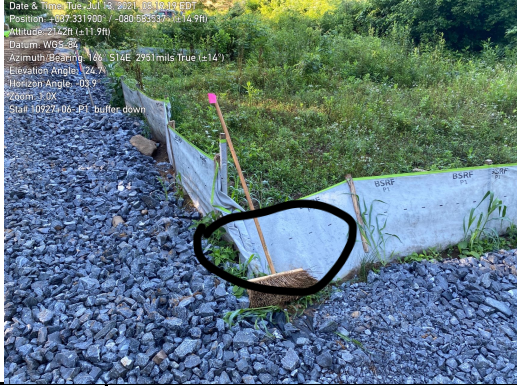
GPS Location	See photo GPS		GPS Location	See photo GPS	
Field Station#	10926+45		Field Station#	10927+06	
Pic 1 Desc.	CFS perimeter controls, end treatments, water bars.		Pic 2 Desc.	Stream S-Y3- Buffer stake broken, issue added to the punch list.

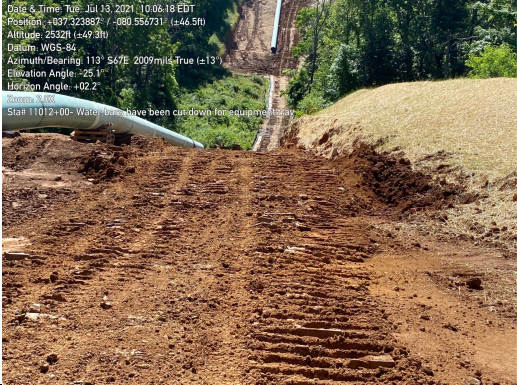
GPS Location	See photo GPS		GPS Location	See photo GPS	
Field Station#	10986+00		Field Station#	11012+00	
Pic 7 Desc.	Stream S-E25		Pic 8 Desc.	Water bars have been removed for equipment travel.

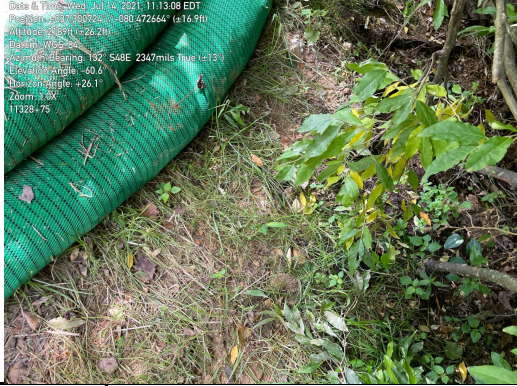
<p>Date & Time: Wed Jul 14, 2021 11:13:08 EDT Position: +037.300857° / -080.472664° (+16.9ft) Altitude: 2231ft (+26.2ft) Datum: WGS-84 Azimuth Bearing: 192° S48E 2347mils true (+13°) Elevation Angle: -60.6° Horizon Angle: +26.1° Zoom: 1.0x 11328+75</p>		GPS Location	See photo
Field Station#	11505+00	Field Station#	11328+75	GPS Location	See photo
Pic 1 Desc.	Hole in P1	Pic 2 Desc.	End treatment undermined

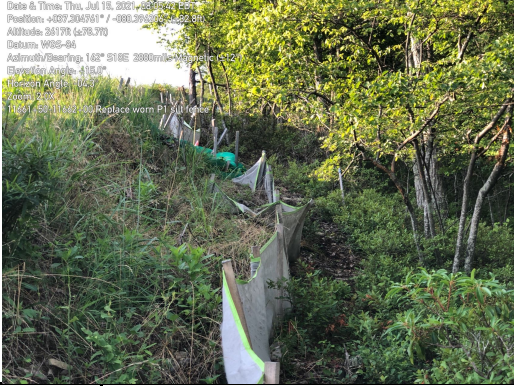
GPS Location	On photo	GPS Location	On photo		
Field Station#	11661+50	Field Station#	11659+90		
Pic 1 Desc.	Communication; replace worn P1 silt fencing 11661+50 - 11662+00.	Pic 2 Desc.	Communication; replace worn P1 silt fencing 11659+90 - 11661+00.

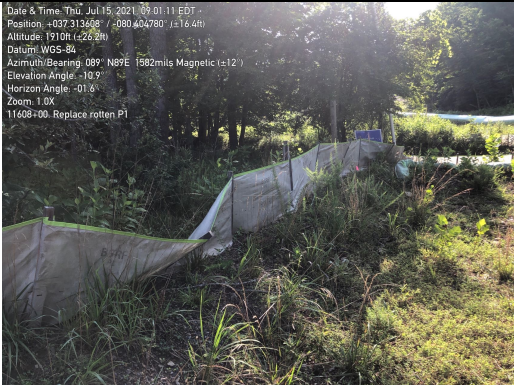
GPS Location	On photo	GPS Location	On photo		
Field Station#	11608+00	Field Station#	11626+04		
Pic 3 Desc.	Communication; Replace worn P1 silt fencing at S-006 crossing.	Pic 4 Desc.	The S-HH18 crossing is stable.

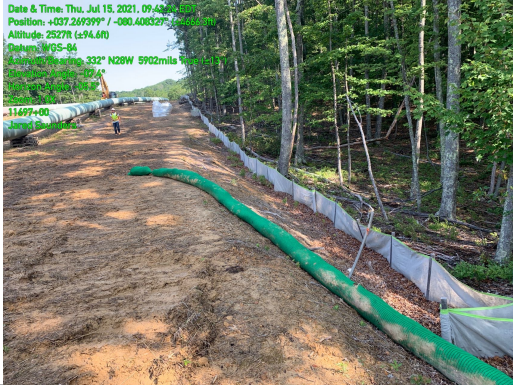
GPS Location		See photo for GPS location.						GPS Location		See photo for GPS location.	
Field Station#		11697+00						Field Station#		11721+00	
Pic 3 Desc.		Perimeter ECDs being replaced.						Pic 4 Desc.		Perimeter controls replaced.
