Visual Site Inspection Report

Project Name	H-600 Pipeline Spread G	AFE	124300137	Spread	H-600 Pipeline Spread G
Contractor	Precision			Report #	26382
Inspector	Clint Sears			Date/Time	7/26/2021 4:15 PM
Permit #	TBD	Inspection Type	VA SWPP	Station Begin	11254+99
State	VA	Inspection Area	Full	Station End	11064+53
County	Giles	Ground	Dry	Temperature (°F)	90.00
Municipality	N/A	Weather	Sunny	Rain Gauge (in)	0.00
				Rain Accumulation Time (days)	1.00

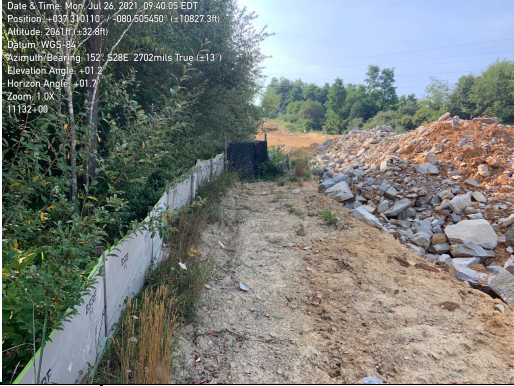
GPS Location	See photo	GPS Location	See photo		
Field Station#	11132+00	Field Station#	11126+70		
Pic 1 Desc.	P1 and super silt fence functional	Pic 2 Desc.	Drainage feature with good vegetation

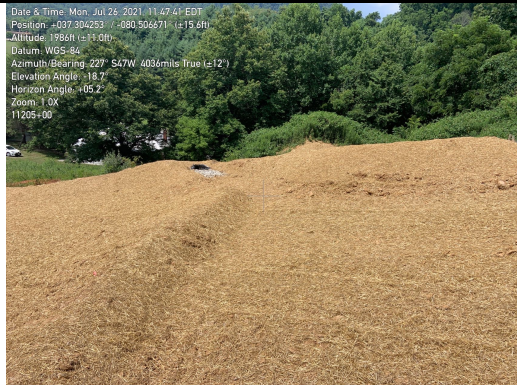
GPS Location	See photo	GPS Location	See photo
Field Station#	11205+00	Field Station#	11115+00
Pic 11 Desc.	Water bar needs redone	Pic 12 Desc.	Stone inlet protection needs maintenance

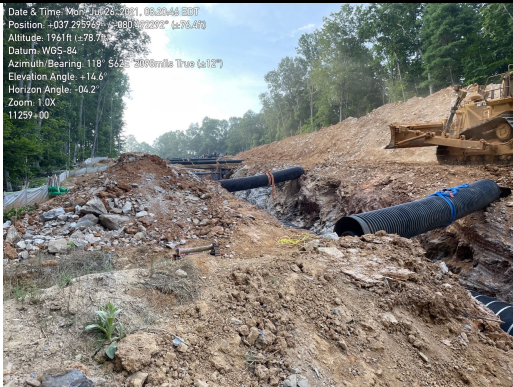
GPS Location		See photo				GPS Location		See photo			
Field Station#		11259+00				Field Station#		11264+50			
Pic 1 Desc.		Drainage pipe in place across ditch to allow water to reach sumps				Pic 2 Desc.		P1 silt fence perimeter control in place

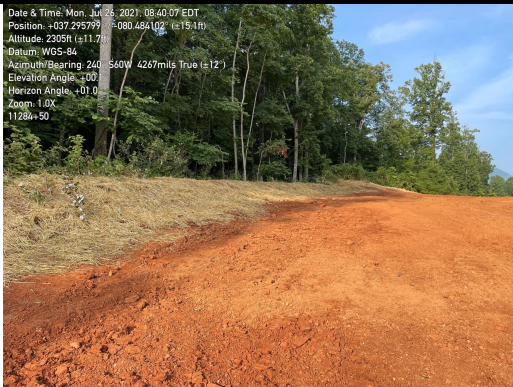
GPS Location		See photo				GPS Location		See photo			
Field Station#		11284+50				Field Station#		11317+25			
Pic 3 Desc.		CWD berm in place and stabilized				Pic 4 Desc.		Triple protection ECDs in place at karst feature

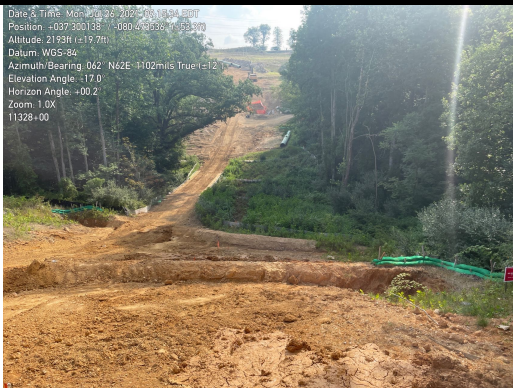
GPS Location		See photo				GPS Location		See photo			
Field Station#		11328+00				Field Station#		11371+00			
Pic 5 Desc.		Stream buffer in place				Pic 6 Desc.		Plunge pool in place

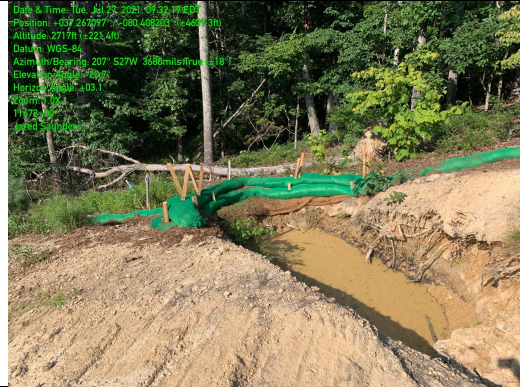
<p>Date & Time: Tue, Jul 27, 2021, 09:32:09 EDT Position: +037.215777° / -080.408231° (±448.9M) Altitude: 2217ft (±22.4M) Datum: WGS-84 Azimuth/Bearing: 207° S27W 368mils True (±10°) Elevation Angle: +00.0° Horizon Angle: +03.1° Zoom: 1.0x Pic 2 Desc.</p>			
GPS Location	See photo for GPS location.	GPS Location	See photo for GPS location.		
Field Station#	11788+00	Field Station#	11672+00		
Pic 1 Desc.	Rain gauge at Mount Tabor Road has a trace amount.	Pic 2 Desc.	Waterbar end treatment replaced.

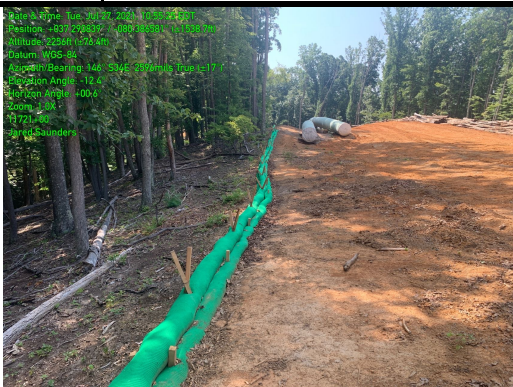
Field Station#	11721+00	Field Station#	11743+50		
Pic 5 Desc.	Perimeter control up graded to triple stack 12 inch CFS.	Pic 6 Desc.	Timber mat bridge being replaced.
