Visual Site Inspection Report

Project Name	H-600 Pipeline Spread G	AFE	124300137	Spread	H-600 Pipeline Spread G
Contractor	Precision			Report #	25410
Inspector	Patrick Shields			Date/Time	7/5/2021 5:48 PM
Permit #	TBD	Inspection Type	VA SWPP	Station Begin	11670+00
State	VA	Inspection Area	Full	Station End	11788+52
County	Montgomery	Ground	Dry	Temperature (°F)	80.00
Municipality	N/A	Weather	Sunny	Rain Gauge (in)	0.00
				Rain Accumulation Time (days)	1.00

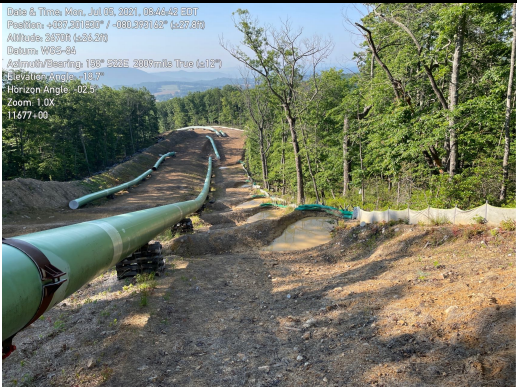
<p>Date & Time: Mon, Jul 05, 2021, 09:43:43 EDT Position: -057.295897, -080.382568 (-111.8th) Altitude: 2231ft (+9.8th) Datum: WGS-84 Azimuth/Bearing: 180° S20W 369mils True (+12°) Elevation Angle: -02.3° Horizon Angle: -02.3° Zoom: 1.0X 11677+00</p>

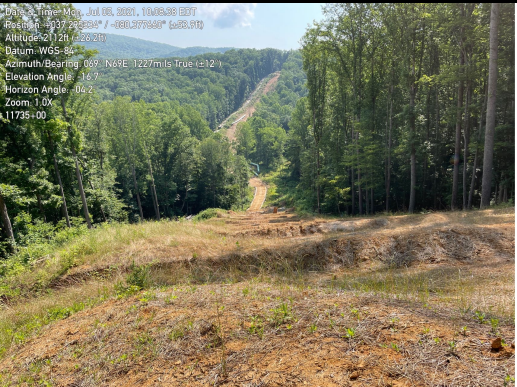
<p>Date & Time: Mon, Jul 05, 2021, 10:46:33 EDT Position: -057.295897, -080.376467 (-111.8th) Altitude: 2121ft (+9.8th) Datum: WGS-84 Azimuth/Bearing: 069° N40E 1227mils True (+12°) Elevation Angle: -16.7° Horizon Angle: -05.2° Zoom: 1.0X 11735+00</p>			
GPS Location	See photo		GPS Location	See photo	
Field Station#	11677+00		Field Station#	11735+00	
Pic 1 Desc.	End treatments in place		Pic 2 Desc.	Waterbars in place

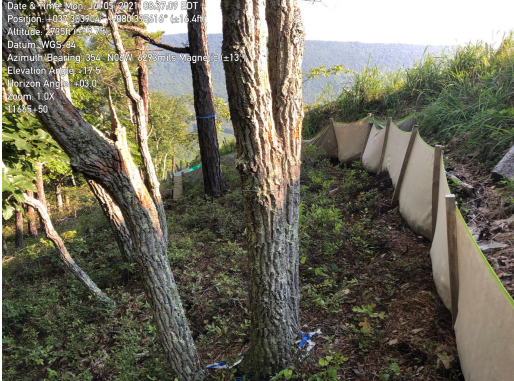
GPS Location	On photo	GPS Location	On photo		
Field Station#	11665+50	Field Station#	11662+00		
Pic 1 Desc.	Perimeter ECDs are in place.	Pic 2 Desc.	Slope breakers functional. ROW surface stable.

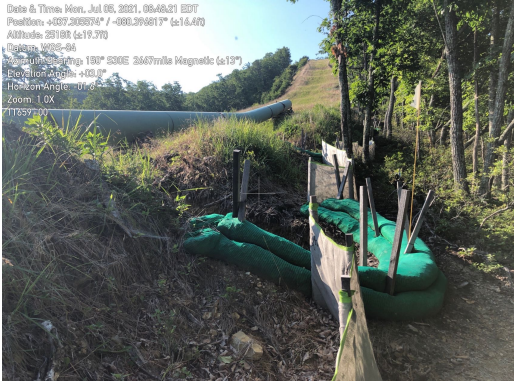
GPS Location	On photo	GPS Location	On photo		
Field Station#	11659+00	Field Station#	11653+25		
Pic 3 Desc.	Perimeter ECDs in place and functioning.	Pic 4 Desc.	Perimeter ECDs in place and functioning.

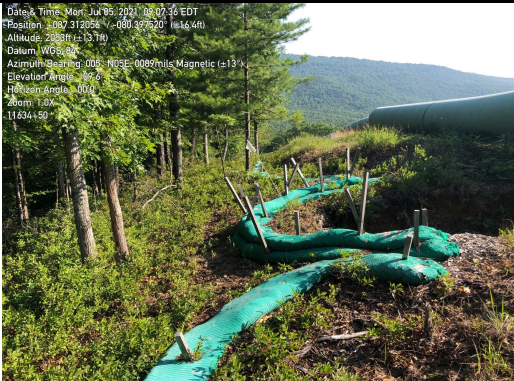
GPS Location	On photo	GPS Location	On photo		
Field Station#	11634+50	Field Station#	11627+00		
Pic 5 Desc.	Perimeter ECDs are functional.	Pic 6 Desc.	No sediment movement. Surface stable. Perimeter ECDs in place.

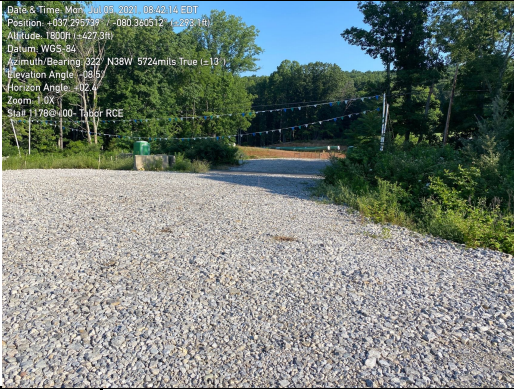
<p>Date & Time: Mon, Jul 05, 2021, 05:49:12 EDT Position: +037.29774° / +080.394512° (+095.14m) Altitude: 1800ft (+227.3m) Datum: WGS-84 Azimuth Bearing: 022° N38W 5724mils True (+13.1°) Elevation Angle: -19.5° Horizon Angle: +02.4° Zoom: 1.0X Sta# 11789+00: Level RCE</p>

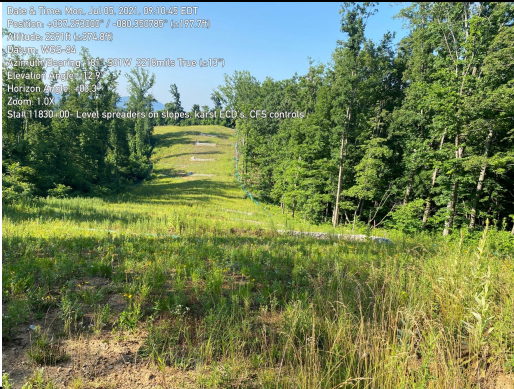
<p>Date & Time: Mon, Jul 05, 2021, 05:14:53 EDT Position: +037.29388° / +080.39859° (+155.2m) Altitude: 2071ft (+630.5m) Datum: WGS-84 Azimuth Bearing: 022° N38W 5514mils True (+12.7°) Elevation Angle: -11.2° Horizon Angle: +01.3° Zoom: 1.0X Sta# 11830+00: Level spreaders on slopes, karst ECD's, CFS controls</p>

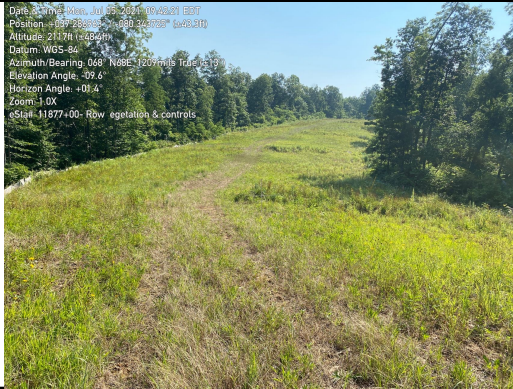
<p>Date & Time: Mon, Jul 05, 2021, 06:40:01 EDT Position: +037.29388° / +080.39789° (+155.2m) Altitude: 2174ft (+660m) Datum: WGS-84 Azimuth Bearing: 049° N86E 1207mils True (+10.7°) Elevation Angle: -39.4° Horizon Angle: +01.4° Zoom: 1.0X Sta# 11877+00: Row vegetation & controls</p>

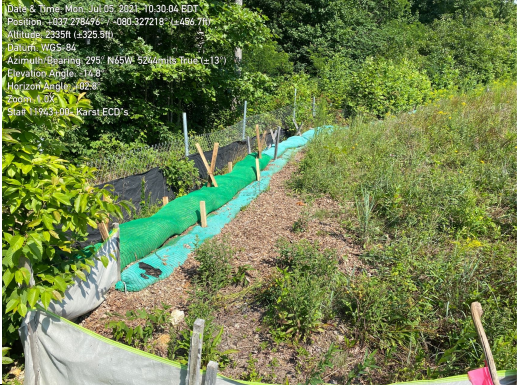
<p>Date & Time: Mon, Jul 05, 2021, 10:30:04 EDT Position: +037 278476° / -080 327218° (±486.7ft) Altitude: 2335ft (±325.5ft) Datum: WGS-84 Azimuth/Bearing: 298° N&W 5540mils True (±13°) Elevation Angle: -108° Horizon Angle: -023° Zoom: 1.0X Star: 11943+00: Karst ECD's</p>

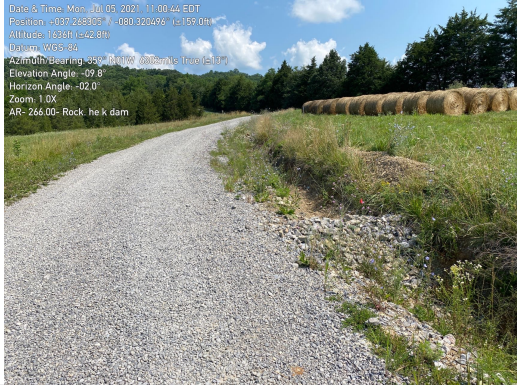
<p>Date & Time: Mon, Jul 05, 2021, 11:00:46 EDT Position: +037 279307° / -080 320496° (±145.6ft) Altitude: 1920ft (±325.5ft) Datum: WGS-84 Azimuth/Bearing: -049° N&W 5080mils True (±12°) Elevation Angle: -09.8° Horizon Angle: -02.0° Zoom: 1.0X AR-266.00- Rock check dam</p>

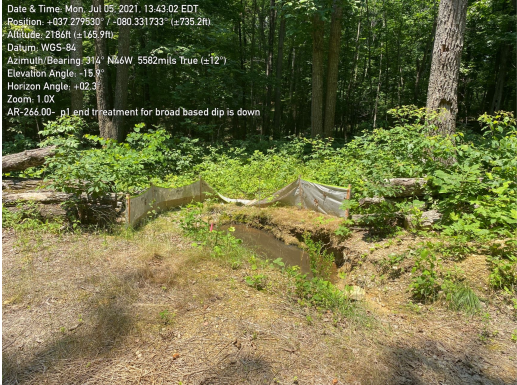
<p>Date & Time: Mon, Jul 05, 2021, 13:43:02 EDT Position: +037 279307° / -080 331733° (±735.2ft) Altitude: 2160ft (±325.5ft) Datum: WGS-84 Azimuth/Bearing: 314° N&W 5582mils True (±12°) Elevation Angle: -15.9° Horizon Angle: -02.3° Zoom: 1.0X AR-266.00- p1 and treatment for broad based dip is down</p>

E&S BMPs	Compliance Level	Corrective Action	Corrective Time Frame	Date Repaired
Broad-Based Dip	Communication	Clean out sediment from outlet protection	48 Hours	
Compost Filter Sock	Communication	Restake CFS end treatments at bro	48 Hours	
Rock Check Dam	Communication	Remove sediment	48 Hours	
Rock Construction Entrance	Acceptable			
Silt Fence (Filter Fabric Fence)	Communication	Replace damaged silt fence	48 Hours	
Silt Fence (Reinforced Filter Fabric Fence)	Acceptable			
Vegetative Stabilization (Permanent)	Acceptable			
Waterbar	Acceptable			
Waterbar Outlet Protection	Acceptable

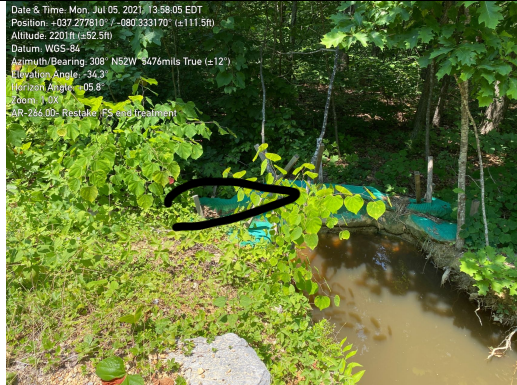
<p>Date & Time: Mon, Jul 05, 2021, 13:58:05 EDT Position: +037 277810° / -080 333170° (±111.5ft) Altitude: 2201ft (±325.5ft) Datum: WGS-84 Azimuth/Bearing: 308° N&W 5476mils True (±12°) Elevation Angle: -34.3° Horizon Angle: -05.8° Zoom: 1.0X AR-266.00- Restake P3 outlet protection</p>

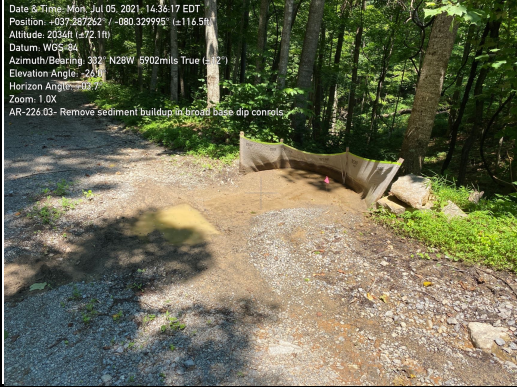
GPS Location	See photo GPS	GPS Location	See photo GPS		
Field Station#	11931+00	Field Station#	11931+00		
Pic 13 Desc.	AR-266.00- P1 controls have multiple holes in fabric. Item punch listed.	Pic 14 Desc.	AR-266.03- Multiple broad base dip outlet controls need sediment removed. Items added to the punch list.

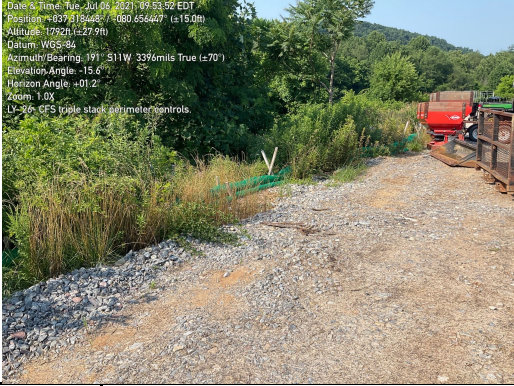
<p>Date & Time: Tue, Jul 06, 2021, 09:53:02 EDT Position: +037.318527° / -080.656407° (±15.0ft) Altitude: 1792ft (±27.0ft) Datum: WGS-84 Azimuth/Bearing: 191° S11W 3396mils True (±70°) Elevation Angle: -15.6° Horizon Angle: +01.2° Zoom: 1.0X LY-26- CFS triple stack perimeter controls.</p>

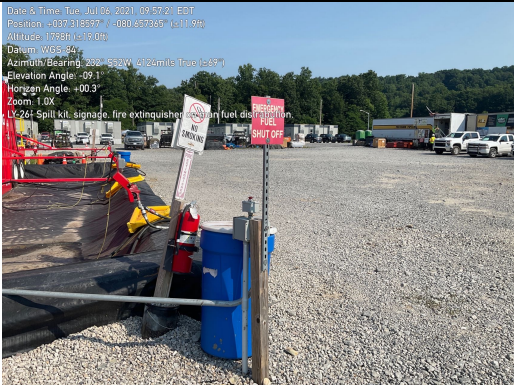
<p>Date & Time: Tue, Jul 06, 2021, 09:57:21 EDT Position: +037.318527° / -080.657367° (±11.5ft) Altitude: 1796ft (±3.0ft) Datum: WGS-84 Azimuth/Bearing: 230° S50W 4089mils True (±69°) Elevation Angle: -09.1° Horizon Angle: +00.3° Zoom: 1.0X LY-26- Spill kit, signage, fire extinguisher on main fuel distribution.</p>

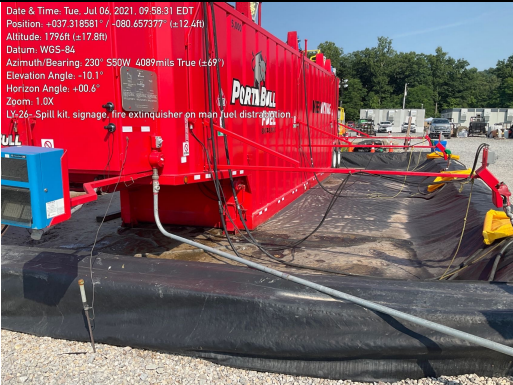
<p>Date & Time: Tue, Jul 06, 2021, 09:58:31 EDT Position: +037.318581° / -080.657377° (±12.4ft) Altitude: 1796ft (±17.8ft) Datum: WGS-84 Azimuth/Bearing: 230° S50W 4089mils True (±69°) Elevation Angle: -10.1° Horizon Angle: +00.6° Zoom: 1.0X LY-26- Spill kit, signage, fire extinguisher on main fuel distribution.</p>

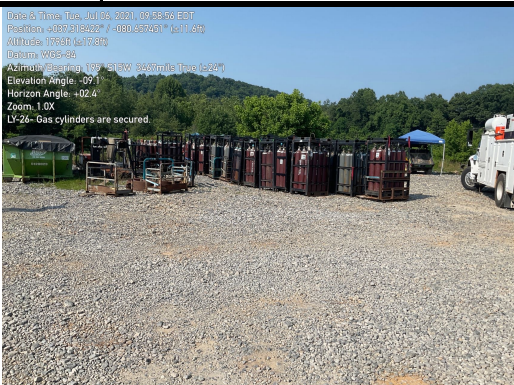
<p>Date & Time: Tue, Jul 06, 2021, 09:58:56 EDT Position: +037.318482° / -080.657454° (±11.2ft) Altitude: 1795ft (±6.4ft) Datum: WGS-84 Azimuth/Bearing: 199° S13W 3966mils True (±26°) Elevation Angle: -09.1° Horizon Angle: +02.4° Zoom: 1.0X LY-26- Gas cylinders are secured.</p>

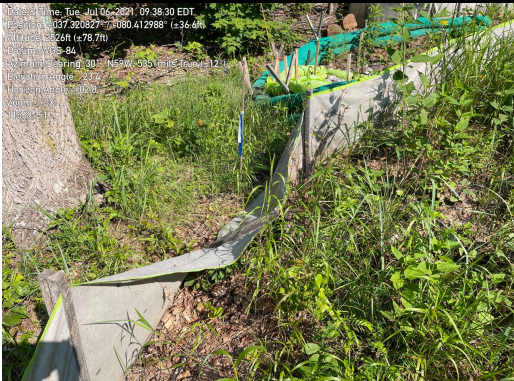
GPS Location	See photo	GPS Location	See photo		
Field Station#	11568+51	Field Station#	11599+50		
Pic 5 Desc.	P1 silt fence perimeter control damaged by wildlife	Pic 6 Desc.	RCE impeding roadway

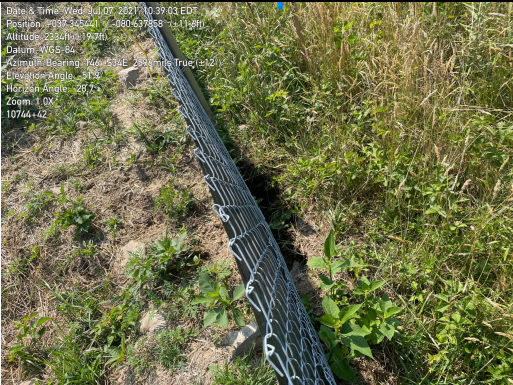
GPS Location	See photo	GPS Location	See photo		
Field Station#	10719+75	Field Station#	10744+42		
Pic 3 Desc.	Waterbar needs installed across travel lane	Pic 4 Desc.	Supersilt fence undermined

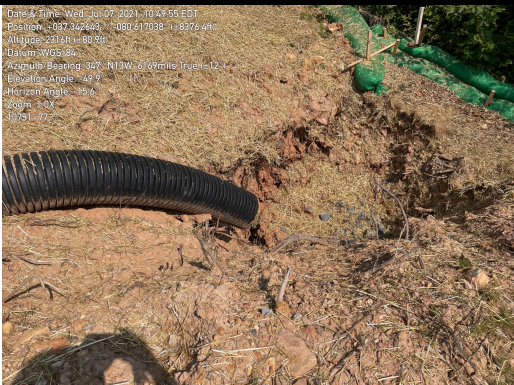
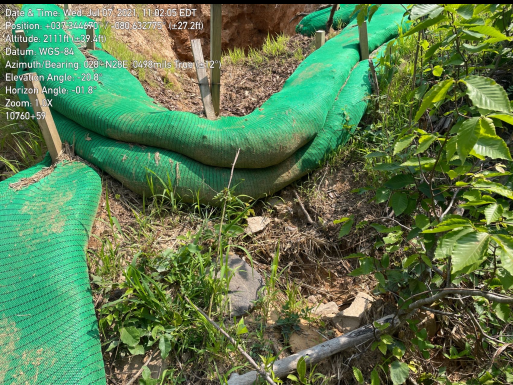
GPS Location	See photo	GPS Location	See photo		
Field Station#	10751+77	Field Station#	10760+59		
Pic 5 Desc.	Slope drain needs extended into sump pit	Pic 6 Desc.	Install erosion control blanket

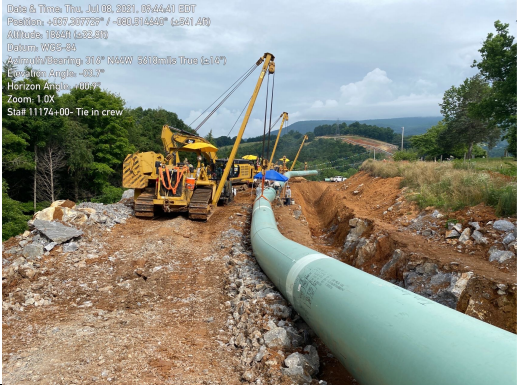
<p>Date & Time: Thu, Jul 08, 2021, 09:44:47 EDT Position: +037.37775° / -080.91444° (+541.47) Altitude: 1834ft (+52.81) Datum: WGS-84 Azimuth/Bearing: 113° 50'W 330mils True (+14°) Elevation Angle: -03.1° Horizon Angle: -00.7° Zoom: 1.0X Stail: 11174+00- Tie in crew</p>

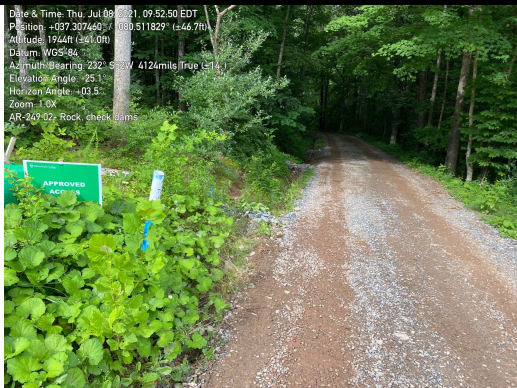
<p>Date & Time: Thu, Jul 08, 2021, 09:52:50 EDT Position: +037.37744° / -080.51182° (+546.71) Altitude: 1944ft (+59.01) Datum: WGS-84 Azimuth/Bearing: 232° S 0°W 412mils True (+14°) Elevation Angle: -25.1° Horizon Angle: -03.5° Zoom: 1.0X AR-249.02 Rock check dams</p>
