Visual Site Inspection Report

Project Name	H-600 Pipeline Spread G	AFE	124300137	Spread	H-600 Pipeline Spread G
Contractor	Precision			Report #	26691
Inspector	Jared Saunders			Date/Time	8/2/2021 5:24 PM
Permit #	TBD	Inspection Type	VA SWPP	Station Begin	11670+00
State	VA	Inspection Area	Partial	Station End	11788+52
County	Montgomery	Ground	Dry	Temperature (°F)	80.00
Municipality	N/A	Weather	Sunny	Rain Gauge (in)	0.00
				Rain Accumulation Time (days)	1.00

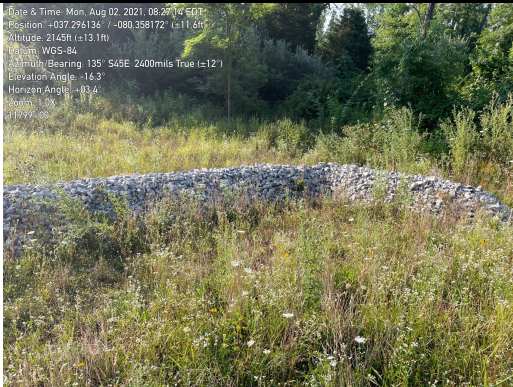
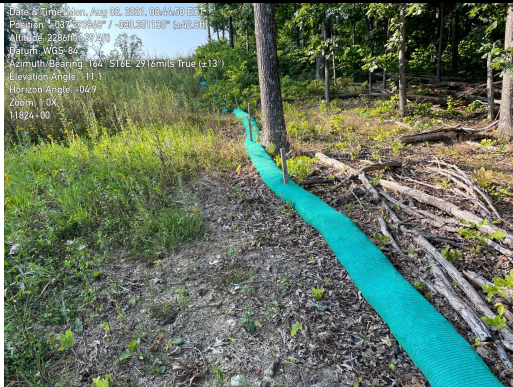
Date & Time: Mon, Aug 02, 2021, 08:29:14 EDT Position: +037.293134° / -080.358172° (±11.8m) Altitude: 2145ft (±13.1m) Datum: WGS-84 Azimuth/Bearing: 135° S45E 2400mils True (±12°) Elevation Angle: -16.3° Horizon Angle: -03.6° Zoom: 1.0X 11799+00				Date & Time: Mon, Aug 02, 2021, 08:44:50 EDT Position: +037.293134° / -080.358172° (±11.8m) Altitude: 2186ft (±13.1m) Datum: WGS-84 Azimuth/Bearing: 124° S16E 2916mils True (±13°) Elevation Angle: -11.1° Horizon Angle: -04.9° Zoom: 1.0X 11824+00											
GPS Location				See photo				GPS Location				See photo			
Field Station#				11799+00				Field Station#				11824+00			
Pic 1 Desc.				Level spreader in place				Pic 2 Desc.				CFS perimeter control in place

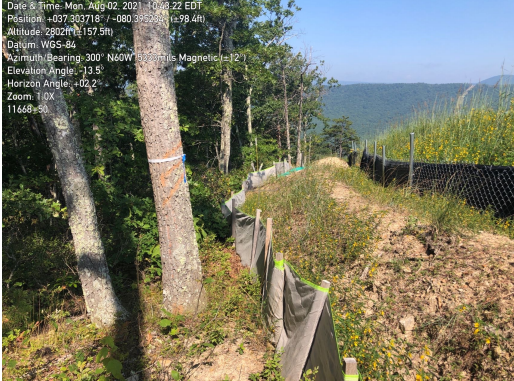
GPS Location	On photo	GPS Location	On photo		
Field Station#	11668+50	Field Station#	11665+50		
Pic 1 Desc.	Perimeter ECDs are in place.	Pic 2 Desc.	Sumps and end treatments are in place and effective.

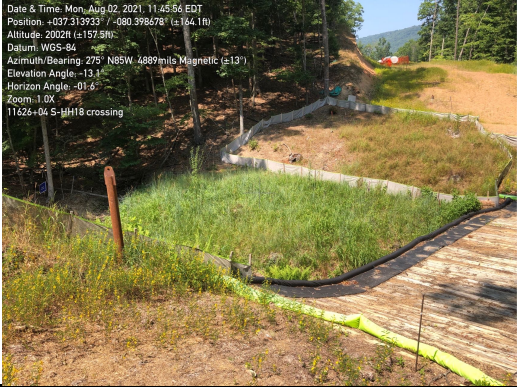
GPS Location	On photo	GPS Location	On photo		
Field Station#	11626+04	Field Station#	11614+20		
Pic 7 Desc.	The S-HH18 crossing is stable.	Pic 8 Desc.	The S-RR14 crossing is stable.		
<p>Date & Time: Mon, Aug 02, 2021, 11:56:38 EDT Position: +037.313528° / -080.405481° (±158.8ft) Altitude: 1929ft (±78.7ft) Datum: WGS-84 Azimuth/Bearing: 196° S16W 3484mils Magnetic (±13°) Elevation Angle: -05.9° Horizon Angle: -01.1° Zoom: 1.0X 11608+17 S-006 crossing</p>

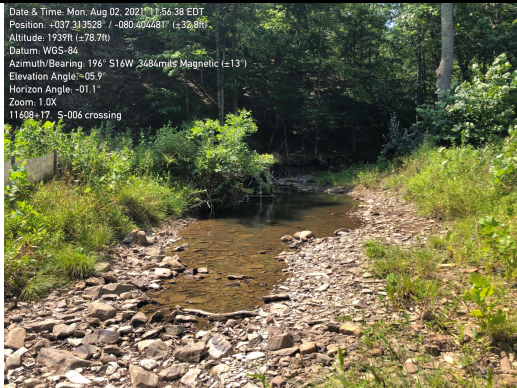
GPS Location	On photo	GPS Location	On photo		
Field Station#	11608+17	Field Station#	11607+00		
Pic 9 Desc.	The S-006 crossing is stable.	Pic 10 Desc.	ROW currently stable.		
<p>Date & Time: Mon, Aug 02, 2021, 11:10:28 EDT Position: +037.306993° / -080.397321° (±161.4ft) Altitude: 2376ft (±19.7ft) Datum: WGS-84 Azimuth/Bearing: 12° S88E 1891mils Magnetic (±12°) Elevation Angle: -02.2° Horizon Angle: -05.4° Zoom: 4.0X</p>

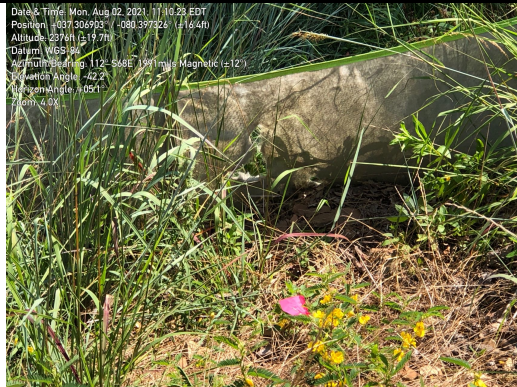
<p style="text-align: center;">Insert image here</p>			
GPS Location	On photo	GPS Location			
Field Station#	11653+30	Field Station#			
Pic 11 Desc.	Example photo of P1 to be replaced.	Pic 12 Desc.

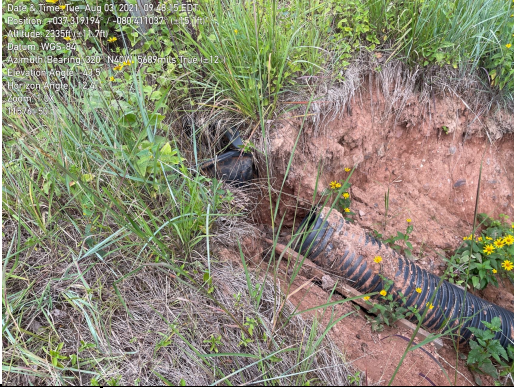
E&S BMPs	Compliance Level	Corrective Action	Corrective Time Frame	Date Repaired
Slope Drain Pipe	Communication	See comments		
Compost Filter Sock	Acceptable			
Culvert	Acceptable			
Equipment Bridge	Acceptable			
Sensitive Resource Buffer	Acceptable			
Silt Fence (Filter Fabric Fence)	Acceptable			
Silt Fence (Reinforce Filter Fence)	Acceptable			
Rock Construction Entrance	Acceptable			
Housekeeping	Acceptable

GPS Location	See photo	GPS Location	See photo		
Field Station#	11576+50	Field Station#	11585+00		
Pic 1 Desc.	Slope drain pipe needs reattached to inlet	Pic 2 Desc.	Stream buffer in place

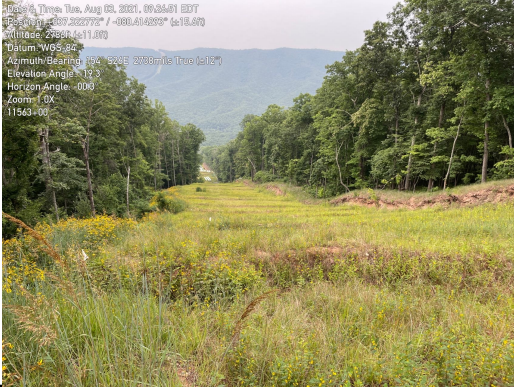
GPS Location	See photo	GPS Location	See photo		
Field Station#	11563+00	Field Station#	11535+00		
Pic 3 Desc.	Waterbars in place	Pic 4 Desc.	Temporary CFS waterbars in place

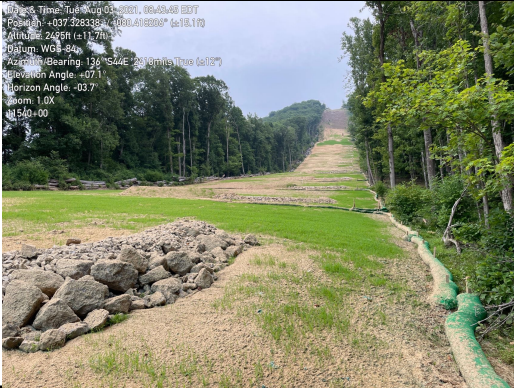
GPS Location	See photo	GPS Location	See photo		
Field Station#	11540+00	Field Station#	11548+00		
Pic 5 Desc.	CFS perimeter control in place	Pic 6 Desc.	Permanent waterbars with level spreaders in place

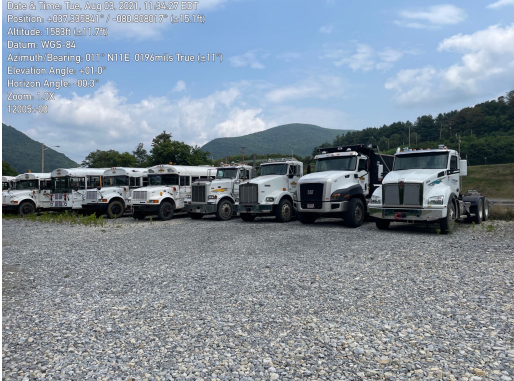
GPS Location	See photo	GPS Location	See photo		
Field Station#	12005+00	Field Station#	12005+00		
Pic 1 Desc.	Vehicles not in use being stored at yard	Pic 2 Desc.	RCE in place

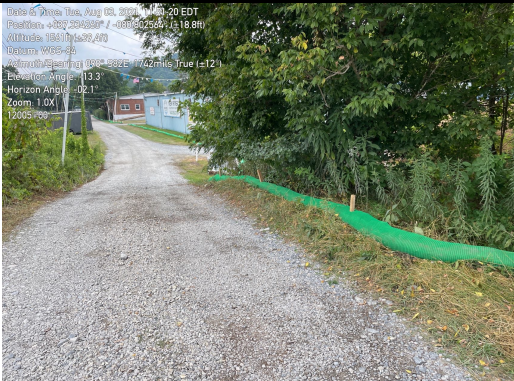
GPS Location	See photo	GPS Location	See photo		
Field Station#	12005+00	Field Station#	12005+00		
Pic 5 Desc.	CFS perimeter controls in place	Pic 6 Desc.	Rock surface in acceptable condition

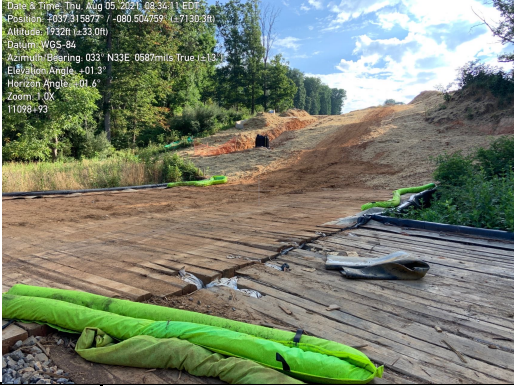
GPS Location	See photo	GPS Location	See photo		
Field Station#	11098+93	Field Station#	11107+00		
Pic 1 Desc.	New straw waddles at equipment bridge	Pic 2 Desc.	Clean water diversion berm functional

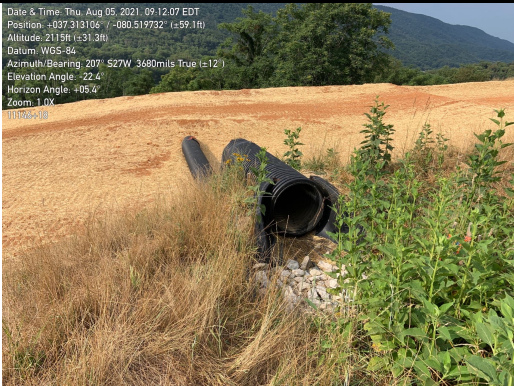
GPS Location	See photo	GPS Location	See photo		
Field Station#	11146+18	Field Station#	11171+00		
Pic 5 Desc.	Clean water diversion pipe and inlet functional	Pic 6 Desc.	Stone inlet protection needs maintenance

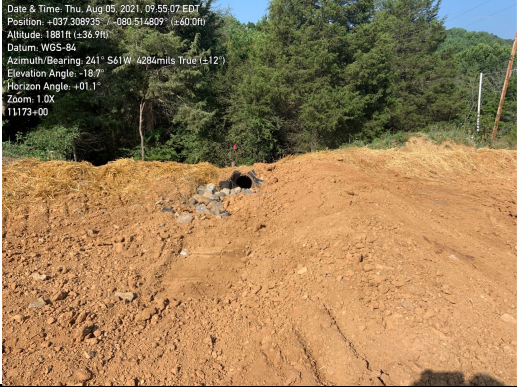
GPS Location	See photo	GPS Location	See photo		
Field Station#	11173+00	Field Station#	11174+65		
Pic 7 Desc.	Stone inlet protection needs maintenance	Pic 8 Desc.	Stone inlet protection needs maintenance		
<p>Date & Time: Thu, Aug 05, 2021, 10:31:02 EDT Position: +037.310212° / -080.504389° (±66.71 ft) Altitude: 1741ft (±36.0ft) Datum: WGS-84 Azimuth/Bearing: 116° S64E 2062mils True (±12°) Elevation Angle: -15.2° Horizon Angle: +01.3° Zoom: 1.0X 11191+00</p>

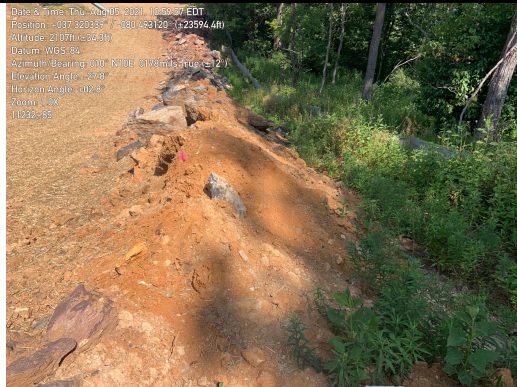
GPS Location	See photo	GPS Location	See photo		
Field Station#	11232+85	Field Station#	11248+50		
Pic 11 Desc.	Subsoil needs over seeded and stabilized	Pic 12 Desc.	Subsoil needs over seeded and stabilized

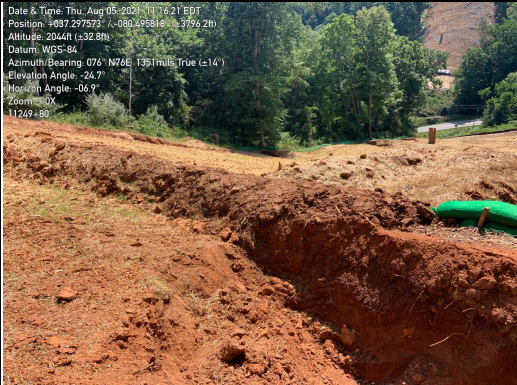
GPS Location	See photo		GPS Location	See photo	
Field Station#	11249+80		Field Station#	11250+50	
Pic 13 Desc.	Subsoil needs over seeded and stabilized		Pic 14 Desc.	Stabilization adequate

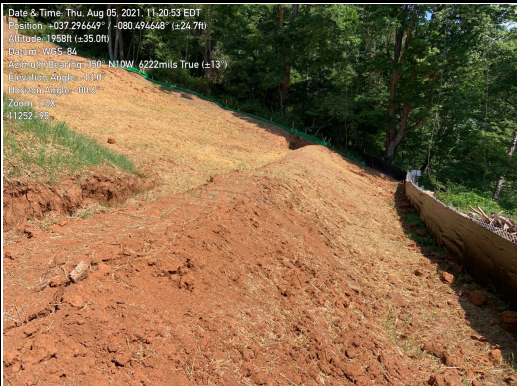
GPS Location	See photo		GPS Location	See photo	
Field Station#	11252+95		Field Station#	11246+10	
Pic 15 Desc.	Top and back of water bar needs seeded and stabilized		Pic 16 Desc.	Subsoil needs over seeded and stabilized

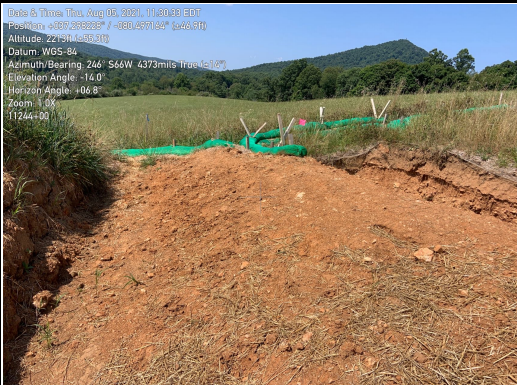
<div>Insert image here</div>			
GPS Location	See photo		GPS Location		
Field Station#	11244+00		Field Station#		
Pic 17 Desc.	Back side of water bar needs seeded and stabilized		Pic 18 Desc.

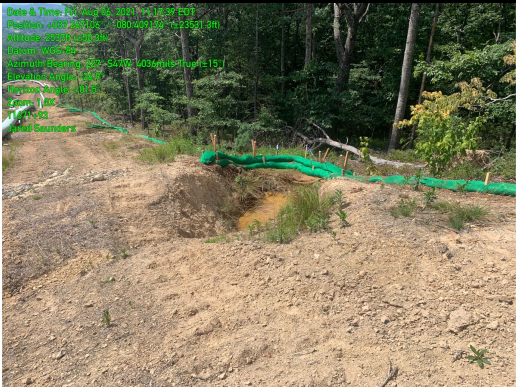
GPS Location	See photo for GPS location.		GPS Location	See photo for GPS location.	
Field Station#	11671+93		Field Station#	11687+40	
Pic 1 Desc.	Waterbar, sump pit, and end treatment in place.		Pic 2 Desc.	Sensitive resource buffer in place at stream S-MN21.

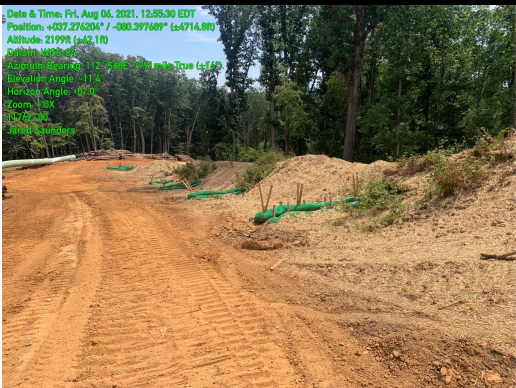
GPS Location	See photo for GPS location.		GPS Location	See photo for GPS location.	
Field Station#	11762+00		Field Station#	11764+00	
Pic 5 Desc.	CFS checks in place.		Pic 6 Desc.	Super silt fence replaced along LOD.
