# Visual Site Inspection Report

<b>Project Name</b>	H-600 Pipeline Spread G	<b>AFE</b>	124300137	<b>Spread</b>	H-600 Pipeline Spread G
<b>Contractor</b>	Precision			<b>Report #</b>	26968
<b>Inspector</b>	Patrick Shields			<b>Date/Time</b>	8/9/2021 6:18 PM
<b>Permit #</b>	TBD	<b>Inspection Type</b>	VA SWPP	<b>Station Begin</b>	12005+00
<b>State</b>	VA	<b>Inspection Area</b>	Full	<b>Station End</b>	12005+00
<b>County</b>	Giles	<b>Ground</b>	Dry	<b>Temperature (°F)</b>	85.00
<b>Municipality</b>	N/A	<b>Weather</b>	Sunny	<b>Rain Gauge (in)</b>	0.00
				<b>Rain Accumulation Time (days)</b>	1.00

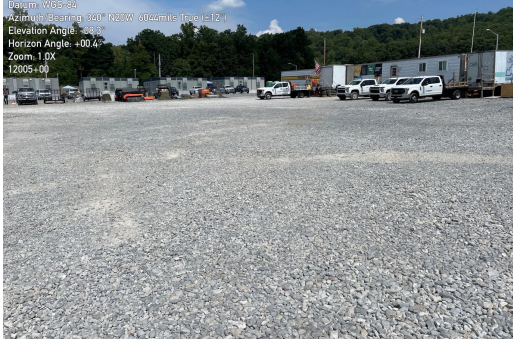
GPS Location				See photo				GPS Location				See photo			
Field Station#				12005+00				Field Station#				12005+00			
Pic 1 Desc.				Rock surface in acceptable condition				Pic 2 Desc.				Secondary containments in place			
<p>Date &amp; Time: Mon, Aug 09, 2021, 12:12:33 EDT Position: +037.318672 / -080.658544 (+15.1m) Altitude: 1790m (+11.7m) Datum: WGS-84 Azimuth/Bearing: 293° N67W 5209mils True (+12.1) Elevation Angle: -14.5° Horizon Angle: +05.3° Zoom: 1.0x 12005+00</p>

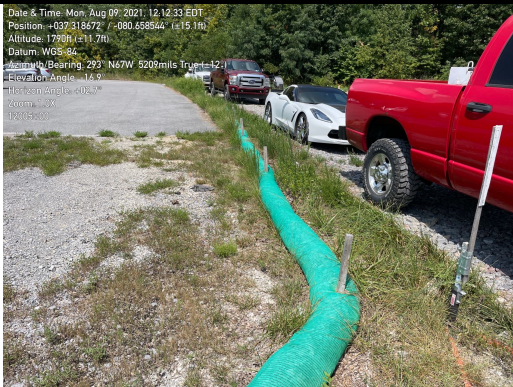
GPS Location				See photo				GPS Location				See photo			
Field Station#				12005+00				Field Station#				12005+00			
Pic 3 Desc.				CFS perimeter control in place				Pic 4 Desc.				Secondary containment in place			
<p>Date &amp; Time: Mon, Aug 09, 2021, 12:11:55 EDT Position: +037.317833 / -080.659232 (+15.5m) Altitude: 1844m (+13.1m) Datum: WGS-84 Azimuth/Bearing: 318° N42W 5653mils True (+12.1) Elevation Angle: +01.8° Horizon Angle: +01.0° Zoom: 1.0x 12005+00</p>

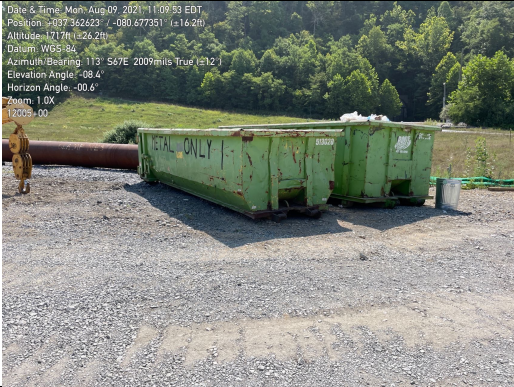
<b>GPS Location</b>	See photo	<b>GPS Location</b>	See photo		
<b>Field Station#</b>	12005+00	<b>Field Station#</b>	12005+00		
<b>Pic 1 Desc.</b>	Dumpsters in place	<b>Pic 2 Desc.</b>	Secondary containment in place

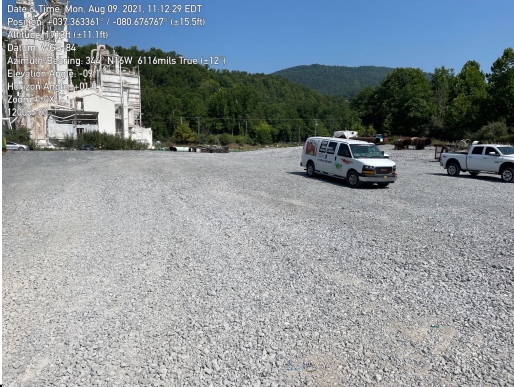
<b>GPS Location</b>	See photo	<b>GPS Location</b>	See photo		
<b>Field Station#</b>	12005+00	<b>Field Station#</b>	12005+00		
<b>Pic 3 Desc.</b>	Rock surface in acceptable condition	<b>Pic 4 Desc.</b>	Culvert in place

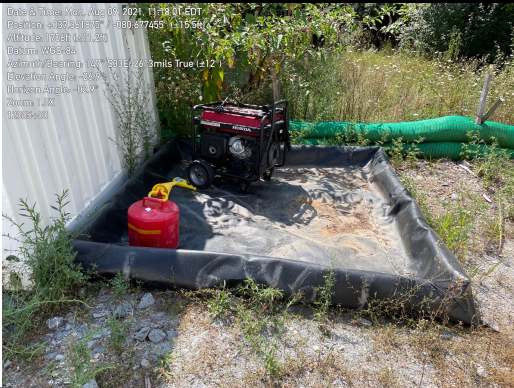
<b>GPS Location</b>	See photo	<b>GPS Location</b>	See photo		
<b>Field Station#</b>	12005+00	<b>Field Station#</b>	12005+00		
<b>Pic 5 Desc.</b>	Secondary containment in place	<b>Pic 6 Desc.</b>	Triple stack CFS perimeter control in place

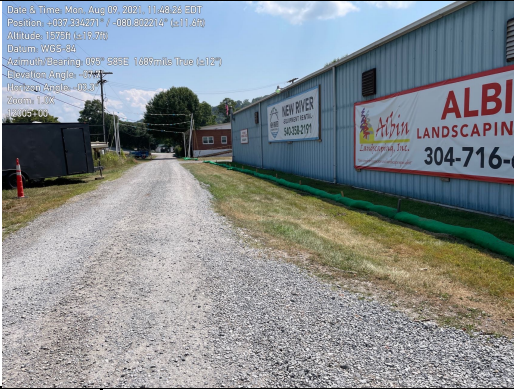
<b>GPS Location</b>	See photo		<b>GPS Location</b>	See photo	
<b>Field Station#</b>	12005+00		<b>Field Station#</b>	12005+00	
<b>Pic 1 Desc.</b>	CFS perimeter control in place		<b>Pic 2 Desc.</b>	Dumpsters in place

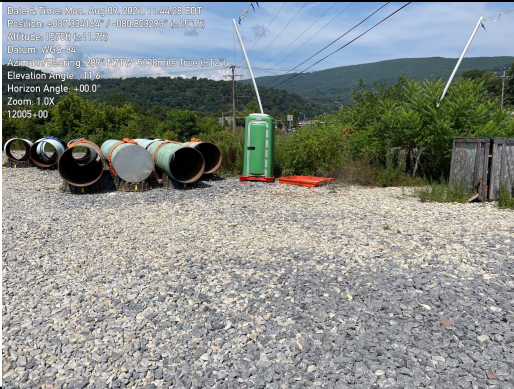
<b>GPS Location</b>	See photo		<b>GPS Location</b>	See photo	
<b>Field Station#</b>	12005+00		<b>Field Station#</b>	12005+00	
<b>Pic 3 Desc.</b>	Secondary containment in place		<b>Pic 4 Desc.</b>	Rock surface in acceptable condition

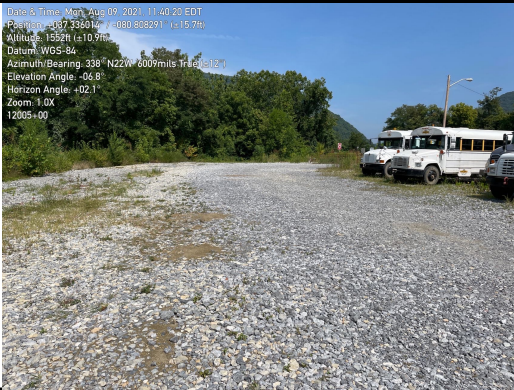
<b>GPS Location</b>	See photo		<b>GPS Location</b>	See photo	
<b>Field Station#</b>	12005+00		<b>Field Station#</b>	12005+00	
<b>Pic 5 Desc.</b>	RCE in place		<b>Pic 6 Desc.</b>	Vehicles being stored at this portion of the yard

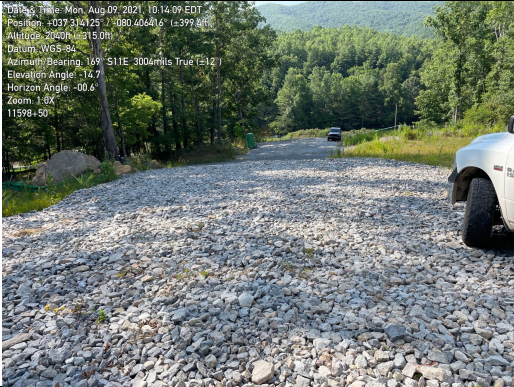
<b>GPS Location</b>	See photo	<b>GPS Location</b>	See photo		
<b>Field Station#</b>	11598+50	<b>Field Station#</b>	11592+00		
<b>Pic 1 Desc.</b>	RCE in place	<b>Pic 2 Desc.</b>	P1 silt fence perimeter control

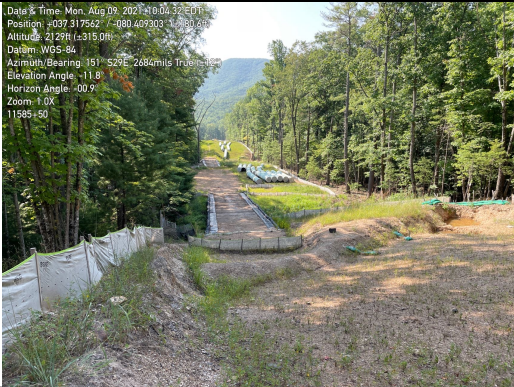
<b>GPS Location</b>	See photo	<b>GPS Location</b>	See photo		
<b>Field Station#</b>	11585+50	<b>Field Station#</b>	11583+50		
<b>Pic 3 Desc.</b>	Stream buffer in place	<b>Pic 4 Desc.</b>	P1 silt fence perimeter control in place

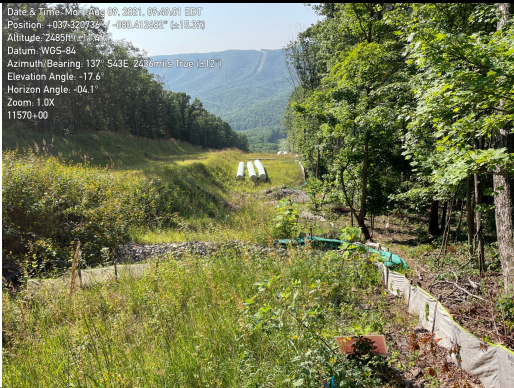
<b>GPS Location</b>	See photo	<b>GPS Location</b>	See photo		
<b>Field Station#</b>	11570+00	<b>Field Station#</b>	11563+00		
<b>Pic 5 Desc.</b>	ECDs in place	<b>Pic 6 Desc.</b>	Waterbars in place

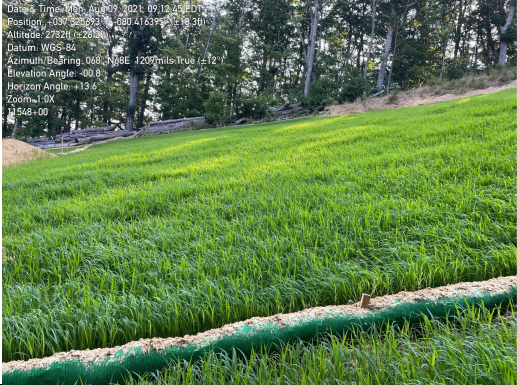
<b>GPS Location</b>		See photo		<b>GPS Location</b>	
<b>Field Station#</b>		11548+00		<b>Field Station#</b>	
<b>Pic 7 Desc.</b>		Good vegetation on ROW		<b>Pic 8 Desc.</b>	
				CFS perimeter controls in place

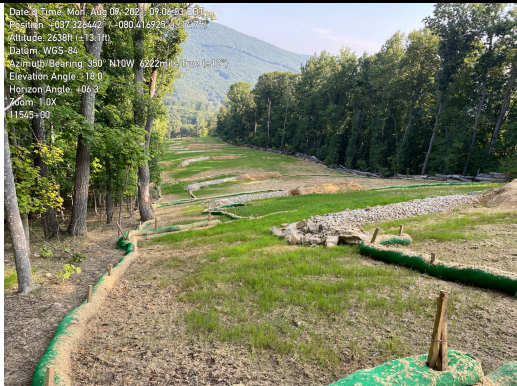
<b>GPS Location</b>		See photo		<b>GPS Location</b>	
<b>Field Station#</b>		11545+00		<b>Field Station#</b>	
<b>Pic 9 Desc.</b>		Level spreaders in place		<b>Pic 10 Desc.</b>	
				Permanent waterbars in place

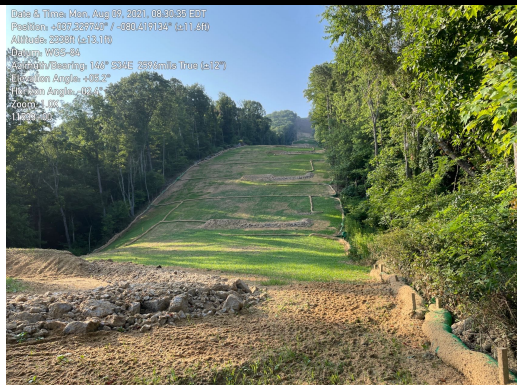
<b>GPS Location</b>		See photo		<b>GPS Location</b>	
<b>Field Station#</b>		11533+00		<b>Field Station#</b>	
<b>Pic 11 Desc.</b>		Temporary CFS waterbars in place		<b>Pic 12 Desc.</b>	
				Drainage feature restored

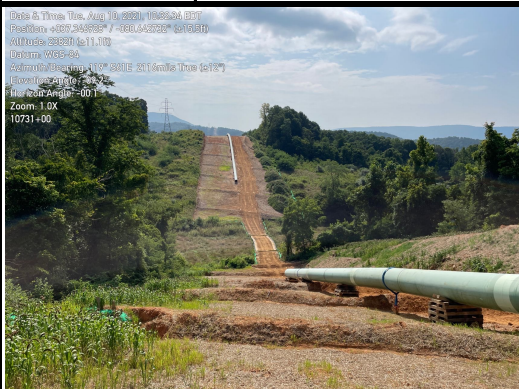
GPS Location	See photo		GPS Location	See photo	
Field Station#	10741+50		Field Station#	10731+00	
Pic 11 Desc.	Clean water diversion berm in place		Pic 12 Desc.	Waterbars in place

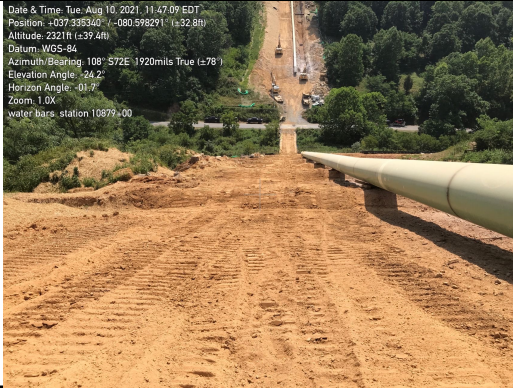
<p>Date &amp; Time: Tue, Aug 10, 2021, 11:47:09 EDT Position: +037.335342° / -080.598291° (+32.8ft) Altitude: 2321ft (+39.4ft) Datum: WGS-84 Azimuth/Bearing: 108° S72E 1920mils True (+78°) Elevation Angle: -24.2° Horizon Angle: -01.7° Zoom: 1.0X water bars station 10879+00</p>				 				<p>Date &amp; Time: Tue, Aug 10, 2021, 11:34:54 EDT Position: +037.337034° / -080.603124° (+32.8ft) Altitude: 2321ft (+39.4ft) Datum: WGS-84 Azimuth/Bearing: 143° S37E 2542mils True (+66°) Elevation Angle: -03.1° Horizon Angle: -00.9° Zoom: 1.0X diversion pipe station 10863+58</p>			
GPS Location		see photo				GPS Location		see photo							
Field Station#		10879+00				Field Station#		10863+58							
Pic 5 Desc.		Water bars				Pic 6 Desc.		Diversion pipe.

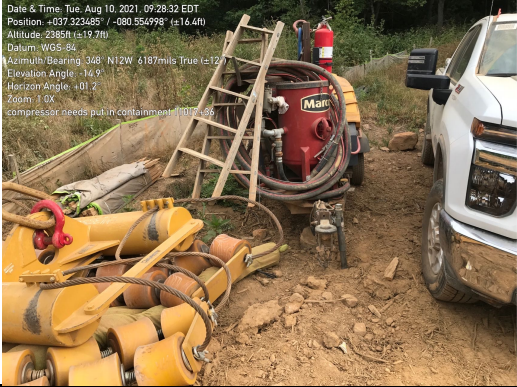
<b>GPS Location</b>	See photo	<b>GPS Location</b>	see photo		
<b>Field Station#</b>	11017+36	<b>Field Station#</b>	11017+36		
<b>Pic 7 Desc.</b>	Bridge needs cleaned	<b>Pic 8 Desc.</b>	Compressor needs containment

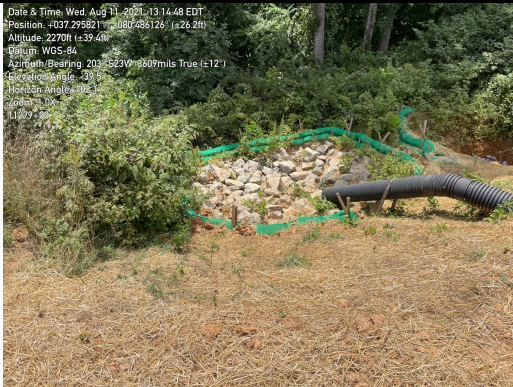
<p>Date &amp; Time: Wed Aug 11, 2021 13:14:48 EDT Position: +037 295231 / -080 485128 / +26.20 Altitude: 2220ft (+39.4ft) Datum: WGS-84 Azimuth/Bearing: 203° 52'30" 9509mils True (+12°) Elevation Angle: -33° Horizon Angle: -03.6° Zoom: 1.0X 11279+00</p>				<p>Date &amp; Time: Wed Aug 11, 2021 13:08:20 EDT Position: +037 295231 / -080 483758 / +26.20 Altitude: 2220ft (+39.4ft) Datum: WGS-84 Azimuth/Bearing: 000° N/AE 1036mils True (+12°) Elevation Angle: -25.6° Horizon Angle: -03.6° Zoom: 1.0X 11285+00</p>											
<b>GPS Location</b>				See photo				<b>GPS Location</b>				See photo			
<b>Field Station#</b>				11279+00				<b>Field Station#</b>				11285+00			
<b>Pic 1 Desc.</b>				Remove dirt clods from plunge pool				<b>Pic 2 Desc.</b>				Remove old CFS

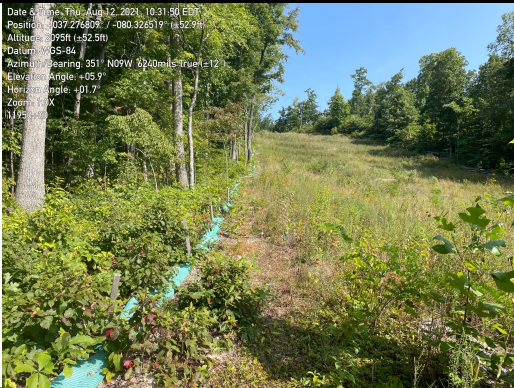
<b>GPS Location</b>	See photo	<b>GPS Location</b>	See photo		
<b>Field Station#</b>	11950+00	<b>Field Station#</b>	11982+00		
<b>Pic 5 Desc.</b>	CFS perimeter control in place	<b>Pic 6 Desc.</b>	P1 silt fence perimeter control in place

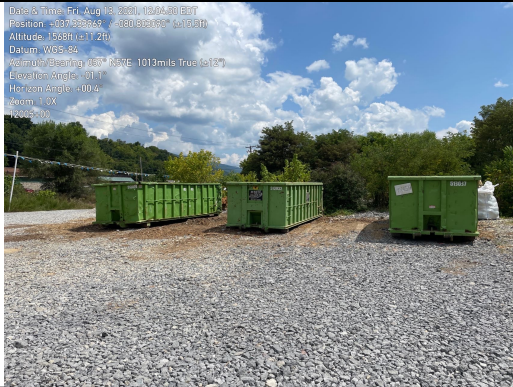
<b>GPS Location</b>		See photo		<b>GPS Location</b>	
<b>Field Station#</b>		12005+00		<b>Field Station#</b>	
<b>Pic 3 Desc.</b>		Rock surface in acceptable condition		<b>Pic 4 Desc.</b>	
<p>Date &amp; Time: Fri Aug 13, 2021 12:05:52 EDT Position: +037.333845° / -080.808190° (-0.0011°) Altitude: 1568ft (+11.2ft) Datum: WGS 84 Azimuth Bearing: 070° N70E 1702mils True (+12.4°) Elevation Angle: +01.1° Horizon Angle: +00.0° Zoom: 1.0X 12005+00</p>

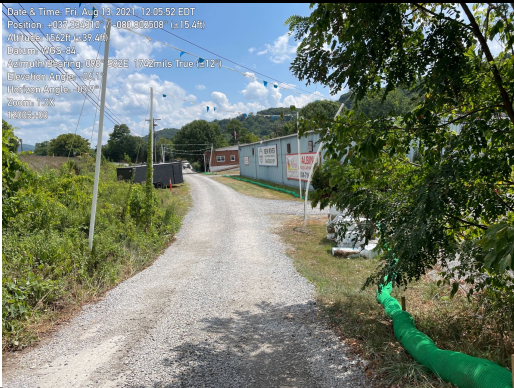
<b>GPS Location</b>		See photo		<b>GPS Location</b>	
<b>Field Station#</b>		12005+00		<b>Field Station#</b>	
<b>Pic 5 Desc.</b>		CFS perimeter control in place		<b>Pic 6 Desc.</b>	
				Secondary containment in place
