# Visual Site Inspection Report

<b>Project Name</b>	H-600 Pipeline Spread G	<b>AFE</b>	124300137	<b>Spread</b>	H-600 Pipeline Spread G
<b>Contractor</b>	Precision			<b>Report #</b>	27289
<b>Inspector</b>	Patrick Shields			<b>Date/Time</b>	8/16/2021 5:54 PM
<b>Permit #</b>	TBD	<b>Inspection Type</b>	VA SWPP	<b>Station Begin</b>	10655+00
<b>State</b>	VA	<b>Inspection Area</b>	Full	<b>Station End</b>	10859+34
<b>County</b>	Giles	<b>Ground</b>	Wet	<b>Temperature (°F)</b>	75.00
<b>Municipality</b>	N/A	<b>Weather</b>	Light Rain	<b>Rain Gauge (in)</b>	1.50
				<b>Rain Accumulation Time (days)</b>	1.00

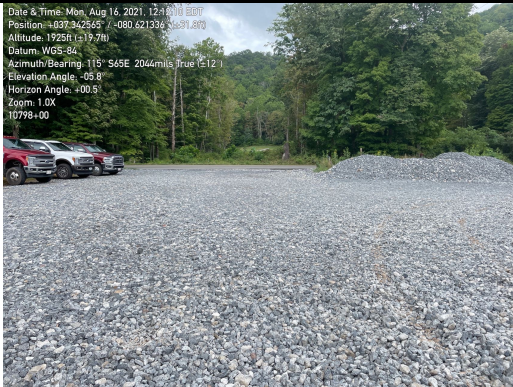
GPS Location		See photo				GPS Location		See photo			
Field Station#		10798+00				Field Station#		10792+00			
Pic 1 Desc.		RCE in place				Pic 2 Desc.		CWD outlet protection in place

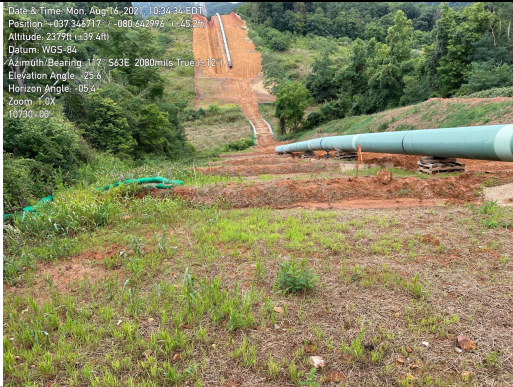
GPS Location		See photo				GPS Location		See photo			
Field Station#		10730+00				Field Station#		10704+00			
Pic 3 Desc.		Waterbars in place				Pic 4 Desc.		End treatments in place

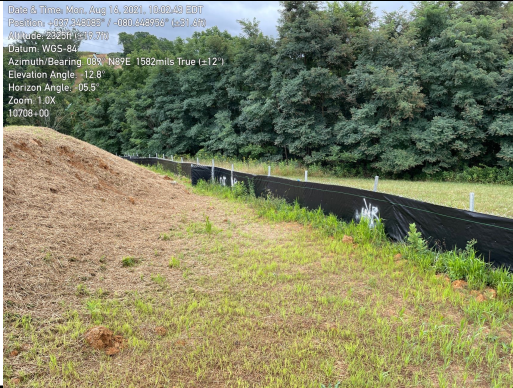
GPS Location		See photo				GPS Location		See photo			
Field Station#		10708+00				Field Station#		10658+75			
Pic 5 Desc.		Supersilt fence perimeter control in place				Pic 6 Desc.		CFS perimeter control in place

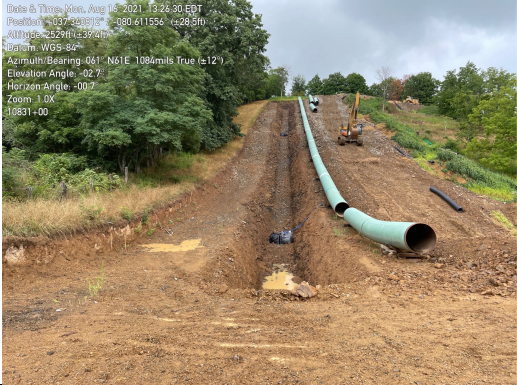
<b>GPS Location</b>	See photo	<b>GPS Location</b>	See photo		
<b>Field Station#</b>	10758+50	<b>Field Station#</b>	10831+00		
<b>Pic 7 Desc.</b>	Stream buffer in place	<b>Pic 8 Desc.</b>	Install end treatment at base of ditch

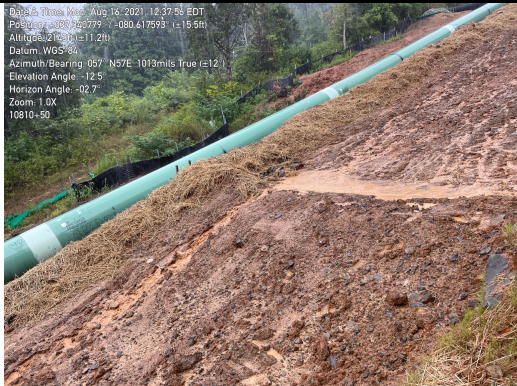
<b>GPS Location</b>	See photo	<b>GPS Location</b>	See photo		
<b>Field Station#</b>	10810+50	<b>Field Station#</b>	10718+80		
<b>Pic 9 Desc.</b>	Waterbar overtopped	<b>Pic 10 Desc.</b>	End treatment needs cleaned off

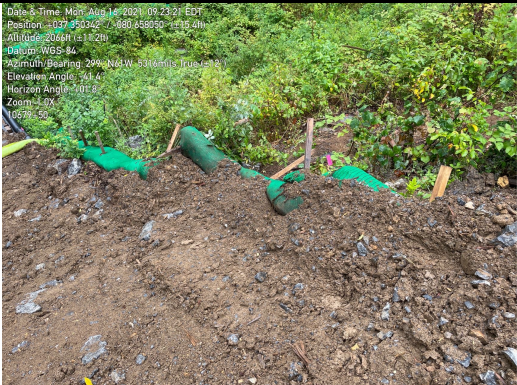
<b>GPS Location</b>	See photo	<b>GPS Location</b>	See photo		
<b>Field Station#</b>	10664+56	<b>Field Station#</b>	10679+50		
<b>Pic 11 Desc.</b>	Slope drain is clogged with sediment	<b>Pic 12 Desc.</b>	Reinstall and clean off CFS

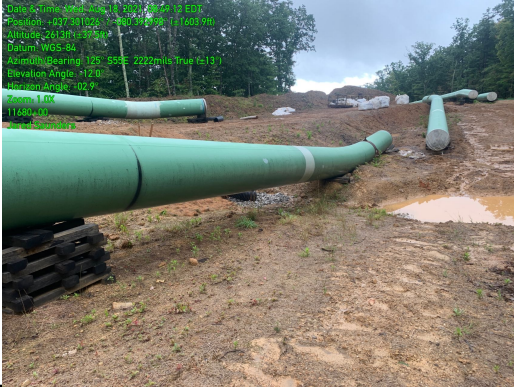
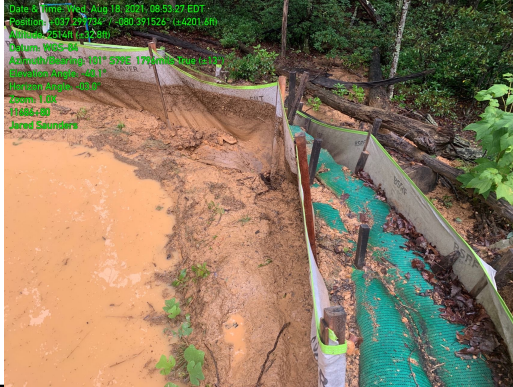
<b>GPS Location</b>	See photo for GPS location.		<b>GPS Location</b>	See photo for GPS location.	
<b>Field Station#</b>	11680+00		<b>Field Station#</b>	11686+80	
<b>Pic 3 Desc.</b>	Rock outlet in place at slope drain over two-tone.		<b>Pic 4 Desc.</b>	Priority one silt fence undermined.

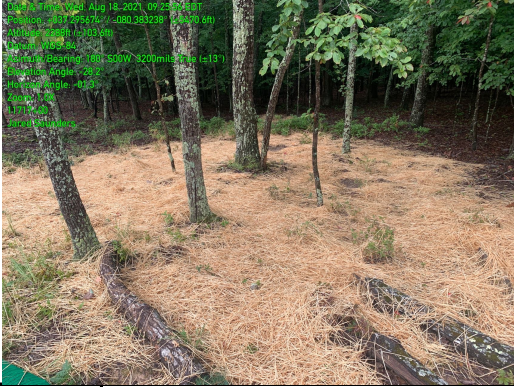
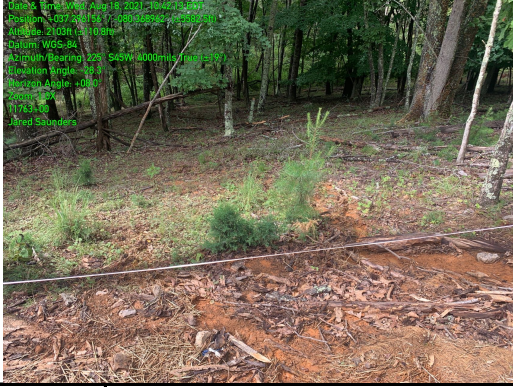
<b>GPS Location</b>	See photo for GPS location.		<b>GPS Location</b>	See photo for GPS location.	
<b>Field Station#</b>	11717+00		<b>Field Station#</b>	11763+00	
<b>Pic 5 Desc.</b>	Off ROW sediment recovered. Area stabilized with seed and mulch.		<b>Pic 6 Desc.</b>	Off ROW sediment located during inspection.

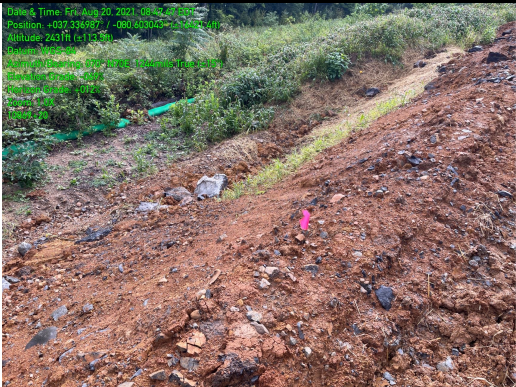
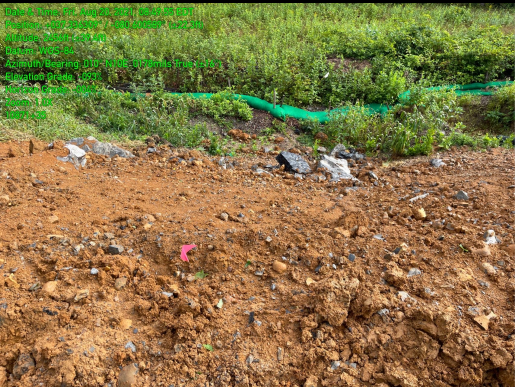
<p>Date &amp; Time: Fri Aug 20, 2021, 5:08:23 EDT Position: 43.323349° / -80.590634° (±15.5m) Altitude: 2631ft (±12.5m) Datum: WGS 84 Azimuth: 150.00° (±0.00°) Heading: 150.00° (±0.00°) Magnetic: 150.00° (±0.00°) True: 150.00° (±0.00°)</p>	
GPS Location	See Photo		GPS Location	See Photo	
Field Station#	10869+20		Field Station#	10871+35	
Pic 1 Desc.	Temporary stabilization of fill slope needed		Pic 2 Desc.	Temporary stabilization of fill slope needed

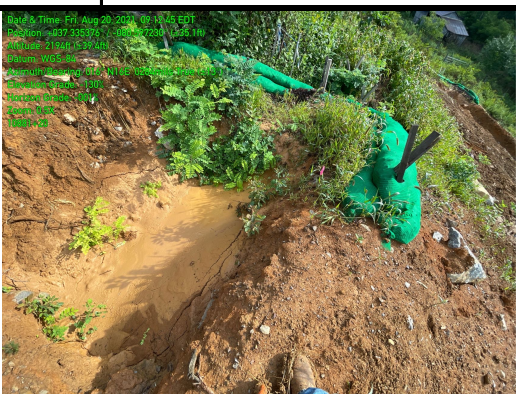
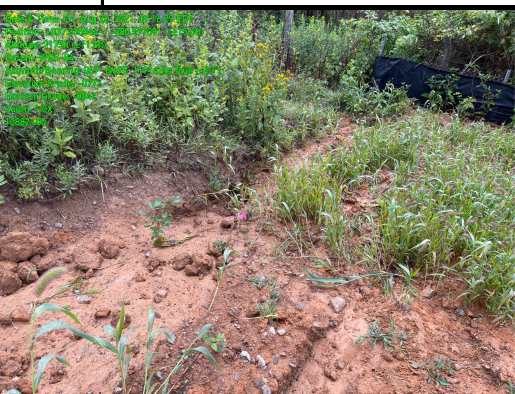
<p>Date &amp; Time: Fri Aug 20, 2021, 09:01:19 EDT Position: 43.323349° / -80.590634° (±15.5m) Altitude: 2631ft (±12.5m) Datum: WGS 84 Azimuth: 150.00° (±0.00°) Heading: 150.00° (±0.00°) Magnetic: 150.00° (±0.00°) True: 150.00° (±0.00°)</p>	
GPS Location	See Photo		GPS Location	See Photo	
Field Station#	10881+20		Field Station#	10882+00	
Pic 5 Desc.	Sump pit and CFS end treatment needing cleaned.		Pic 6 Desc.	Erosion rills along LOD needing repaired

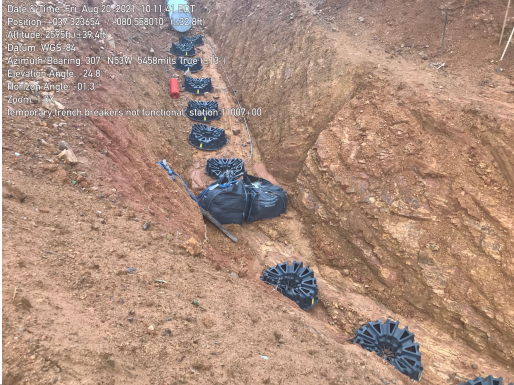
<p>Date &amp; Time: Fri, Aug 20, 2021, 10:37:41 EDT  Position: +037.325741° / -080.556299° (±32.8ft)  Altitude: 2345ft (±38.4m)  Datum: WGS-84  Azimuth Bearing: 240° S46W 4247mils True (±13°)  Elevation Angle: -9.0°  Horizon Angle: +00.2°  Zoom: 1.0x  Sump needs cleaned out station 10980+00</p>

<b>GPS Location</b> see photo		<b>GPS Location</b> see photo	
<b>Field Station#</b> 11007+00		<b>Field Station#</b> 10980+00	
<b>Pic 3 Desc.</b> Trench breaker needs repaired		<b>Pic 4 Desc.</b> Sump needs cleaned	
<p>Date &amp; Time: Fri, Aug 20, 2021, 11:19:29 EDT  Position: +037.355222° / -080.556299° (±16163.0m)  Altitude: 2290ft (±35.3m)  Datum: WGS-84  Azimuth Bearing: 184° S04W 3271mils True (±80°)  Elevation Angle: -11.3°  Horizon Angle: -01.0°  Zoom: 1.0x  Hammer needs wrapped 10947+00</p>

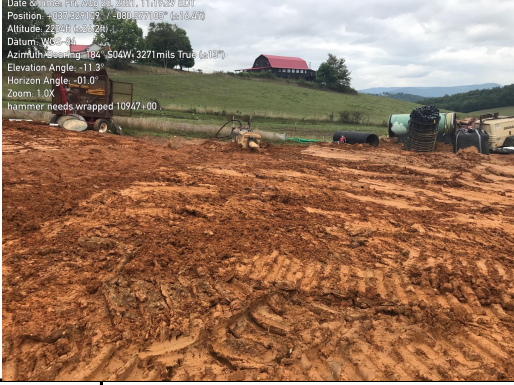
<p>Date &amp; Time: Fri, Aug 20, 2021, 13:01:09 EDT  Position: +037.314946° / -080.544218° (±16.4ft)  Altitude: 2178ft (±9.8ft)  Datum: WGS-84  Azimuth Bearing: 198° S18W 3520mils True (±14°)  Elevation Angle: -25.4°  Horizon Angle: -00.4°  Zoom: 1.0x  Rock on slope drains needs refreshed station 11061+83</p>

<b>GPS Location</b> see photo		<b>GPS Location</b> see photo	
<b>Field Station#</b> 10947+00		<b>Field Station#</b> 11061+83	
<b>Pic 5 Desc.</b> Hammer needs put in containment		<b>Pic 6 Desc.</b> Slope drain

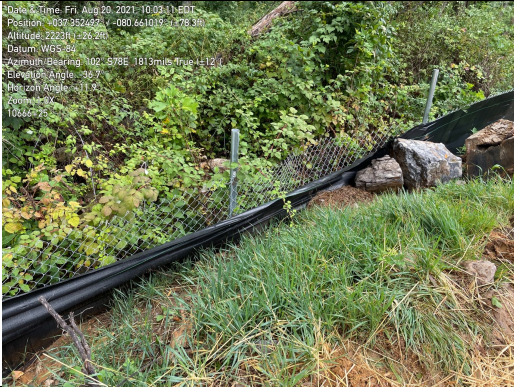
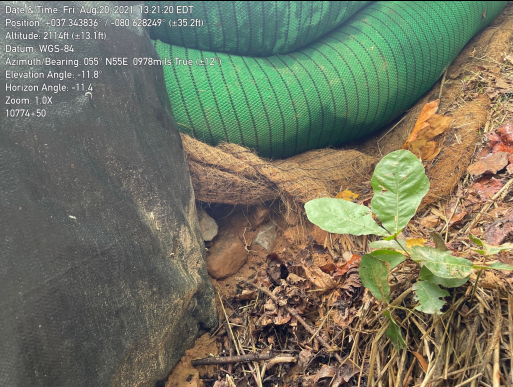
<p>Date &amp; Time: Fri Aug 20, 2021 13:21:20 EDT Position: +037.342636 / -080.628249 (+35.2ft) Altitude: 2114ft (+13.1ft) Datum: WGS-84 Azimuth/Bearing: 055 N55E 0978mils True (+12.1) Elevation Angle: -11.8 Horizon Angle: -11.4 Zoom: 1.0x 10774+50</p>			
<b>GPS Location</b>	See photo	<b>GPS Location</b>	See photo		
<b>Field Station#</b>	10666+25	<b>Field Station#</b>	10774+50		
<b>Pic 1 Desc.</b>	Supersilt silt fence fabric needs reattached to chain link	<b>Pic 2 Desc.</b>	End treatment undermined
