Visual Site Inspection Report

Project Name	H-600 Pipeline Spread G	AFE	124300137	Spread	H-600 Pipeline Spread G
Contractor	Precision			Report #	27618
Inspector	Clint Sears			Date/Time	8/23/2021 6:25 PM
Permit #	TBD	Inspection Type	VA SWPP	Station Begin	11064+53
State	VA	Inspection Area	Full	Station End	11254+99
County	Giles	Ground	Damp	Temperature (°F)	90.00
Municipality	N/A	Weather	Sunny	Rain Gauge (in)	0.00
				Rain Accumulation Time (days)	1.00

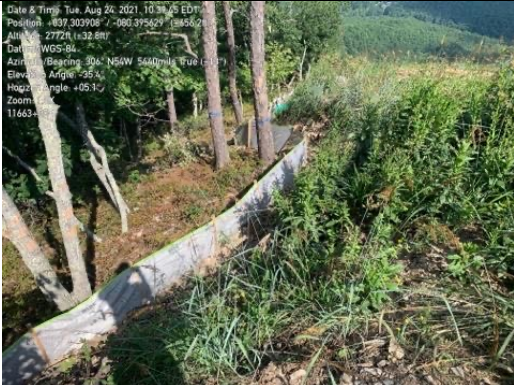
GPS Location	On photo	GPS Location	On photo		
Field Station#	11663+00	Field Station#	11665+00		
Pic 1 Desc.	Perimeter ECDs are in place.	Pic 2 Desc.	Sumps and end treatments are in acceptable condition.

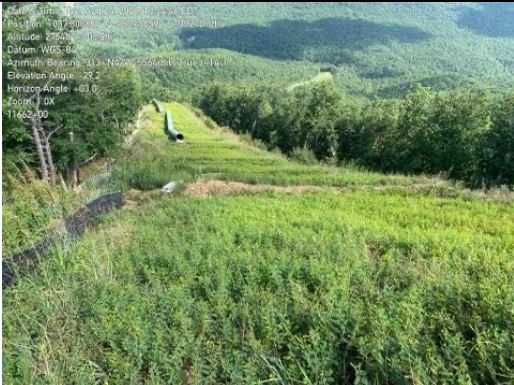
GPS Location	On photo	GPS Location	On photo		
Field Station#	11662+00	Field Station#	11658+00		
Pic 3 Desc.	No surface erosion. Slope breakers functional.	Pic 4 Desc.	Perimeter ECDs are in place.

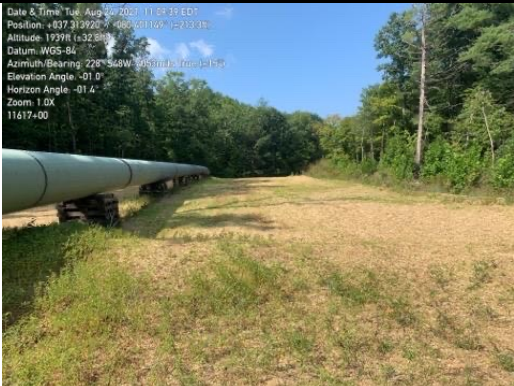
GPS Location	On photo	GPS Location	On photo		
Field Station#	11617+00	Field Station#	11626+04		
Pic 5 Desc.	Recently stabilized ROW on private tracts is stable.	Pic 6 Desc.	Resource buffers are stable. ECDs are in place.

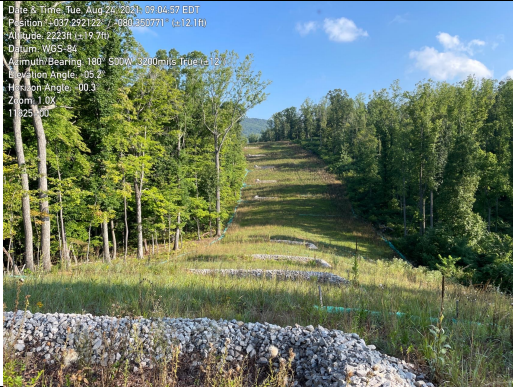
GPS Location		See photo		GPS Location	
Field Station#		11791+00		Field Station#	
Pic 1 Desc.		RCE in place		Pic 2 Desc.	
				Level spreaders in place	
<p>Date & Time: Tue, Aug 24, 2021, 05:45:00 EDT Position: +409.597554° / -86.336886° (s19.37) Altitude: 2231ft (s19.37) Datum: WGS-84 Azimuth/Bearing: 170° S10E 3022mils True (s12) Elevation Angle: -15.8 Horizon Angle: -03.5 Zoom: 1.0x 11906+00</p>

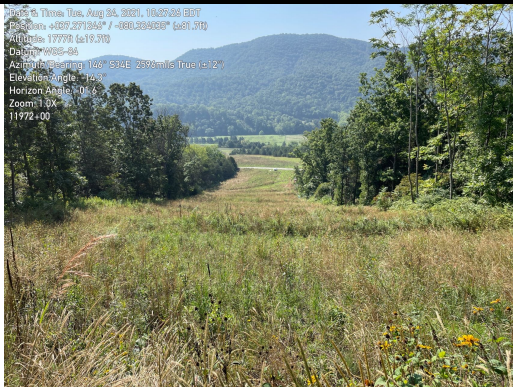
GPS Location		See photo		GPS Location	
Field Station#		11906+00		Field Station#	
Pic 3 Desc.		P1 silt fence perimeter control in place		Pic 4 Desc.	
				Waterbars in place	
<p>Date & Time: Tue, Aug 24, 2021, 06:38:10 EDT Position: +409.597554° / -86.336886° (s19.37) Altitude: 2164ft (s19.37) Datum: WGS-84 Azimuth/Bearing: 037° N23W 3991mils True (s12) Elevation Angle: -12.1 Horizon Angle: +01.3 Zoom: 1.0x 11820+00</p>

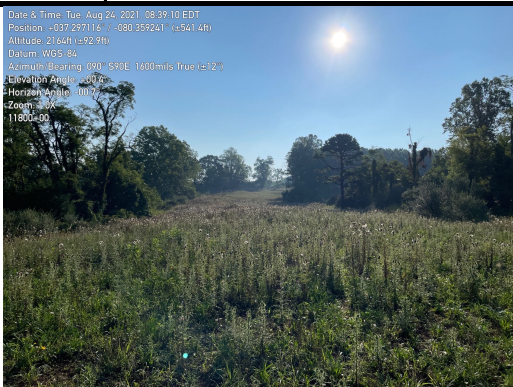
GPS Location		See photo		GPS Location	
Field Station#		11820+00		Field Station#	
Pic 5 Desc.		CFS perimeter control in place		Pic 6 Desc.	
				Good vegetation on ROW

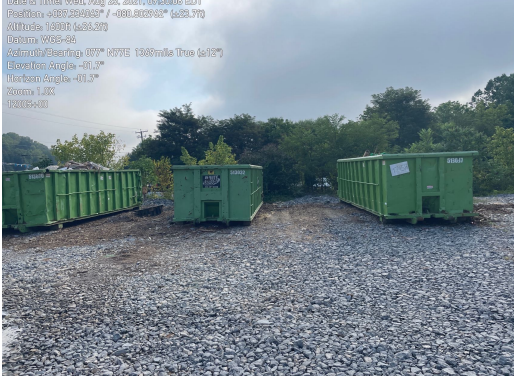
GPS Location	See photo	GPS Location	See photo		
Field Station#	12005+00	Field Station#	12005+00		
Pic 1 Desc.	Dumpsters in place	Pic 2 Desc.	CFS perimeter control in place

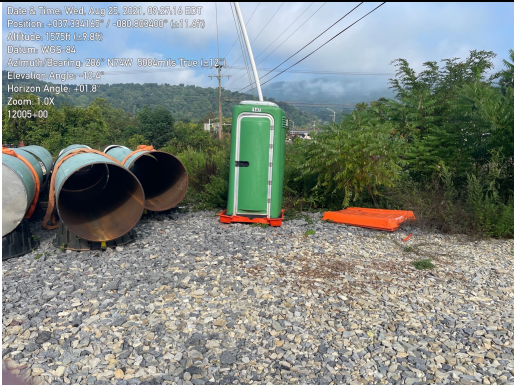
GPS Location	See photo	GPS Location	See photo		
Field Station#	12005+00	Field Station#	12005+00		
Pic 3 Desc.	Secondary containment in place	Pic 4 Desc.	Rock surface in acceptable condition

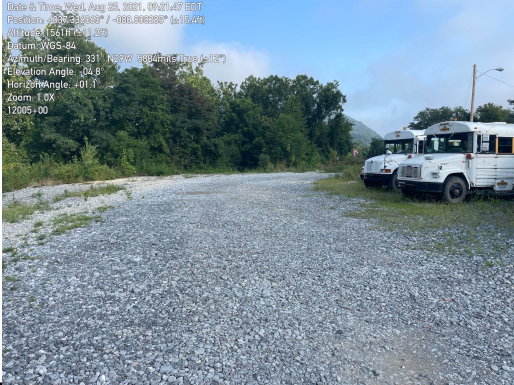
GPS Location	See photo	GPS Location	See photo		
Field Station#	12005+00	Field Station#	12005+00		
Pic 5 Desc.	RCE in place	Pic 6 Desc.	Inspected parked vehicles for any visible spills or leaks

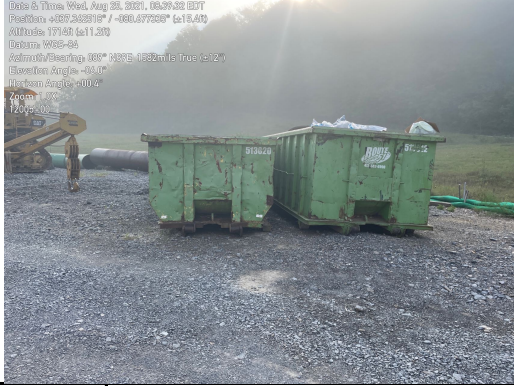
<p>Date & Time: Wed, Aug 25, 2021, 08:56:38 EDT Position: +37.345117° / -80.67762° (±11.4m) Altitude: 1734.8 (±11.5m) Datum: WGS-84 Azimuth: Bearing: 087° N45E 1032mils True (±12) Elevation Angle: -21.5° Horizon Angle: +00.7° Zoom: 1.0X 12005+00</p>			
GPS Location	See photo	GPS Location	See photo		
Field Station#	12005+00	Field Station#	12005+00		
Pic 1 Desc.	Culvert in place	Pic 2 Desc.	Dumpsters in place

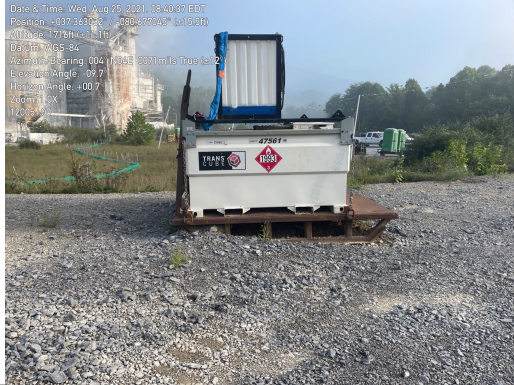
GPS Location	See photo	GPS Location	See photo		
Field Station#	12005+00	Field Station#	12005+00		
Pic 3 Desc.	Secondary containment in place	Pic 4 Desc.	Inspected fuel cell for any visible leaks or spills

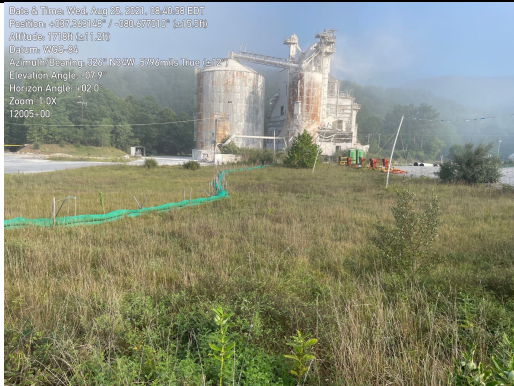
<p>Date & Time: Wed, Aug 25, 2021, 09:40:08 EDT Position: +37.345117° / -80.67762° (±11.4m) Altitude: 1710.0 (±11.4m) Datum: WGS-84 Azimuth: Bearing: 020° N45W 376mils True (±12) Elevation Angle: -07.9° Horizon Angle: +02.0° Zoom: 1.0X 12005+00</p>			
GPS Location	See photo	GPS Location	See photo		
Field Station#	12005+00	Field Station#	12005+00		
Pic 5 Desc.	Triple stack CFS perimeter control in place	Pic 6 Desc.	Triple stack CFS perimeter control in place

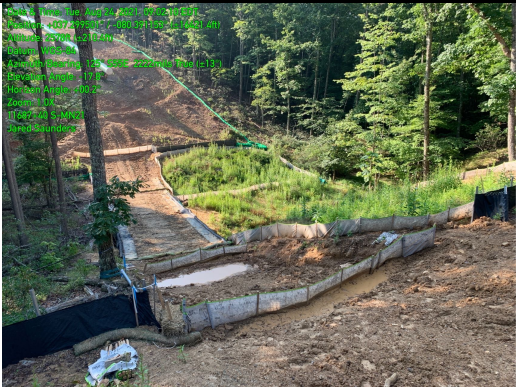
GPS Location	See photo for GPS location.		GPS Location	See photo for GPS location.	
Field Station#	11687+40		Field Station#	11688+25	
Pic 1 Desc.	Sensitive resource buffer in place at stream S-MN21.		Pic 2 Desc.	Waterbar, end treatment, and sump pit in place.

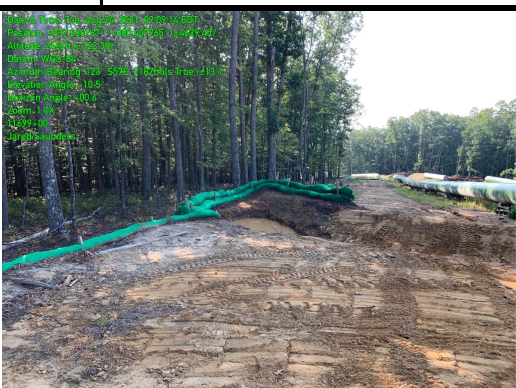
GPS Location	See photo for GPS location.		GPS Location	See photo for GPS location.	
Field Station#	11699+00		Field Station#	11704+10	
Pic 3 Desc.	Upgrade end treatment to triple stack 18 inch CFS due to being overwhelmed during rain events.		Pic 4 Desc.	Sensitive resource buffer in place at stream S-MN22.

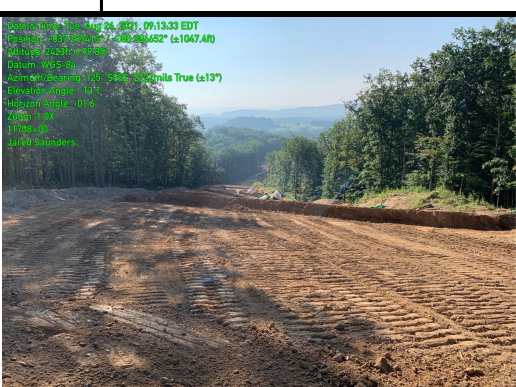
GPS Location	See photo for GPS location.		GPS Location	See photo for GPS location.	
Field Station#	11708+00		Field Station#	11767+00	
Pic 5 Desc.	Waterbars being added and current waterbars being reinstalled to 2-5% fall.		Pic 6 Desc.	RCE in place at Main Line Valve 26.

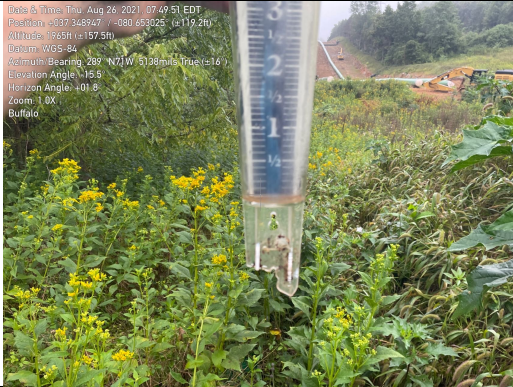
<p>Date & Time: Thu, Aug 26, 2021, 07:49:51 EDT Position: +037.34594° / -080.633025° (±11.9 2ft) Altitude: 2055ft (±157.5ft) Datum: WGS-84 Azimuth/Bearing: 289° N21°W 5138mils True (±1.6°) Elevation Angle: -15.5° Horizon Angle: -10.8° Zoom: 1.0x Buffalo</p>			
GPS Location	See photo	GPS Location	See photo		
Field Station#	10510+78	Field Station#	10698+77		
Pic 1 Desc.	AR 234 rain gauge	Pic 2 Desc.	Buffalo anklets rain gauge

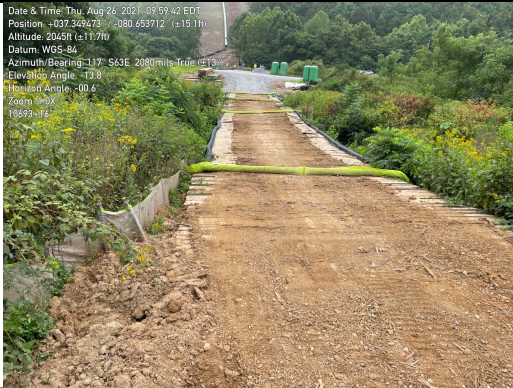
<p>Date & Time: Thu, Aug 26, 2021, 09:59:42 EDT Position: +037.34473° / -080.633712° (±15.1ft) Altitude: 2045ft (±11.7ft) Datum: WGS-84 Azimuth/Bearing: -117° S63°E 2080mils True (±1.3°) Elevation Angle: -13.8° Horizon Angle: -10.6° Zoom: 1.0x 10693+16</p>			
GPS Location	See photo	GPS Location	See photo		
Field Station#	10679+11	Field Station#	10693+16		
Pic 5 Desc.	Equipment bridge functional	Pic 6 Desc.	Equipment bridge functional

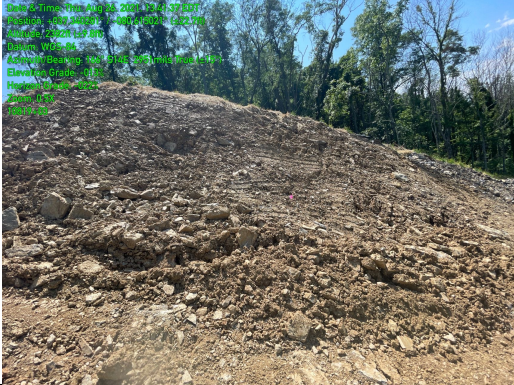
GPS Location	See Photo	GPS Location	See Photo		
Field Station#	10819+03	Field Station#	10900+80		
Pic 1 Desc.	View of additional stabilization needed.	Pic 2 Desc.	Silt fence needing to be properly adjacent to existing silt fence panels.

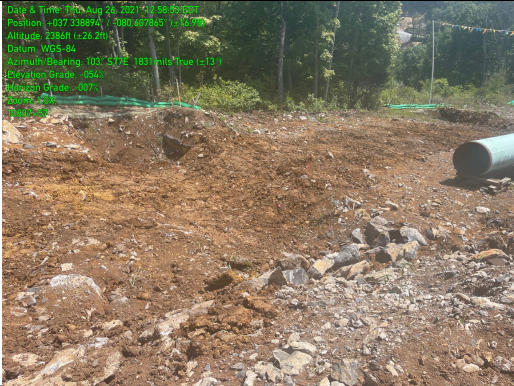
GPS Location	See Photo	GPS Location	See Photo		
Field Station#	10837+57	Field Station#	10844+33		
Pic 5 Desc.	Low spot in water bar.	Pic 6 Desc.	Undercut and no definitive water bar throat.

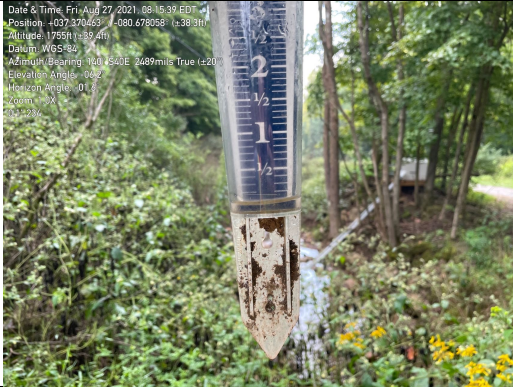
GPS Location	See photo	GPS Location	See photo		
Field Station#	10695+77	Field Station#	10510+78		
Pic 1 Desc.	Buffalo anklets rain gauge	Pic 2 Desc.	AR 234 rain gauge		
<p>Date & Time: Fri Aug 27, 2021, 16:18:02 EDT Position: +037.348453° / -080.648635° (+136.3m) Altitude: 2178ft (+210.0m) Datum: WGS-84 Azimuth/Bearing: 097° S83E 1724mils True (+13°) Elevation Angle: +03.2° Horizon Angle: +00.9° Zoom: 1.0X 10/12+39</p>
