# Visual Site Inspection Report

<b>Project Name</b>	H-600 Pipeline Spread G	<b>AFE</b>	124300137	<b>Spread</b>	H-600 Pipeline Spread G
<b>Contractor</b>	Precision			<b>Report #</b>	28422
<b>Inspector</b>	Clint Sears			<b>Date/Time</b>	9/13/2021 4:20 PM
<b>Permit #</b>	TBD	<b>Inspection Type</b>	VA SWPP	<b>Station Begin</b>	10859+34
<b>State</b>	VA	<b>Inspection Area</b>	Full	<b>Station End</b>	11064+53
<b>County</b>	Giles	<b>Ground</b>	Dry	<b>Temperature (°F)</b>	84.00
<b>Municipality</b>	N/A	<b>Weather</b>	Sunny	<b>Rain Gauge (in)</b>	0.00
				<b>Rain Accumulation Time (days)</b>	1.00

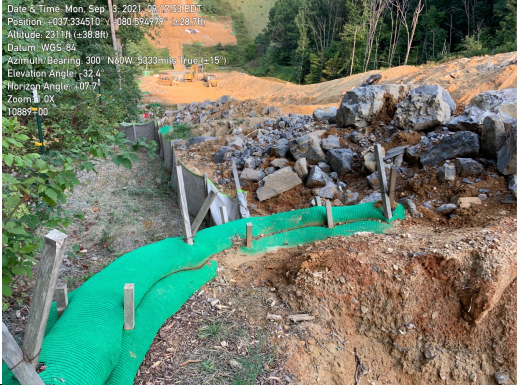
<b>GPS Location</b>	See photo		<b>GPS Location</b>	See photo	
<b>Field Station#</b>	10889+00		<b>Field Station#</b>	10917+60	
<b>Pic 7 Desc.</b>	Silt fence needs redone to allow water to exist the LOD		<b>Pic 8 Desc.</b>	Scouring behind CFS needs maintenance

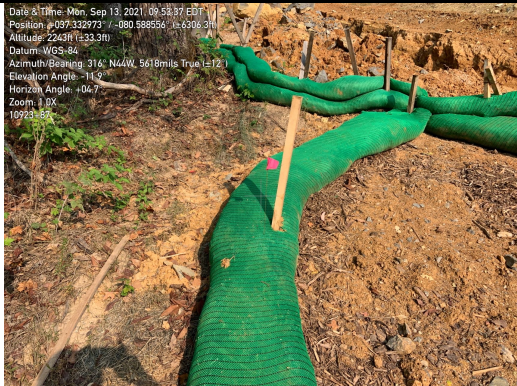
<b>GPS Location</b>	See photo		<b>GPS Location</b>	See photo	
<b>Field Station#</b>	10923+87		<b>Field Station#</b>	11025+00	
<b>Pic 9 Desc.</b>	Sediment behind CFS needs pulled back inside of controls		<b>Pic 10 Desc.</b>	Adequate resource signage

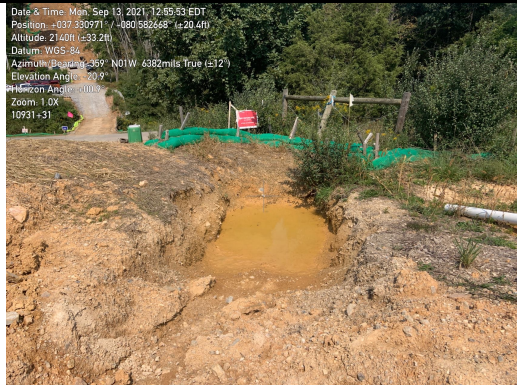
<b>GPS Location</b>	See photo		<b>GPS Location</b>	See photo	
<b>Field Station#</b>	10931+31		<b>Field Station#</b>	10887+00	
<b>Pic 11 Desc.</b>	Sump pit needs cleaned out		<b>Pic 12 Desc.</b>	Silt fence needs redone to allow water to exist off the LOD

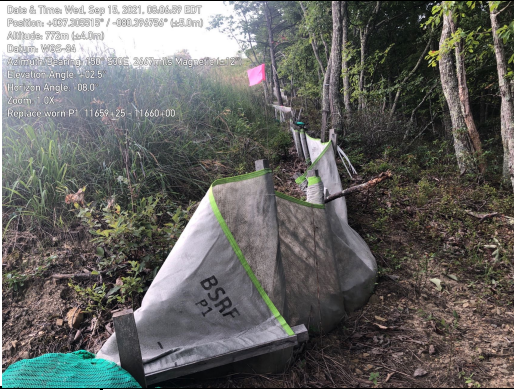
<b>GPS Location</b>	On photo	<b>GPS Location</b>	On photo		
<b>Field Station#</b>	11659+25	<b>Field Station#</b>	11655+50		
<b>Pic 1 Desc.</b>	Example of worn silt fence to be replaced.	<b>Pic 2 Desc.</b>	Sumps and end treatments are functioning as designed.

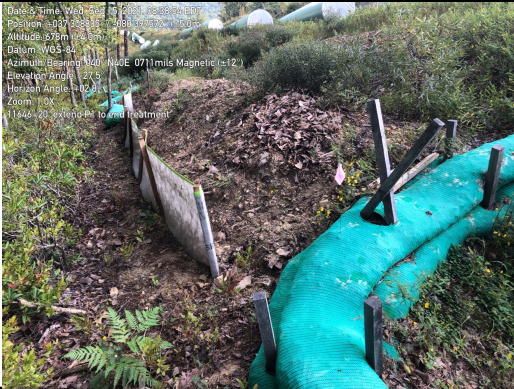
<b>GPS Location</b>	On photo	<b>GPS Location</b>	On photo		
<b>Field Station#</b>	11646+20	<b>Field Station#</b>	11630+00		
<b>Pic 3 Desc.</b>	Silt fence to be tied in correctly to end treatment.	<b>Pic 4 Desc.</b>	Slope stable. ECDs in place.

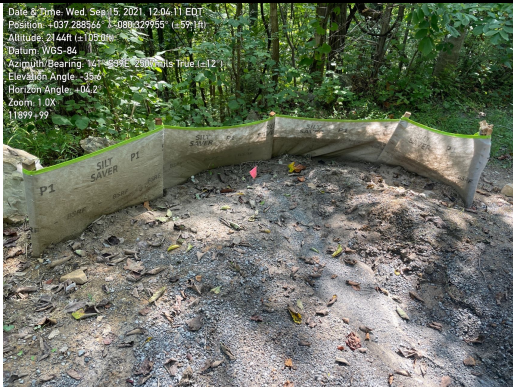
GPS Location				See photo				GPS Location				See photo			
Field Station#				11899+99				Field Station#				11790+00			
Pic 1 Desc.				Silt fence no longer filtering				Pic 2 Desc.				RCE in place

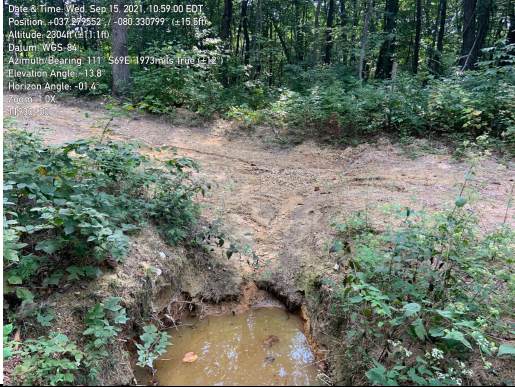
<b>GPS Location</b>	See photo	<b>GPS Location</b>	See photo		
<b>Field Station#</b>	11930+00	<b>Field Station#</b>	11930+00		
<b>Pic 7 Desc.</b>	Vehicle ruts on AR266 need graded	<b>Pic 8 Desc.</b>	Sediment needs clean from throat of water bar		
<small>Date &amp; Time: Wed, Sep 15, 2021, 11:04:54 EDT Position: +037.278547 / -080.322289 (±15.4ft) Altitude: 2250ft (±11.3ft) Datum: WGS-84 Azimuth/Bearing: 309° N51W 4493mils True (±3.7°) Elevation Angle: +22.4° Horizon Angle: +05.4° Zoom: 1.0X 11930+00</small>

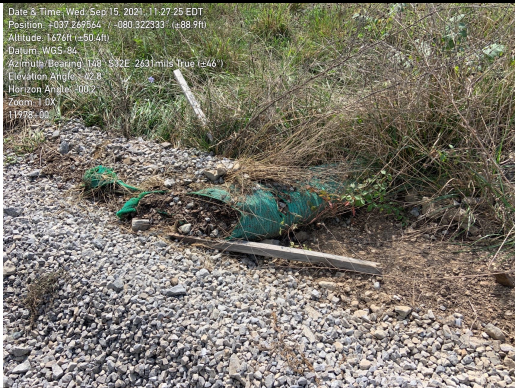
<b>GPS Location</b>	See photo	<b>GPS Location</b>	See photo		
<b>Field Station#</b>	11930+00	<b>Field Station#</b>	11978+00		
<b>Pic 9 Desc.</b>	P1 silt fence needs replaced	<b>Pic 10 Desc.</b>	Damaged CFS needs removed		
Insert image here		Insert image here			
<b>GPS Location</b>		<b>GPS Location</b>			
<b>Field Station#</b>		<b>Field Station#</b>			
<b>Pic 11 Desc.</b>		<b>Pic 12 Desc.</b>

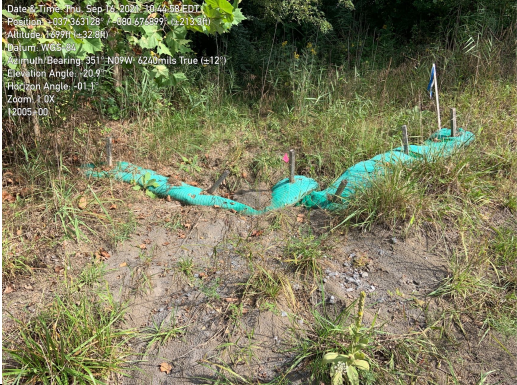
<p>Insert image here</p>			
<b>GPS Location</b>	See photo	<b>GPS Location</b>			
<b>Field Station#</b>	12005+00	<b>Field Station#</b>			
<b>Pic 7 Desc.</b>	CFS needs replaced along AR238.01	<b>Pic 8 Desc.</b>			
<p>Insert image here</p>		<p>Insert image here</p>			
<b>GPS Location</b>		<b>GPS Location</b>			
<b>Field Station#</b>		<b>Field Station#</b>			
<b>Pic 9 Desc.</b>		<b>Pic 10 Desc.</b>			
<p>Insert image here</p>		<p>Insert image here</p>			
<b>GPS Location</b>		<b>GPS Location</b>			
<b>Field Station#</b>		<b>Field Station#</b>			
<b>Pic 11 Desc.</b>		<b>Pic 12 Desc.</b>

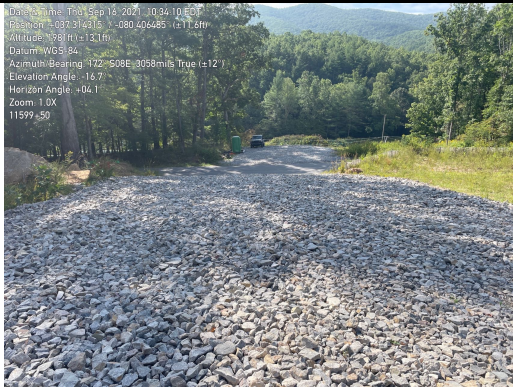
<p>Date &amp; Time: Thu, Sep 16, 2021, 10:34:10 EDT Position: -037.316313° / -080.406485° (-11.1m) Altitude: 2361ft (-13.1m) Datum: WGS 84 Azimuth/Bearing: 122° S08E 3058mils True (-12°) Elevation Angle: -16.7° Horizon Angle: +04.1° Zoom: 1.0x 11599+50</p>			
GPS Location		See photo				GPS Location		See photo							
Field Station#		11532+75				Field Station#		11599+50							
Pic 1 Desc.		Additional controls need installed at low spot				Pic 2 Desc.		RCE in place
