Visual Site Inspection Report

Project Name	H-600 Pipeline Spread G	AFE	124300137	Spread	H-600 Pipeline Spread G
Contractor	Precision			Report #	28117
Inspector	Clint Sears			Date/Time	9/6/2021 10:08 AM
Permit #	TBD	Inspection Type	VA SWPP	Station Begin	12005+00
State	VA	Inspection Area	Full	Station End	12005+00
County	Giles	Ground	Damp	Temperature (°F)	79.00
Municipality	N/A	Weather	Cloudy	Rain Gauge (in)	0.10
				Rain Accumulation Time (days)	1.00

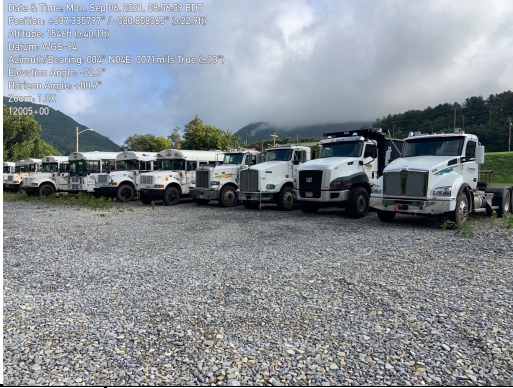
<p>Date & Time: Mon, Sep 06, 2021, 08:06:57 EDT Position: +037.334291° / -080.800742° (-213.3ft) Altitude: 1546ft (+54.6ft) Datum: WGS-84 Azimuth/Bearing: 106.704° 304mils True (+14°) Elevation Angle: +33.7° Horizon Angle: +00.8° Zoom: 1.0X 12005+00</p>			
GPS Location	See photo	GPS Location	See photo		
Field Station#	12005+00	Field Station#	12005+00		
Pic 1 Desc.	Safety fence and CFS functional	Pic 2 Desc.	Contractor vehicles parked at RCE

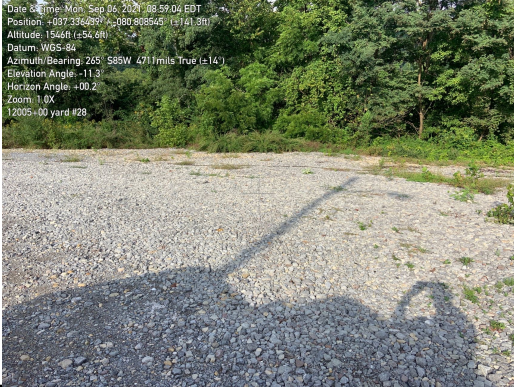
GPS Location	See photo	GPS Location	See photo		
Field Station#	12005+00	Field Station#	12005+00		
Pic 3 Desc.	RCE clean and functional	Pic 4 Desc.	CFS along access road functional

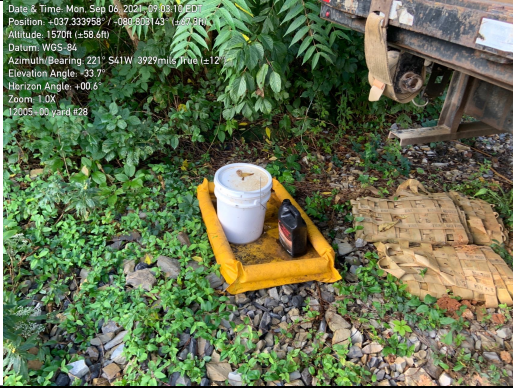
<p>Date & Time: Mon, Sep 06, 2021, 09:10:11 EDT Position: +037.334291° / -080.800742° (-213.3ft) Altitude: 1570ft (+58.6ft) Datum: WGS-84 Azimuth/Bearing: 221.541° 3929mils True (+12°) Elevation Angle: +33.7° Horizon Angle: +00.8° Zoom: 1.0X 12005+00 yard #28</p>			
GPS Location	See photo	GPS Location	See photo		
Field Station#	12005+00	Field Station#	12005+00		
Pic 5 Desc.	Trash contained in dumpsters as required	Pic 6 Desc.	Liquids stored in secondary containment

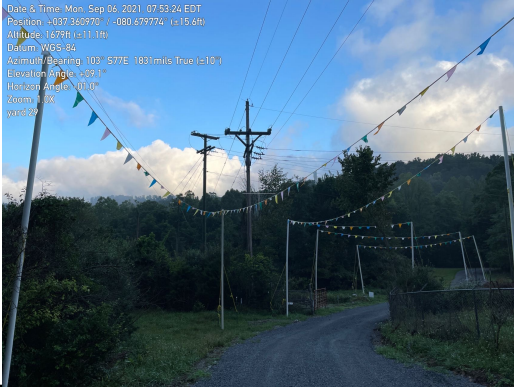
GPS Location	See photo	GPS Location	See photo		
Field Station#	12005+00	Field Station#	12005+00		
Pic 3 Desc.	Goal poles in place	Pic 4 Desc.	Broad base dips functional		
<p>Date & Time: Mon, Sep 06, 2021, 07:50:52 EDT Position: +037.362973 / -080.679774 (-15.6m) Altitude: 1710ft (+11.3m) Datum: WGS-84 Azimuth/Bearing: 141° S39E 2507mils True (+10°) Elevation Angle: -14.5° Horizon Angle: -05.3° Zoom: 1.0X yard 29</p>

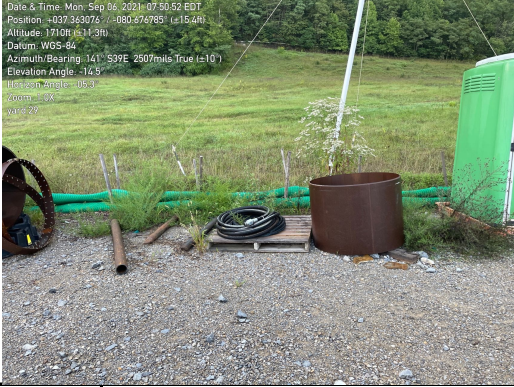
GPS Location	See photo	GPS Location	See photo		
Field Station#	1205+00	Field Station#	1205+00		
Pic 5 Desc.	Triple stack CFS in place	Pic 6 Desc.	RCE & CFS functional

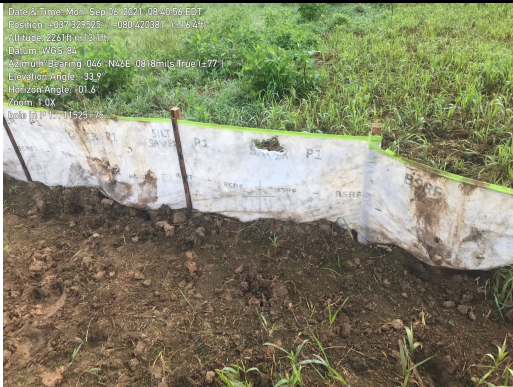
<p>Date & Time: Mon, Sep 06, 2021, 08:22:32 EDT Position: +037.325922° / -080.426381° (-16.4ft) Altitude: 2327ft (-9.5ft) Datum: WGS-84 Azimuth Bearing: 162° S18E 2880mils True (-2.5°) Elevation Angle: -27.5° Horizon Angle: 100.3° Zoom: 1.0X 11528+00</p>			
GPS Location		See photo		GPS Location see photo	
Field Station#		11525+75		Field Station# 11528+00	
Pic 1 Desc.		P1 needs repaired		Pic 2 Desc. Sock undermined

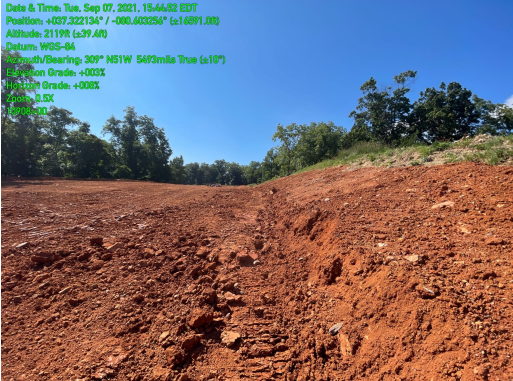
<p>Date & Time: Tue, Sep 07, 2021, 15:46:52 EDT Position: +037.322134° / -080.603254° (±1.6991.0m) Altitude: 2119ft (±39.4m) Datum: WGS-84 Azimuth/Bearing: 309° NS1W 5493mils True (±10°) Elevation Grade: +000% Horizontal Grade: +000% Pitch: 0.0° Roll: 0.0° Mag: 10908+00</p>			
GPS Location	See Photo		GPS Location	See Photo	
Field Station#	10860+54		Field Station#	10908+00	
Pic 1 Desc.	View of water bar needing maintenance to required permit conditions		Pic 2 Desc.	View of raw soil needing stabilization

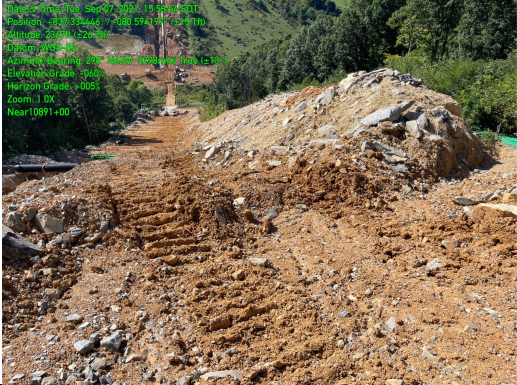
Insert image here			
GPS Location	See Photo	GPS Location	See Photo		
Field Station#	10891+00	Field Station#			
Pic 7 Desc.	View of damaged water bar from equipment traffic.	Pic 8 Desc.			
Insert image here		Insert image here			
GPS Location	See Photo	GPS Location	See Photo		
Field Station#		Field Station#			
Pic 9 Desc.		Pic 10 Desc.			
Insert image here		Insert image here			
GPS Location		GPS Location			
Field Station#		Field Station#			
Pic 11 Desc.		Pic 12 Desc.

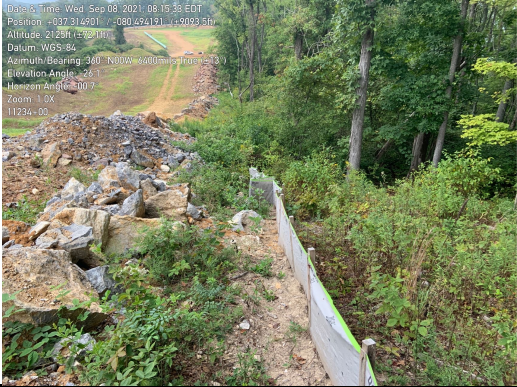
<p>Date & Time: Wed, Sep 08, 2021, 09:15:35 EDT Position: +037.314901, -080.474131, +900.3ft Altitude: 2125ft (+900.3ft) Datum: WGS-84 Azimuth/Bearing: 360° North 2400mils True (+13.1°) Elevation Angle: +24.0° Horizon Angle: +00.7° Zoom: 1.0X 11234+00</p>			
GPS Location	See photo	GPS Location	see photo		
Field Station#	11229+25	Field Station#	11234+00		
Pic 7 Desc.	Water bar needs maintenance	Pic 8 Desc.	P1 silt fence functional

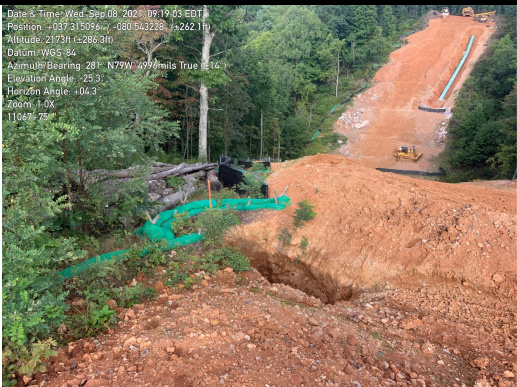
<p>Date & Time: Wed, Sep 08, 2021, 09:19:43 EDT Position: +037.315096, -080.543228, +262.1ft Altitude: 2173ft (+262.1ft) Datum: WGS-84 Azimuth/Bearing: 201° N79W 4998mils True (+12.1°) Elevation Angle: +25.3° Horizon Angle: +04.3° Zoom: 1.0X 11067+75</p>			
GPS Location	See photo	GPS Location	See photo		
Field Station#	11077+45	Field Station#	11067+75		
Pic 11 Desc.	Temporary stabilization of subsoil adequate	Pic 12 Desc.	Sump pit, CFS and SSF functional

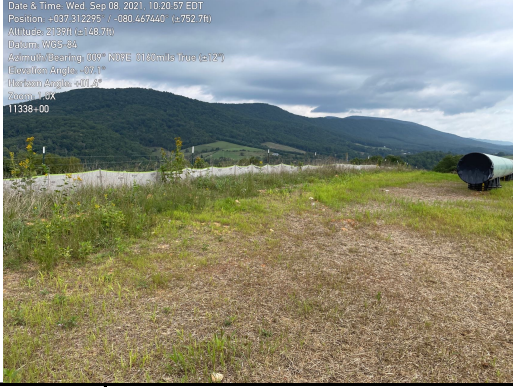
<p>Date & Time: Wed, Sep 08, 2021, 10:20:57 EDT Position: +037.312295 / -080.457448 (+19.2ft) Altitude: 2333ft (+26.2ft) Datum: WGS-84 Azimuth/Bearing: 300° N48E -8100mils True (+12.1) Elevation Angle: -02.1 Horizon Angle: -00.4 Zoom: 1.0x 11338+00</p>			
GPS Location	See photo	GPS Location	See photo		
Field Station#	11317+00	Field Station#	11338+00		
Pic 5 Desc.	Triple protection ECDs in place at karst feature	Pic 6 Desc.	P1 silt fence perimeter control in place

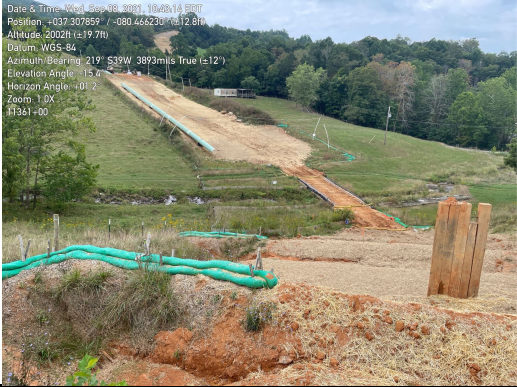
GPS Location		See photo		GPS Location	
Field Station#		11361+00		Field Station#	
Pic 7 Desc.		End treatments in place		Pic 8 Desc.	
				Permanent waterbar with level spreader in place	
<p>Date & Time: Wed, Sep 08, 2021, 11:45:03 EDT Position: +037.219547° / -080.459201° (+25.4ft) Altitude: 2207ft (+20.2ft) Datum: WGS-84 Azimuth Bearing: 003° R03E 1150mils True (+12°) Elevation Angle: +20.9° Horizon Angle: +02.0° Zoom: 1.0X 11410+00</p>

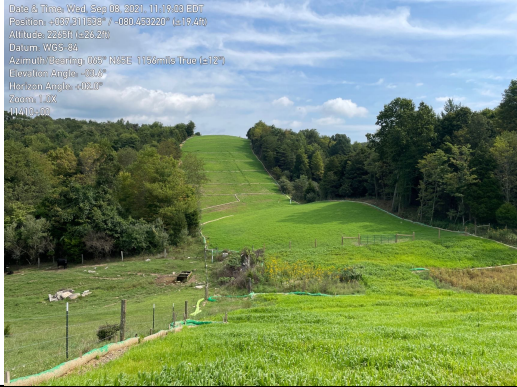
GPS Location		See photo		GPS Location	
Field Station#		11410+00		Field Station#	
Pic 9 Desc.		CFS controls in place		Pic 10 Desc.	
				CFS perimeter control in place	
<p>Date & Time: Wed, Sep 08, 2021, 12:21:45 EDT Position: +037.222284° / -080.455811° (+16.0ft) Altitude: 2331ft (+11.5ft) Datum: WGS-84 Azimuth Bearing: 003° R03E 1707mils True (+12°) Elevation Angle: +15.1° Horizon Angle: +05.0° Zoom: 1.0X 11477+00</p>

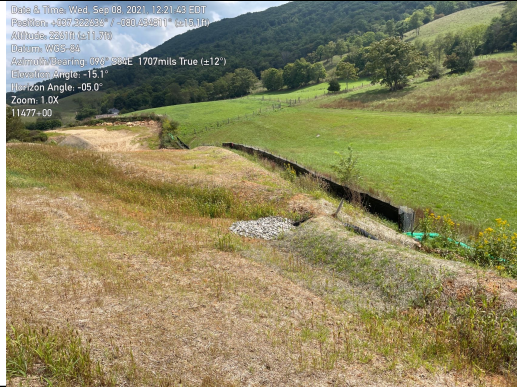
GPS Location		See photo		GPS Location	
Field Station#		11477+00		Field Station#	
Pic 11 Desc.		Stone inlet protection in place		Pic 12 Desc.	
				Stream buffer in place
