Visual Site Inspection Report

Project Name	H-600 Pipeline Spread H	AFE	124300138	Spread	H-600 Pipeline Spread H
Contractor	Precision			Report #	25774
Inspector	Jonathan Altizer			Date/Time	7/12/2021 6:30 PM
Permit #	TBD	Inspection Type	VA SWPP	Station Begin	13024+00
State	VA	Inspection Area	Partial	Station End	13141+65
County	Roanoke	Ground	Damp	Temperature (°F)	83.00
Municipality	N/A	Weather	Sunny	Rain Gauge (in)	0.60
				Rain Accumulation Time (days)	2.00

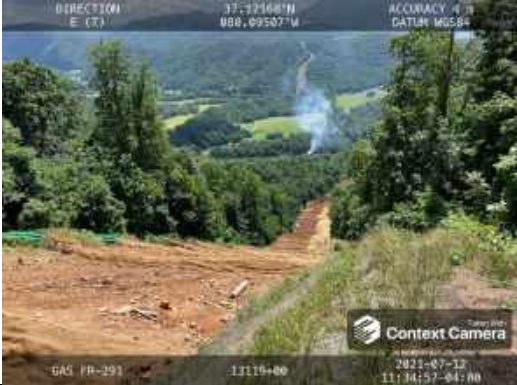
GPS Location	See photo		GPS Location	See photo	
Field Station#	13119+00		Field Station#	13137+00	
Pic 13 Desc.	Current ROW conditions on GAS FR-291		Pic 14 Desc.	Current ROW conditions on CIS of FR-292

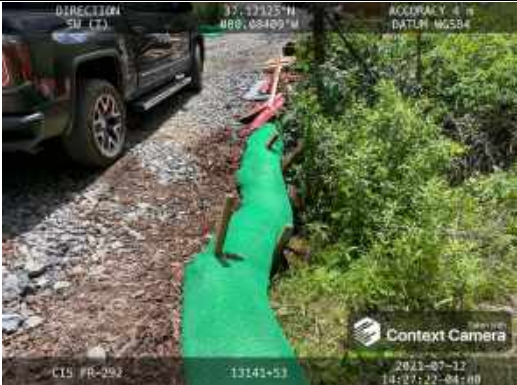
GPS Location	See photo		GPS Location	See photo	
Field Station#	13141+53		Field Station#	13141+53	
Pic 17 Desc.	Triple Stack CFS along FR-292 fallen down slope towards stream. Needs to be relocated upslope.		Pic 18 Desc.	CFS has been moved upslope and re-staked

7. Identify all remedial measures that have been taken since the previous inspection was conducted.					
Comments (Reference above questions as appropriate.)					
<p>The VADEQ required SWPPP Inspection was performed on this date. An inspection was performed from Station 13024+00 to Station 13141+65. Stream Crossings included in the inspection were S-G24, S-G25, S-H1, S-G26, S-G27, S-RR18, S-RR16, S-EF17, S-D17 and S-D14. There were no issues or impacts observed at stream crossings. Access roads FR-289, FR-290, FR-291, and FR-292 were inspected and no issues observed. RCEs and perimeter controls were well maintained. The ROW from Station 13024+00 to Station 13044+00 and Station 13061+00 to Station 13064+00 is still in temporary stabilization. Stabilization observed appeared to be adequate and no issues were found. The ROW from Station 13044+00 to Station 13061+00 and Station 13064+00 to Station 13113+00 has been restored. The vegetation in this area appeared to be well established and maturing. Permanent ECDs appeared to be in compliance and functional. PPL crews were actively working between FR-291 and FR-292. ECDs were installed and functional. At Station 13126+00, a French Drain has been installed to allow water from seap to be collected and discharged. All waterbars were reinstalled at the end of the day. An operator was actively spreading new gravel on Access Road FR-292 where gravel has been displaced. Stockpiles were stabilized.</p> <p>On Access Road FR-290 (Station 13141+53), triple stack CFS has been pushed downslope from construction traffic and is nearly touching stream that runs adjacent to Adney Gap Road. This CFS needs to be moved back upslope and re-staked. This item was added to the Punch List as a 72 Hour maintenance item. This item was completed by the end of the day.</p>

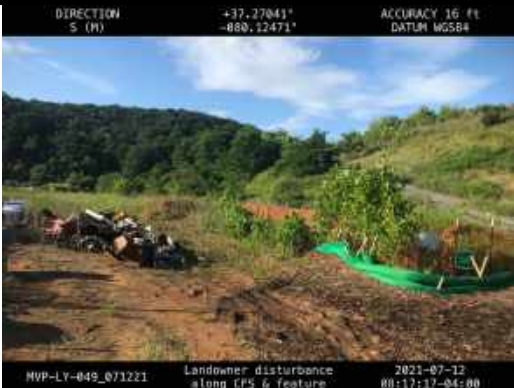
GPS Location	MVP-LY-049 See photo for gps data		GPS Location	MVP-LY-049 See photo for gps data	
Field Station#	+0		Field Station#	+0	
Pic 3 Desc.	Landowner soil disturbance along edge of feature W-CV21A. Area not stabilized. Looking NW.		Pic 4 Desc.	Landowner soil disturbance in 2 locations west of feature W-CV21B. Areas not stabilized. Looking SW.
