Visual Site Inspection Report

Project Name	H-600 Pipeline Spread H	AFE	124300138	Spread	H-600 Pipeline Spread H
Contractor	Precision			Report #	26088
Inspector	Jonathan Altizer			Date/Time	7/19/2021 6:48 PM
Permit #	TBD	Inspection Type	VA SWPP	Station Begin	12638+00
State	VA	Inspection Area	Partial	Station End	12868+00
County	Roanoke	Ground	Damp	Temperature (°F)	75.00
Municipality	N/A	Weather	Cloudy	Rain Gauge (in)	0.00
				Rain Accumulation Time (days)	2.00

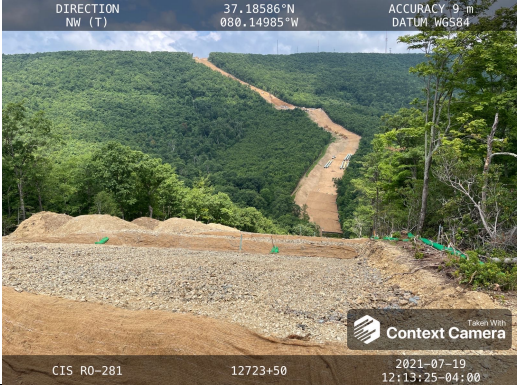
GPS Location	See photo		GPS Location	See photo	
Field Station#	12723+50		Field Station#	12742+50	
Pic 7 Desc.	Current ROW condition on CIS RO-281		Pic 8 Desc.	Buffer at Stream S-EF34B on GAS RO-281

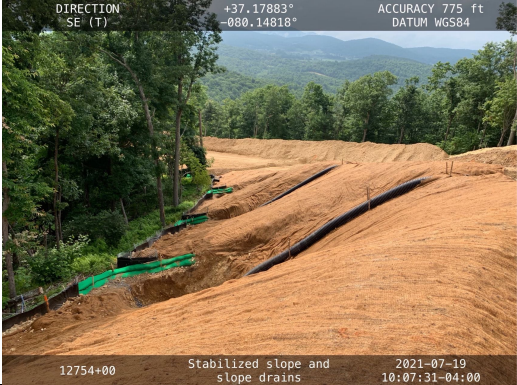
GPS Location	See photo		GPS Location	See photo	
Field Station#	12754+00		Field Station#	12756+00	
Pic 13 Desc.	Fill Slope stabilized and slope drains functional		Pic 14 Desc.	Current ROW conditions on CIS RO-282

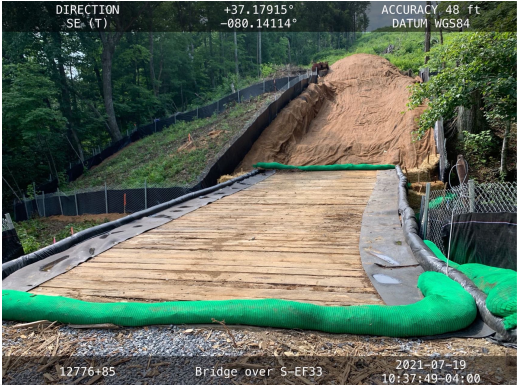
GPS Location	See photo		GPS Location	See photo	
Field Station#	12776+85		Field Station#	12776+85	
Pic 15 Desc.	Bridge over Stream S-EF33 on GAS RO-282		Pic 16 Desc.	Stream S-EF33 on GAS RO-282

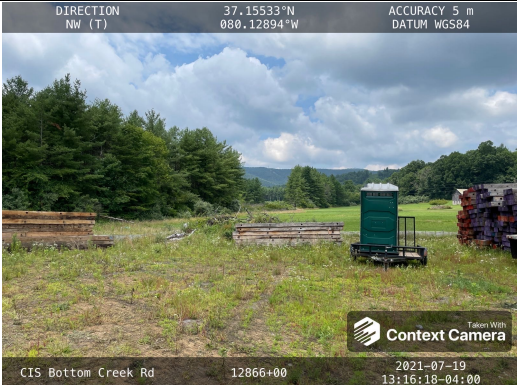
GPS Location	See photo		GPS Location	See photo	
Field Station#	12866+00		Field Station#	12867+00	
Pic 17 Desc.	Current ROW conditions on CIS Bottom Creek Road		Pic 18 Desc.	Current ROW condition on GAS Bottom Creek Road

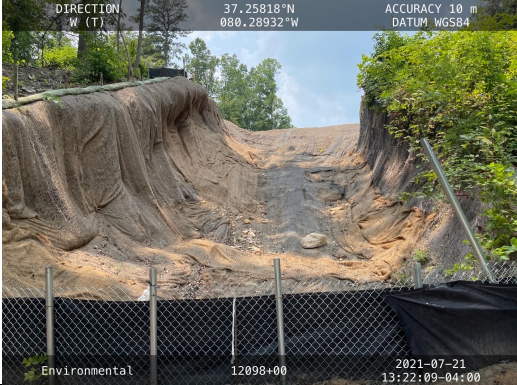
GPS Location	See photo		GPS Location	See photo	
Field Station#	12098+00		Field Station#	12098+44	
Pic 7 Desc.	Stabilized cut bank in acceptable condition		Pic 8 Desc.	Bridge and ECDs crossing stream S-MM13 in acceptable condition

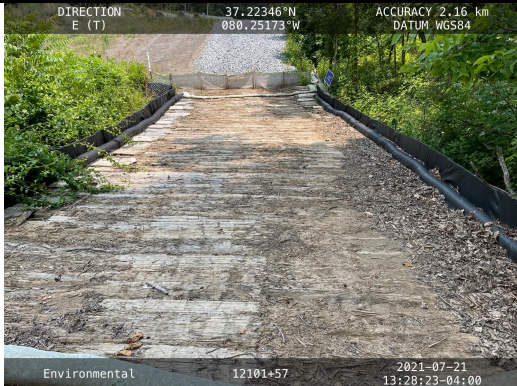
GPS Location	See photo		GPS Location	See photo	
Field Station#	12101+57		Field Station#	12102+00	
Pic 9 Desc.	Bridge and ECDs at stream crossing S-MM11 in acceptable condition		Pic 10 Desc.	RCE clean and in acceptable condition

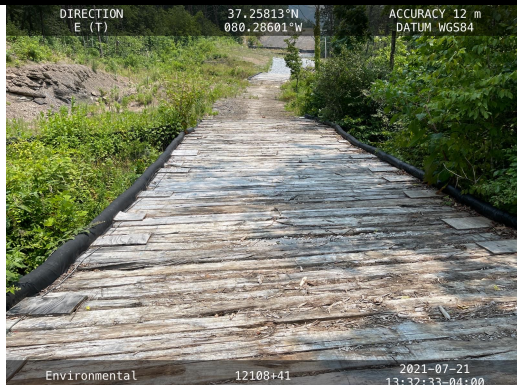
GPS Location	See photo		GPS Location	See photo	
Field Station#	12108+41		Field Station#	12112+13	
Pic 11 Desc.	Bridge and ECDs crossing stream S-F15 in acceptable condition		Pic 12 Desc.	Bridge and ECDs crossing stream S-F16A/B in acceptable condition

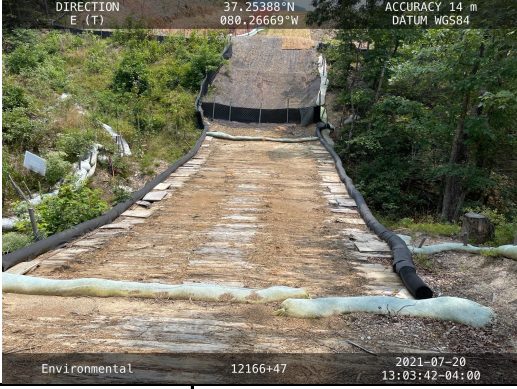
GPS Location	See photo		GPS Location	See photo	
Field Station#	12173+00		Field Station#	12166+47	
Pic 9 Desc.	Stabilized ROW in acceptable condition		Pic 10 Desc.	Bridge and ECDs at stream crossing S-C24 in acceptable condition

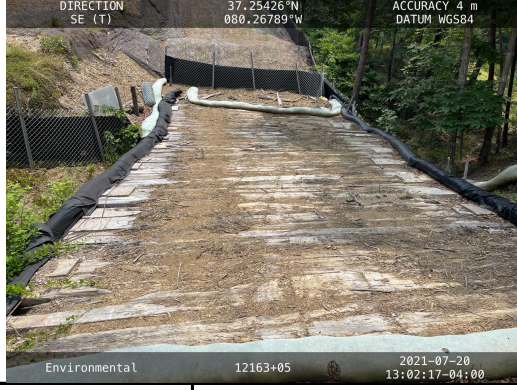
GPS Location	See photo		GPS Location	see photo	
Field Station#	12163+05		Field Station#	12158+40	
Pic 11 Desc.	Bridge and ECDs at stream crossing S-C25 in acceptable condition		Pic 12 Desc.	Clean water crossing in acceptable condition

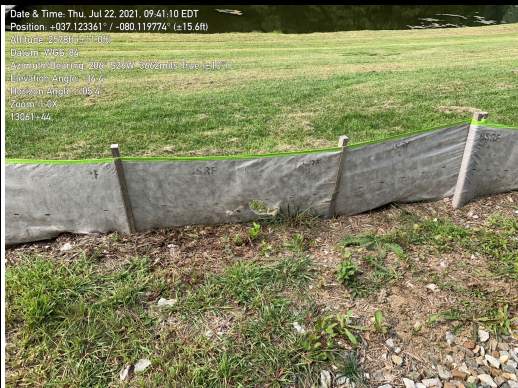
GPS Location	0	GPS Location	0		
Field Station#	13061+44	Field Station#	13008+00		
Pic 9 Desc.	72 hour maintenance item, repair holes in P1 along access road MVP-FR-290		Pic 10 Desc.	ROW and ECDs in good condition, with good vegetation established across ROW	
<p>Date & Time: Thu, Jul 22, 2021, 10:09:11 EDT Position: +437.12193° / -88.09970° (±14.9m) Altitude: 3330 (±3.1m) Datum: WGS-84 Azimuth/Bearing: 112° 58'E 1931mils True (±12°) Elevation Angle: +11.0° Horizon Angle: +02.9° Zoom: 1.0X 13115+97</p>

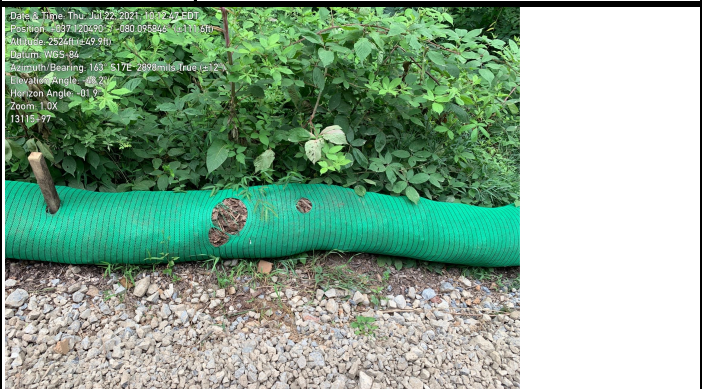
GPS Location	0	GPS Location	0		
Field Station#	13115+97	Field Station#	13115+97		
Pic 11 Desc.	ROW and ECDs in good condition, ROW is stable		Pic 12 Desc.	72 hour maintenance item, repair holes and tears in Sock along access road MVP-FR-291

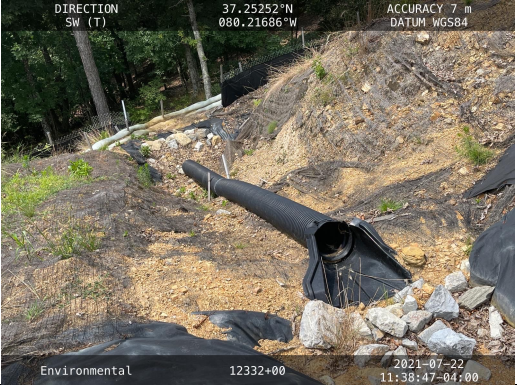
GPS Location	See photo		GPS Location	See photo	
Field Station#	12355+00		Field Station#	12332+00	
Pic 13 Desc.	Stabilized Row in acceptable condition		Pic 14 Desc.	Fill slope drain in acceptable condition

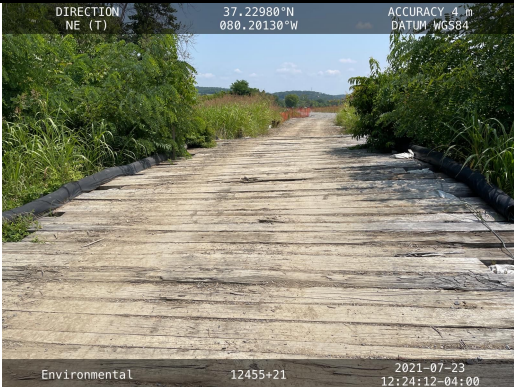
GPS Location	See photo		GPS Location	See photo	
Field Station#	12455+21		Field Station#	12461+81	
Pic 1 Desc.	Bridge and ECDs crossing stream S-CD12b in acceptable condition		Pic 2 Desc.	Wetland W-KL58 in acceptable condition

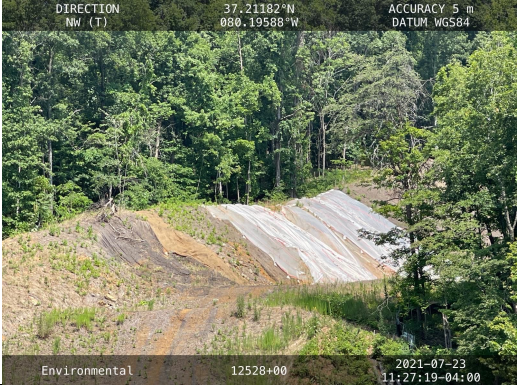
GPS Location	See photo		GPS Location	See photo	
Field Station#	12528+00		Field Station#	12534+00	
Pic 13 Desc.	Plastic covered spoil pile in acceptable condition		Pic 14 Desc.	Stabilized Row in acceptable condition

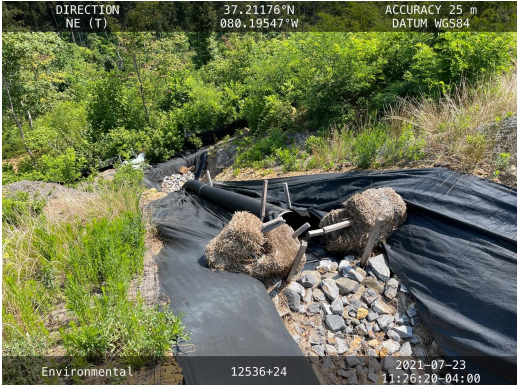
GPS Location	See photo		GPS Location	See photo	
Field Station#	12536+24		Field Station#	12542+00	
Pic 15 Desc.	Slope drain pipe in acceptable condition		Pic 16 Desc.	Plastic covered spoil pile in acceptable condition
